EAST CAROLINA UNIVERSITY

Facility Condition Assessment

Cardiovascular Building
Asset CARD

Inspected November 6, 2018

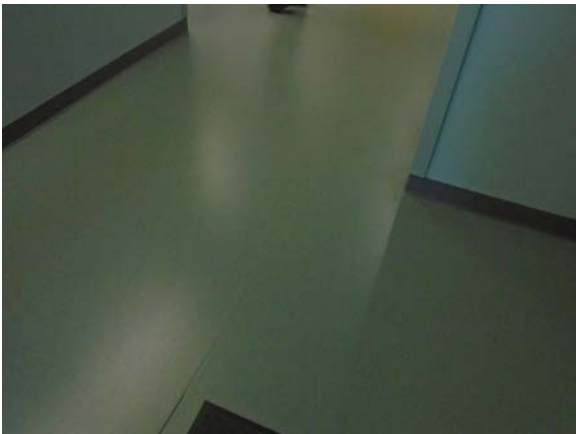
The interior finishes are mostly original and in good condition. The office suites, public waiting rooms, conference rooms, and administrative support areas typically have carpeting. While in good condition, the carpeting dating to 2009 will likely require replacement within the next ten years. The newer carpeting should outlast the scope of this report. Carpeting in higher traffic areas will always need more frequent replacement. Labs and exam rooms have 12-inch vinyl tile or sheet vinyl, and the main lobby and auditorium prefunction area have terrazzo flooring. Restrooms typically have ceramic tile on the floors and lower wall section. Some of the smaller single-occupant restrooms in the patient areas have vinyl floor tile. The original sheet vinyl has some areas with separating seams and should be replaced within the next ten years.

CARD023a 11/6/2018
Seams opening up in sheet flooring
Fourth floor

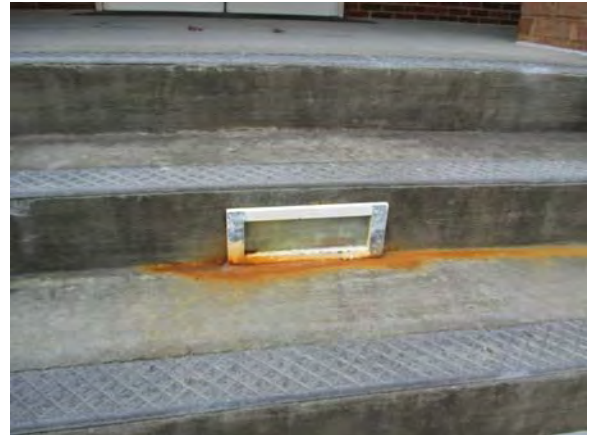
Exterior areas are illuminated by original CFL wall-mounted, recessed ceiling, and recessed step fixtures. Modern LED wall-mounted, post, and stanchion lights were added later. The LED lighting should outlast the scope of this report, while the original fixtures should be scheduled for replacement in the next six to eight years. Install energy-efficient fixtures with photocell activation. Also, the loading dock steps are not illuminated. Install an LED fixture to provide a safe environment for building users.

CARD104e 11/6/2018
Corroding exterior step light
East exterior

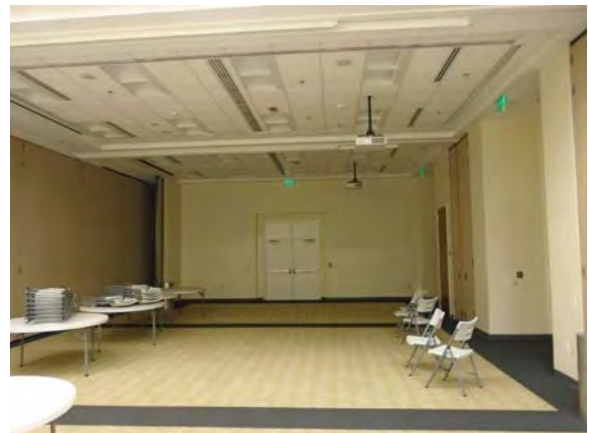
Even though the brick exterior is less than ten years old, several areas have experienced moisture infiltration, including around windows. Some areas, but not all, have been repaired, and it is anticipated that additional work will be necessary. A significant renovation of the masonry walls, including window seals and gaskets as necessary, is recommended to ensure the exterior envelope is waterproof.

CARD140a 11/6/2018
Water intrusion/damage from infiltration around
windows
Prefunction space 1408

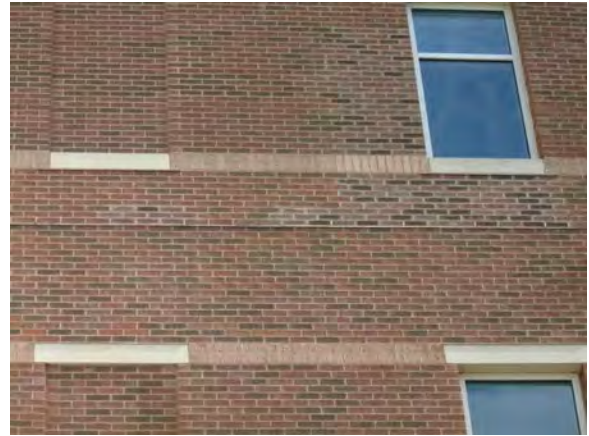
CARD172a 11/6/2018
Previous brick masonry repairs
Northwest exterior

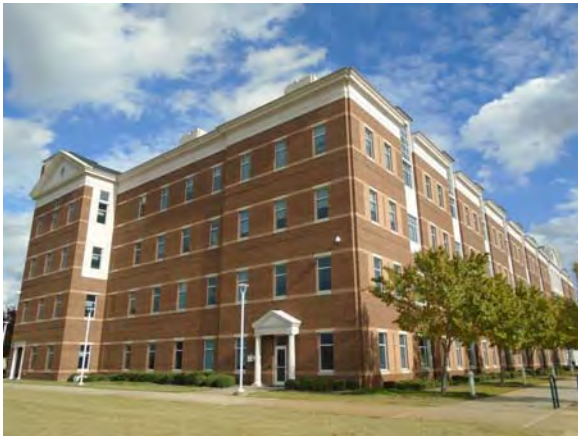
CARD173a 11/6/2018
Previous brick masonry repairs
Northwest exterior

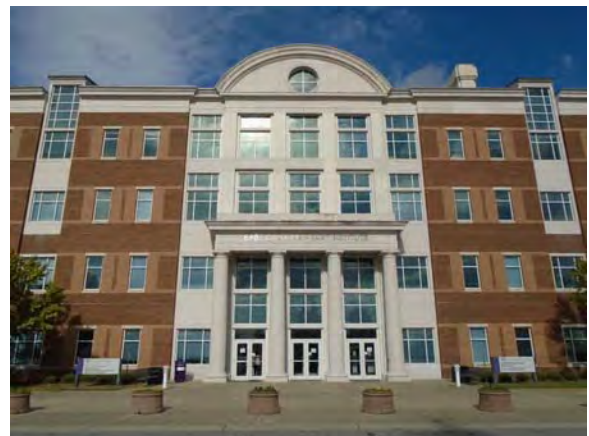
CARD176a 11/6/2018
Previous brick masonry repairs
Southwest exterior
