EAST CAROLINA UNIVERSITY

Facility Condition Assessment

Family Medicine Center

Inspected May 11, 2021

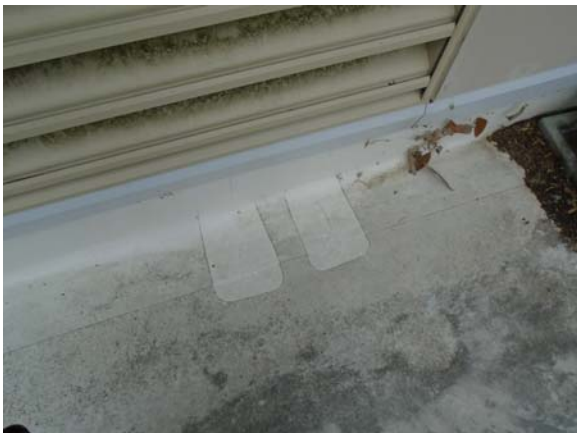
255009a 5/11/2021
Previous roof repair
Roof

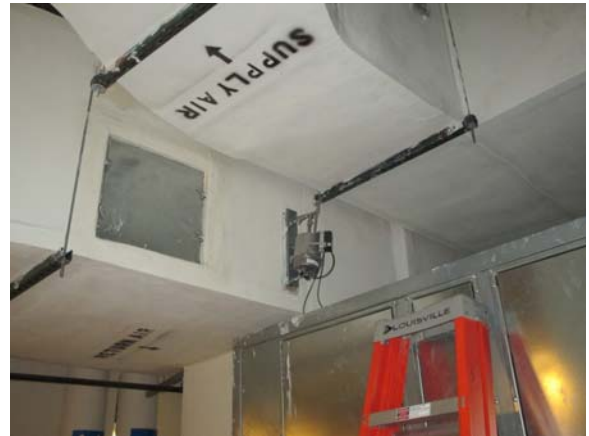
255014a 5/11/2021
Screws visible in panels
Mechanical penthouse

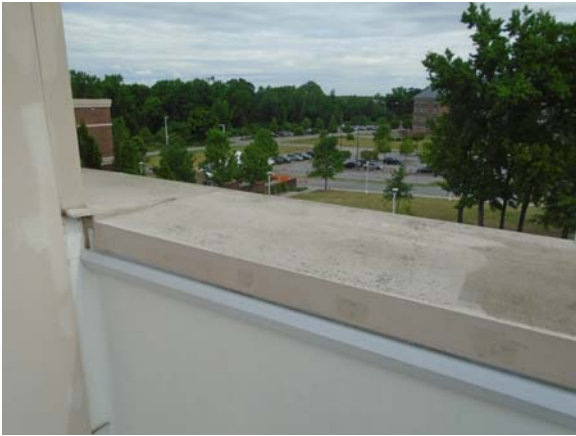
The brick veneer exterior walls are in good condition and require no repairs at this time. The EIFS accents, however, have become damaged due to exposure and cracking. Some of the EIFS mounting screws have corroded and stained the exterior. The EIFS will need some refinishing and resealing to restore a satisfactory aesthetic.

255019a 5/11/2021
Parapet cap is stained EIFS
Roof

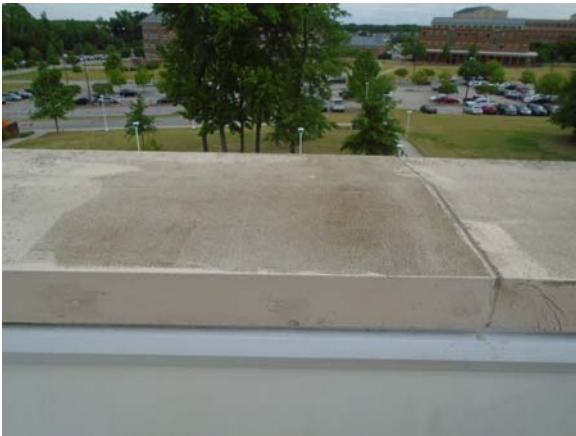
255020a 5/11/2021
Parapet cap is stained and damaged EIFS
Roof

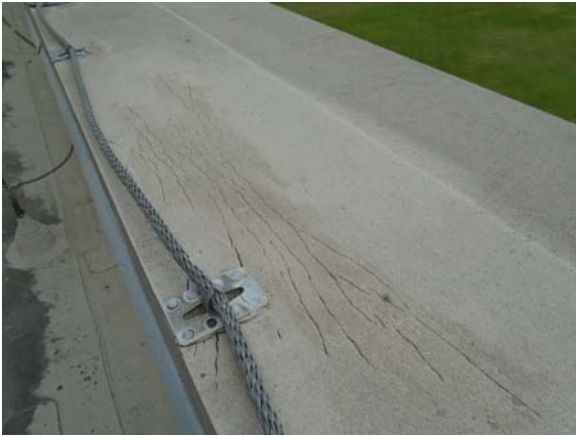
255022a 5/11/2021
Parapet cap is stained and damaged EIFS
Roof

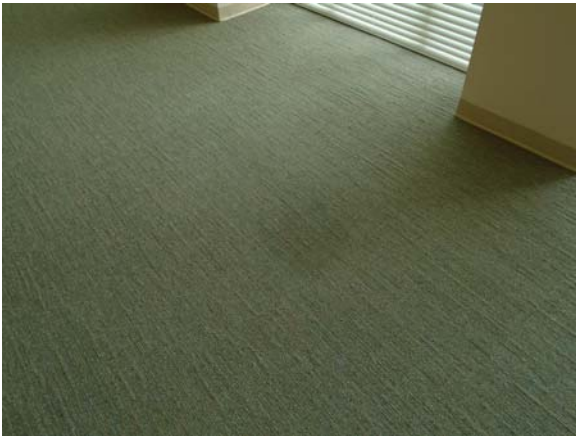
255032a 5/11/2021
Stained carpet
Second floor student lounge

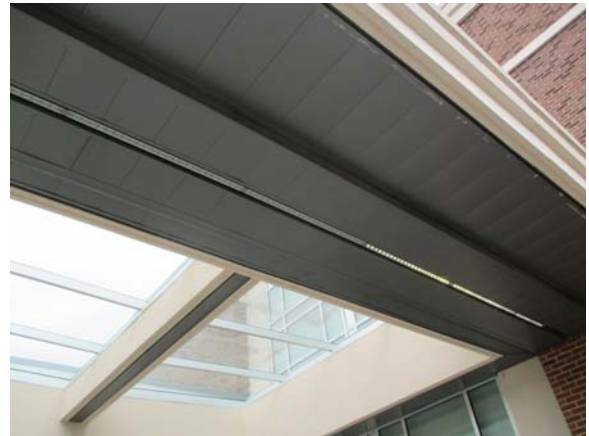
Exterior areas adjacent to the buildings are illuminated by wall-mounted, ground-mounted, post, stanchion, string, recessed, and step light fixtures. Both CFL and LED lamps were observed. Several of the string LED fixtures at the south entrances appear to be nonfunctional and should be replaced in the near term. The other fixtures are in good condition but should be scheduled for lifecycle replacement in the next five years. Install energy-efficient fixtures, and place them on photocell activation. Also, the roof entrances to the east and southwest penthouses are not illuminated. Install LED lighting to ensure a safe environment for those who might need access to the roof.

255071e 5/11/2021
Several nonfunctional string LED light fixtures
South exterior

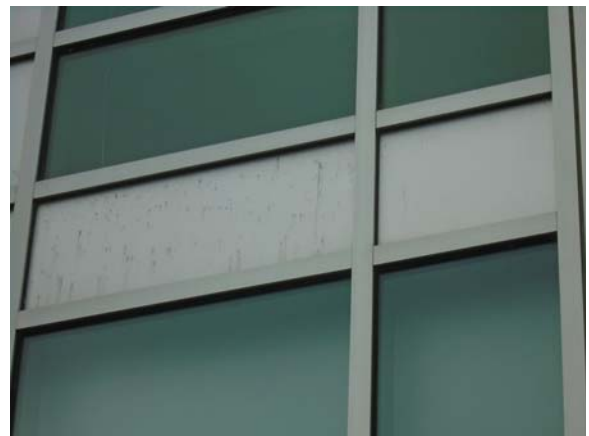
255123a 5/11/2021
Stained exterior metal panel
North exterior

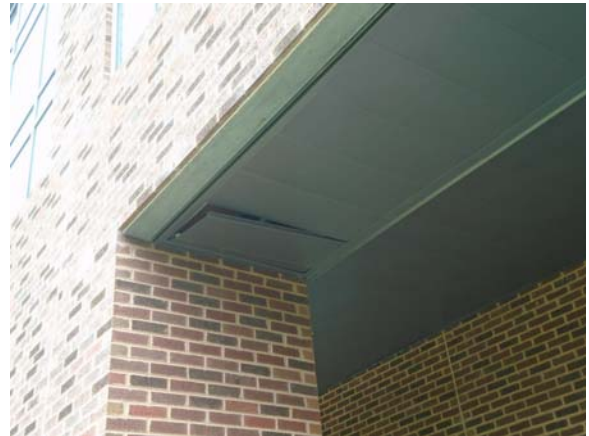
255127a 5/11/2021
Metal fascia needing repair
West exterior

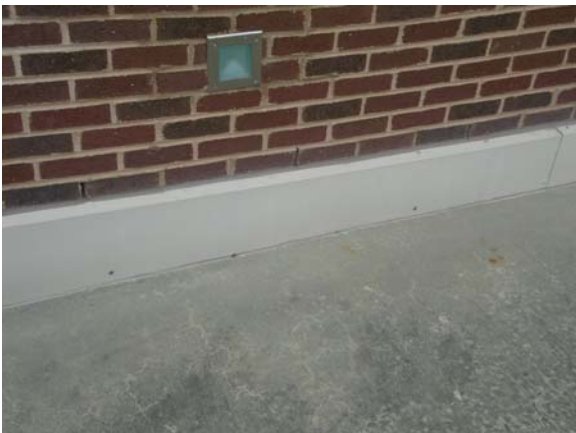
255128a 5/11/2021
Screws visible in EIFS panels
West exterior

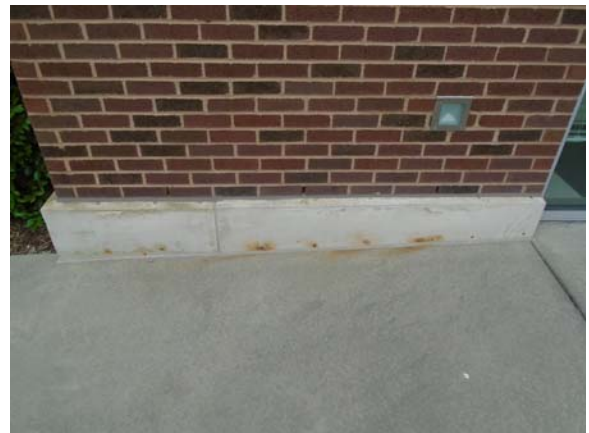
255141a 5/11/2021
Screws rusting in EIFS accents
Northeast exterior
