EAST CAROLINA UNIVERSITY

Facility Condition Assessment

Allied Health Sciences Building
Asset AHSB

Inspected April 20, 2016

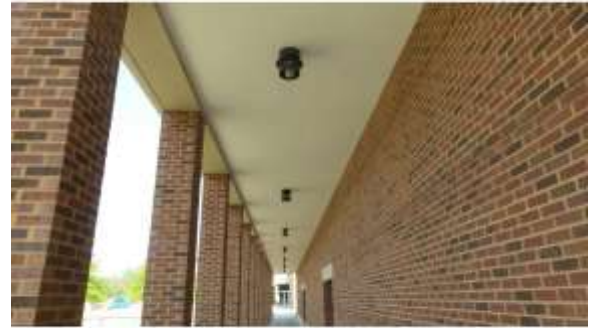
The existing brick masonry veneer exterior walls from the original 2006 construction exhibit significant moisture penetration around the windows and through the masonry. Numerous areas of the exterior were uncovered and found to have systematic deficiencies throughout. This appears to be a result of improper flashing installation and/or faulty design and construction of the internal wall drainage cavity. A major rehabilitation is recommended of the exterior envelope’s vertical masonry walls, including any window resealing and re-gasketing as necessary to ensure a waterproof exterior envelope. This should include the removal and replacement of the existing deficient flashing within the wall structure at the existing openings and creation of an improved end-damn condition.

AHSB055a 4/20/2016
Deficient exterior brick masonry and a previous repair
Exterior envelope

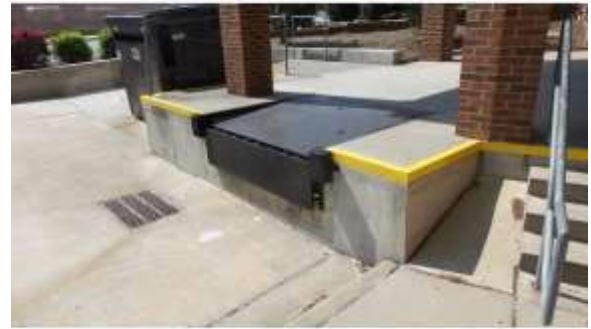
AHSB056a 4/20/2016
Deficient exterior brick masonry and a previous repair
Exterior envelope

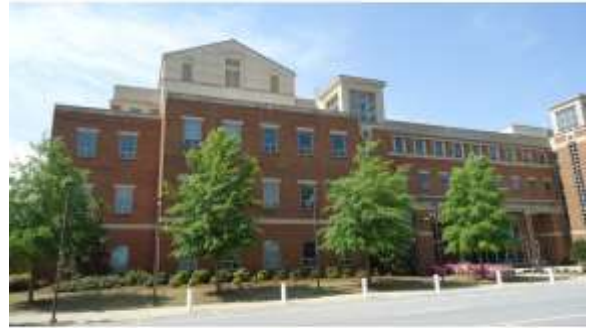
AHSB059a 4/20/2016
Deficient exterior brick masonry and a previous repair
Exterior envelope

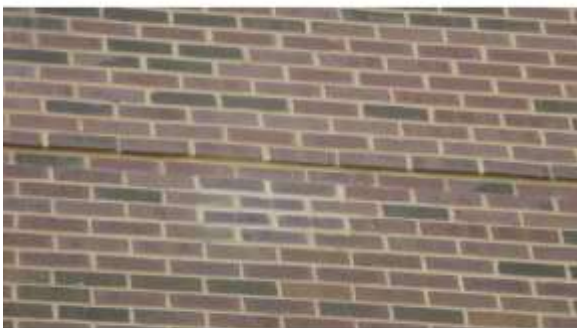
AHSB062a 4/20/2016
Deficient exterior brick masonry and a previous repair
Exterior envelope

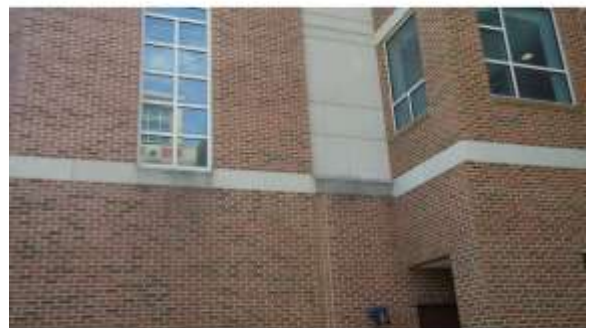
AHSB063a 4/20/2016
Deficient exterior brick masonry and a previous repair
Exterior envelope

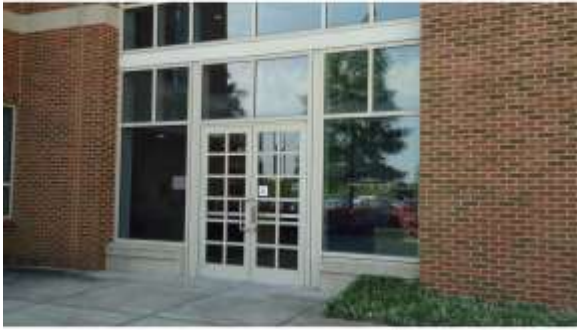
AHSB064a 4/20/2016
Stained and deficient exterior brick masonry
Exterior envelope

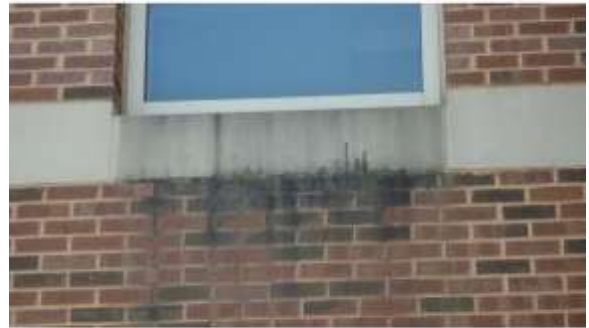
AHSB069a 4/20/2016
Deficient exterior brick masonry and a previous repair
Exterior envelope

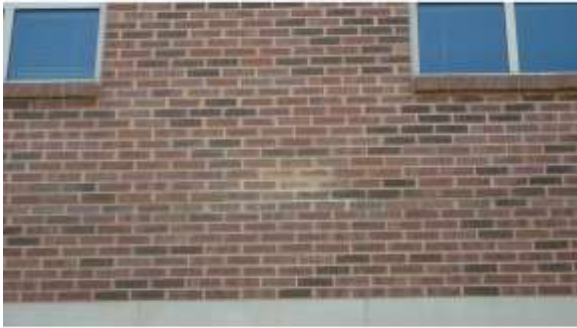
AHSB070a 4/20/2016
Stained and deficient exterior brick masonry
Exterior envelope

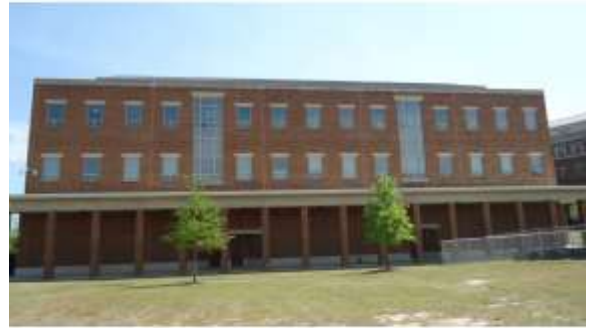
AHSB071a 4/20/2016
Deficient exterior brick masonry and a previous repair
Exterior envelope

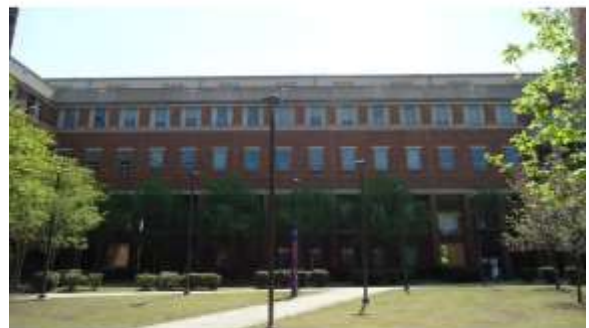
AHSB075a 4/20/2016
Deficient exterior brick masonry and a previous repair
Exterior envelope

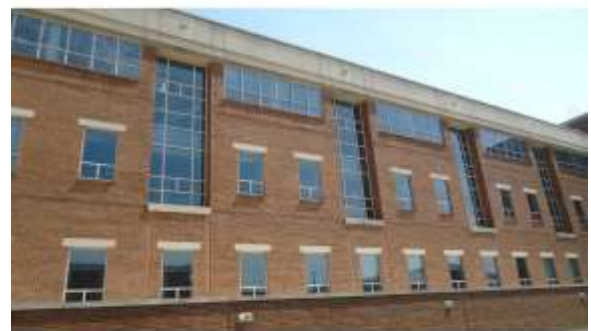
The windows located in this facility are either large inoperable, tempered units or dual-pane windows. The windows are typically in good condition and not expected to need any replacements. However, some are exhibiting loose gasket seals and the seals should be repaired or replaced. This issue is addressed in the exterior masonry recommendation.

AHSB081a 4/20/2016
Rubber gasket seal coming out in interior
South elevation, E wing

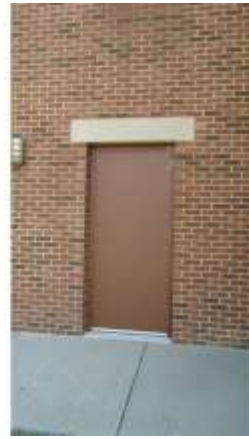
AHSB083a 4/20/2016
Deficient exterior brick masonry and a previous weep
repair
Exterior envelope

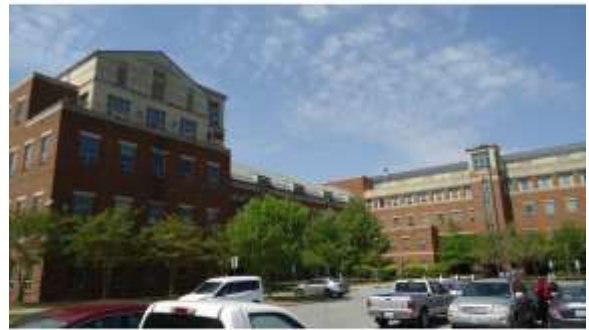
AHSB085a 4/20/2016
Deficient exterior brick masonry and a previous repair
Exterior envelope
