EAST CAROLINA UNIVERSITY

Facility Condition Assessment

Ross Hall
Asset 256

Inspected May 11, 2021

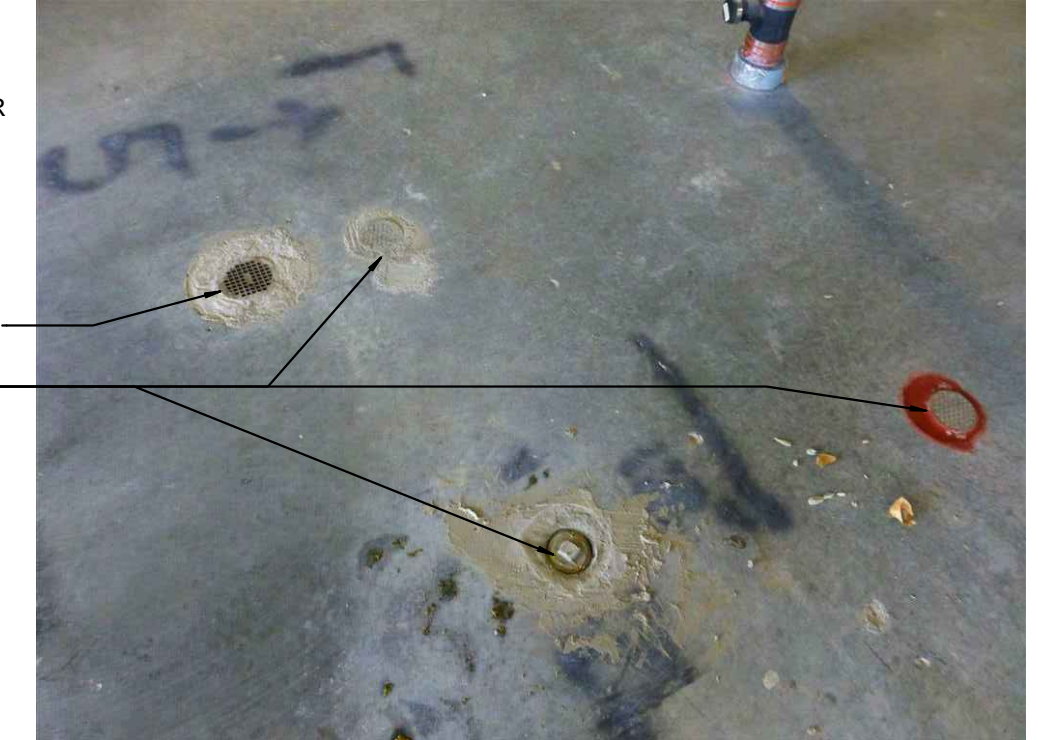
IMAGE B:
 REPAIR EXISTING CLEANOUTS AND FLOOR DRAINS WHERE REQUIRED TO BE LEVEL WITH NEW FLOOR FINISH. SEE NOTE UNDER IMAGE C.

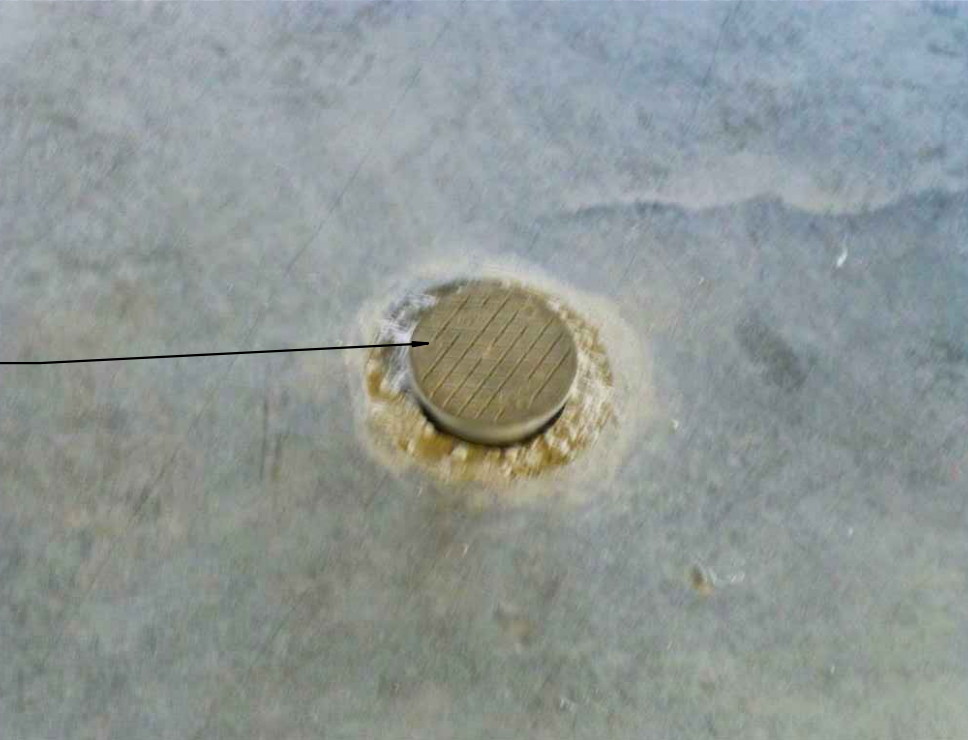
IMAGE C:
 EXISTING CLEANOUT. CUT WHERE REQUIRED TO BE LEVEL WITH NEW FLOOR FINISH. FLOAT / PATCH CONCRETE WERE REQUIRED. IN ORDER TO ENSURE NEW FLOOR FINISH CAN BE INSTALLED PER MANUFACTURER'S INSTRUCTIONS. TOTAL ON FOURTH FLOOR: 29. SOME ARE ABOVE FLOOR. SOME ARE BELOW FLOOR. SOME ARE CROOKED.

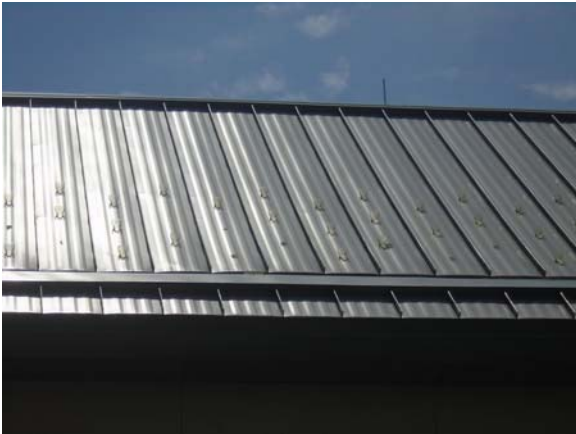
256028a 5/12/2021
Broken plastic "ice cleats" attached to metal roofing
Pitched standing seam metal roof

Both the main four-story section and the lower southeast lecture hall wing have perimeter pitched standing seam metal grey roofing and a central flat built-up asphalt roof. No roofing upgrade needs are expected within the next ten years, though the built-up roof will likely require replacement shortly after the report scope. The central skylights over the atrium also appear to be in satisfactory condition and should outlast the scope of this report. The pitched metal roof has ice cleats to keep ice from falling and possibly injuring someone. These cleats are plastic, and many have already broken, limiting their overall effectiveness. Repair the ice cleats to reduce the possibility of injury and limit liability.

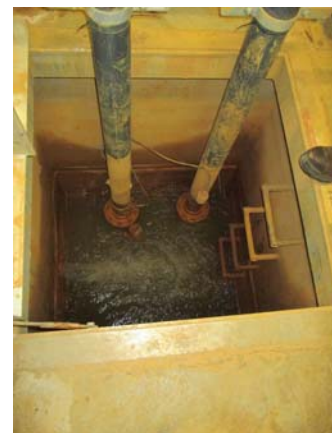
Groundwater has been an issue in this facility from the beginning. The 8-foot deep foundation sump pump system barely keeps up with the normal groundwater entering the sump from around the foundation. There is a two-pump system—one operating full time and the other kicking on based on the float switch. Flooding in the basement would close the entire facility, and relying on this system appears risky at best. This operation is going through four pumps per year just to keep the sump from overflowing. A hydrogeological study of the site is recommended to ascertain valuable site specific hydrogeological information to properly design a solution that addresses the need to lower the water table and provide for redundancy and reliability at all times. Additional sumps, well points, and/or a permanent dewatering system for the foundation should all be explored. It should be noted that, through a review of the foundation drawings, it was determined that several exterior areas, such as the loading dock trench drain and north exterior basement secondary emergency egress area, are discharging stormwater into this same foundation sump. Removing these exterior areas from this sump would reduce the load on these pumps during stormwater events.

256117e 5/11/2021
Pit with two sump pumps for problematic foundation
infiltration
Room B0100

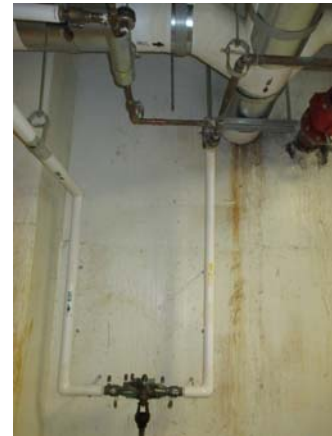
There are two water booster systems. The smaller system in the penthouse has two 1 hp pumps and serves the PP1 water pipes. The larger system in the basement has two 5 hp pumps and serves the NCWCP-1 water pipes. These systems are in good condition and should outlast the report scope. The water pipes connected to the NCWCP system have a hammering issue in the northeast corner of the basement. Pressure surges cause the piping to momentarily shake violently. This issue can and should be addressed as part of routine maintenance.

256119e 5/11/2021
1.25 inch backflow preventer on NPCW pipe with
hammering issue
Room B0100

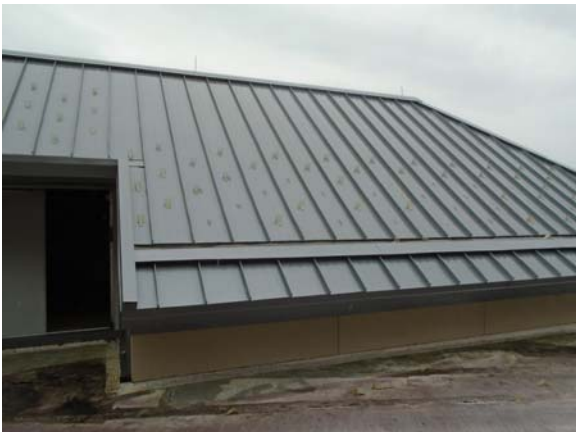
256126a 5/12/2021
Broken plastic "ice cleats" attached to metal roofing
Pitched standing seam metal roof
