EAST CAROLINA UNIVERSITY

Health Sciences Campus

HSC Electrical Distribution

Utility Condition Assessment

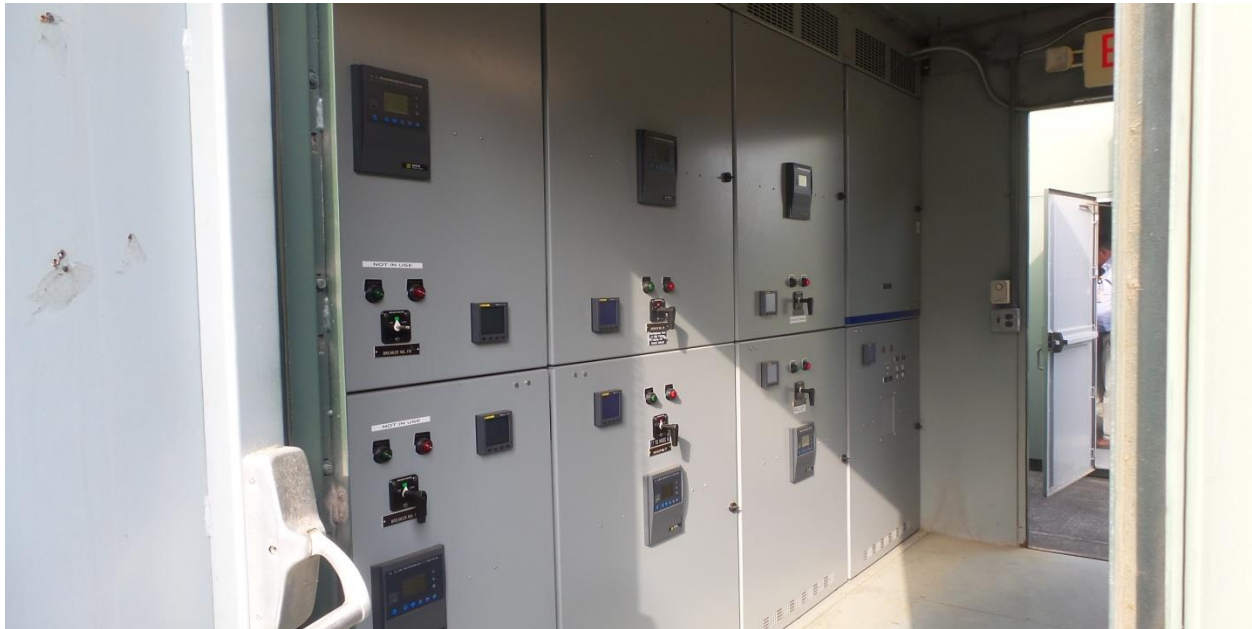
Image 1: Metalclad Switchgear MSG2

The switchgear cabinets housing the breakers have been retrofitted with Square D SEPAM digital relays and Square D Powerlogic type PM800 digital monitoring and recordings devices. This section of switchgear will reach the end of its reliable statistical life within the next ten years and should be updated. It should also be noted that this section has been subject to very limited maintenance and operation. As a result, it is probable that the charging mechanisms within the breakers have seized, as have the contact points between the breakers and the bus.

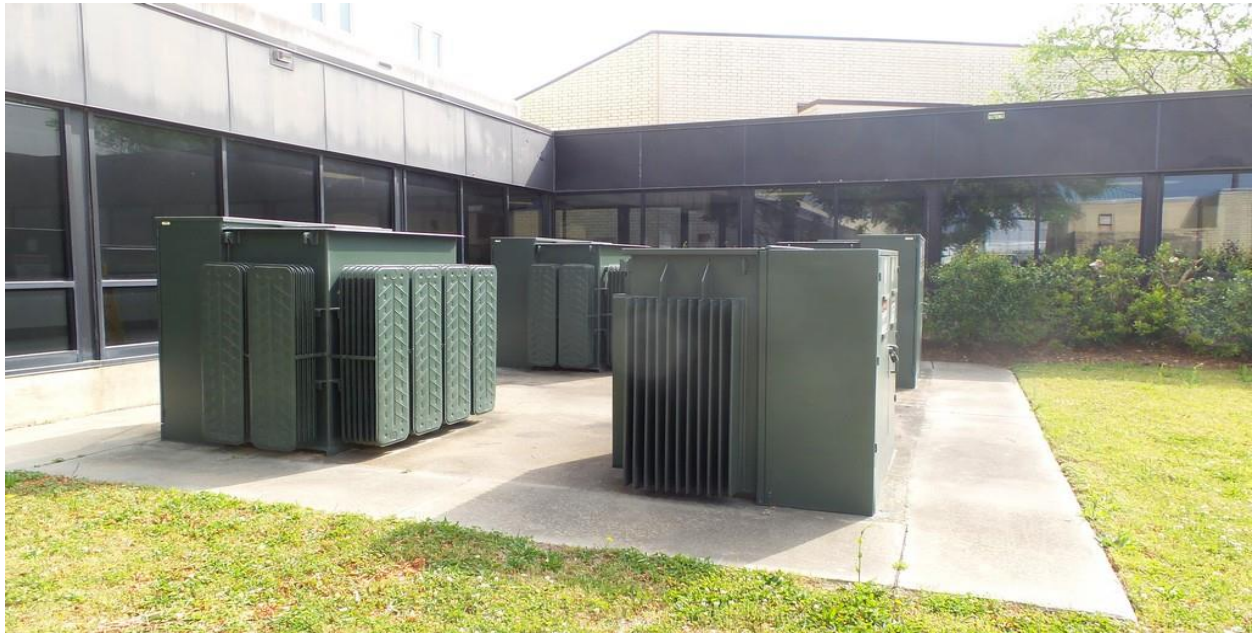
Image 2: Transformers TX-4, TX-5, TX-6, and TX-7 at Brody

Outside of Brody are transformers TX-4, TX-5, TX-6, and TX-7. TX-4, TX-5 and TX-7 were installed in 1982 and have a rated capacity of 2,500 kVA. TX-6 was installed in 1984 and has a rated capacity of 750 kVA. These are currently in proper working condition but will reach the end of their reliable service life within the next ten years. Replacement is recommended at that time.

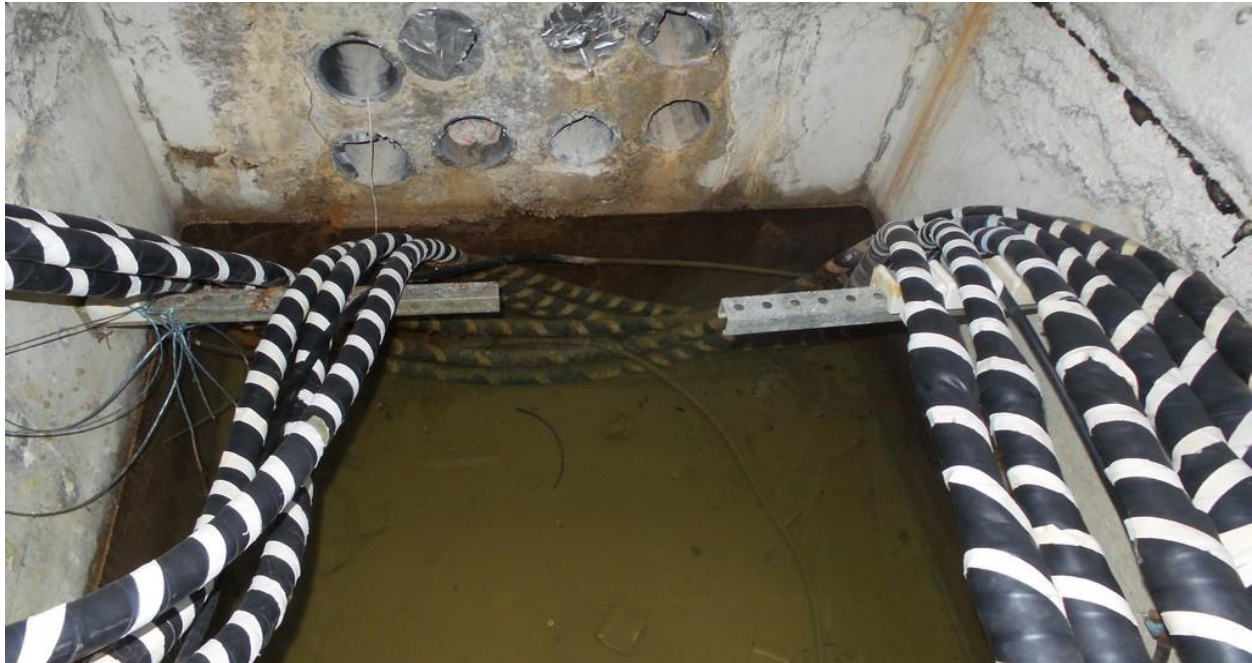
premature deterioration of cable splicing and ultimately to spalling of concrete floor and walls. Most 15 kV cable or wire installed in an underground distribution network is designed to be water resistant to an extent. Unless originally designed to be submerged in water, cable wrapping will prematurely deteriorate. To eliminate the possibility for this kind of failure, it is recommended that these vaults be equipped with small submersible sump pumps. This not only reduces the opportunity for water to cause an unscheduled forced outage, it reduces the cost of manually pumping out the vaults.

Image 3: 15 kV cable submerged in standing water within a utility vault

Approximately six manholes are recommended for refurbishment. Repair spalling concrete, reseal and waterproof the seams, joints, and cracks, and install a proper NEMA rated access ladder. This does not apply to any specific vault, as this recommendation is a placeholder for future capital expenditure.

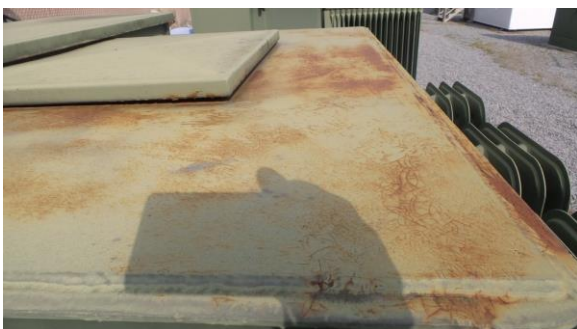
HSEL011e 4/21/2016  
Slight frame deterioration on transformer  
Main substation

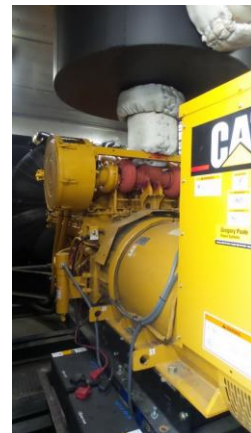
HSEL018e 4/21/2016  
1,250 kW CUP emergency generator  
Main substation

A 1,250 kW generator provides emergency power to not only the CUP but also to Allied Health Sciences and the Heart Institute. It is recommended that these two facilities be equipped with dedicated emergency generators. Install new generators, fuel-oil tanks, day tanks, battery chargers, and battery banks.

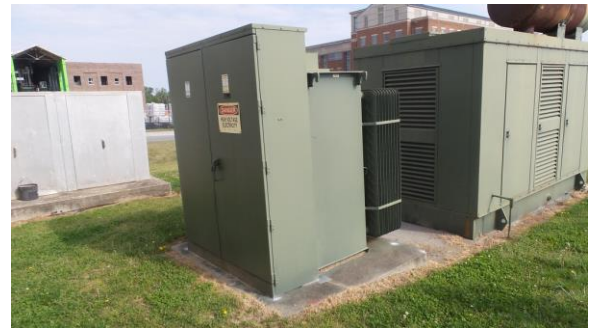
The transformer identified as TX-10 located outside Warren Life Sciences has a small leak inside the unit. A fuse holder has developed a minor crack that needs to be further inspected. No recommendation for repair or replacement has been developed, as further inspection is required to determine the severity of the damage or deterioration.

HSEL022e 4/21/2016  
Transformer TX-10  
Warren Life Sciences exterior

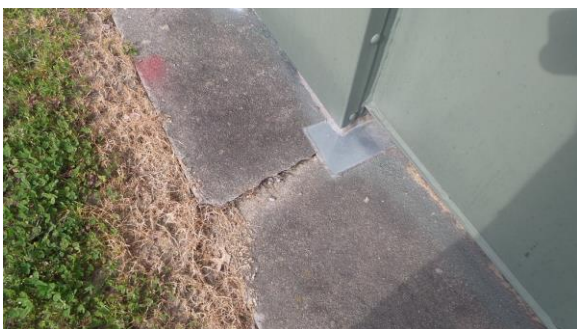
HSEL023e 4/21/2016  
Damaged and repaired concrete slab  
Warren Life Sciences exterior

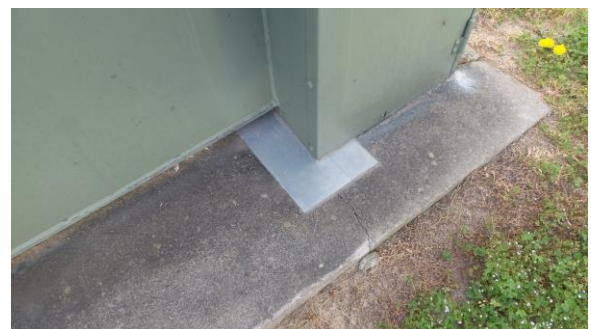
HSEL024e 4/21/2016  
Damaged and repaired concrete slab  
Warren Life Sciences exterior

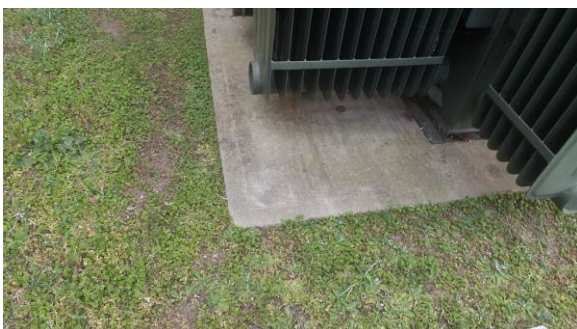
HSEL029e 4/21/2016  
Transformer concrete slab settlement  
Allied Health exterior

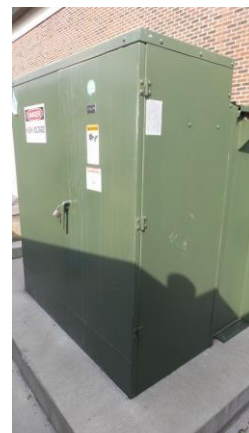
The primary service feed to the Ross School of Dental Medicine is from an exterior oil-filled transformer rated for 2,000 kVA. This facility was originally designed to be equipped with multiple transformers, but limited funding and design space prevented the installation of the redundant service transformer. It is recommended that an additional 2,000 kVA transformer be installed to provide a redundant service feed. Additional project funding has been included for the redesign and renovation of the main electrical room 1182 if necessary.

HSEL030e 4/21/2016  
Transformer TX17  
Ross Hall exterior

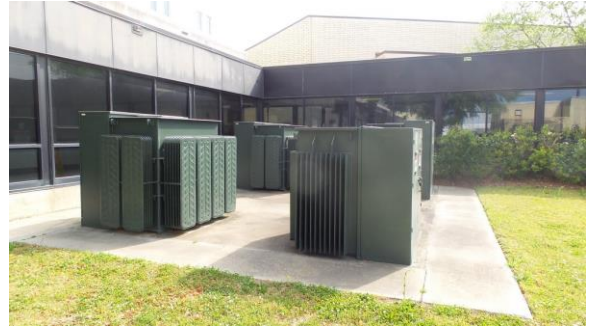
HSEL038e 4/21/2016  
Four oil-filled transformers  
Brody exterior

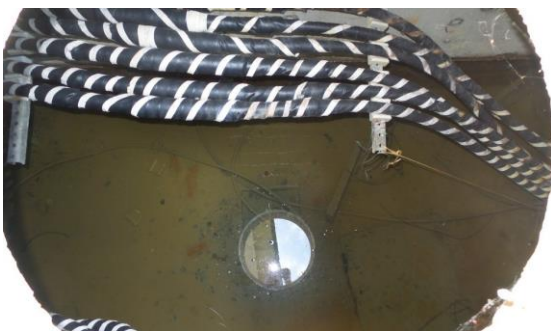
HSEL041e 4/21/2016  
Standing water in manhole  
Between Brody and Life Sciences

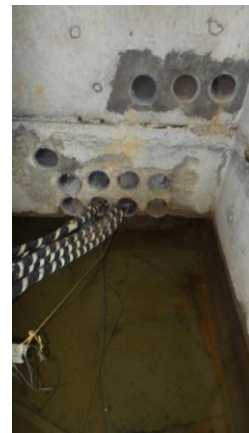
HSEL042e 4/21/2016  
Standing water in manhole  
Between Brody and Life Sciences

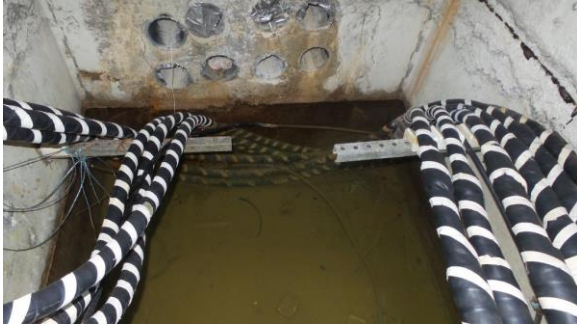
HSEL043e 4/21/2016  
15 kV cable submerged in standing water  
Between Brody and Life Sciences
