EAST CAROLINA UNIVERSITY

Health Sciences Campus

Potable Water & Fire
Protection System

Utility Condition Assessment

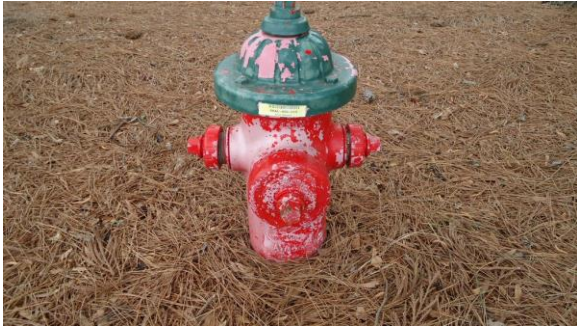
HSPWFP001e 3/8/2017
Older fire hydrant
Campus grounds

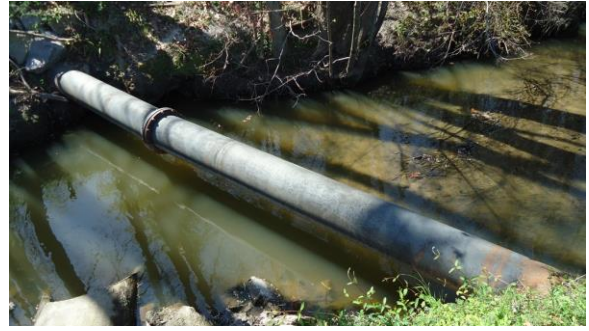
HSPWFP002e 3/8/2017
City-owned 15 inch ductile iron pipe crossing creek
South side of West 5th Street

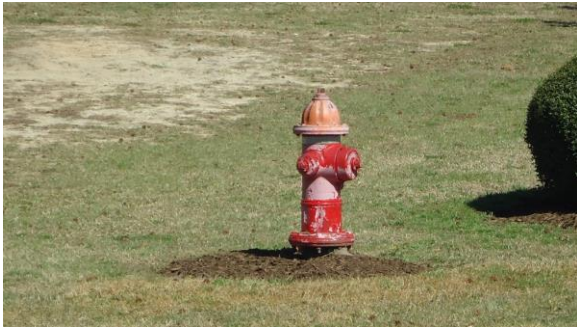
HSPWFP003e 3/8/2017
Older fire hydrant
Campus grounds

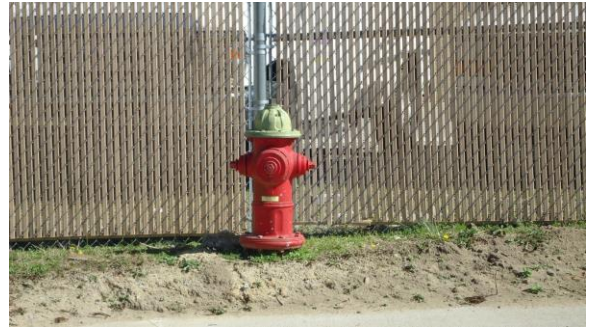
HSPWFP004e 3/8/2017
Older fire hydrant
Campus grounds

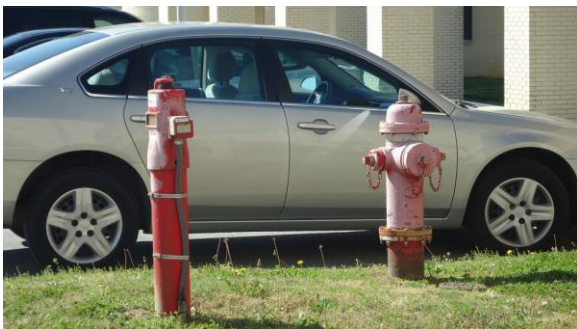
HSPWFP005e 3/8/2017
Older fire hydrant
Campus grounds

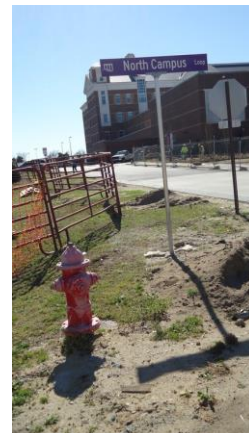
HSPWFP006e 3/8/2017
Older fire hydrant
Campus grounds

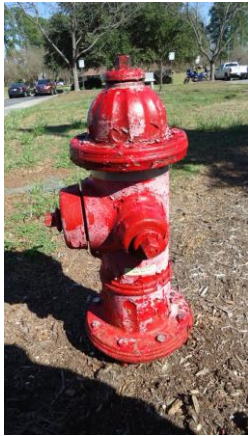
HSPWFP007e

Older fire hydrant
Campus grounds

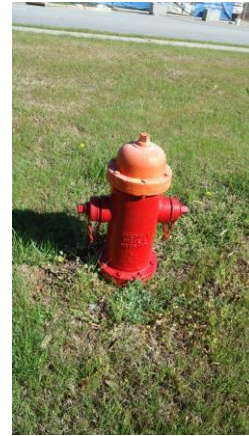
HSPWFP008e

Older fire hydrant
Campus grounds

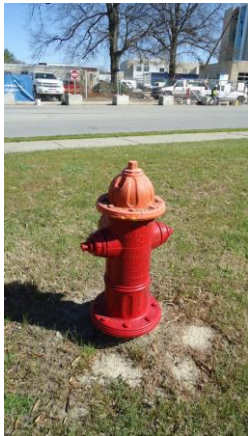
HSPWFP009e

Older fire hydrant
Campus grounds

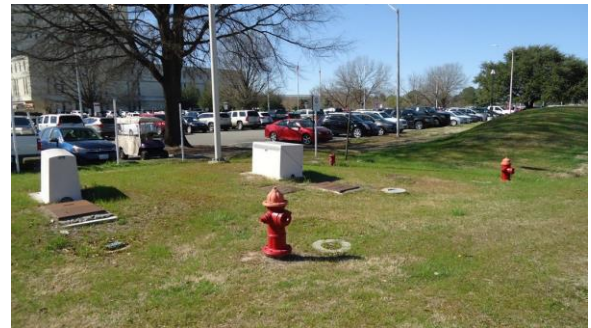
HSPWFP010e

Older fire hydrant
Campus grounds

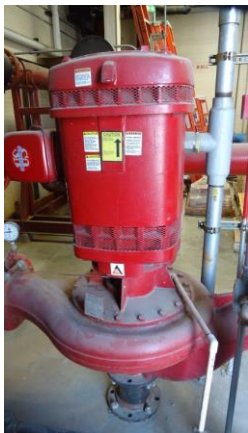
HSPWFP011e

125 hp fire pump
Central Plant

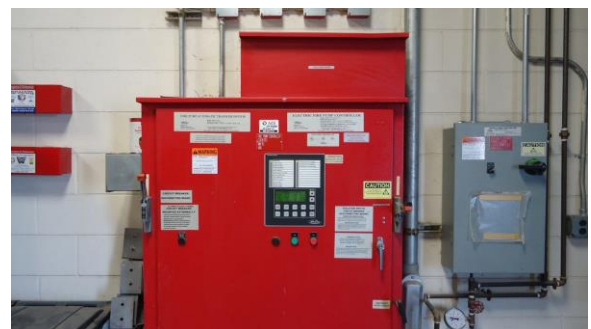
HSPWFP012e

Electric fire pump controller
Central Plant

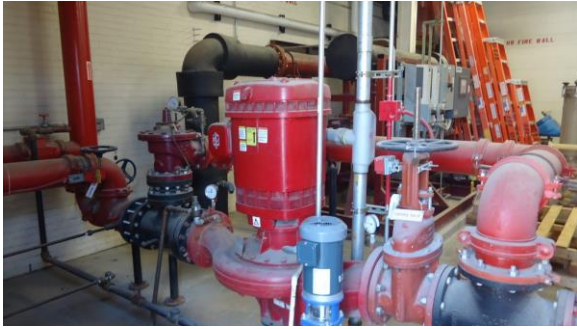
HSPWFP013e 3/8/2017
125 hp fire pump set-up
Central Plant

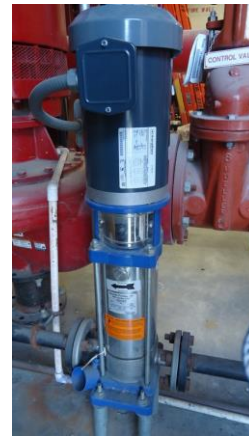
HSPWFP014e 3/8/2017
Inline centrifugal pump
Central Plant

Based on the relatively good condition and young age of the main pipe network, none of the linear assets of the potable and fire water supply are expected to require general lifecycle replacement. However, the two 15 hp domestic pumps and their variable frequency drives in room 113 of the Central Utility Plant are expected to reach the end of their lifecycles within the next ten years and should be replaced.

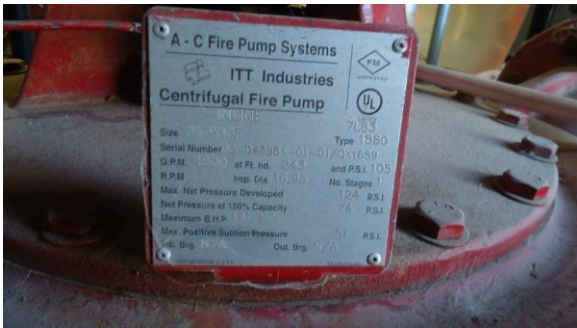
HSPWFP015e 3/8/2017
Inline centrifugal pump
Central Plant

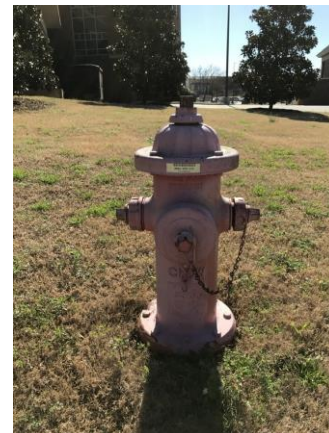
HSPWFP018e 3/8/2017
Older fire hydrant
Campus grounds

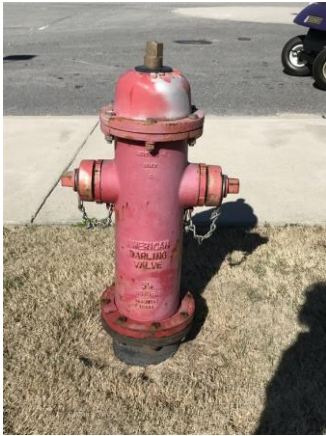
HSPWFP019e 3/8/2017
Older fire hydrant
Campus grounds

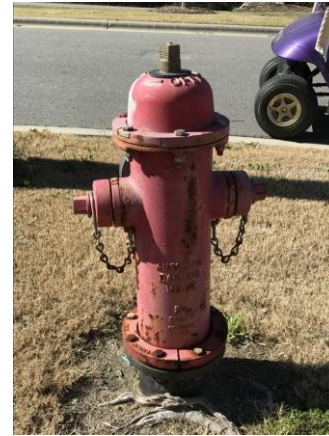
HSPWFP020e 3/8/2017
Older hydrant and new FDC
Family Medicine

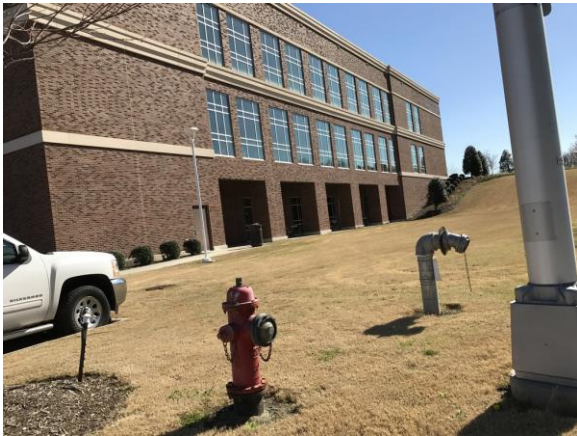
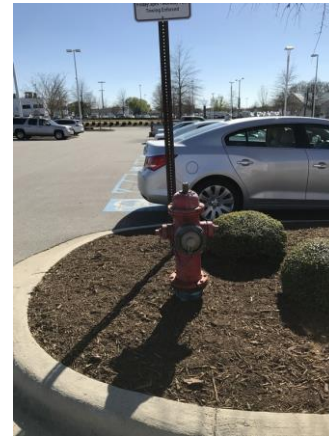
HSPWFP021e 3/8/2017
Older fire hydrant
Campus grounds

HSPWFP022e 3/8/2017
Other side of fire hydrant in photo 21e
Campus grounds
