EAST CAROLINA UNIVERSITY

Stormwater Sewer System
Utility Condition Assessment

April 26, 2017

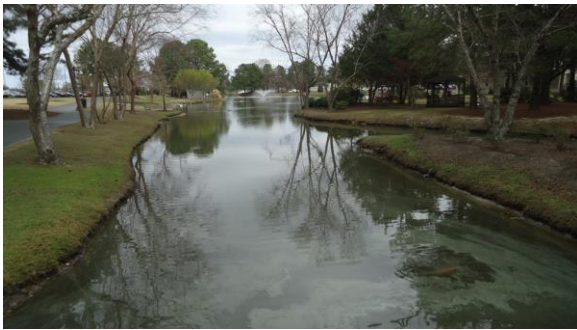
STRM003e 3/8/2017
Lake Laupus
South end of Lake Laupus

Lake Laupus should be dredged out at least once every ten years or so to maintain the original design capacity of this manmade stormwater retention lake and maintain the concrete outlet and control structures. The lake was dredged about four to five years ago, and it is anticipated that it will require dredging in another five to six years.

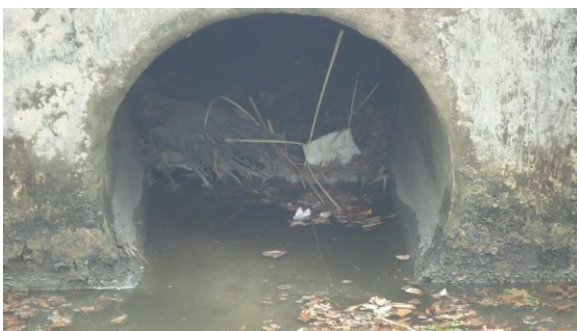
STRM005e 3/8/2017
36 inch pipe with outlet blockage
South end of Lake Laupus

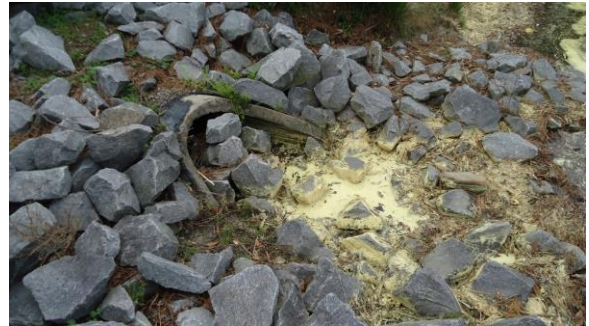
STRM010e 3/8/2017
Riprap-armored slope around pipe outlet with stone
blocking outlet
Lake Laupus northeast side

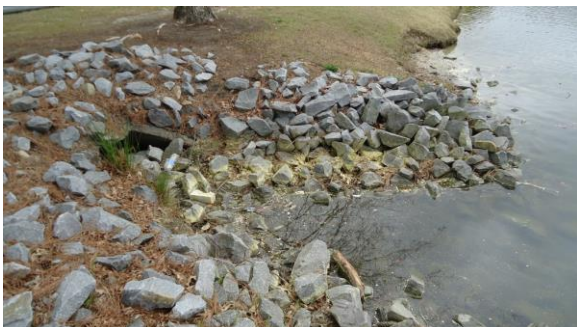
STRM011e 3/8/2017
Riprap-armored slope around pipe outlet with stone
blocking outlet
Lake Laupus northeast side

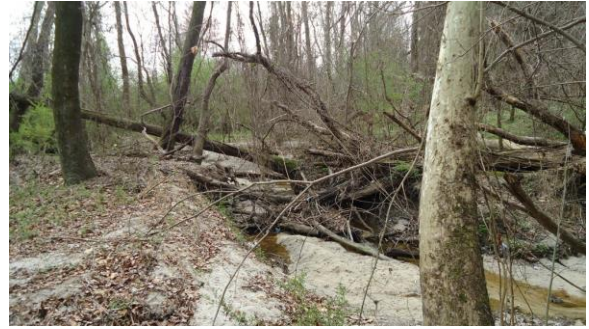
STRM032e 3/8/2017
Wood debris from past flooding blocking main channel
Meeting House Branch
