# EAST CAROLINA UNIVERSITY

Facility Condition Assessment

Austin Building (006)

Inspected May 11, 2021

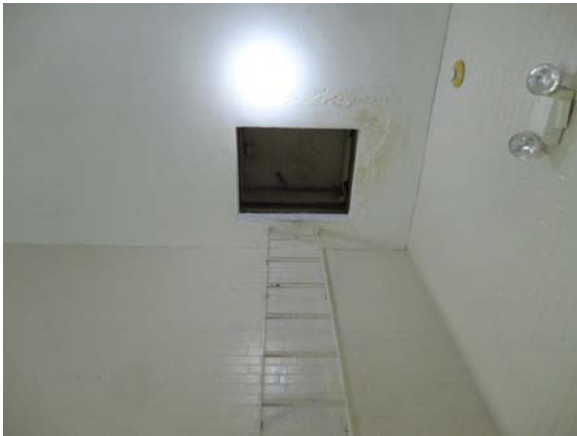
AUST002a 5/11/2021  
Deteriorated roof access hatch and ladder  
Third floor, stair tower

The roof is a modified bitumen system that was reportedly installed in 2005 and should be due for in-kind replacement in the near future. The unballasted membrane roof on the west elevator tower should also be replaced within this same timeframe. The two roof hatches and accompanying roof access ladders are aging and inadequate given the height exposure in the stair towers. Install new roof hatch assemblies and include new permanent roof access ladders with fall guards.

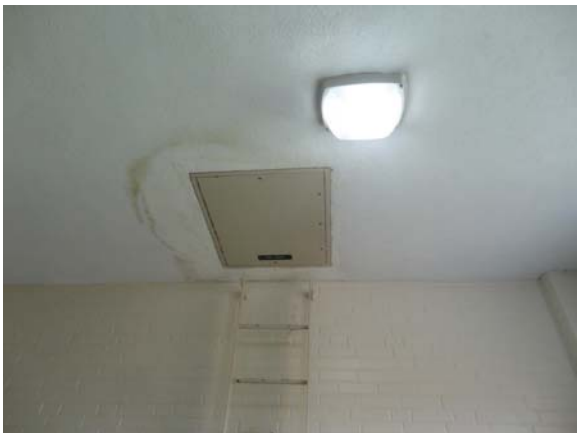
AUST003a 5/11/2021  
A second deteriorated roof access hatch and ladder  
Third floor, stair tower

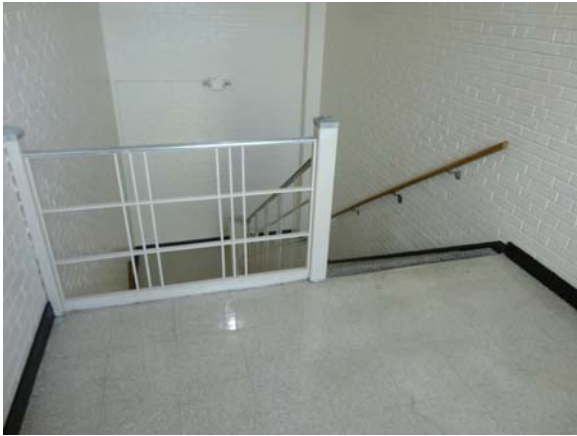
AUST004a 5/11/2021  
Nonaccessible railing design  
Third floor, stair tower

Access to the building is provided by ramp systems on the north and west. Both entrances are equipped with power-assisted door openers. The building has a fully accessible passenger elevator on the west end. However, the four stair towers lack accessible railing designs. Retrofit new accessible inner and outer railings on each stair flight and replace the stair treads once the existing tread finishes are properly removed.

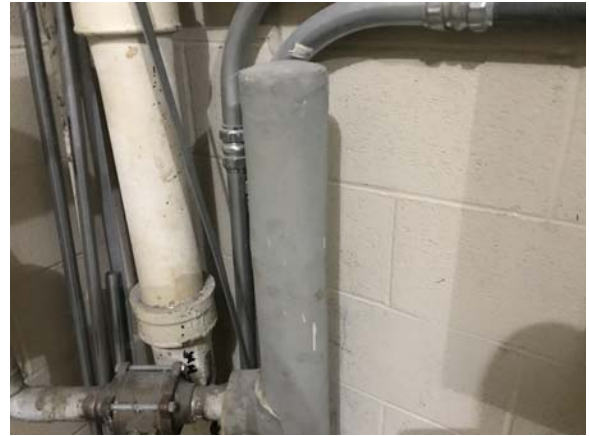
AUST010e 5/11/2021  
Potential asbestos insulation on mechanical piping  
Room 336

The nine-inch vinyl tile and mastics and the textured ceilings are suspected to contain asbestos, and it is assumed that nine-inch vinyl tile is present under the carpeting and that textured ceilings are present above the acoustical lay-in ceilings. Asbestos insulation was also observed on mechanical piping. Prior to any future renovation efforts, it is recommended that any asbestos material be properly abated.

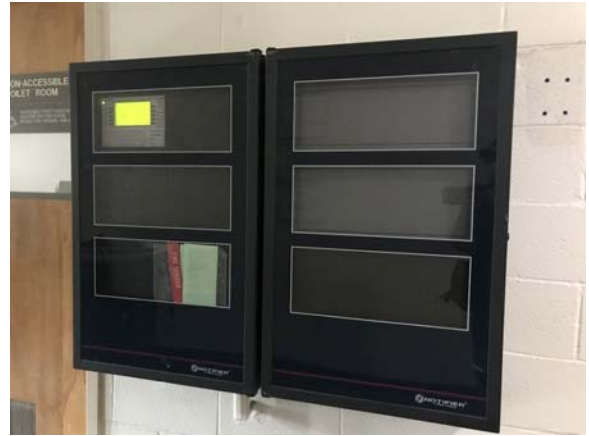
AUST016e 5/11/2021  
Main fire alarm panel  
Room 144

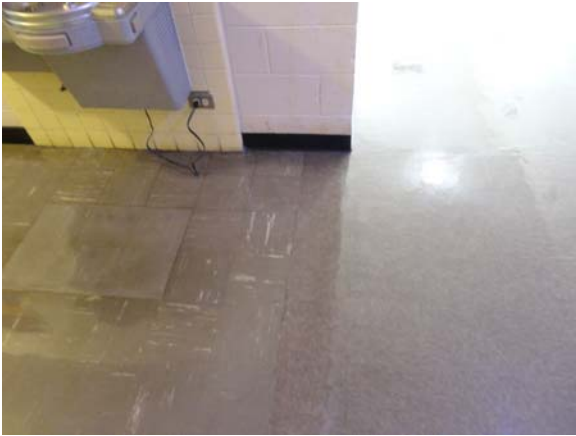
AUST028a 5/11/2021  
Some dissimilar vinyl flooring repairs  
Second floor corridor

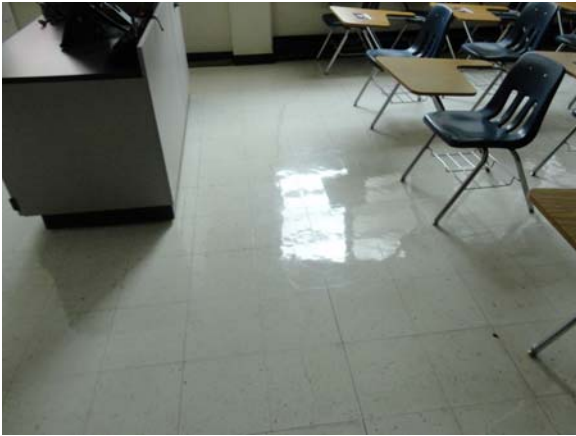
AUST040a 5/11/2021  
Localized settlement crack in floor slab  
First floor, classroom

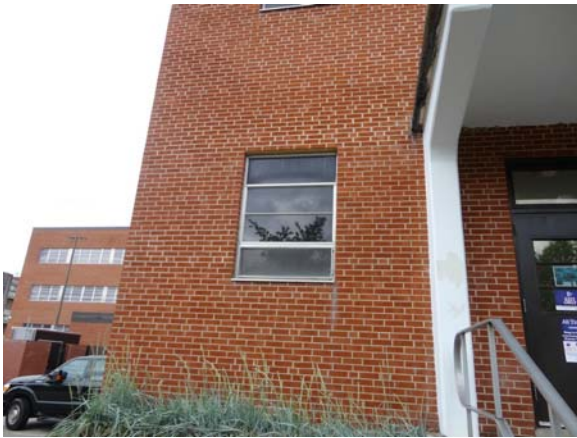
AUST043a 5/11/2021  
Original single-pane, metal-framed glazing  
East end elevation

The brick facades have a good overall appearance other than some surface staining on upper elevations. The cut stone accents around the main entry are in satisfactory condition. The original single-pane glazing is in poor condition and should be considered for replacement with new thermal-pane, metal-framed glazing. The newer brick veneer and thermal-pane glazing on the west tower addition is in good condition and no upgrades are warranted.

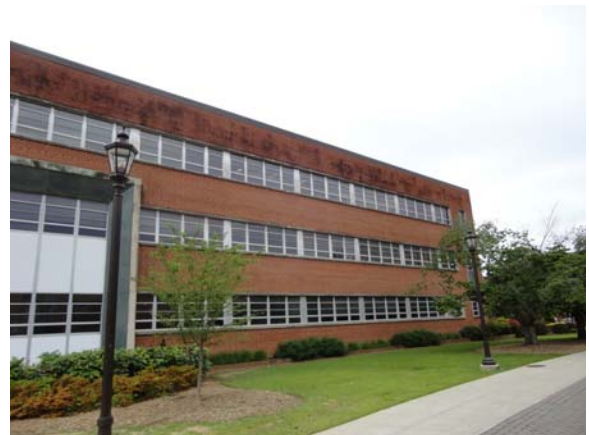
AUST046a 5/11/2021  
Bands of original single-pane glazing  
North elevation

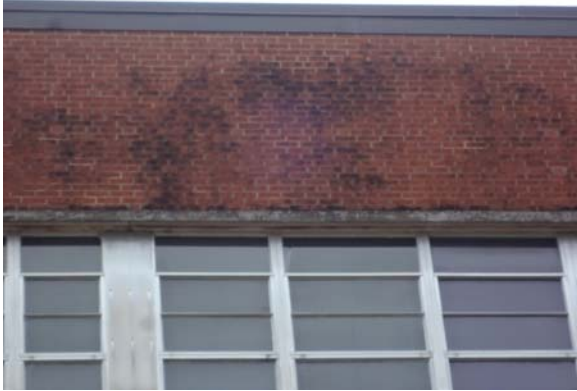
AUST047a 5/11/2021  
Signs of upper masonry staining  
North elevation
