EAST CAROLINA UNIVERSITY

Facility Condition Assessment

Harold H. Bate Building (095)

Inspected May 11, 2021

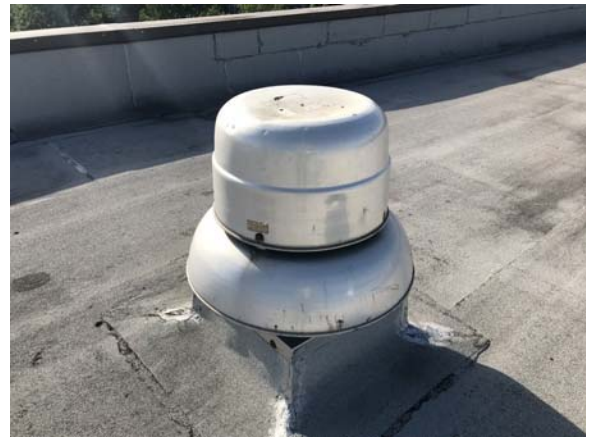
BATE004a 5/11/2021
Minor issue with cap sheet
Main roof

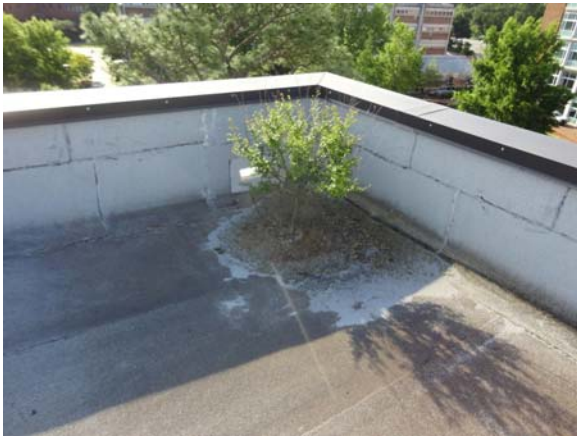
BATE005a 5/11/2021
Restricted roof drain
Main roof

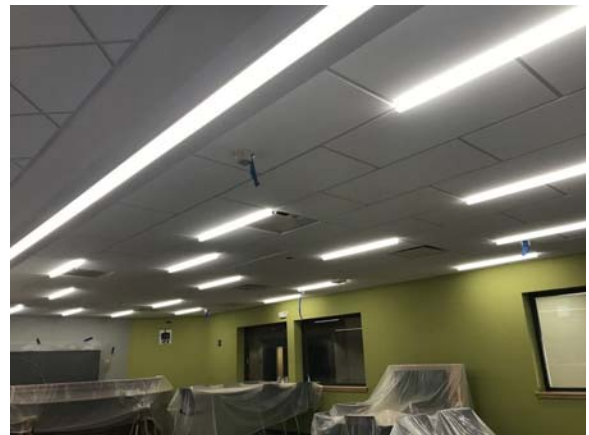
BATE006a 5/11/2021
Older VCT, acoustical ceiling, and painted block walls
Third floor corridor

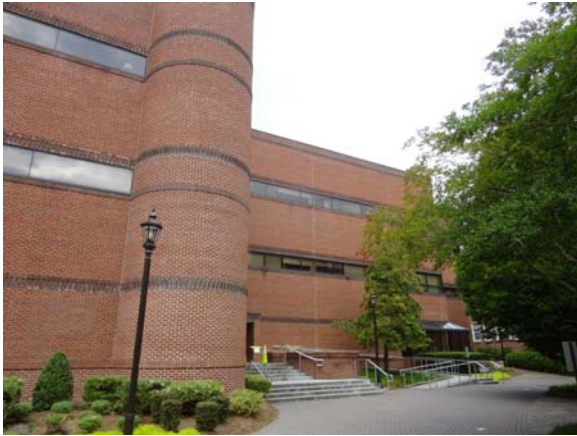
BATE060a 5/11/2021
Staining and streaking on exterior masonry
South end of east elevation

The brick facades have some signs of staining and the building should be cleaned and selectively repointed and recaulked as needed. The metal-framed glazing is at or near the end of its normal lifecycle and should be replaced. A number of panels on the first floor atrium glazing are fogged indicating accelerated weathering. The primary and secondary glass entry/egress doors are aging and should be replaced in kind in the near future. The secondary hollow-metal service doors are also showing age and should be considered for replacement within the next eight to ten years. The built-up roof was installed around 2009 and is in average condition for its age. It should be replaced within the next nine to ten years.

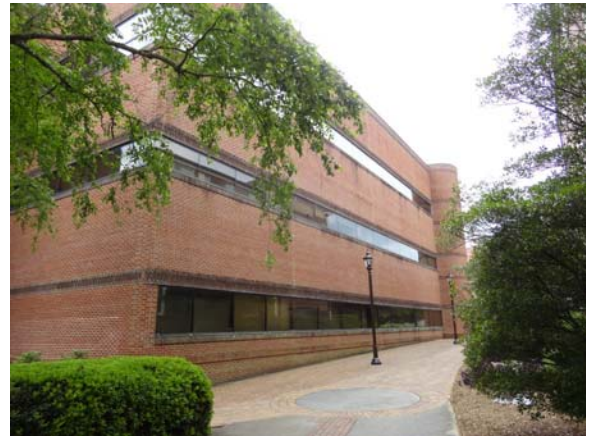
BATE063a 5/11/2021
Fogging atrium glazing
Northeast elevation

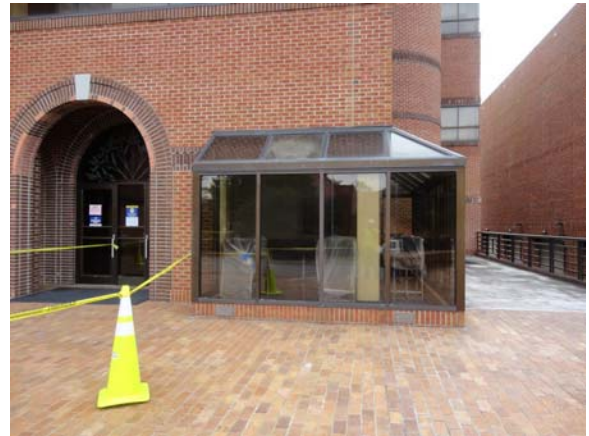
BATE069a 5/11/2021
Signs of efflorescence on plaza steps
Southwest corner plaza
