EAST CAROLINA UNIVERSITY

Facility Condition Assessment

Rawl Building (004)

Inspected May 10, 2021

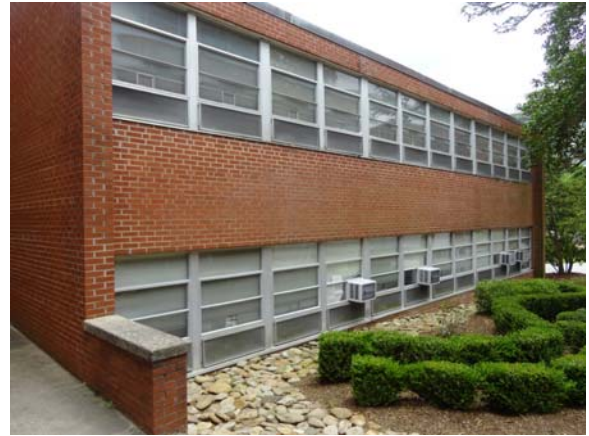
RAWL049a 5/10/2021
Exterior window too close to grade
Annex

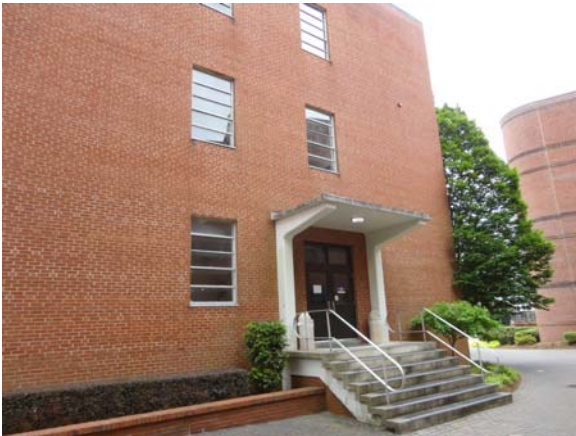
The brick facades have an average appearance, with some surface staining on upper elevations. Older brick facades should be cleaned and repointed in the near future. The cut stone accents around the main entry also appear adequate at this time. The original single-pane glazing is in poor condition and should be considered for replacement with thermal-pane, metal frame glazing. The newer brick veneer and thermal-pane glazing on the east tower addition is in good condition, and no upgrades are warranted. The glass entry doors at the main elevation are newer and in good condition, as are the glass doors at the east elevator tower and the hollow metal secondary entry egress and service doors. The basement hollow metal service doors are more weathered and due for in-kind replacement. The roof over the main building and elevator tower addition is a modified bitumen system reportedly installed in 2006. It will be due for in-kind replacement in the near future. The older built-up roof on the south annex is in poor condition and past due for replacement.

RAWL062a 5/10/2021
Light staining on upper brick
Upper north elevation
