EAST CAROLINA UNIVERSITY

Facility Condition Assessment

Rivers West

Inspected May 12, 2021

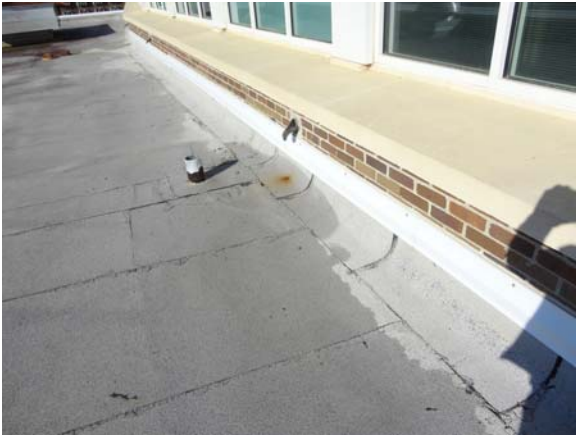
The hipped, terra cotta tile main upper and south tower roofs are in good condition and no upgrades appear to be needed. The lower east flat, built-up roofs are also in adequate condition for their age but will reach the end of their normal lifecycle within the next few years and should be replaced in kind.

RIVW004a 5/12/2021
Lower roof counter flashing detail
Lower east roof

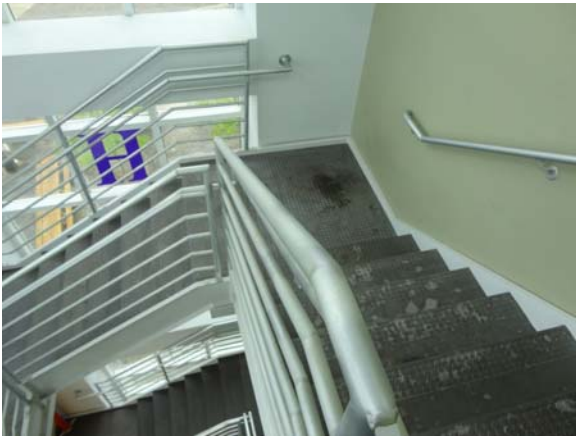
The stair finishes are beginning to deteriorate and should be upgraded before they become unsafe. Install stair treads and color contrast nosings that will provide adequate traction during egress.

RIVW005a 5/12/2021
Stair tread finishes and painted walls
Stair tower

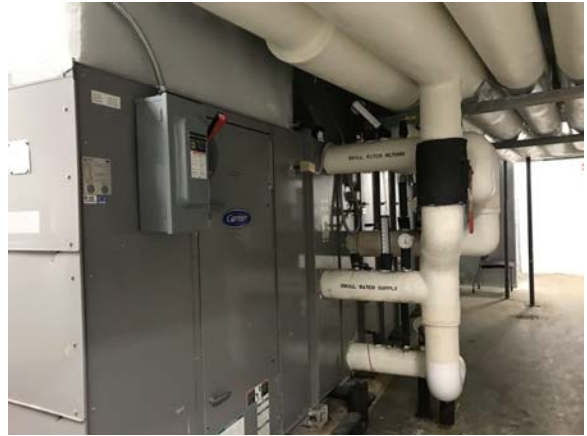
The main HVAC system provides heating and cooling via two belt-driven air handling units. Exhaust for the restrooms is handled by a centrifugal exhaust fan, and an inline exhaust fan serves the main mechanical room. The air handling units are in good condition with routine scheduled maintenance. They are expected to remain viable for the next ten years. Due to lifecycle depletion, the inline and rooftop exhaust fans should be evaluated for replacement within the next decade.

RIVW007e 5/12/2021
Air handling unit AHU-002
Room RW-222

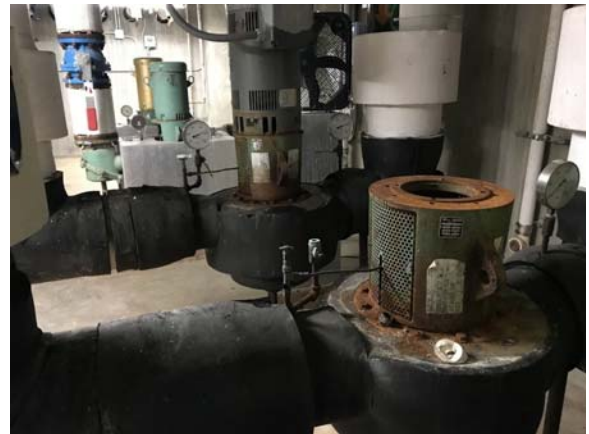
Chilled water is supplied by the central chilled water plant. Two 30-hp inline chilled water pumps act as a backup as the chilled water plant provides adequate pressure for the building. However, the pumps should be evaluated for replacement, and/or removal, depending upon the future needs of the building. Heating hot water is generated through a shell-and-tube heat exchanger utilizing steam generated at the central steam plant. High pressure steam is reduced to low pressure steam through a pressure reducing valve. Heating hot water is circulated throughout via two 10-hp inline centrifugal pumps. Condensate from the heat exchanger is collected and transferred back to the central plant via a duplex condensate receivers. The chilled water and heating hot water systems also serve the adjacent Rivers Building. The heat exchanger and heating hot water pumps are believed to be in good condition and expected to remain viable for the next ten years. The condensate receiver and the pressure reducing valve should be evaluated for replacement within the next ten years due to lifecycle depletion.

RIVW012e 5/12/2021
Chilled water pumps
Room RW-006

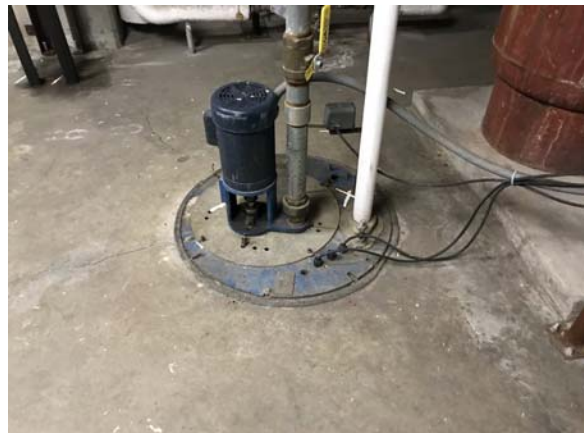
A small modular sump pump in the mechanical room was likely installed within the last ten years. Due to service life depletion, it should be expected that the pump will need to be replaced within the next decade.

RIVW021e 5/12/2021
Sump pump
Room RW-006

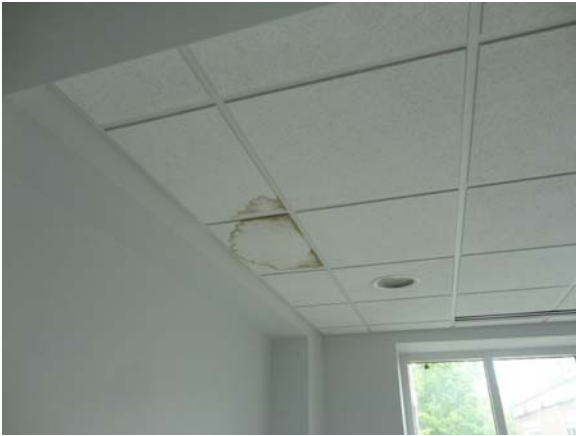
RIVW022a 5/12/2021
Ceiling tile stains due to possible roof leak
Second floor link to Rivers Building

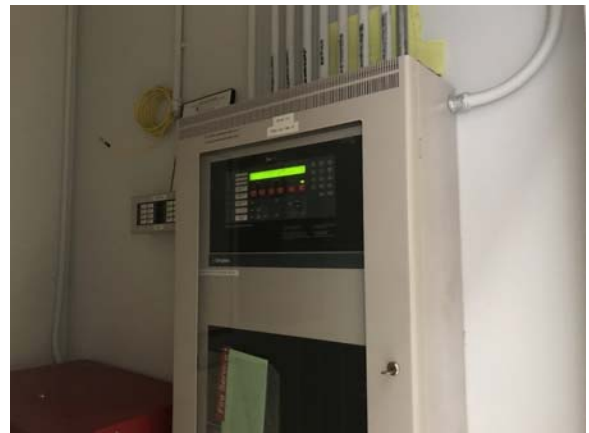
This facility contains a Simplex point addressable fire alarm and detection system that contains a main fire alarm panel, manual pull stations, smoke detectors, and horn and strobe alarm systems. The panel and devices are original and should be evaluated for replacement within the next ten years due to technical obsolescence.

RIVW024e 5/12/2021
Main fire alarm panel
Room RW-119

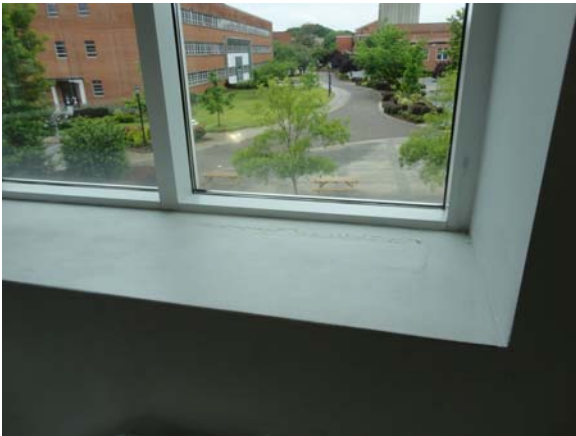
RIVW029a 5/12/2021
Minor window sill damage due to condensation
Second floor window detail

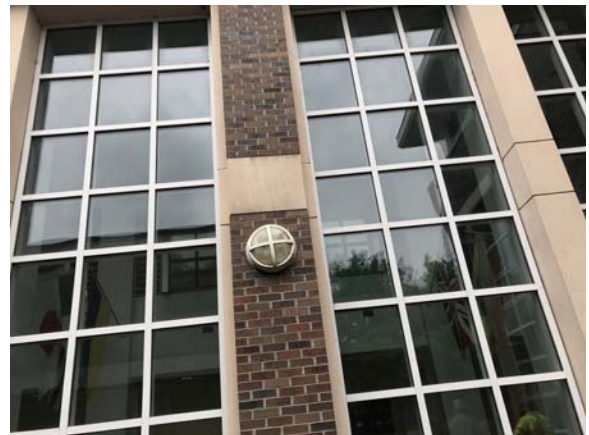
The exterior lighting consists of recessed can CFLs, CFL sconces, and bollard fixtures. While currently functional, the exterior lighting is less efficient and requires more frequent maintenance than modern LED-based outdoor lighting. It is recommended that the exterior lighting be replaced with LED fixtures.

RIVW030e 5/12/2021
CFL sconce lighting fixture
Exterior

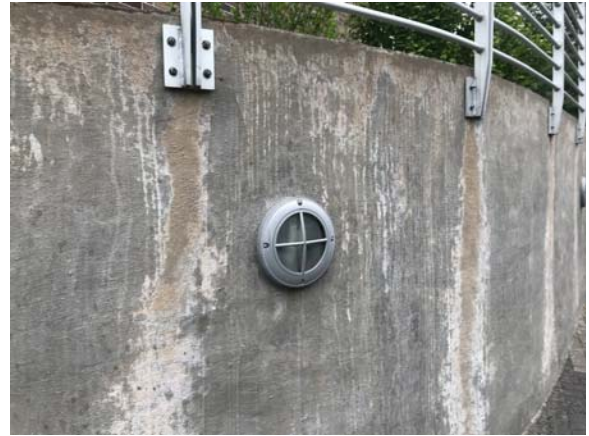
RIVW031e 5/12/2021
CFL sconce lighting fixture
Exterior

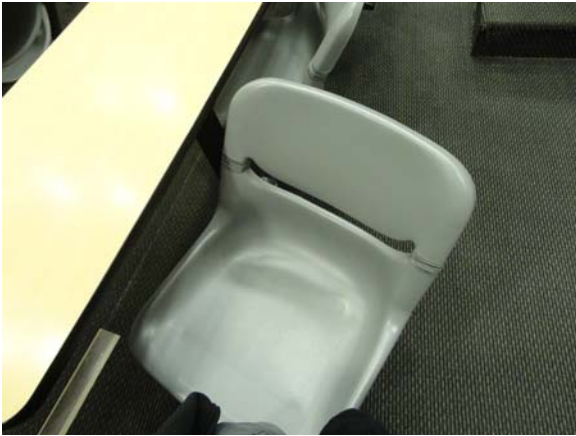
RIVW034a 5/12/2021
Minor wear on fixed seating
First floor, auditorium

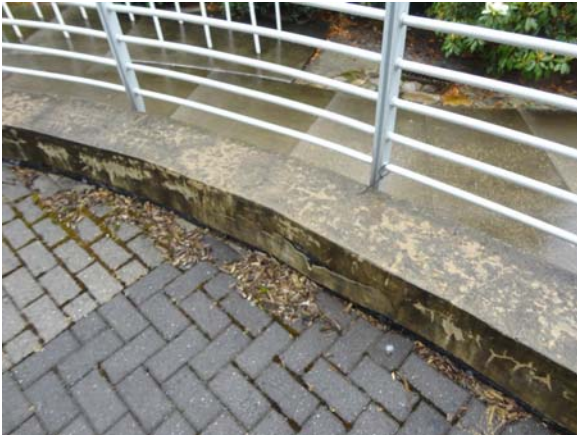
RIVW046a 5/12/2021
Spalling finish on plaza wall
South plaza
