EAST CAROLINA UNIVERSITY

Facility Condition Assessment

Rivers Building (010)

Inspected May 13, 2021

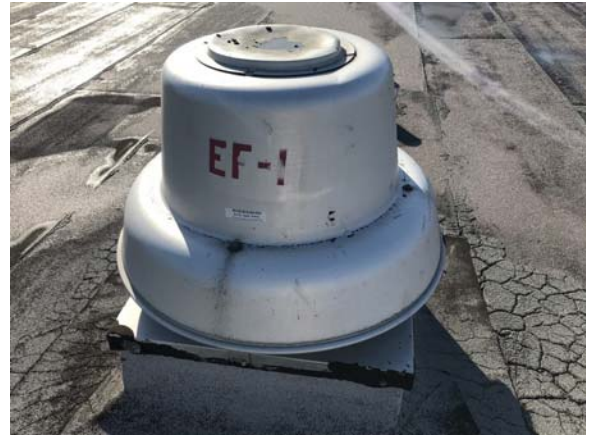
RIVE001e 5/13/2021
Centrifugal rooftop exhaust fan
Roof

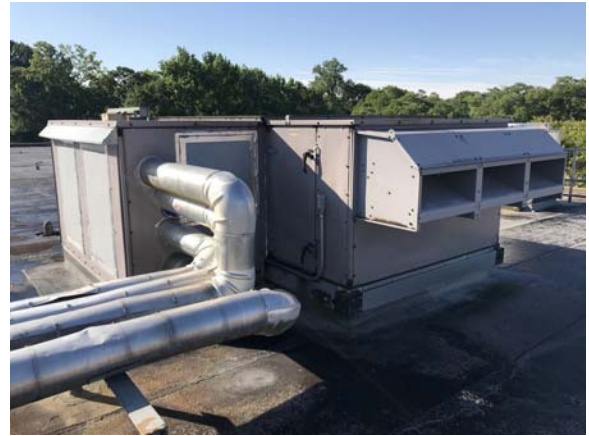
RIVE007a 5/13/2021
Heavy weathering of granular finish on cap sheet
Main roof

The flat, built-up roofing system is heavily weathered and at, or past, its normal lifecycle. Replace the main roof in kind in the very near future. The small east addition has a much newer built-up roof that is in good condition and no upgrades are needed.

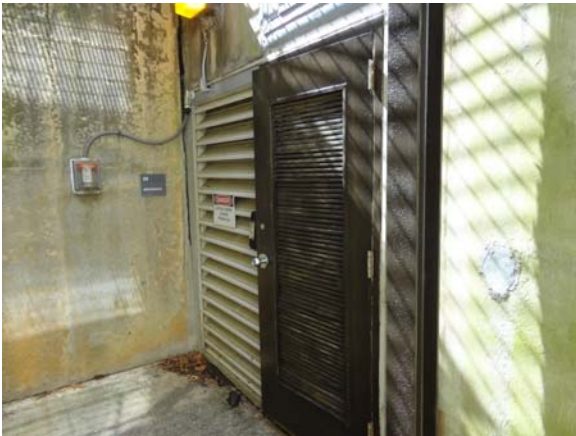
RIVE074a 5/13/2021
Rusted areaway access steps
Courtyard

The building has accessible entry points, but the southeast entry ramp has failed and should be replaced in kind. The entrances lack fully accessible wall-mounted handrails, and certain entry steps will require modifications. Some of the key entry doors have power door assist units that also need to be upgraded. Prep and repaint the areaway service stairs as part of this ramp and railing upgrade work.

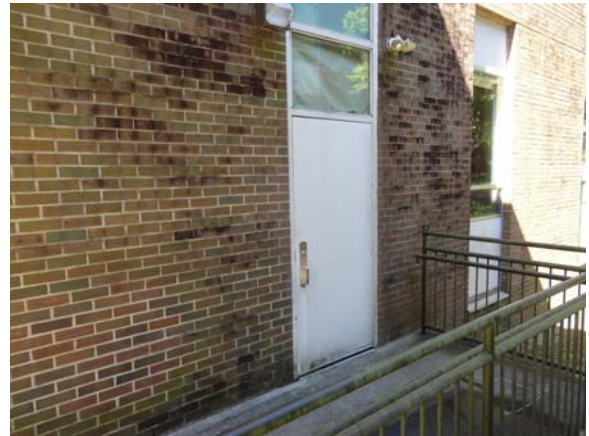
RIVE081a 5/13/2021
Rusted out pedestrian entry ramp
Southeast elevation

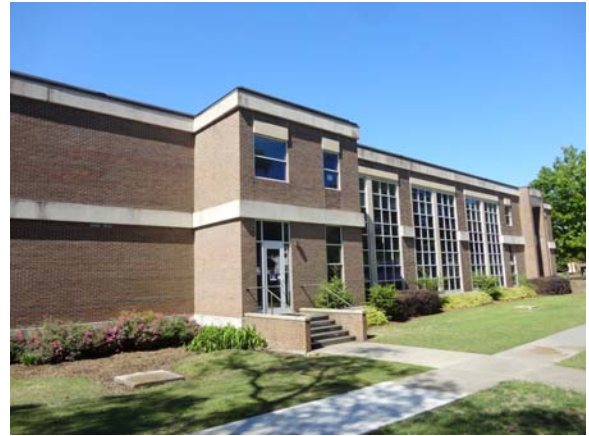
RIVE085a 5/13/2021
Staining visible on upper banding
South elevation

The brick facades and upper precast concrete banding are stained and the caulking along the banding is weathered. Some of the banding has stress cracks and select panels may require replacement. Cleaning, surface preparation, and selective repairs are recommended to restore the aesthetics and integrity of the building envelope.
