# EAST CAROLINA UNIVERSITY

Facility Condition Assessment

Slay Hall (076)

Inspected May 12, 2021

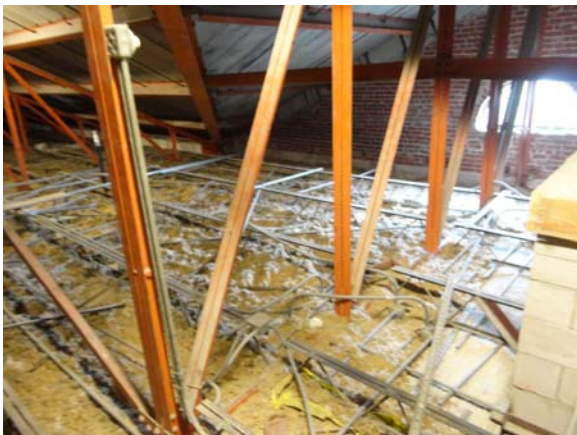
SLAY003a 5/12/2021  
Inadequate insulation in attic  
Attic

The single-ply membrane roof on the north entry lobby is past its normal lifecycle. Signs of water staining on the lobby ceiling indicate that this flat roof should be replaced in the very near future. The hipped clay tile roof on the main building was reportedly refelted in the mid-1990s reusing the existing clay tiles where possible. While the roof should outlast the scope of this report, there are reported roof leaks around some of the dormers that are being addressed. Also, there are current water infiltration issues on the perimeter of the third floor. The source of these water leaks are likely attributed to integral gutter issues. Clean and line these original gutters with a membrane to better control roof drainage. The attic also has inadequate roof insulation and additional batt insulation should be installed as part of routine maintenance.

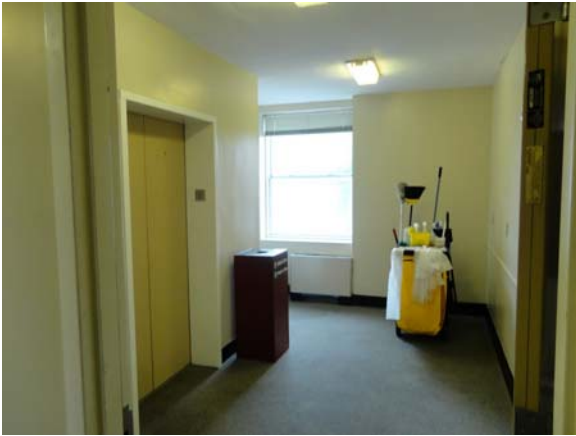
SLAY004a 5/12/2021  
Worn carpeting and older paint on walls and ceiling  
Third floor corridor

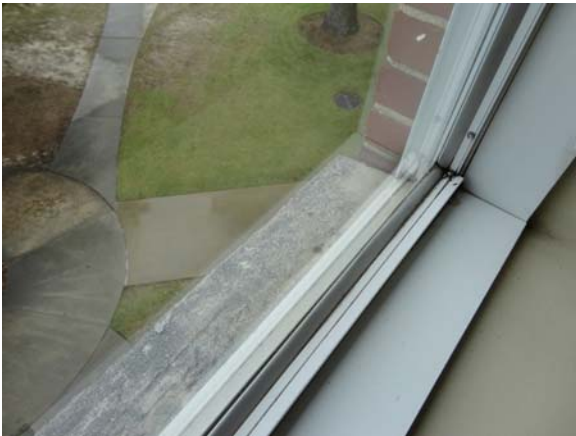
SLAY005a 5/12/2021  
Aging metal-framed windows  
Third floor

While the brick facades and upper cut stone accents appear to be sound, they have localized staining and some masonry stress cracks are visible. The facades will need to be cleaned and repointed in the near future. The main entry doors for the north lobby are aging and should be upgraded in kind. The hollow-metal secondary and service doors are still in adequate working order and no upgrades are recommended at this time. The windows were upgraded around 1995 but many are fogging and should be replaced. The stair tower windows are older, original single-pane windows that should be upgraded at the same time. Install new metal-framed, thermal-pane windows building-wide in the next few years.

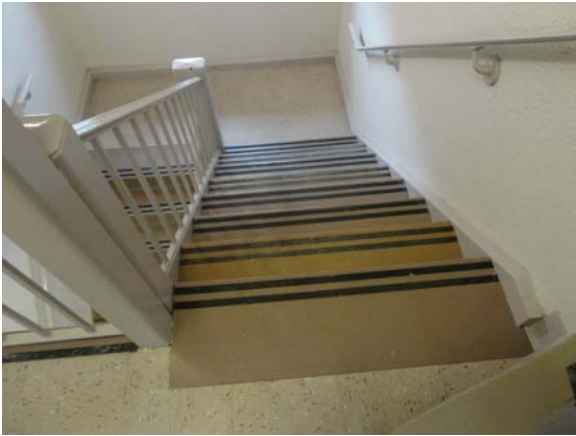
SLAY007a 5/12/2021  
Worn rubber stair treads  
Third floor, stair tower

As mentioned above, the worn rubber stair treads in the three stair towers should be replaced with new rubber treads to help improve user safety.

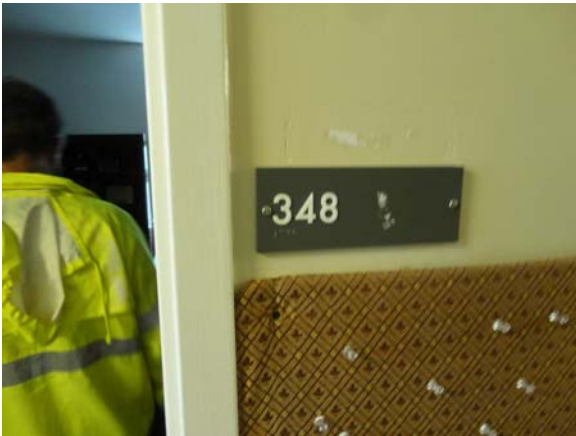
SLAY008a 5/12/2021  
Accessible room signage but damaged wall paint  
Third floor corridor

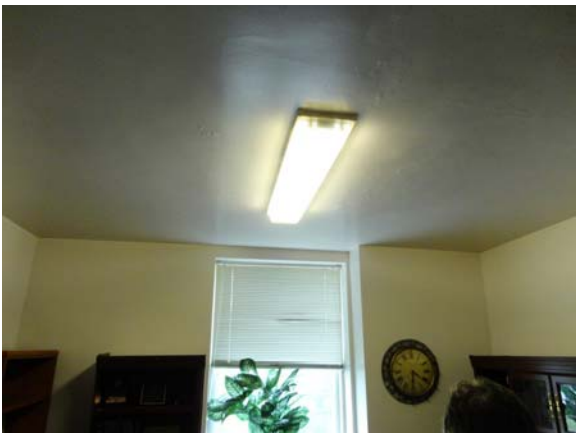
SLAY009a 5/12/2021  
Some finish damage on painted ceiling  
Third floor, office

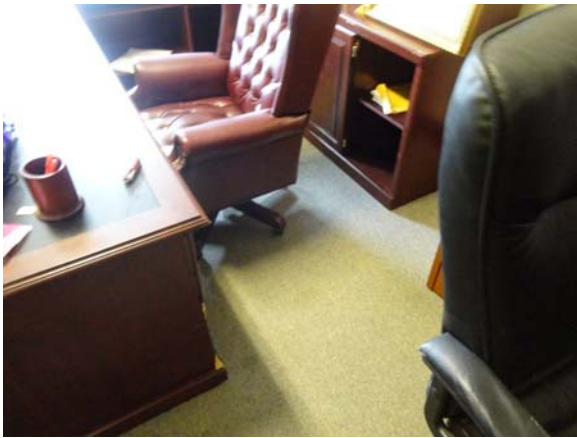
SLAY010a 5/12/2021  
Older broadloom carpeting  
Third floor, office

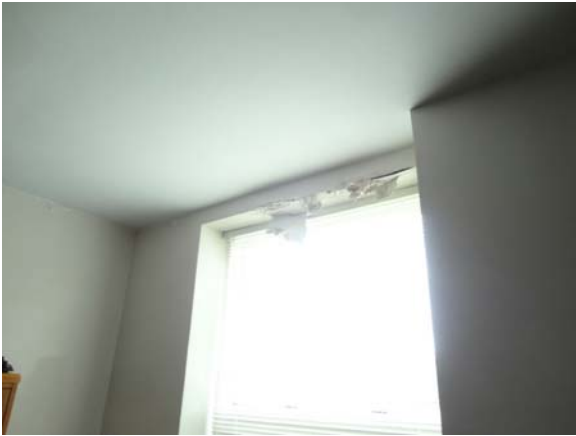
SLAY019a 5/12/2021  
Ceiling damage possibly due to integral gutter issues  
Third floor

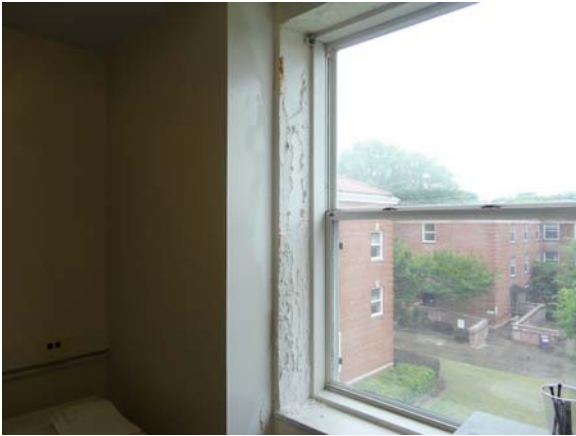
SLAY022a 5/12/2021  
Water damage around exterior glazing  
Third floor

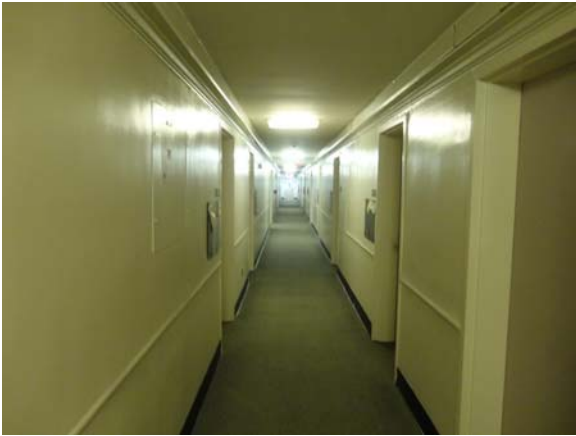
SLAY028a 5/12/2021  
Worn carpeting and painted walls and ceiling  
First floor corridor

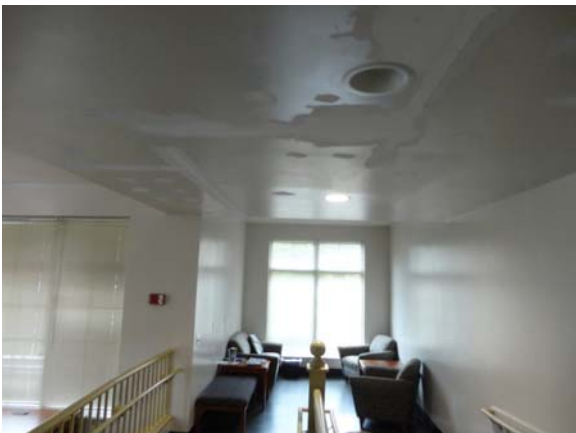
SLAY030a 5/12/2021  
Unrepaired water damage to lobby ceiling  
First floor, entry lobby

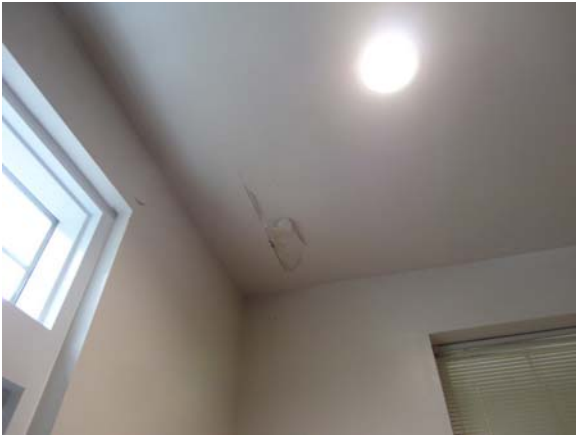
SLAY031a 5/12/2021  
Unrepaired water damage to lobby ceiling  
First floor, entry lobby

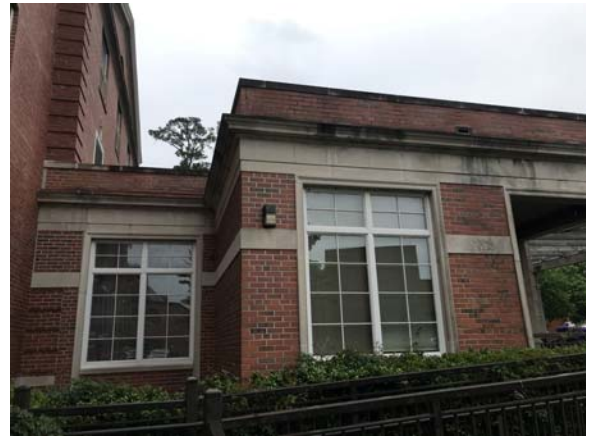
The exterior lighting consists of HID wallpacks that were likely installed in the mid-1990s during the renovation. While currently functional, the majority of the exterior lighting is less efficient and requires more frequent maintenance than modern LED-based outdoor lighting. It is recommended that the exterior lighting be replaced with LED fixtures.

SLAY032e 5/12/2021  
HID wallpack  
Exterior

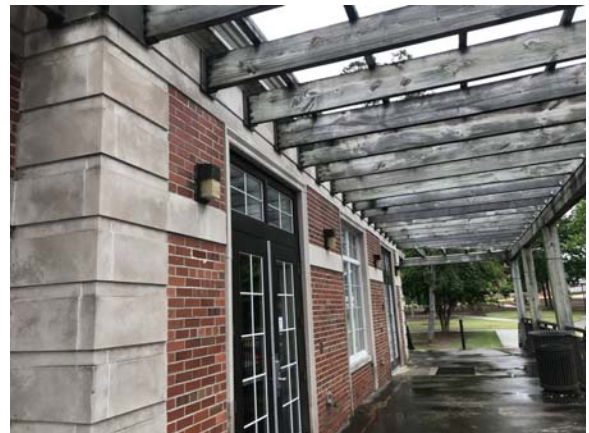
SLAY033e 5/12/2021  
HID wallpacks  
Exterior

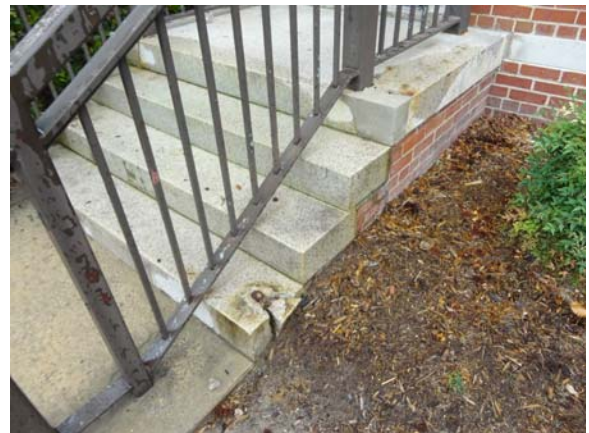
SLAY043a 5/12/2021  
Granite steps with some failed repairs  
Southwest corner elevation

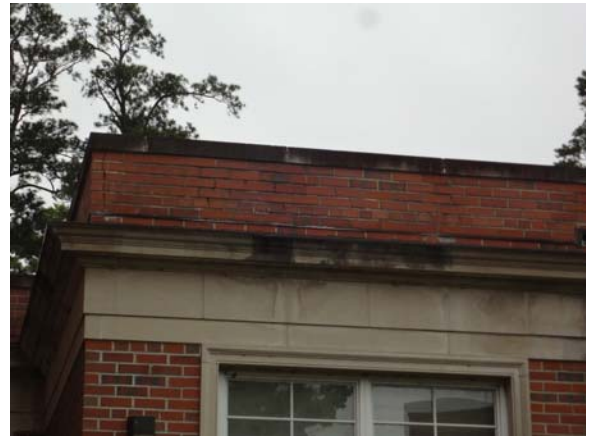
SLAY047a 5/12/2021  
Stress cracks at corner of brick and staining of cut stone  
Upper east elevation
