EAST CAROLINA UNIVERSITY

Facility Condition Assessment

Speight Building (012)

Inspected May 11, 2021

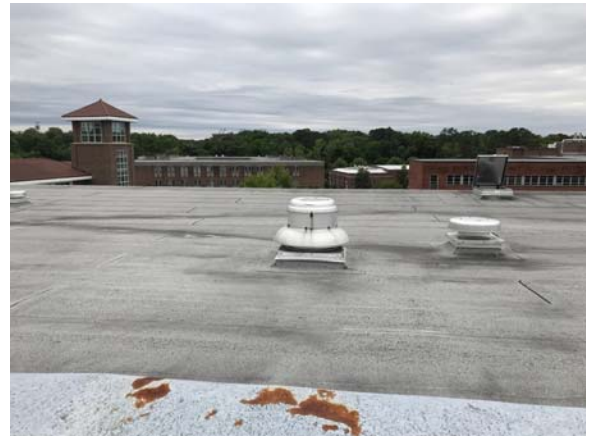
The multi-level flat roofs are aging and should be upgraded in the near few years. The roof hatch in the #3 stair tower has a newer top hatch but the lower hatch is poor and the ladder lacks any handrail extension features. Replace the lower hatch and install a railing extension unit to the top of the access ladder. Also, relocate the roof transition ladder that is located too close to the edge of the roof to help improve safety for service personnel.

SPEI002a 5/11/2021
Poor lower hatch and no stair rail extension
Roof hatch

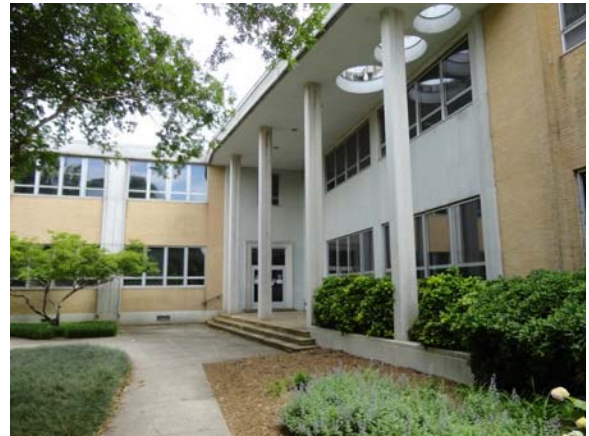
The exterior facades are a mixture of yellow brick and precast concrete panels that are stained. There are also numerous step cracks that need to be repaired. Cleaning, surface preparation, selective repairs, and applied finish or penetrating sealant upgrades are recommended to restore the aesthetics and integrity of the building envelope.

SPEI047a 5/11/2021
Stained exterior masonry and precast concrete panels
Northwest elevation

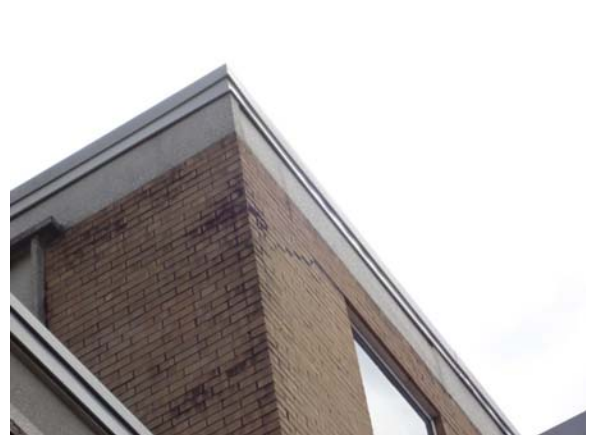
SPEI049a 5/11/2021
Vertical stress cracks on north elevation
Northwest upper corner of third floor

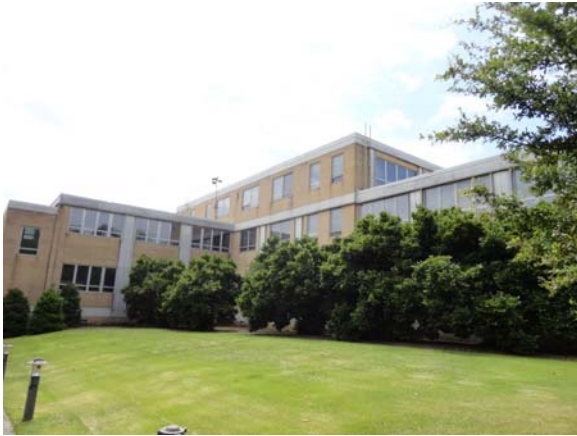
SPEI050a 5/11/2021
Step cracking on north elevation
Northwest upper corner of third floor

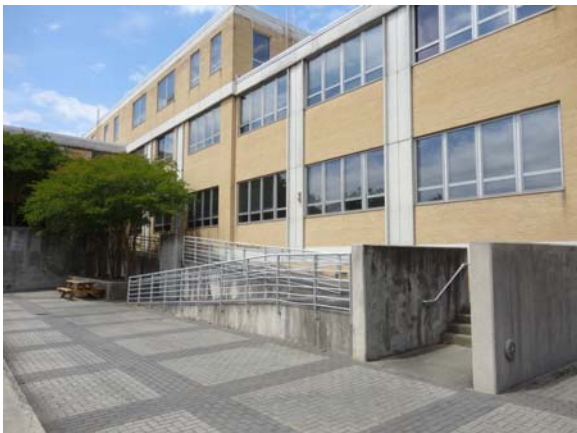
SPEI054a 5/11/2021
Upper corner masonry step cracking
Southeast upper corner of third floor
