EAST CAROLINA UNIVERSITY

STUDENT HEALTH SERVICES ADDITION

FACILITY CONDITION ANALYSIS

DECEMBER 16, 2009

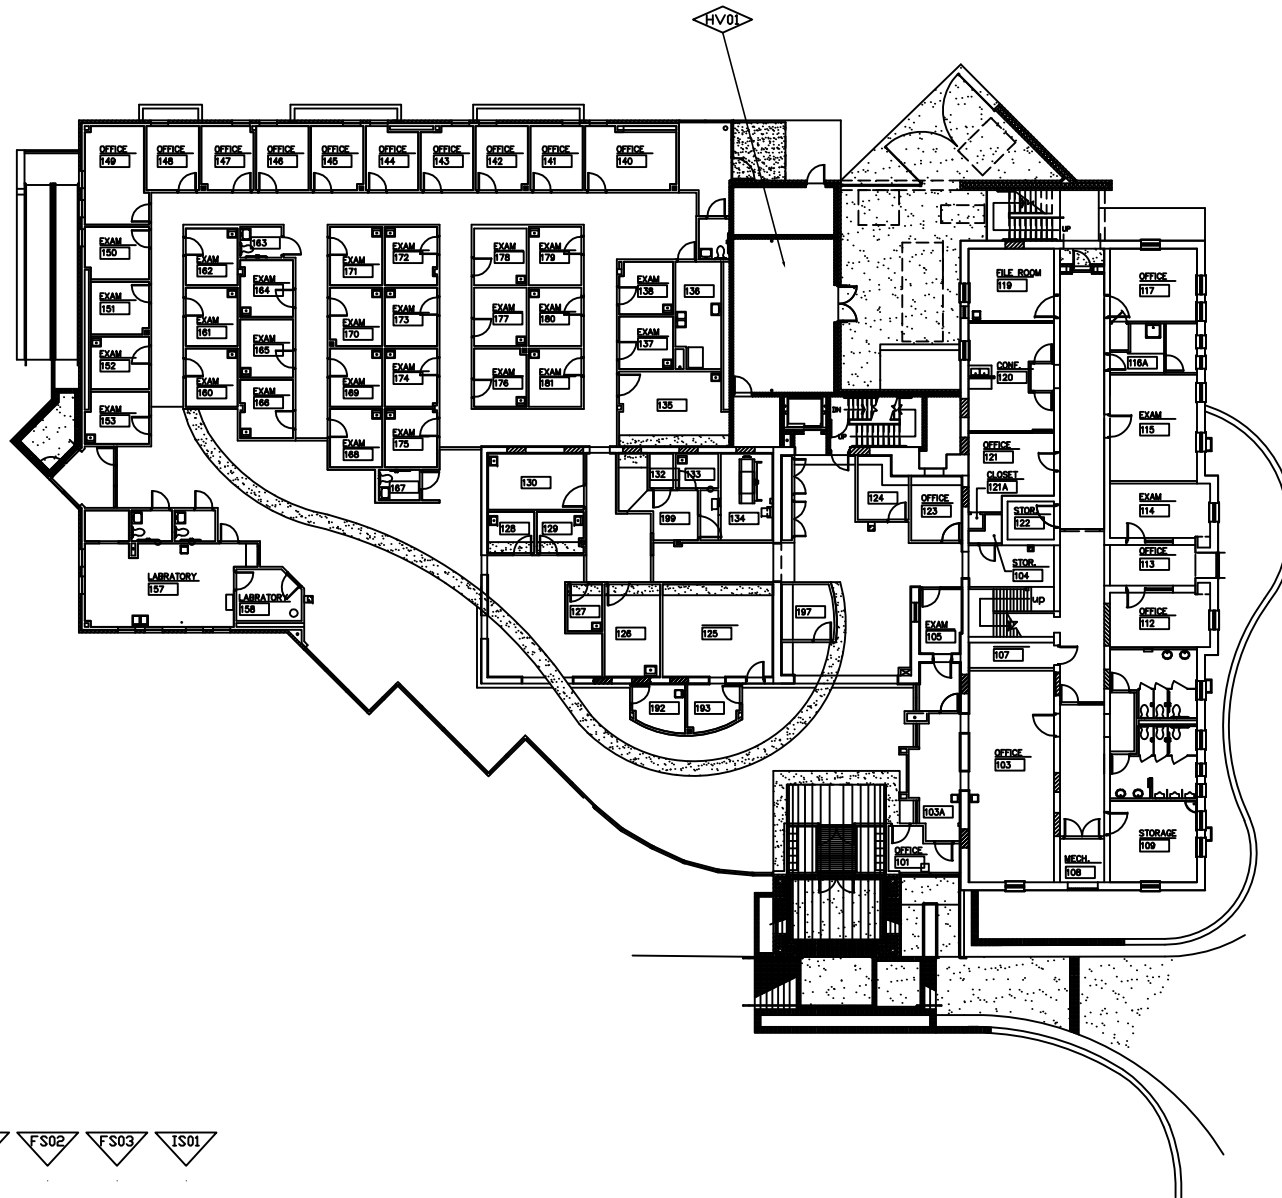
ES01

Brick veneer is the primary exterior finish. While the brick is fundamentally sound, exposure to the elements has caused some deterioration of the mortar joints and expansion joints. Cleaning, surface preparation, selective repairs, and applied finish or penetrating sealant upgrades are recommended to restore the aesthetics and integrity of the building envelope.
