EAST CAROLINA UNIVERSITY

Facility Condition Assessment
Umstead Residence Hall (075)
Asset UMST

Inspected May 12, 2021

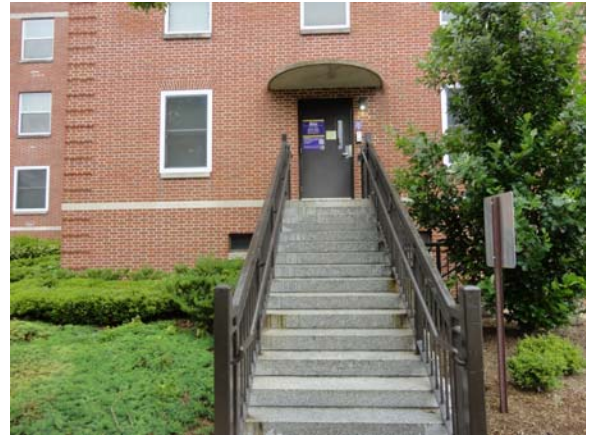
The landscaping around the building consists of turf grass, ornamental shrubs, and some mature trees. It is in average condition and should be adequate for the near future. Concrete sidewalks have some differential settlement issues in a few locations and portions of this walkway should be removed and replaced. The adjoining parking lots are considered part of campus infrastructure and not addressed in this report.

UMST049a 5/12/2021
Some differential settlement on concrete sidewalks
Southeast corner of site

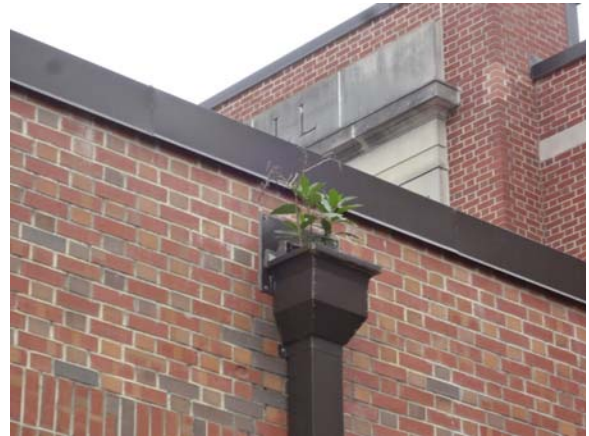
UMST052a 5/12/2021
Sign of blocked drain scupper
Lower south roof

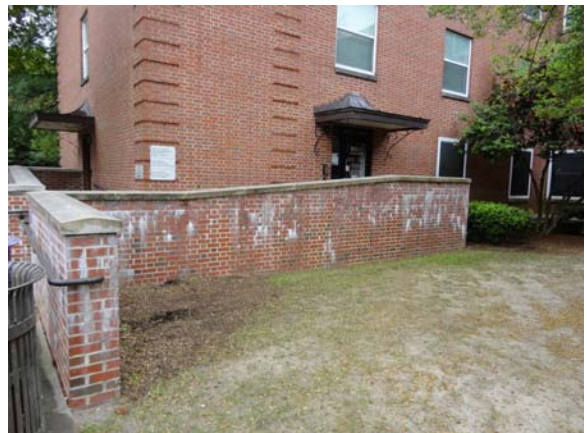
The brick facades are in average condition and no major repointing work is warranted at this time. However, the low masonry walls at the north central entry/egress ramp have heavy efflorescence and should be cleaned and repointed to help control water infiltration.

UMST059a 5/12/2021
Efflorescence on masonry site walls
Central north wing

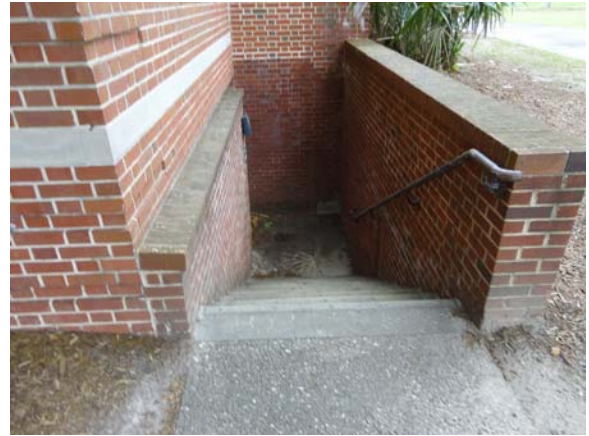
UMST062a 5/12/2021
Only one handrail on service stair
East basement service entry
