EAST CAROLINA UNIVERSITY

Facility Condition Assessment

Whichard Building (031)

Inspected May 10, 2021

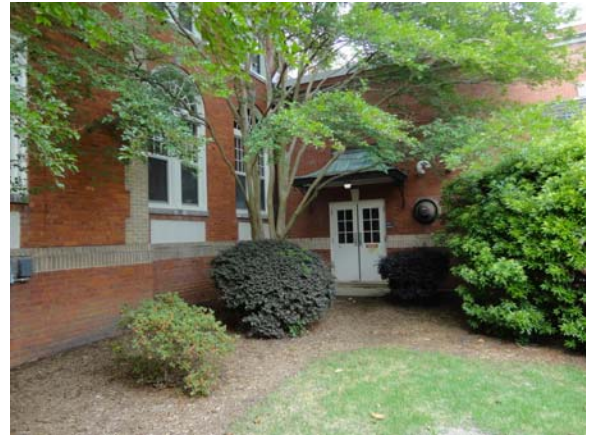
WHIC061a 5/10/2021
Signs of efflorescence on entry steps
South elevation of original building

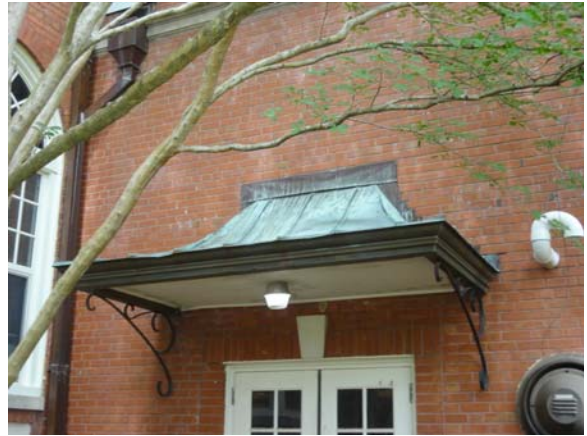
WHIC069a 5/10/2021
Localized dry rot on soffit
South elevation
