EAST CAROLINA UNIVERSITY

Facility Condition Assessment

Belk Annex 1

Inspected January 11, 2023

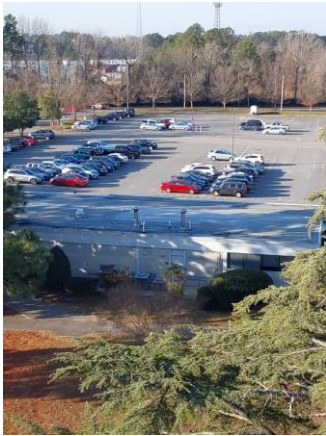
059001a 1/11/2023
Modified bitumen roof
Roof

The flat roof is a modified bitumen system with internal drains and some small rooftop equipment. Although direct access to the roof could not be made, replacement is recommended due to the roof's documented age provided by East Carolina University and a visual inspection from an adjacent building. Replace the old roofing and flashing with similar applications. The exterior facades have concrete panel cladding with two stationary bands of storefront glazing and storefront at the north and west entries. The concrete panels are in good condition but require routine joint maintenance. The glazing is new and, as are the aluminum storefront and hollow metal doors, and no upgrade is recommended.

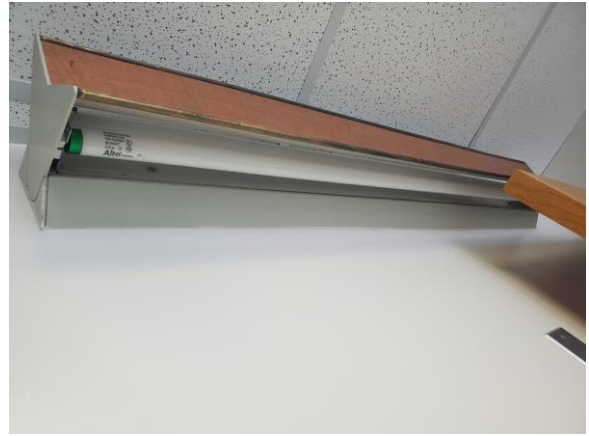
059004e 1/11/2023
Surface-mounted light fixture with T12 fluorescent lamp
Waiting room

Interior lighting is provided by recessed, surface-mounted, and wall mounted fixtures. Some have been retrofitted with LED lamp kits, but aged and inefficient fluorescent T12 lamps remain. The lighting system should be replaced in the next ten years due to age and condition. A modern, energy-efficient system with LED lamps, occupancy sensors, and a daylight control system is recommended.

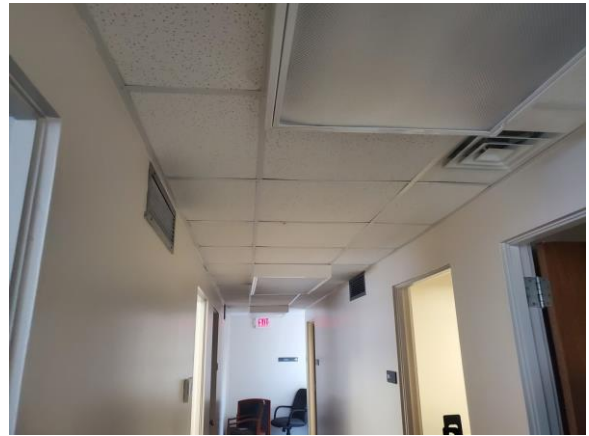
059005e 1/11/2023
Aged, surface-mounted light fixtures
Corridor

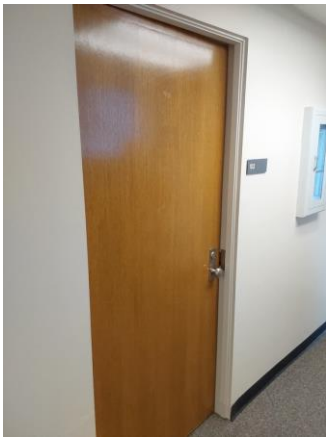
059006a 1/11/2023
Nonrated wood door with knob hardware
Room 102

Accessibility legislation requires that door hardware be designed for people with little or no ability to grasp objects with their hands. To comply with the intent of this legislation, it is recommended that lever handle hardware be installed on all doors that still have knobs.

This facility does not have rated doors and frames along corridors and into stair towers as required by modern building code. Complete replacement of the door systems and hardware according to a code-compliant plan to properly protect egress passages is recommended.

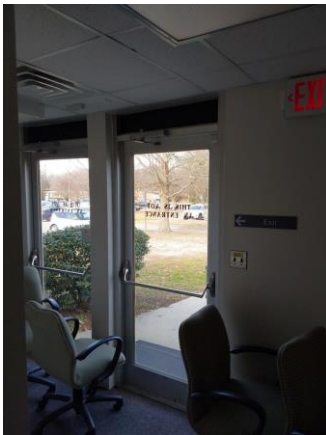
059009a 1/11/2023
Exit doors with old style panic hardware
Corridor

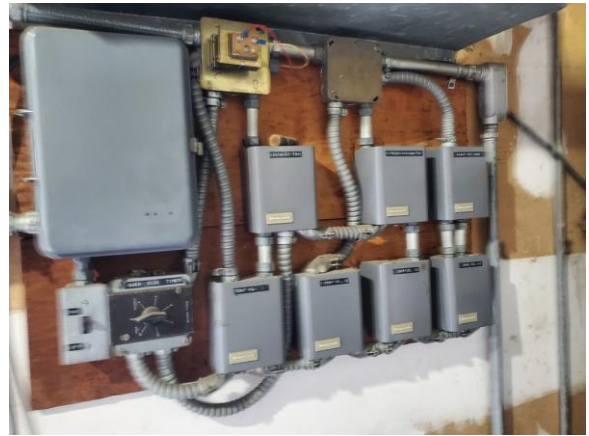
059014e 1/11/2023
Aged electromechanical HVAC equipment starters
Mechanical room 116

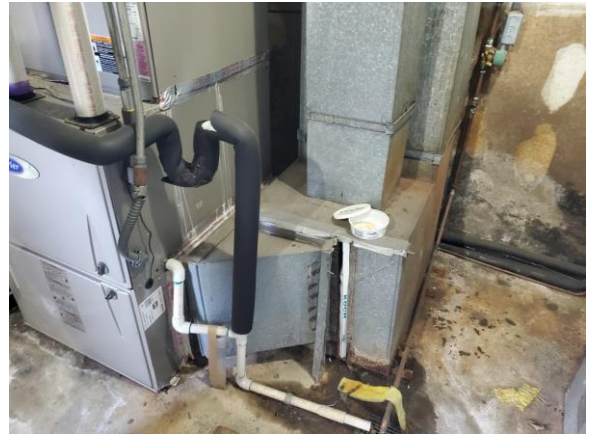
059016e 1/11/2023
Corroded metal ductwork
Mechanical room 116

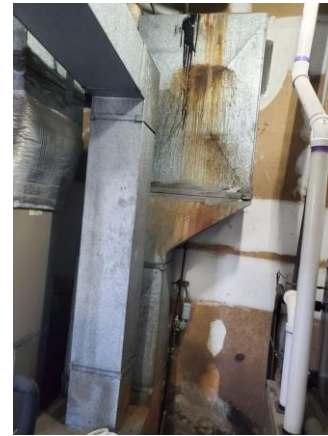
059017e 1/11/2023
Aged metal ductwork
Mechanical room 116

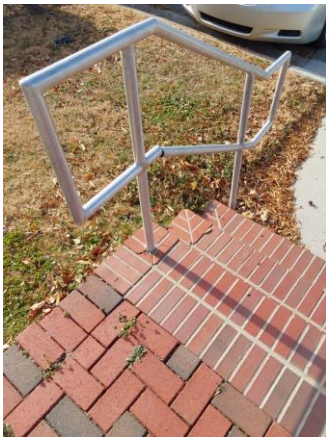
Current accessibility legislation requires that building entrances be wheelchair accessible. The wheelchair ramp on the east elevation lacks handrails. The installation of a handrails is recommended to comply with ADA standards. Also, the entrance stair handrail is broken and should be replaced.

059021a 1/11/2023
Broken exterior entrance stair railing
West site

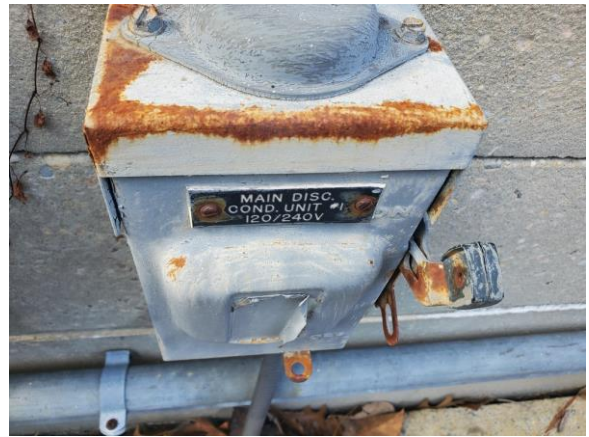
059021e 1/11/2023
Corroded disconnect housing
Exterior

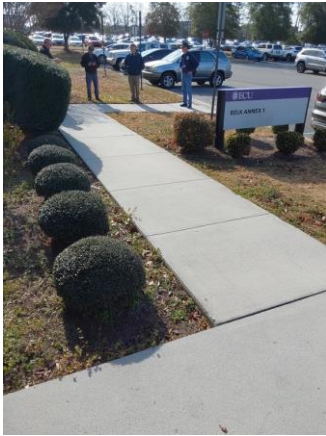
059022a 1/11/2023
Wheelchair ramp without handrail
West site

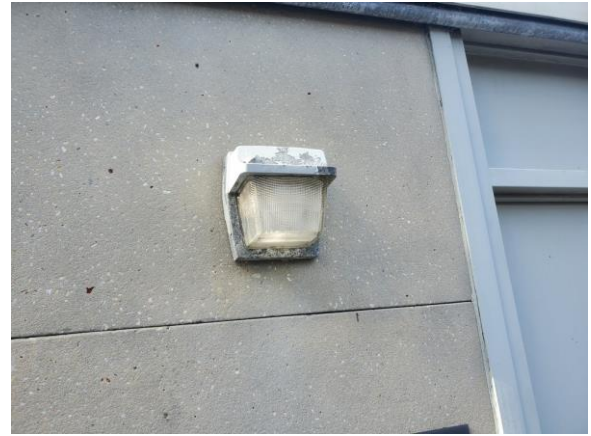
The exterior lighting is provided by surface-mounted and recessed fixtures with HID and LED lamps. The fixtures are currently serviceable, but the aged HID fixture and recessed lights are recommended for replacement due to age and condition.

059022e 1/11/2023
Aged surface-mounted exterior light with HID lamp
Exterior

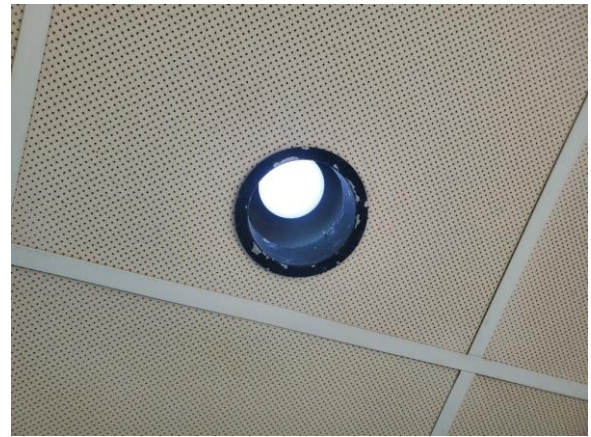
059024e 1/11/2023
Aged recessed light fixture
Exterior

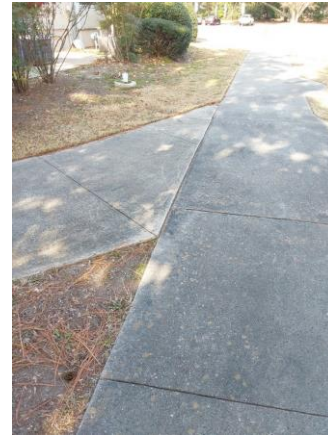
A small portion of the east walkway has settled and created a tripping hazard at one of the joints. It is recommended that this crack be sealed to create an even walking surface and prevent tripping.

059028a 1/11/2023
Curb bump safety hazard
East site
