EAST CAROLINA UNIVERSITY

Facility Condition Assessment

Belk Building

Inspected January 11, 2023

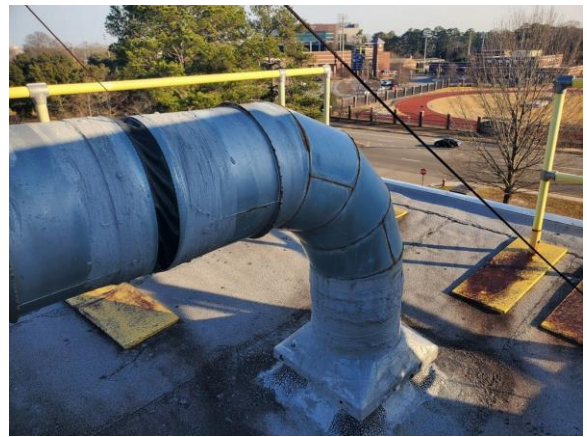
The roof is comprised of flat, single level modified bitumen. The roof drains via an internal roof drain system. There is equipment on the roof as well as skylights. It is recommended that the roof be replaced as the existing stress conditions will lead to failure if left unattended. Replace the stressed roofing and flashing with similar applications. The fiberglass skylights will also need replacement within ten years.

013003a 1/11/2023
Roof blister
Roof

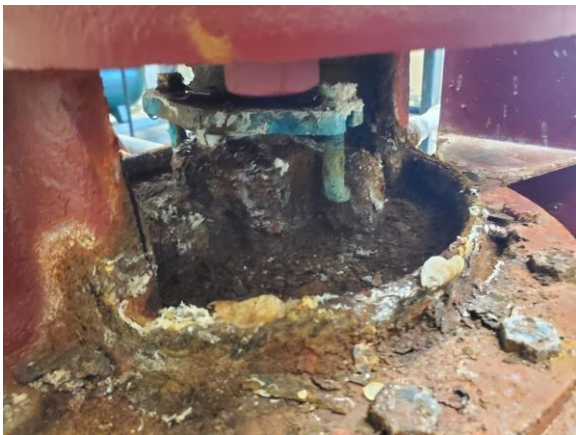
013063e 1/11/2023
Corrosion on fire pump casing
Room 1307
