# EAST CAROLINA UNIVERSITY

Facility Condition Assessment

Flanagan Building

Inspected January 9, 2023

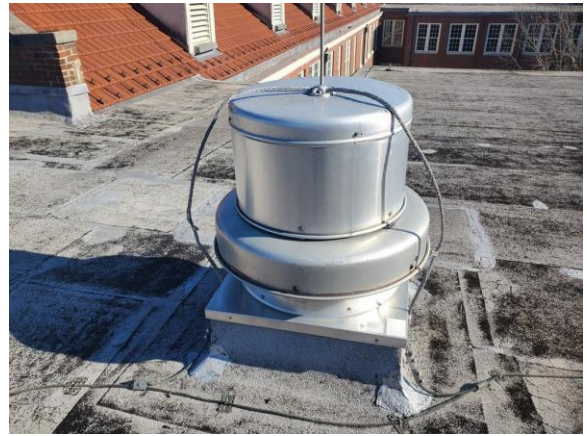
002001e 1/9/2023  
Rooftop exhaust fan EF-2  
Roof

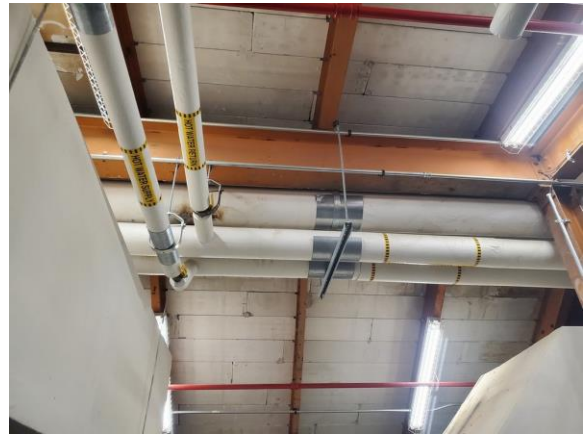
002014a 1/9/2023  
Corrosion of structural steel members  
Roof attic

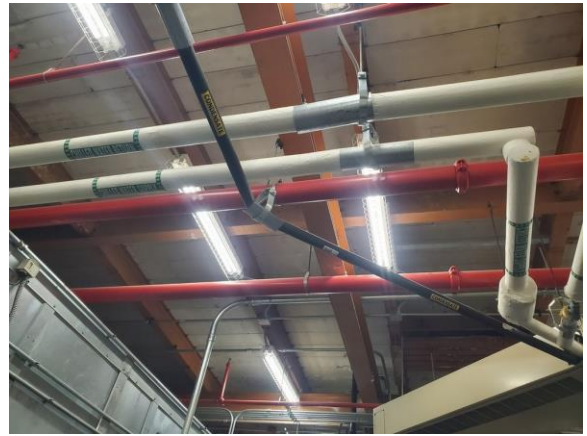
002016a 1/9/2023  
Signs of water infiltration from exterior  
Roof attic

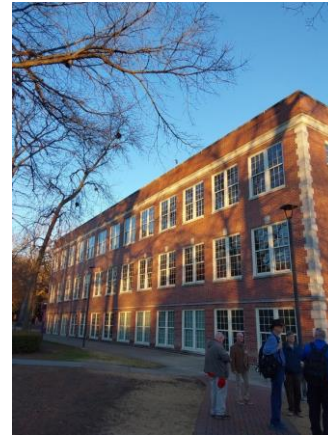
002102a 1/9/2023  
Concrete backer against brick has deteriorated  
West elevation
