# EAST CAROLINA UNIVERSITY

Facility Condition Assessment

Fletcher Music Center

Inspected January 10, 2023

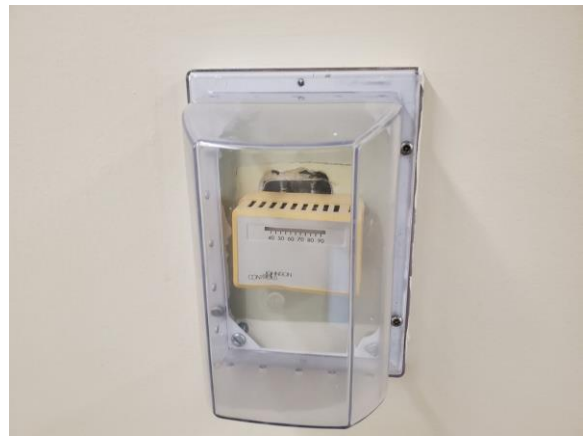
009009e 1/10/2023  
Original thermostat to be replaced  
Third floor corridor

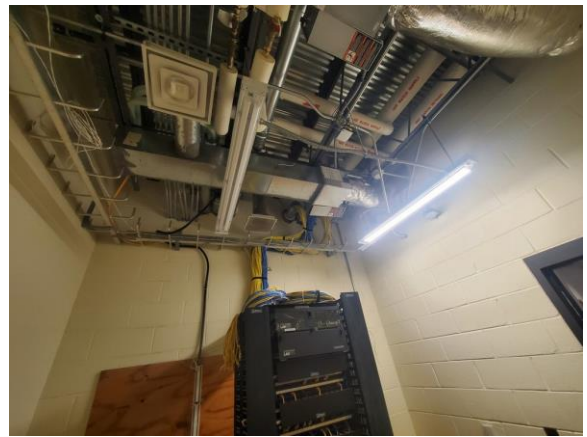
009039e 1/10/2023  
Server rack that needs drip pan installed above  
Data B112

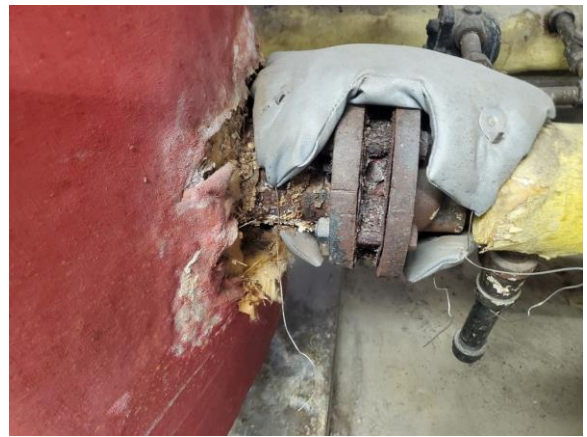
Domestic water is heated by an aged heat exchanger that utilizes steam. This unit has served beyond its expected lifecycle. The insulation is damaged in areas and moderate corrosion was observed. It is recommended that this unit be replaced.

009051e 1/10/2023  
Moderate corrosion on domestic water heater  
Mechanical 124

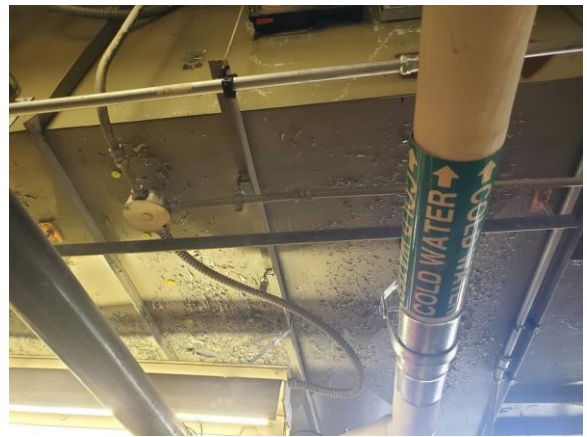
009054e 1/10/2023  
Flaking paint on HVAC system ductwork  
Mechanical 124

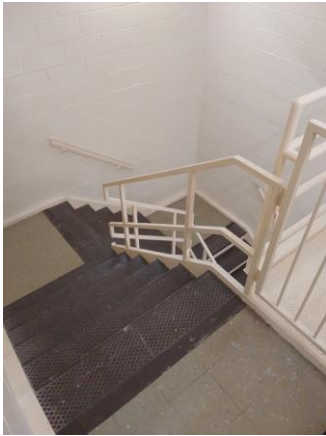
009068a 1/10/2023  
Noncompliant stair handrail  
Room 100A

The stairs have older rubber treads and painted metal railing and the tread finishes on the fire stairs are old and do not have the proper gripping ability for safety. Current accessibility legislation requires that stairs have graspable handrails on both sides, that the rails have a specific end geometry, and that the handrails continue horizontally at the landings. In addition, guardrails must prevent the passage of a four-inch diameter sphere (six inches in the triangle formed by the lower rail and tread/riser angle). The stair railing systems should be replaced and treads upgraded. Additionally, the stage stairs and the loading area stairs do not have proper handrails on either side. It is recommended that compliant handrails and guardrails be installed in these areas.

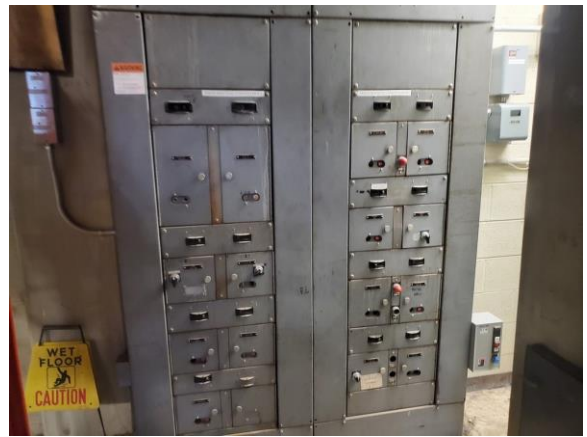
The electrical distribution network is a dual-voltage configuration. 277/480 volt power is distributed to branch transformers that step the power down to 120/208 volts. The lighting and major mechanical systems are supported by the 277/480-volt circuit. Most of the system was installed in 1966. A 300-amp main switchboard was observed in room A124. The secondary electrical panels for the original portion of the building were manufactured predominantly by General Electric. The 2006 addition is served primarily by Square D products. Overall, the majority of the facility is served by an aging and deficient electrical distribution system. The original 300-amp switchboard and secondary electrical equipment in the original portion of the building is recommended for renewal. It is also recommended that the main switchboard be upsized. The aged motor control center in room A124 is also recommended for renewal due to age.

009069e 1/10/2023  
Aged motor control center  
Mechanical 124

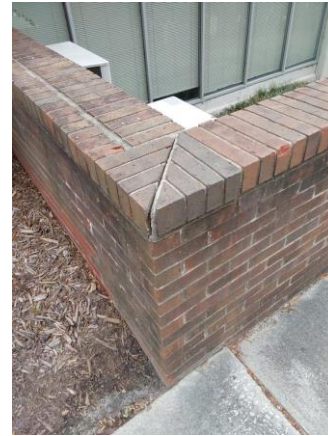
009104a 1/10/2023  
Efflorescence on brick retaining wall  
West elevation

The exterior is brick veneer with stone accents. While the brick and stone are fundamentally sound, exposure to the elements has caused some deterioration of the mortar and expansion joints. Cleaning, surface preparation, selective repairs, and applied finish or penetrating sealant upgrades are recommended to restore the aesthetics and integrity of the building envelope. There are also multiple areas with efflorescence and grime that require a light chemical treatment and power washing.

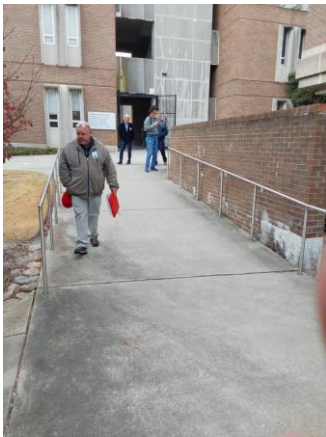
009105a 1/10/2023  
Damaged brick on retaining wall  
West elevation

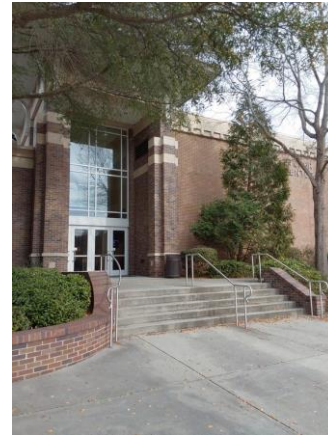
009114a 1/10/2023  
Brick landscaping wall damaged  
South elevation

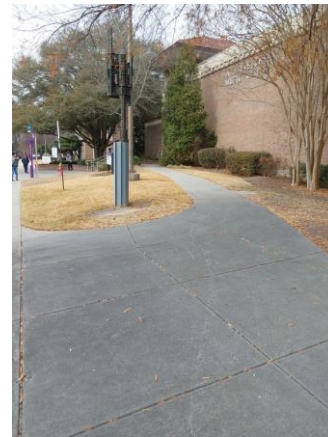
009118a 1/10/2023  
Missing ADA curb cut  
South elevation

ADA-compliant parking spaces in the south lot lead to curb cuts and a sidewalk system serving all entrances. The ADA parking space is missing a curb ramp and will require a new one.
