EAST CAROLINA UNIVERSITY

Facility Condition Assessment

Joyner East

Inspected January 12, 2023

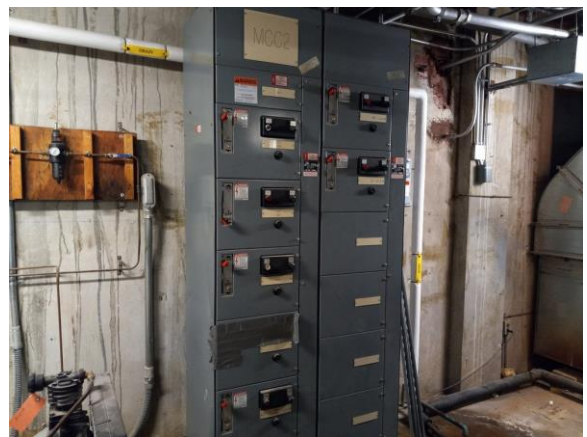
A motor control center identified as MCC-2 was observed in room B01. This two-section controller is rated for 600 amps and was installed in 1997. This MCC will reach the end of its reliable service life in the next five years and is recommended for renewal.

001A006e 1/12/2023
Motor control center MCC-2
Room B01

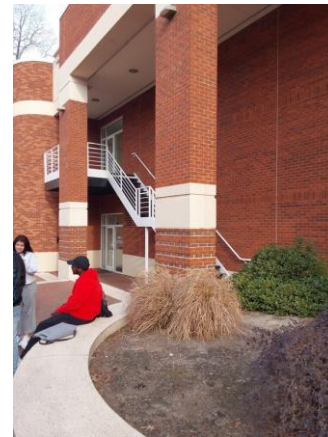
001A076a 1/12/2023
Open risers
South elevation
