EAST CAROLINA UNIVERSITY

Facility Condition Assessment

McGinnis Auditorium

Inspected January 10, 2023

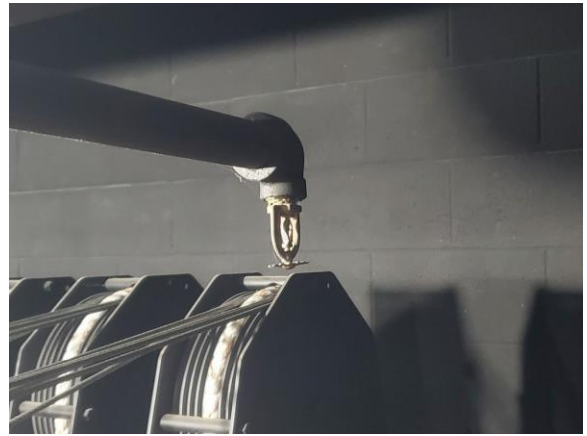
033001e 1/10/2023
Fire suppression system sprinkler head
Auditorium mezzanine

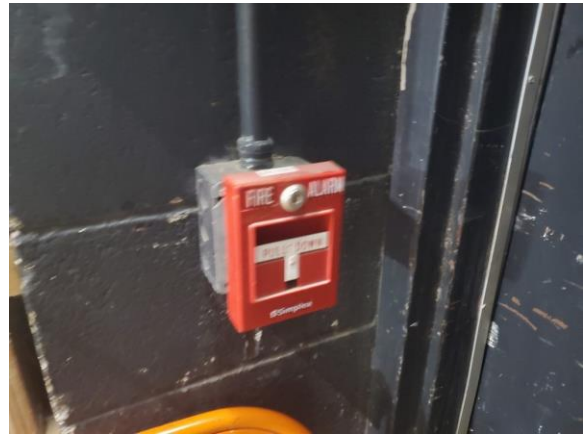
033002e 1/10/2023
Fire alarm pull station
Stage 209

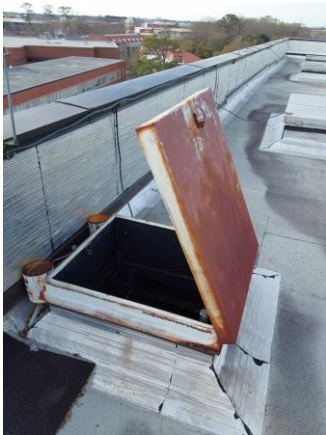
033003a 1/10/2023
Rusted roof hatch
Stage roof

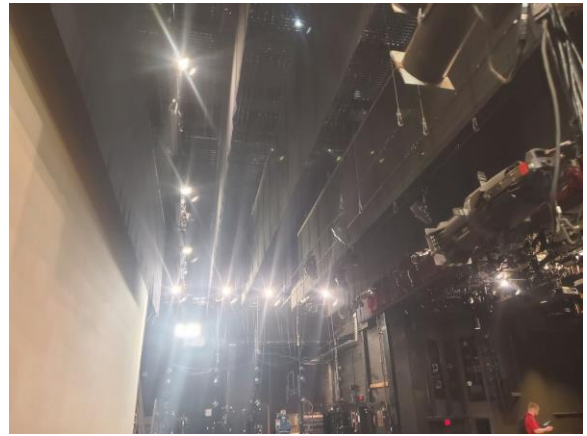
033004e 1/10/2023
Overview of theater lighting
Stage 209

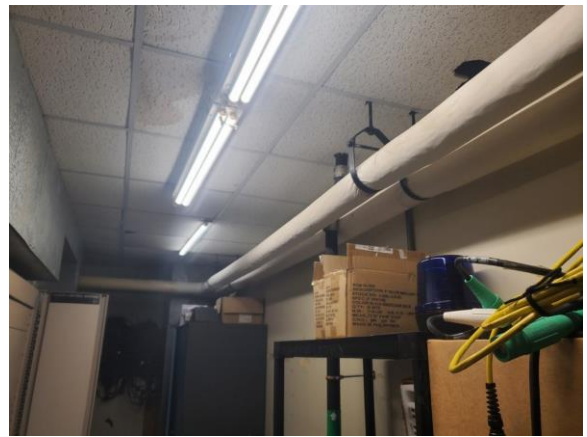
033006e 1/10/2023
Aged lighting and distribution piping
Dimmer room 214

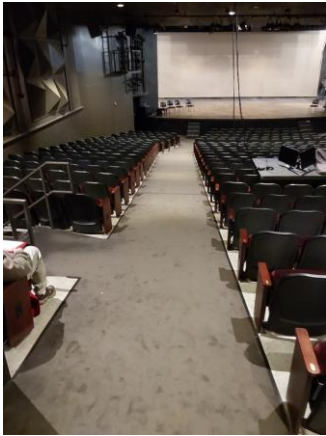
033014a 1/10/2023
Missing aisle handrail
Room 209

The auditorium has multiple barriers to accessibility. First, there are no table seating spaces designated for wheelchair use. It is recommended that seats in each section be modified to accommodate persons in a wheelchair. Second, install transmitter and headphone receiver sets to accommodate those individuals that require audible assistance. Third, the stage is inaccessible, and it is recommended that a wheelchair lift be installed at the stage to provide adequate access. Finally, the ramps in the auditorium are devoid of supportive handrails. It is recommended that compliant painted metal handrails be installed.

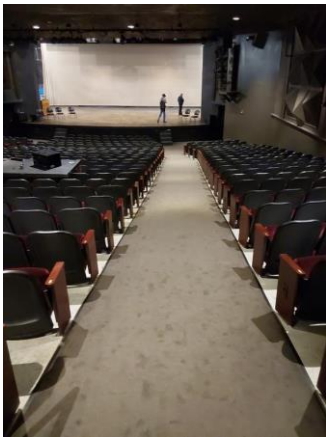
033015a 1/10/2023
Missing aisle handrail and ADA locations
Room 209

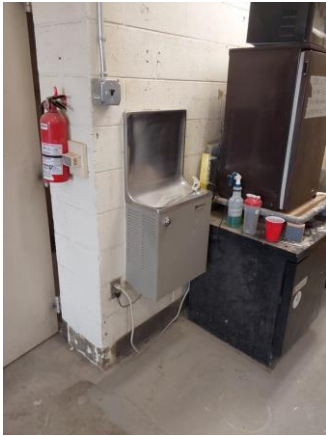
033026a 1/10/2023
Noncompliant water fountain
2-E-1

There are five single-level drinking fountains on the first and second floors of the building. The single-level drinking fountain configuration is a barrier to accessibility and all single-level drinking fountains should be replaced with dual-level, refrigerated units.

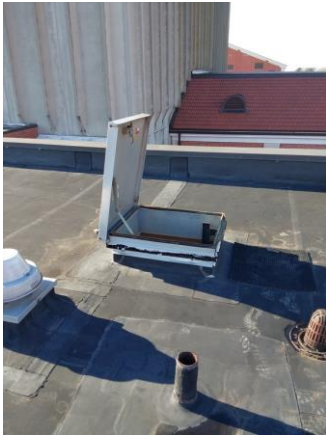
033028a 1/10/2023
Roof hatch with missing fall protection
2-E-1

The roof hatch is missing fall protection. Installation of fall protection is recommended to improve worker safety and limit liability.

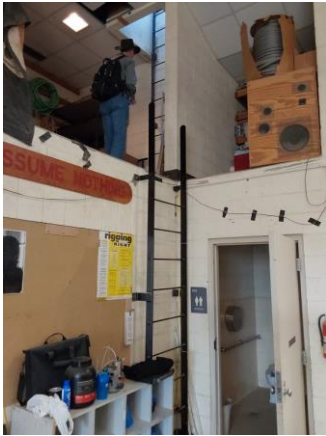
033031a 1/10/2023
Partial roof ladder safety hazard
2-E-1

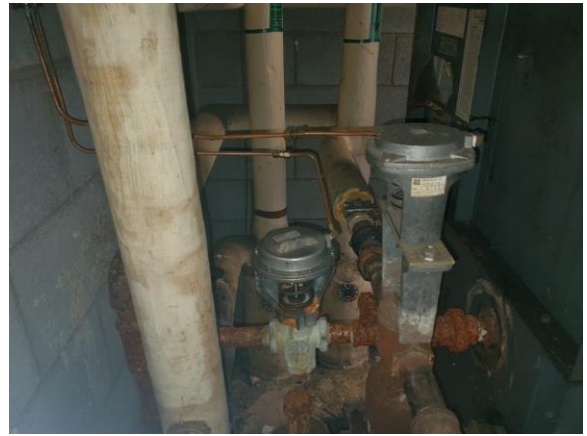
033031e 1/10/2023
Aged pneumatic controls and corroded pipe
Mechanical 127

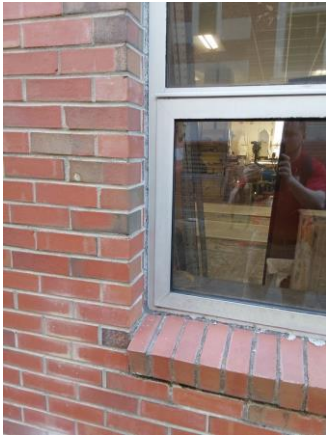
033043a 1/10/2023
Deteriorated seals on shop windows
Room 101

The metal-framed curtainwall systems have thermal-pane glazing and are deteriorated. It is recommended that these systems be upgraded. The main building entrance has anodized aluminum glass doors, while the secondary entrances have hollow-metal service doors. There is also an overhead door at the loading dock and wood doors with glass lites. The aluminum and glass doors, most of the

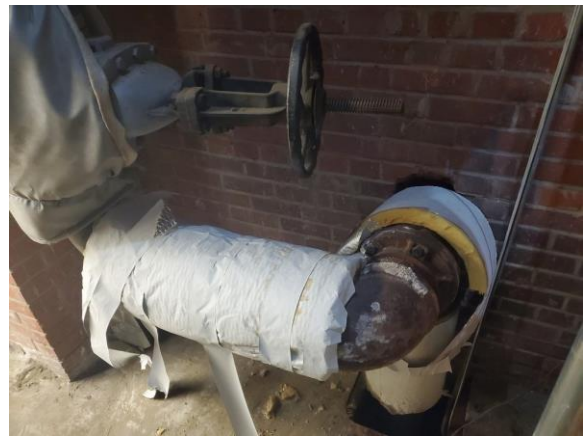
033045e 1/10/2023
Leaking main steam pipe
Room 112A

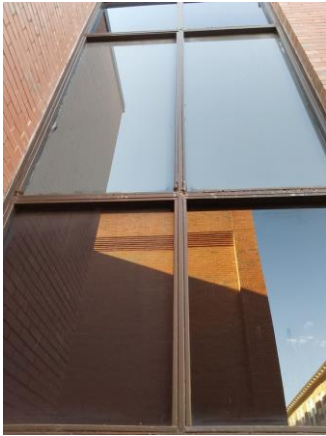
033046a 1/10/2023
Deteriorated steel mullions
Room 121

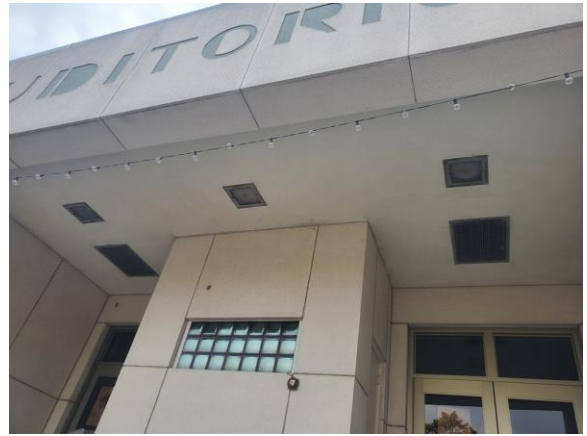
033068e 1/10/2023
Aged and corroded recessed exterior lights
Exterior

The exterior areas are illuminated by building-mounted, recessed, and ground level fixtures equipped with HID, LED, and some compact fluorescent lamps. These exterior light fixtures are mostly in proper condition but are aged and are recommended for renewal.

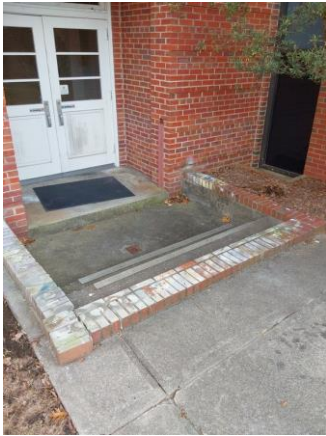
033071a 1/10/2023
Trip hazard and drainage issue
Room 110

There is a stormwater drainage problem on the west entrance that causes flooding into the building. The construction of a storm drain and line is recommended to prevent water infiltration into the building.

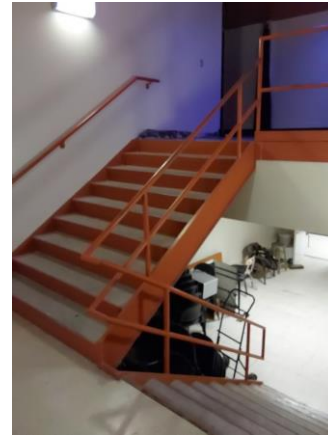
033072a 1/10/2023
Noncompliant stair handrail
Room 120

The interior stairs lack compliant railing systems. It is recommended that noncompliant railings be upgraded with compliant guard and handrail systems and stair treads be upgraded with compliant treads with a grip surface.

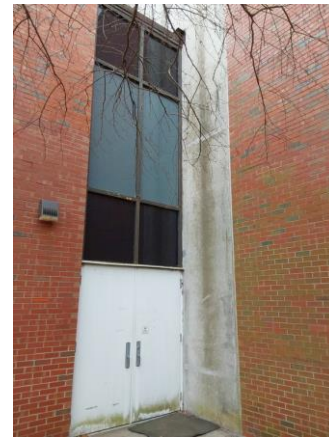
033080a 1/10/2023
Deteriorated steel mullions with grime on wall
West elevation

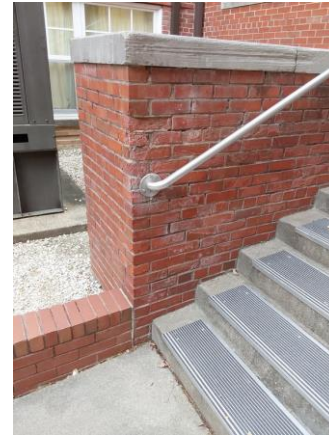
033088a 1/10/2023
Damaged brick on stairway
West arcade

The exterior consists of brick and precast concrete panels. While the brick and concrete panels are fundamentally sound, exposure to the elements has caused some deterioration of the mortar and expansion joints. Cleaning, surface preparation, selective repairs, and applied finish or penetrating sealant upgrades are recommended to restore the aesthetics and integrity of the building envelope.

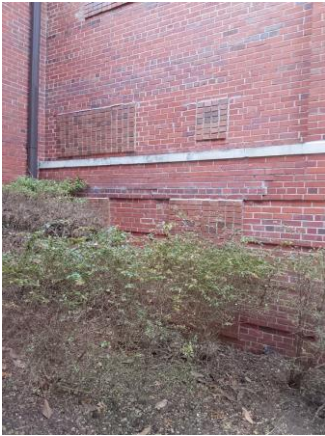
033089a 1/10/2023
Damaged brick on wall
East elevation

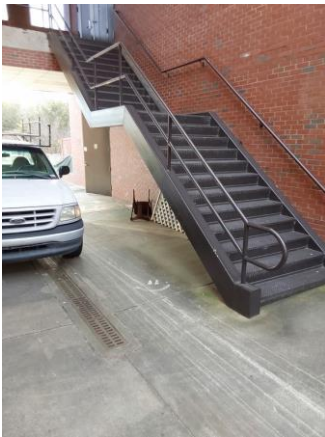
033091a 1/10/2023
Stair with missing cane rail
East elevation

The building has a shared parking lot with Messick Theatre Arts to the north and the north first floor entrance is wheelchair accessible. However, multiple exterior stairs have deficient or nonexistent guardrails and deficient handrails. Installation of compliant guardrails is recommended for the mechanical room entry, the south shop entry, the east shop entry, the areaway, and the shop connector. Installation of compliant handrails is also recommended for the mechanical room entry, the south shop entry, the east shop entry, the areaway, the building arcade, and the shop connector. Additionally, the exterior shop stair creates a collision hazard to those with vision impairments. The installation of a cane rail under the stair run is recommended to comply with ADAAG.
