EAST CAROLINA UNIVERSITY

Facility Condition Assessment

Old Cafeteria Complex

Inspected January 26, 2023

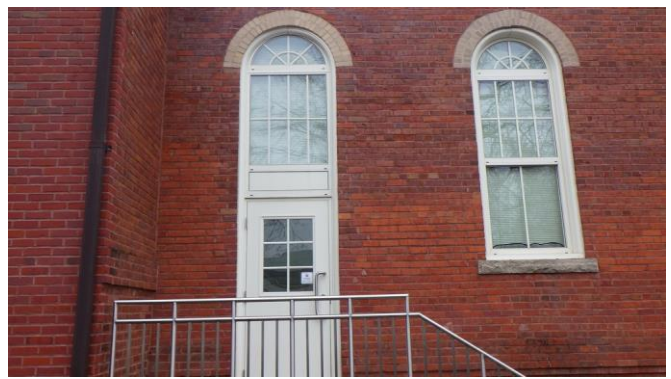
Exterior lighting is provided by LED and HID wall packs and recessed fluorescents. All are operational, but the recessed CFL fixtures should be planned for replacement. It is also recommended that additional exterior lighting be installed at the south entry/exit to ensure a safe environment for building users. Place all new lighting on photocell activation.

047080e 1/26/2023
Exit with no exterior lighting
South exterior
