# EAST CAROLINA UNIVERSITY

Facility Condition Assessment

Physicians Quad N

Inspected January 26, 2023

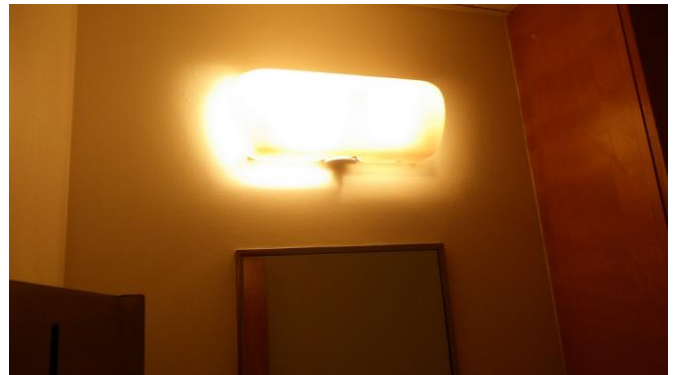
119002e 1/26/2023  
Incandescent lighting  
Restroom

The lighting configuration consists of lay-in and surface-mounted T8 fluorescent fixtures and aging incandescent fixtures. All have depleted their lifecycle and are recommended for replacement. Also install occupancy sensors in select areas for additional energy conservation.

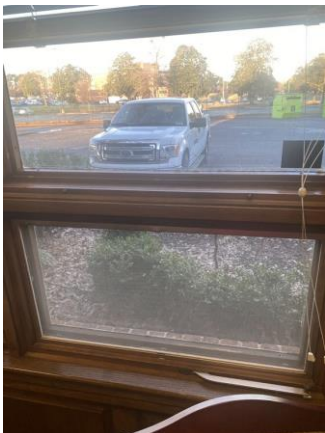
119003a 1/26/2023  
Single-pane window  
Office

The brick exterior is in fair condition and should be cleaned and repointed to preserve the integrity and aesthetics of the wall finish. Windows are original single-pane, wood frame units and are recommended for upgrade to energy-efficient dual-pane windows. Exterior doors are wood and appear to be original. They are due for replacement. The pitched asphalt shingle roof was replaced in 2021 and should outlast the report scope.

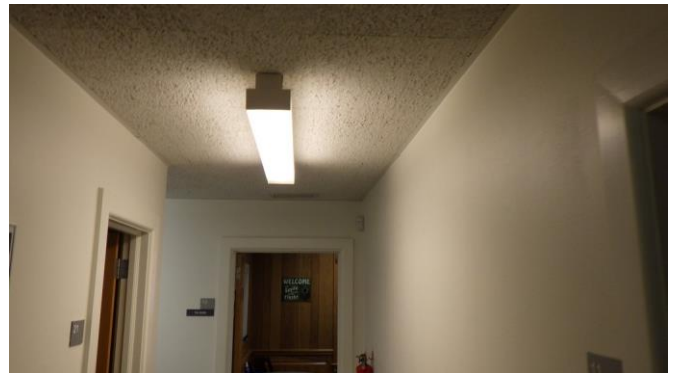
119003e 1/26/2023  
T8 fluorescent surface-mounted lighting  
Patient corridor

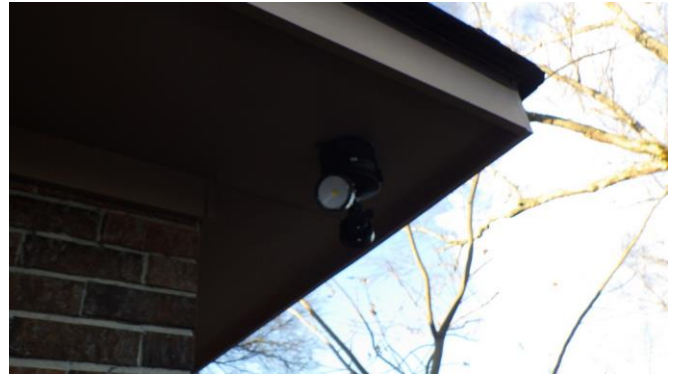
119004e 1/26/2023  
Incandescent floodlight  
Exterior corner soffit

Nighttime illumination is provided by incandescent lights and a surface-mounted LED fixture. While the LED fixture should outlast the report scope, the older incandescent lights are due for replacement. The illumination level was not easily verified during this daytime inspection, but it appears additional lighting is needed. Install additional exterior light fixtures to ensure a safe environment for building users, and place all new lighting on photocell activation.

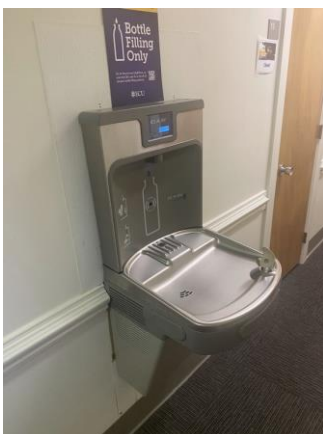
119006a 1/26/2023  
Single-level water fountain  
Corridor

The restrooms are not fully ADA compliant. The installation of accessible fixtures and accessories is recommended. Also, the single-level drinking fountain should be replaced with a dual-level unit set in an alcove or with a tapered lower cabinet design.

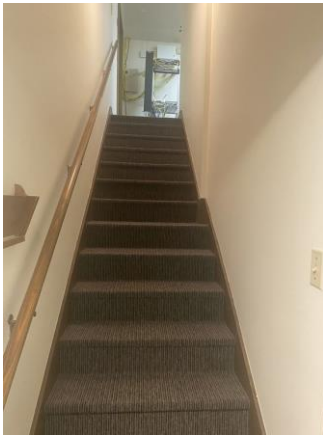
119011a 1/26/2023  
Carpet treads  
Stairway

Accessibility legislation requires that stairs have graspable handrails on both sides, that the rails have a specific end geometry, and that the handrails continue horizontally at the landings. The stairs are deficient in handrail design relative to current standards. Future renovation efforts should include comprehensive stair railing upgrades.

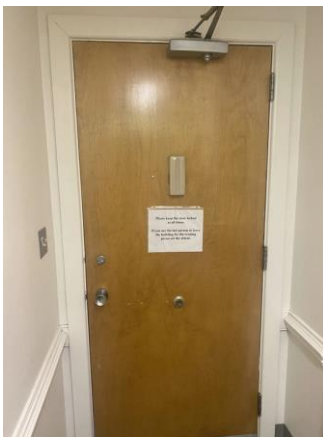
119012a 1/26/2023  
Wood door with knob hardware  
Corridor

Accessibility legislation requires that door hardware be designed for people with little or no ability to grasp objects with their hands. To comply with the intent of this legislation, it is recommended that lever handle hardware be installed on all doors that still have knobs.

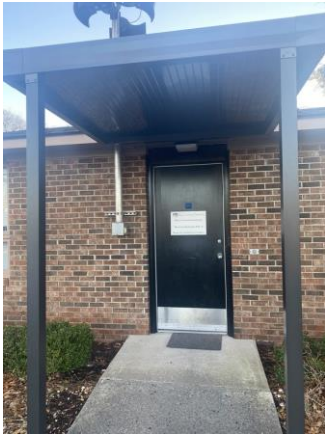
119013a 1/26/2023  
Brick exterior, wood door with knob hardware  
Main entry

The knob hardware on all exterior doors should be replaced with ADA compliant lever hardware, and accessible parking spaces should be designated in the parking lot.

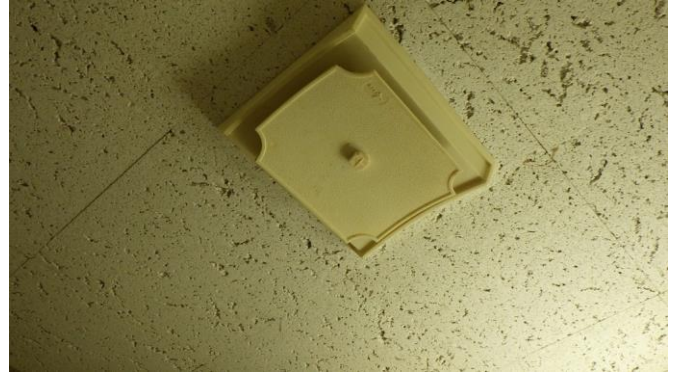
119013e 1/26/2023  
Bathroom exhaust fan  
Bathroom

Heating and cooling are provided by two split DX systems equipped with electric furnaces. Air-cooled condensers are located at the exterior, and indoor air handlers with furnaces are in the attic. The systems vary in age, and the older condenser and evaporator units will be due for replacement within the next ten years. The newer system should remain serviceable beyond the scope of this assessment. Forced air distribution is uninsulated or internally insulated flexible metal ductwork that appears to be original. The ductwork is deteriorated and should be replaced. The fractional horsepower exhaust fans in each bathroom are well beyond their useful lifecycle and should be replaced.

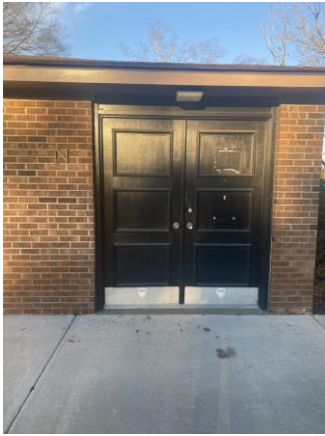
119018a 1/26/2023  
Brick exterior, wood doors with knob hardware  
Exterior

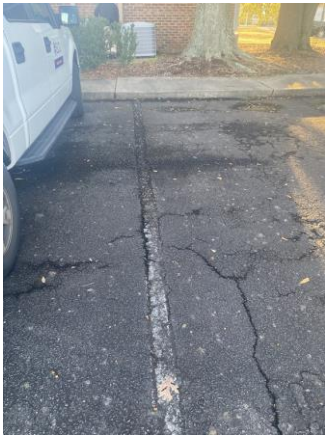
The pedestrian and vehicular paving systems are in overall poor condition. Replacement of these paving systems is recommended

119020a 1/26/2023  
Cracked asphalt parking lot  
Site

Task Description	Unit	Qty	Material Unit Cost	Total Material Cost	Labor Unit Cost	Total Labor Cost	Total Cost
Replace pedestrian concrete walkways	SF	1,000	\$5.45	\$5,450	\$6.00	\$6,000	\$11,450
Rebuild asphalt parking lot paving structure	SY	700	\$36.91	\$25,837	\$46.14	\$32,298	\$58,135
<b>Base Material/Labor Costs</b>				<b>\$31,287</b>		<b>\$38,298</b>	
<b>Indexed Material/Labor Costs</b>				<b>\$31,506</b>		<b>\$27,306</b>	<b>\$58,812</b>
<b>Construction Mark Up at 20.0%</b>							<b>\$11,762</b>
<b>Original Construction Cost</b>							<b>\$70,575</b>
<b>Date of Original Estimate:</b>	2/6/2023		<b>Inflation</b>			<b>\$0</b>	
<b>Current Year Construction Cost</b>							<b>\$70,575</b>
<b>Professional Fees at 16.0%</b>							<b>\$11,292</b>
<b>TOTAL PROJECT COST</b>							<b>\$81,867</b>

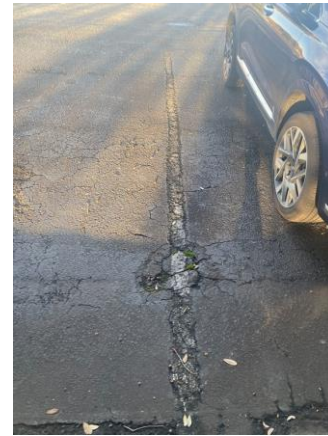
119021a 1/26/2023  
Cracked asphalt parking lot  
Site
