EAST CAROLINA UNIVERSITY

Facility Condition Assessment

ECU Transit

Inspected January 25, 2023

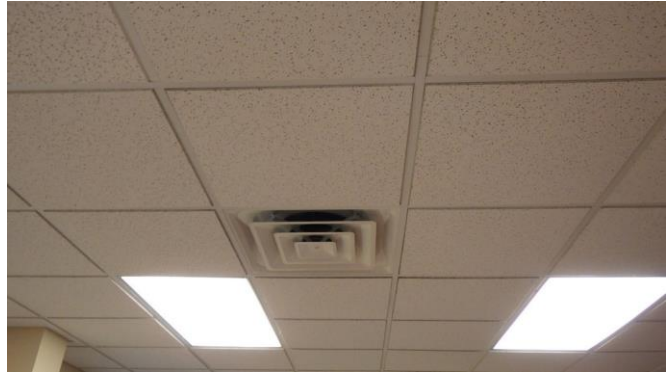
258001e 1/25/2023
Fluorescent indoor lighting
Office area

Interior lighting in the office area consists of lay-in fluorescent fixtures, and the wash bay has high bay fluorescent fixtures. Newer LED fixtures have been installed in the shop. While these fixtures should outlast the report scope, the older lighting is due for replacement, along with the battery back-up emergency light wall packs.

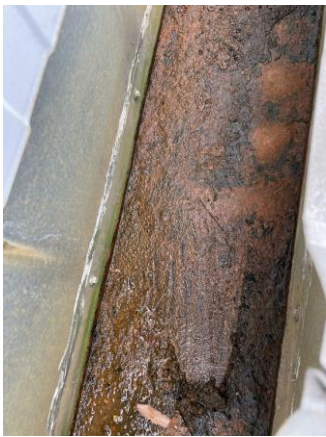
258003a 1/25/2023
Rusted rain gutter
Office roof

The facility has two separate sections of roof. Both are standing-seam metal applications and in good condition. The roof drains via galvanized metal gutters and downspouts. These systems are in fair condition and recommended for replacement.

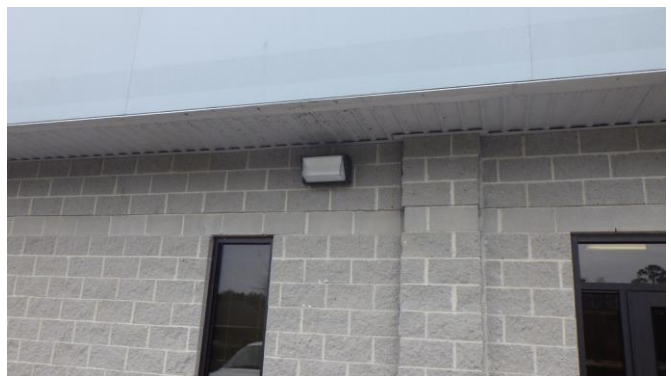
258003e 1/25/2023
HID exterior lighting
Exterior wall

Nighttime illumination is provided by wall-mounted compact HID lighting fixtures. Compact LED fixtures are provided at all exit doors. The LED fixtures are in good condition but the HID wall fixtures should be scheduled for replacement in two to three years.

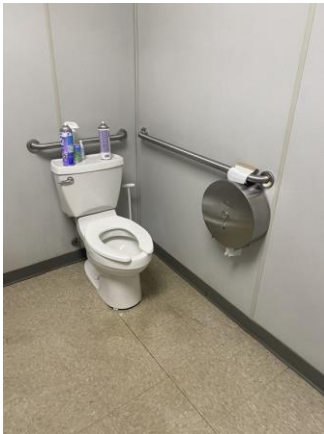
258010a 1/25/2023
Fiberglass reinforced panels
Restroom

The painted gypsum wall finishes are in good to fair condition but due to normal wear will need to be repainted in four to six years. One restroom has fiberglass reinforced panels. These are in fair condition and should be replaced within the next ten years. Ceilings are suspended acoustical tiles and in good condition. No upgrade is recommended at this time. Offices have carpet tile and composite vinyl tile flooring. These finishes are recommended for replacement. Also, apply a clear sealant to the concrete floors in the warehouse area and wash bays to maintain their overall condition.

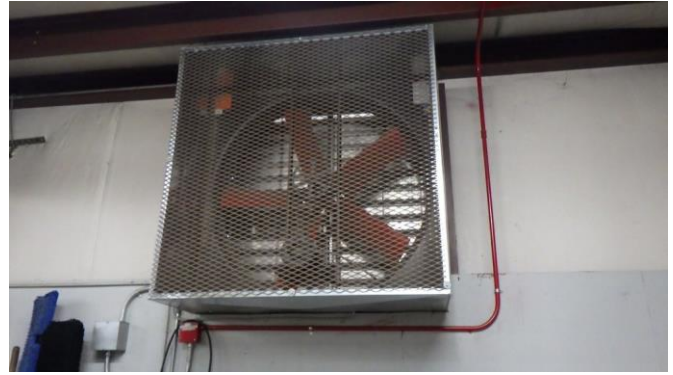
258010e 1/25/2023
Ventilation fan
Wash bay

Heating and cooling are provided primarily by natural gas rooftop package units with a metal duct distribution system. The gas package units appear to be in good condition and should outlast the ten-year scope of this report. The HVAC controls were upgraded in 2014. The HVAC distribution system has been modified multiple times and is not servicing all areas efficiently and should be redesigned and replaced. Two DX split systems are installed for the office areas. The warehouse and wash bay are heated with natural gas unit heaters that are suspended from the ceiling. These will need to be scheduled for replacement in three to five years. The electric wall heaters in the restrooms and other various locations are in poor condition and should be scheduled for near-term replacement. The wash bay area ventilation is provided by wall-mounted exhaust fans that were installed in 2013 as part of the renovation. They are in good condition and should outlast the ten-year scope of this report. The warehouse fans and restroom ventilation fan appear to be original and should be replaced.

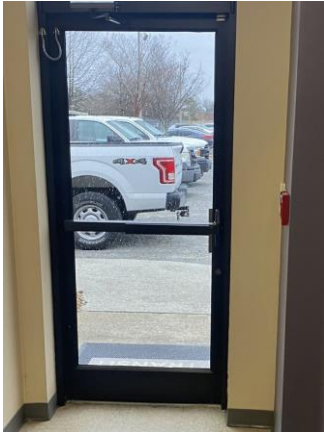
258016a 1/25/2023
Aluminum and glass exterior door
Secondary office exit

The aluminum and glass exit doors are in fair condition and should be replaced within the next ten years. While the hollow metal secondary exit doors are structurally in good condition, they should be painted to maintain their overall condition.

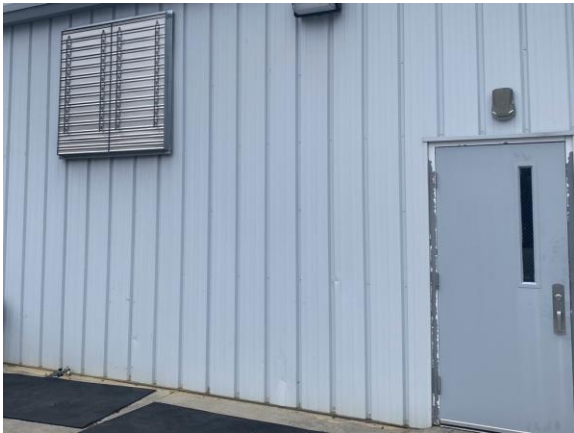
258023a 1/25/2023
Corrugated metal siding
Wash bay

The exterior consists of split faced CMU with metal panels on the top soffit and fascia areas. Additionally, the wash bay has corrugated metal siding. The metal panels and corrugated panels will need some maintenance to the screws and joint sealants. Aluminum and glass glazing is limited to the office area only and is in good condition with no recommendations.
