EAST CAROLINA UNIVERSITY

Facility Condition Assessment

Physicians Quad C

Inspected January 26, 2023

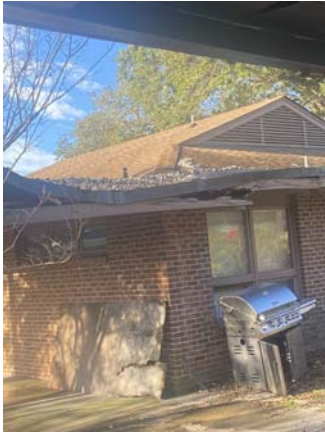
117001a 1/26/2023
Asphalt shingle roofing
Main roof

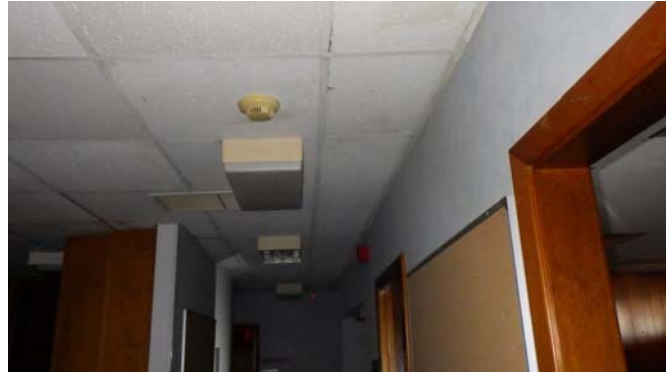
The current lighting configuration consists of recessed and surface-mounted aging incandescent fixtures. Based on lifecycle depletion, the replacement of these fixtures is recommended. Install occupancy sensors in select areas for additional energy conservation.

117001e 1/26/2023
Incandescent lighting
Commons area

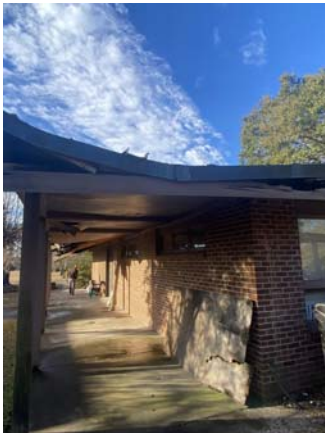
The roof joists, decking, soffits, and fascia trim have all been severely damaged by water intrusion due to the dilapidated shingle roof. All these structures will need to be demolished and reconstructed.

117002a 1/26/2023
Damage to roof system
Front breezeway

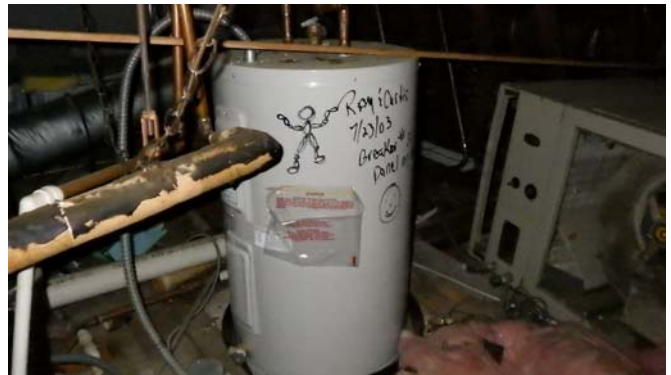
117005e 1/26/2023
Electric water heater 19602
Attic space

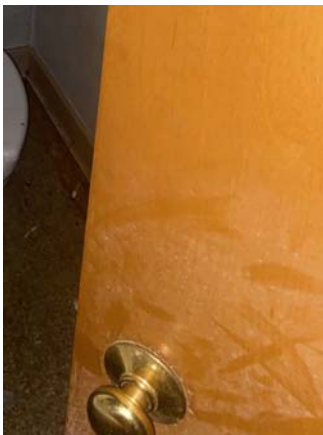
The knob actuated door hardware is a barrier to accessibility. Accessibility legislation requires that door hardware be designed for operation by people with little or no ability to grasp objects with their hands. To comply with the intent of this legislation, it is recommended that lever handle hardware be installed on all doors that still have knobs. In addition, the signage to the permanent spaces is not ADA compliant. It is recommended that all noncompliant signage be upgraded to conform to appropriate accessibility standards. Compliant signage should meet specific size, graphical, Braille, height, and location requirements.

117009a 1/26/2023
Noncompliant knob hardware
Office door

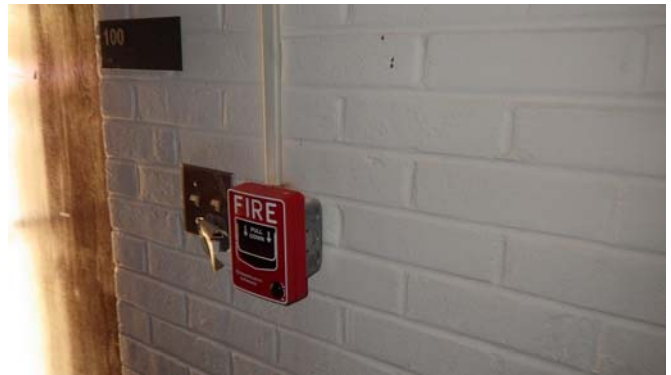
There is currently no fire alarm system installed in this building. Some monitoring devices are connected to the security system, but this should be replaced with a modern fire alarm system to serve this facility. Specify a point addressable supervised main fire alarm panel with an annunciator. This includes pull stations, audible and visible alarms, smoke and heat detectors, and an associated wiring network. Install all devices in accordance with current NFPA and ADA requirements. The system should be monitored to report activation or trouble to an applicable receiving station.

117011e 1/26/2023
Manual fire alarm device
Corridor at exit

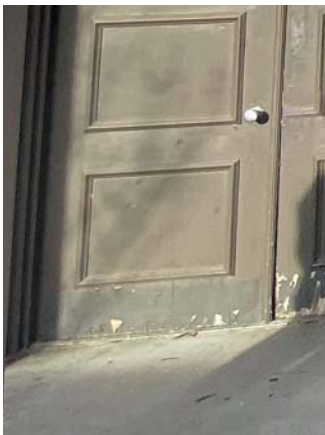
117012a 1/26/2023
Noncompliant knob hardware
Main entrance

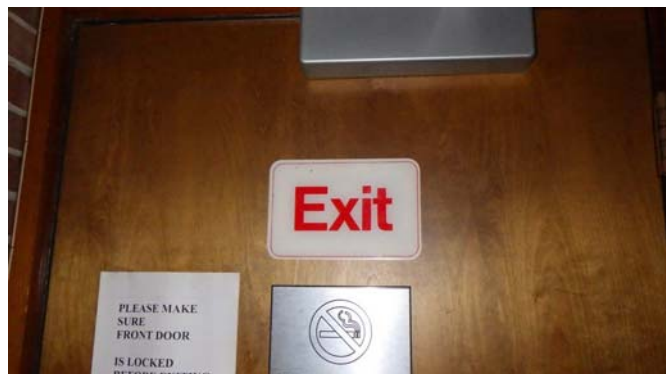
The egress path is not clearly designated by exit signs. It is recommended that new LED-type exit signs be installed. Also, install emergency batter back-up lighting.

117012e 1/26/2023
Noncompliant exit sign
Corridor area

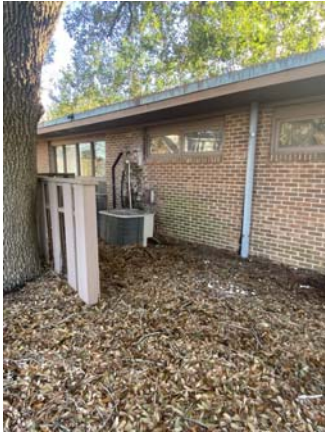
The brick exterior brick joints have deteriorated over time and need to be repointed. This should include restoration or replacement of damaged brick and repointing of all masonry joints as needed. Match any new masonry units and pointing to the existing systems as well as possible.

117013a 1/26/2023
Exterior brick walls
All elevations

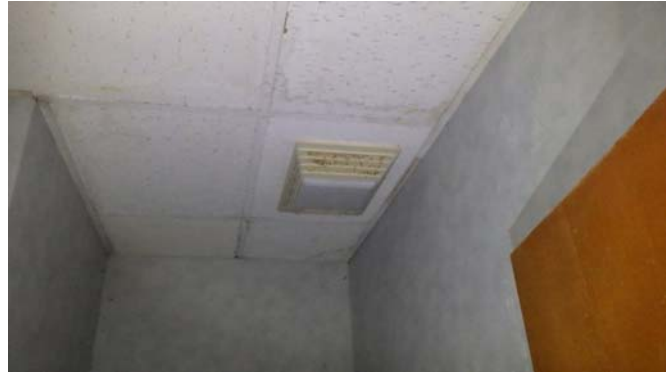
117013e 1/26/2023
Exhaust fan
Bathroom

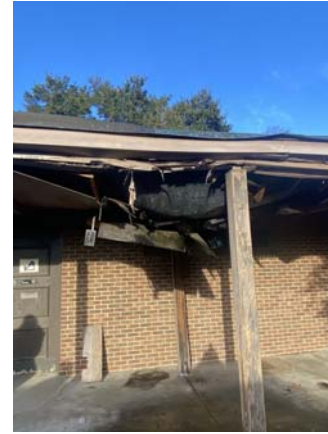
117019a 1/26/2023
Damage to roof system
Front soffit area

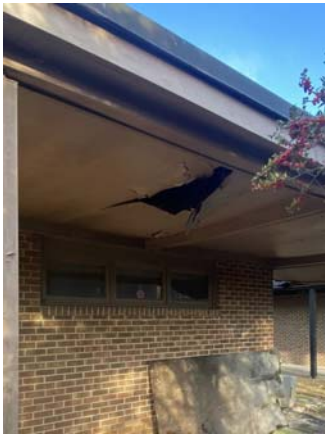
117020a 1/26/2023
Damage to roof system
Front soffit area

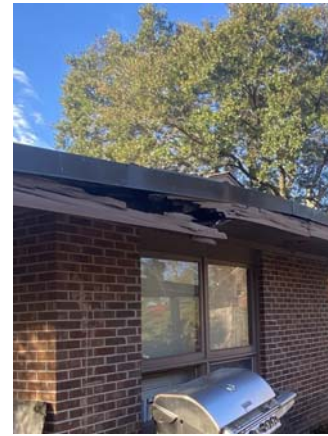
117021a 1/26/2023
Damage to roof system
East elevation

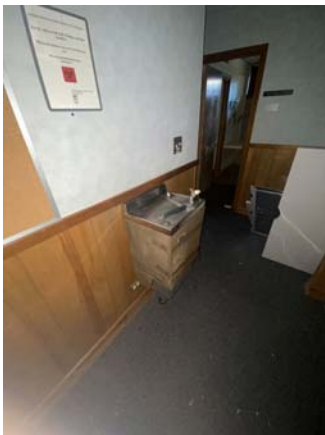
Current legislation requires that building amenities be generally accessible to all persons. The configuration of the single-level drinking fountain is a barrier to accessibility and it should be replaced with a dual-level unit.

117022a 1/26/2023
Single-level drinking fountain
Interior
