EAST CAROLINA UNIVERSITY

Facility Condition Assessment

Physicians Quad M

Inspected January 26, 2023

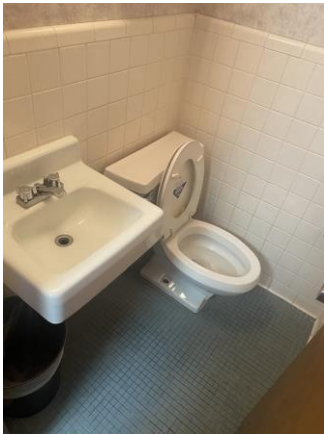
Restroom plumbing fixtures include wall-hung lavatories and tank-type water closets. These fixtures are in satisfactory working condition but have exceeded their expected service life and should be considered for replacement within the next ten years. The kitchen sink should outlast the scope of this report.

118001a 1/26/2023
Tile walls and floor, wall covering, lavatory, and tank
water closet
Restroom

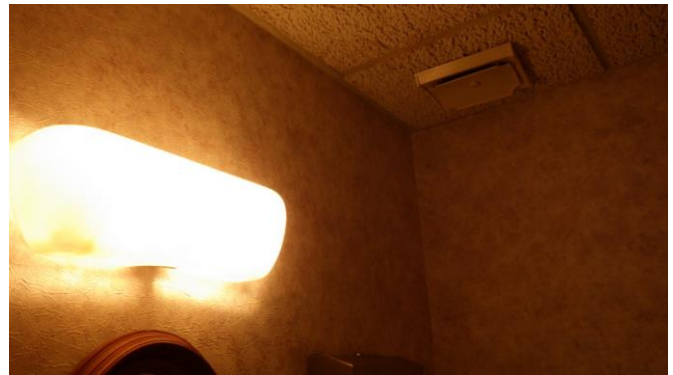
The current lighting configuration consists of lay-in and surface-mounted T8 and T5 fluorescent fixtures and aging incandescent fixtures. Based on lifecycle depletion, replacement of the T8, T5, and all of the incandescent fixtures is recommended. Install occupancy sensors in select areas for additional energy conservation.

118002e 1/26/2023
Incandescent lighting
Restroom

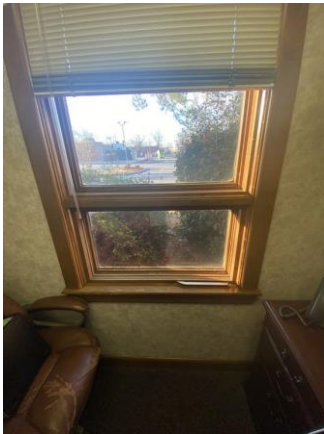
The exterior facade is brick with wood-framed, single-pane glazing. The exterior wall finish is timeworn and weathered and needs to be repointed and cleaned with a light chemical. The brick finish itself appears to be structurally sound. The windows are original and should be upgraded to dual-pane, energy-efficient glazing. Exterior doors are wood, were recently replaced, and have commercial lockset hardware. They should outlast the scope of this report. The pitched asphalt shingle roof, as well as the gutter and downspout system, should also be replaced.

118004a 1/26/2023
Wood-framed, single-pane window
Office

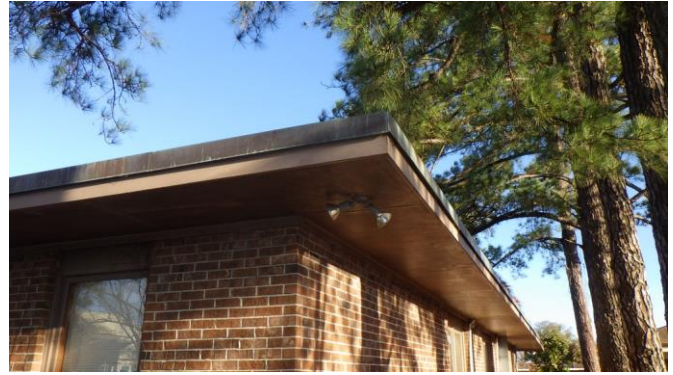
118004e 1/26/2023
Incandescent flood lighting
Exterior corner soffit

It is recommended that additional exterior lighting be installed in order to illuminate the areas surrounding this facility. During the inspection, a deficiency in quantity of light fixtures was observed. Install new exterior lighting systems in order to ensure a safe environment for building users during dark hours of the day. Place all new exterior lighting systems on photocell activation.

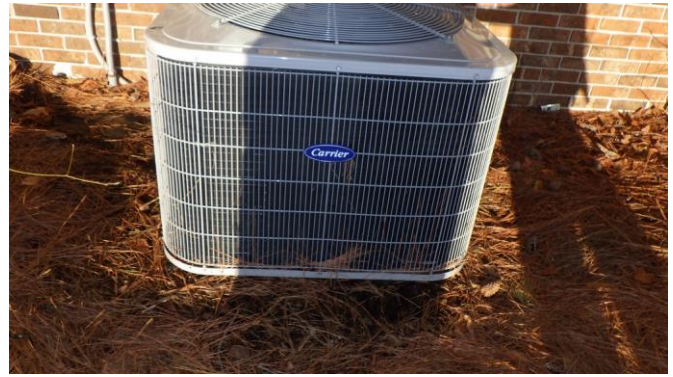
Heating and cooling for this medical clinic are provided by a split DX system equipped with an electric furnace. The unit is in the attic and was installed in 2015. The condenser unit was also replaced in 2015 and is in fair condition. The split system should remain serviceable for the scope of this assessment. A fractional horsepower exhaust fan in the bathroom is well beyond its useful lifecycle and should be replaced. Replacement of the HVAC distribution networks is also recommended.

118007e 1/26/2023
Condensing unit 1
Site

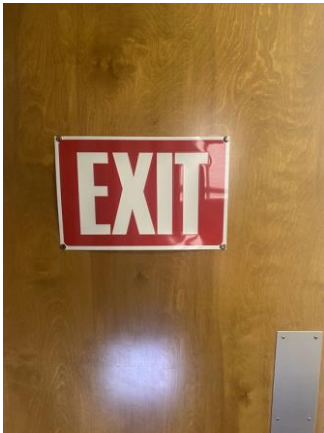
118008a 1/26/2023
Noncompliant exit signage
Exit

The egress path is not clearly designated by exit signs. It is recommended that new LED-type exit signs be installed. Also, install emergency batter back-up lighting.

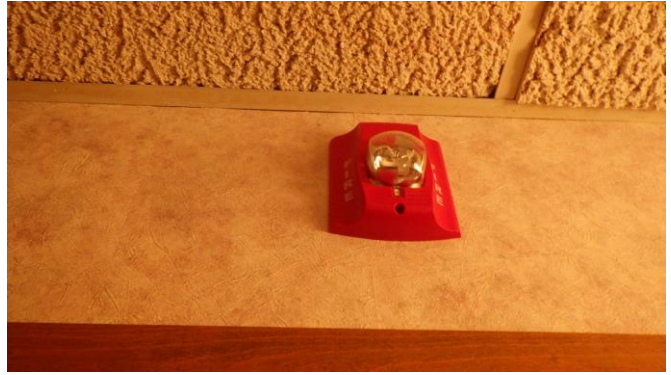
Currently, the building has a security alarm system installed but no fire alarm system. The security alarm system does provide alarm points to the visual/audible devices but there are no useable manual input devices. Smoke detectors are lacking in the egress corridors or unoccupied rooms. A programable multi point fire alarm system is recommended.

118010e 1/26/2023
Audible/visual alarm device
Corridor

There is currently a security alarm system installed but no fire alarm system installed in this building. Some monitoring devices are connected to the security system, but this should be replaced with a modern fire alarm system to serve this facility. Specify a point addressable supervised main fire alarm panel with an annunciator. This work includes pull stations, audible and visible alarms, smoke and heat detectors, and an associated wiring network. Install all devices in accordance with current NFPA and ADA requirements. The system should be monitored to report activation or trouble to an applicable receiving station.

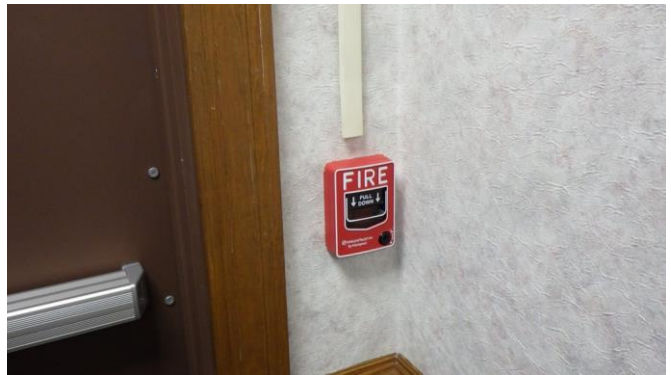
118011e 1/26/2023
Manual fire alarm device
Side exit door

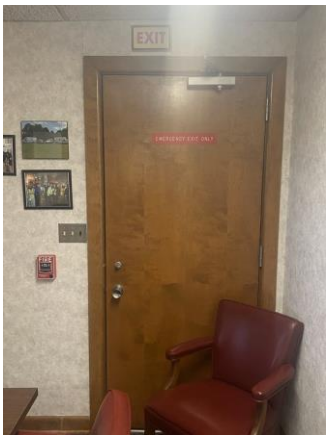
118012a 1/26/2023
Wood door with knob hardware and noncompliant exit
sign
Exit

To comply with ADA legislation, it is recommended that lever handle door hardware be installed on all doors that still have knobs. In addition, the signage to the permanent spaces is not ADA compliant. It is recommended that all noncompliant signage be upgraded to conform to the appropriate accessibility standards. Compliant signage should meet specific size, graphical, Braille, height, and location requirements. This scope includes all directional signage.

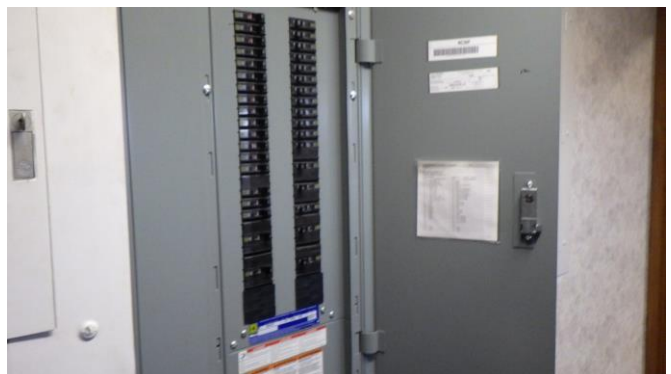
High voltage from the utility company is reduced to 120/240 volt, two-phase power via a service entrance transformer located on the site. The related 175-amp General Electric main electrical panel has been in service for over thirty-five years. The electrical distribution network supplies 120/240-volt power throughout the building. Aging components, such as the circuit breakers, serve as potential fire hazards if they fail to open a circuit in an overload or short circuit condition. Remove the aged electrical components and branch circuitry. Install new power panels, switches, raceways, conductors, and devices. Provide molded case thermal magnetic circuit breakers and HACR circuit breakers for HVAC equipment. Redistribute the electrical loads to the appropriate areas to ensure safe and reliable power

118012e 1/26/2023
Electrical distribution panel
Corridor

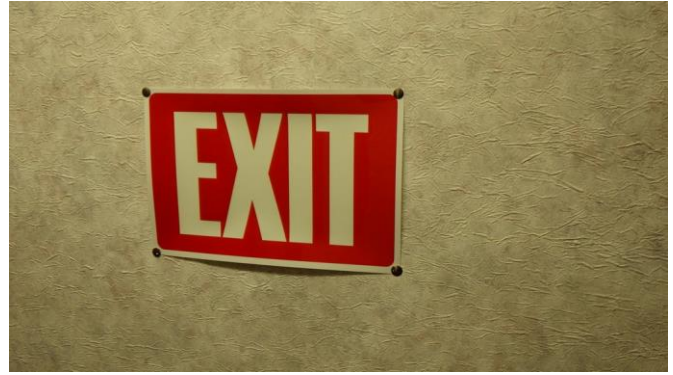
118013e 1/26/2023
Noncompliant exit sign
Corridor

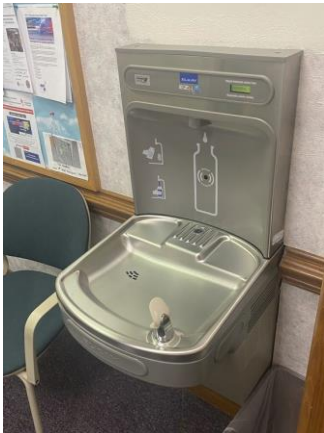
118014a 1/26/2023
Single-level water fountain
Waiting room

The configuration of the drinking fountains is a barrier to accessibility. All single-level drinking fountains should be replaced with dual-level units. Additionally, building amenities are required to be accessible to all persons. The current configuration of the casework in the kitchenettes is a barrier to accessibility. The cabinetry should be replaced with casework to accommodate compliant frontal wheelchair access.

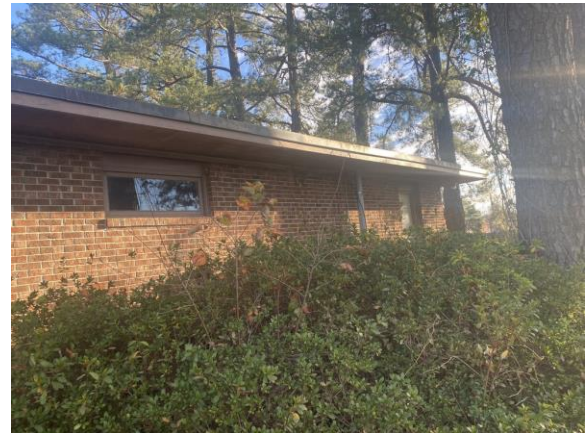
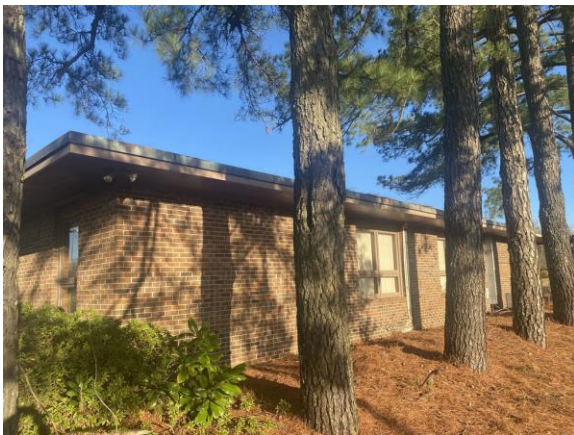
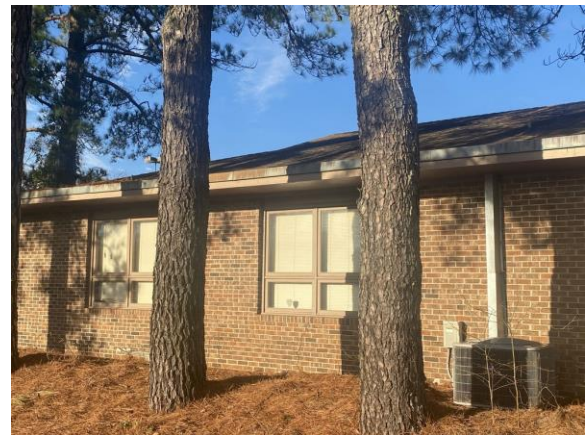
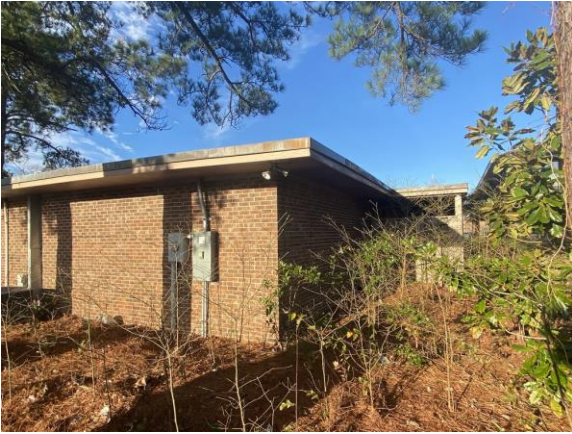
Brick veneer is the primary exterior finish. While the brick is fundamentally sound, exposure to the elements has caused some deterioration of the mortar joints and expansion joints. Cleaning, surface preparation, selective repairs, and applied finish or penetrating sealant upgrades are recommended to restore the aesthetics and integrity of the building envelope.

118019a 1/26/2023
Brick exterior and glazing
Exterior

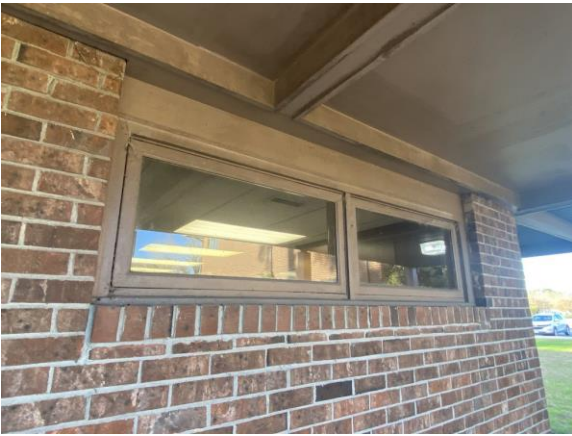
118024a 1/26/2023
Wood-framed, single-pane windows
Exterior

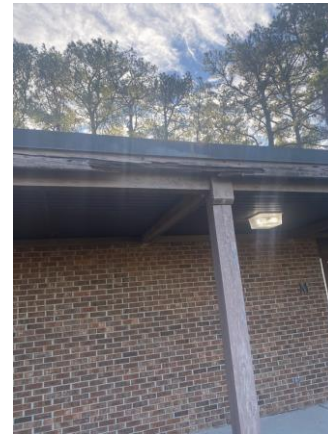
118025a 1/26/2023
Deteriorated roof awning
Exterior
