EAST CAROLINA UNIVERSITY

Facility Condition Assessment

Hardy Building

Inspected January 25, 2023

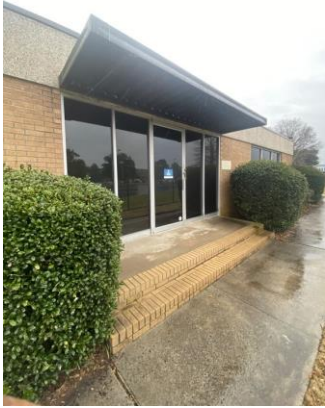
The exterior is a light brick with aggregate pebble trim. These exterior systems appear to be in good condition and are not expected to need restoration or replacement within the next ten years. The metal-framed, single-pane glazing has exceeded its lifecycle and should be considered for replacement with dual-pane, energy-efficient glazing. The exterior doors are metal and glass with commercial locksets. Although in satisfactory working condition, the doors and hardware should be replaced within the next ten years. The flat EPDM roof is in fair to poor condition. Water is evacuated via roof drains which are clogged due to tree debris and there are reports of leaks and signs of water infiltration. The roof system has exceeded its lifecycle and should be replaced.

098001a 1/25/2023
Brick exterior, stone aggregate, and glazing
Exterior

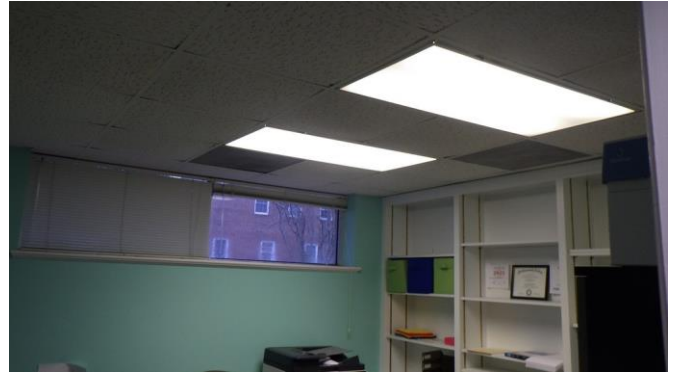
The current lighting configurations consist of lay-in and surface-mounted T12 fluorescent fixtures. Based on lifecycle depletion, replacement of the interior fixtures is recommended. Install occupancy sensors in select areas for additional energy conservation.

098001e 1/25/2023
Fluorescent troffer lights
Office area

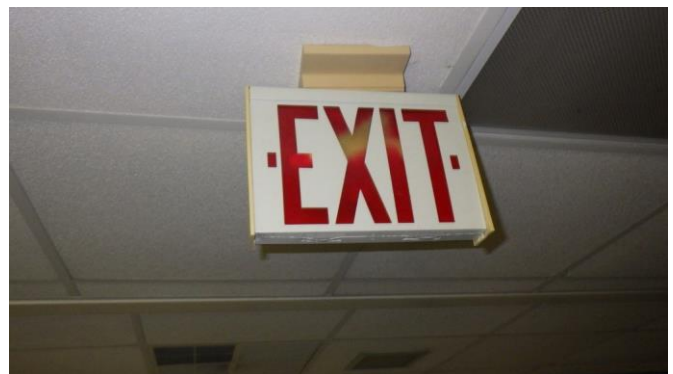
The egress path is not clearly designated by exit signs. It is recommended that new LED-type exit signs be installed. Also, install emergency batter back-up lighting.

098003e 1/25/2023
Illuminated exit lighting
Main corridor

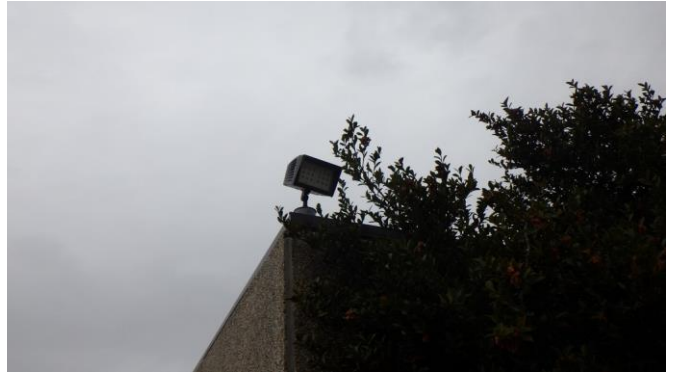
Nighttime illumination is provided by soffit and wall-mounted compact fluorescent lighting fixtures. All of the exterior lighting should be scheduled for replacement.

098004e 1/25/2023
HID area lighting
Roof gable

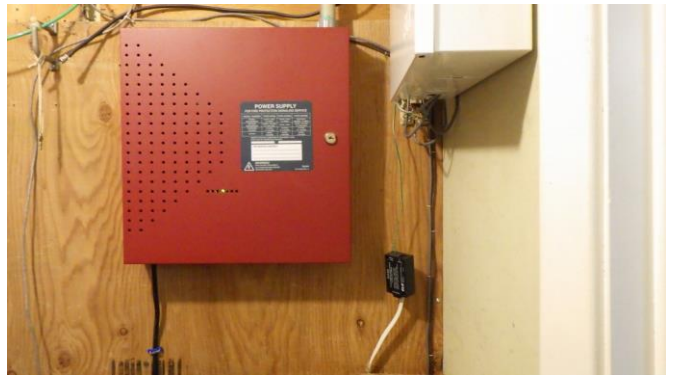
The fire alarm system is equipped with outdated opaque strobes and audible annunciator units. Smoke detectors are lacking in the egress corridors or unoccupied room, such as mechanical, electrical, and storage rooms or janitor's closets. The fire alarm system is at the end of its useful service life and should be replaced with a programmable multi-input fire alarm system.

098005e 1/25/2023
Fire alarm power panel
Electrical room

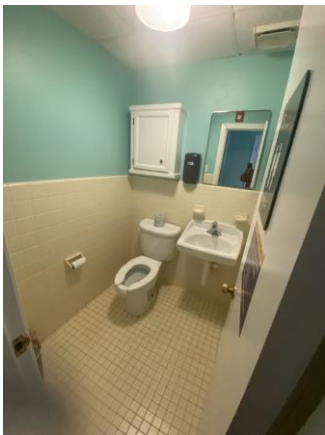
Domestic hot water is served by a residential electric water heater that has reached the end of its useful service life and should be replaced. Restroom plumbing fixtures include wall-hung lavatories and tank-type water closets. These fixtures, as well as the utility sink, are in satisfactory working condition but are near the end of their expected service life and should be considered for replacement within the next ten years. The kitchen sinks should outlast the report scope.

098006a 1/25/2023
Tile walls and floor, ACT, tank water closet, and wall-hung
lavatory
Restroom

The restrooms throughout the building are not fully compliant with ADA legislation, installation of ADA-compliant fixtures as well as grab bars and signage should remedy the situation. Additionally, the drinking fountains are a single-level design and should be replaced with dual-level units set in alcoves or with a tapered lower cabinet design.

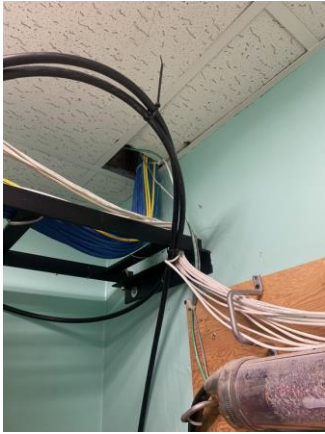
Structural fire separations are not maintained according to code requirements for new construction in select areas of this facility. These areas include data and telecom rooms. Although only these instances were noted, other fire separation compromises may exist elsewhere in this building. It is recommended that the entire building be surveyed for similar problem areas, especially in conditions and spaces that are similar to those that were observed. Intumescent passive firestopping and some minor structural separation repairs should be accomplished promptly.

098007a 1/25/2023
Ceiling penetration
Data Room

Structural fire separations are not maintained according to code requirements for new construction in select areas of this facility. These areas include data and telecom closets. Although only these instances were noted, other fire separation compromises may exist elsewhere in this building. It is recommended that the entire building be surveyed for similar problem areas, especially in conditions and spaces that are similar to those that were observed. Intumescent passive firestopping and some minor structural separation repairs should be accomplished promptly.

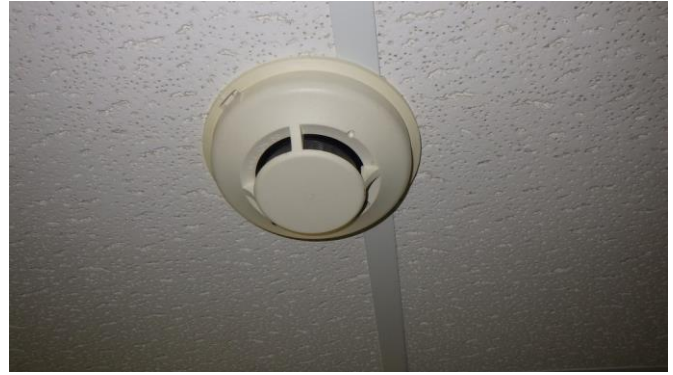
098007e 1/25/2023
Smoke detector
Office ceiling

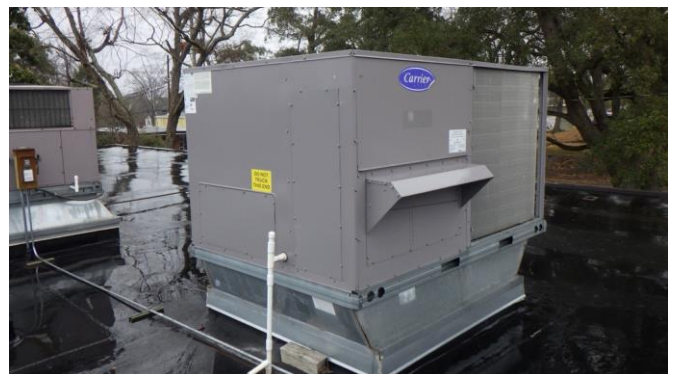
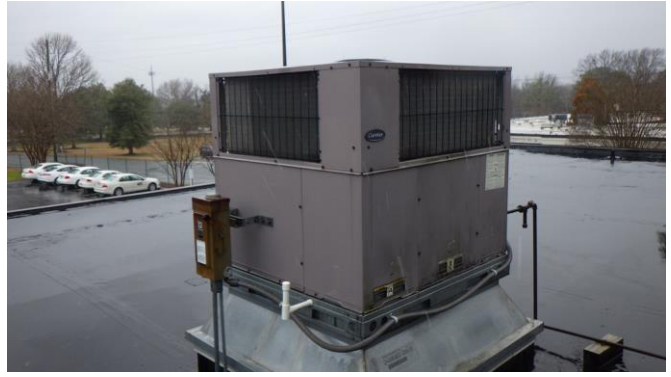
Heating and cooling is provided by two natural gas furnace rooftop package units. The equipment ranges in age from 6 to 12 years old but should provide reliable service for the ten year scope of this report. The metal and flexible ducts are believed to be original and should be scheduled for replacement.

098009e 1/25/2023
Natural gas package unit
Main room

098010e 1/25/2023
Natural gas package unit
Main room

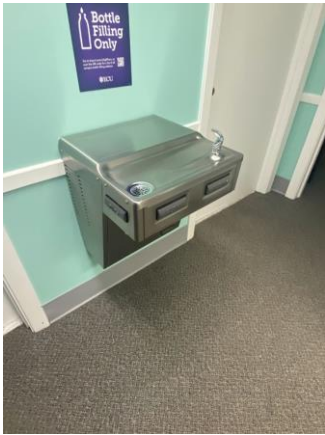
The drinking fountains are a single-level design and should be replaced with dual-level units set in alcoves or with a tapered lower cabinet design. Also, the restrooms throughout the building are not fully compliant with ADA legislation. Installation of ADA-compliant fixtures as well as grab bars and signage should remedy the situation.

098012a 1/25/2023
Single-level drinking fountain
Corridor

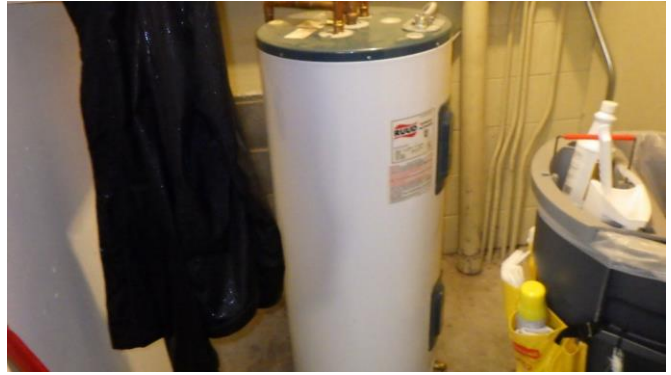
098013e 1/25/2023
Residential electric water heater
Mechanical room

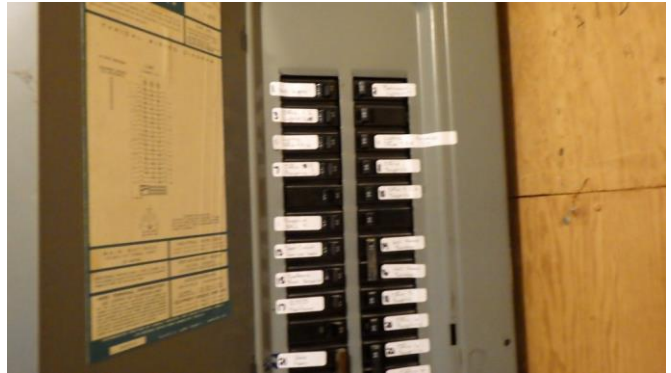
High voltage from the utility company is reduced to 120/208 volt, three-phase power via a service entrance transformer on the site. A main switchgear in the electrical room distributes 120/208 service to the 225-amp main electrical panels that have been in service for over forty years. The electrical distribution network supplies 120/208-volt power throughout the building. Aging components, such as the circuit breakers, wiring and devices serve as potential fire hazards if they fail to open a circuit in an overload or short circuit condition. Remove existing aged electrical components and branch circuitry. Install new power panels, switches, raceways, conductors, and devices. Provide molded case thermal magnetic circuit breakers and HACR circuit breakers for HVAC equipment. Redistribute the electrical loads to the appropriate areas to ensure safe and reliable power to building occupants. Provide ground fault circuit interrupter (GFCI) protection where required, and clearly label all panels for circuit identification.

098014e 1/25/2023
Electrical distribution panel
Electrical room

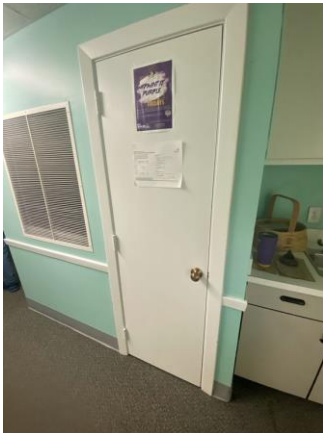
The knob actuated door hardware is a barrier to accessibility. Accessibility legislation requires that door hardware be designed for operation by people with little or no ability to grasp objects with their hands. To comply with the intent of this legislation, it is recommended that lever handle hardware be installed on all doors that still have knobs. In addition, the signage to the permanent spaces is not ADA compliant. It is recommended that all noncompliant signage be upgraded to conform to the appropriate accessibility standards. This scope includes all directional signage.

098018a 1/25/2023
Wood door with knob
Corridor

The knob actuated door hardware is a barrier to accessibility. Accessibility legislation requires that door hardware be designed for operation by people with little or no ability to grasp objects with their hands. To comply with the intent of this legislation, it is recommended that lever handle door hardware be installed on all doors that still have knobs. In addition, the signage to the permanent spaces is not ADA compliant. It is recommended that all noncompliant signage be upgraded to conform to the appropriate accessibility standards. This scope includes all directional signage.

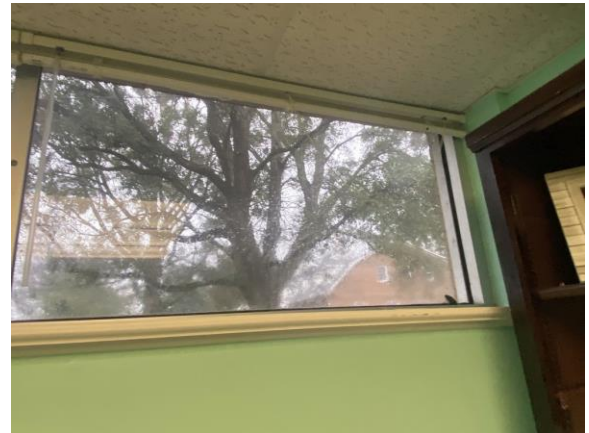
098019a 1/25/2023
Single-pane, metal-framed glazing
Office

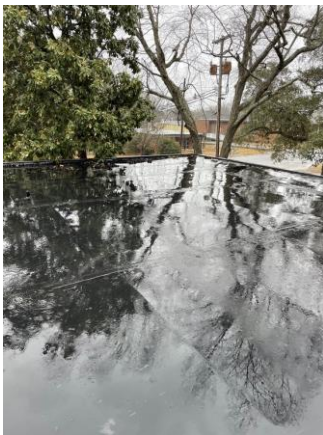
098020a 1/25/2023
Black EPDM roof
Roof

Fall protection is required for roofing installations to protect the welfare of workers on roofing systems located over six feet above grade. The installation of hard looped tie-off points is recommended at intervals throughout the roof to support workers associated lifelines and harness personal protective equipment.

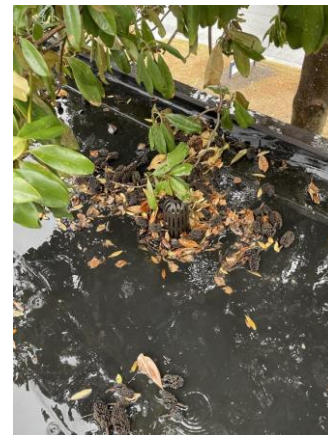
098021a 1/25/2023
Black EPDM roof and clogged drain
Roof
