EAST CAROLINA UNIVERSITY

Facility Condition Assessment

Cardiovascular Building
Asset CARD

Inspected November 6, 2018

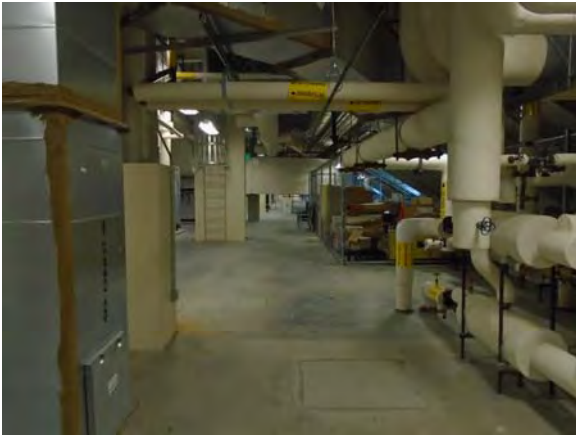
CARD001a 11/6/2018
Original sealed concrete slab floor
Penthouse

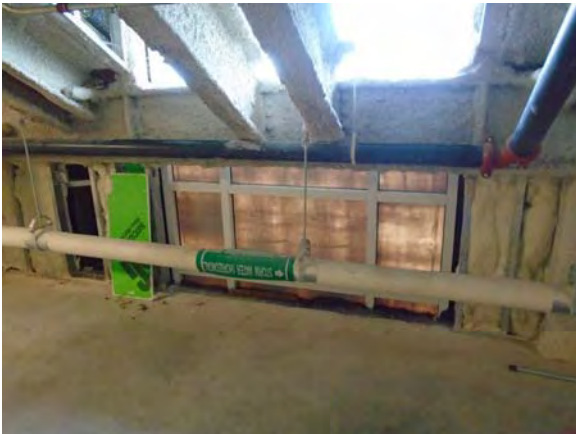
CARD002a 11/6/2018
Wall insulation and sprayed-on fireproofing
Penthouse

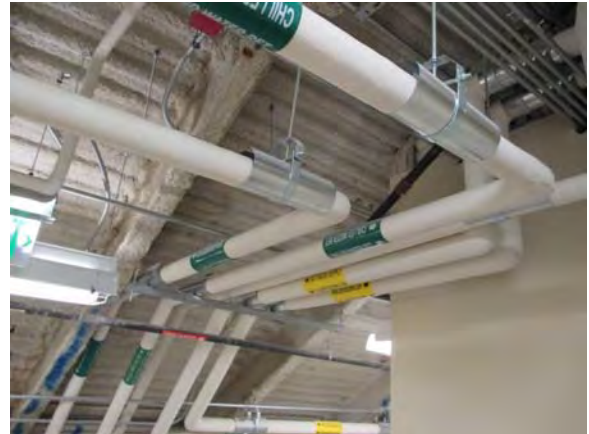
CARD002e 11/6/2018
Insulated piping (chilled and heating hot water)
Northeast mezzanine

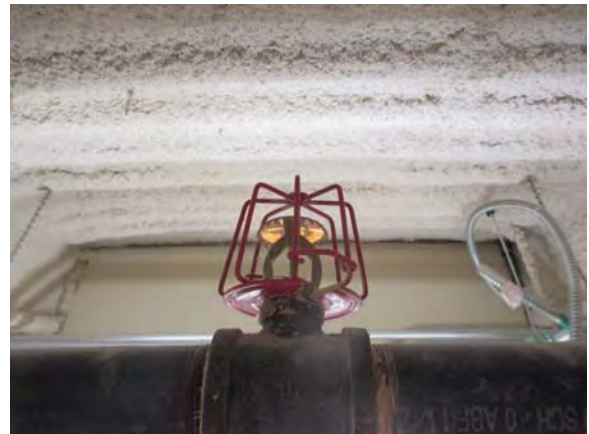
CARD003e 11/6/2018
Sprinkler head
Northeast mezzanine

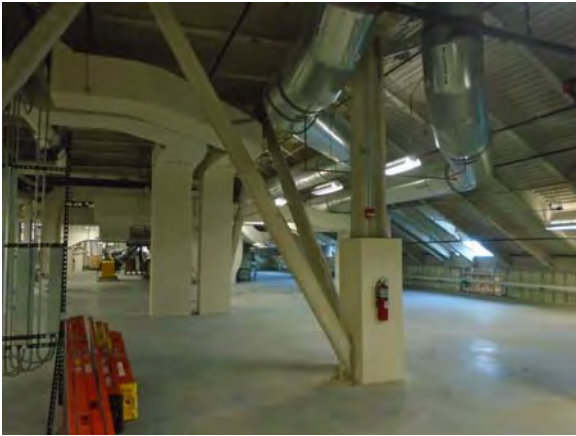
CARD004a 11/6/2018
Original sealed concrete slab floor
Penthouse

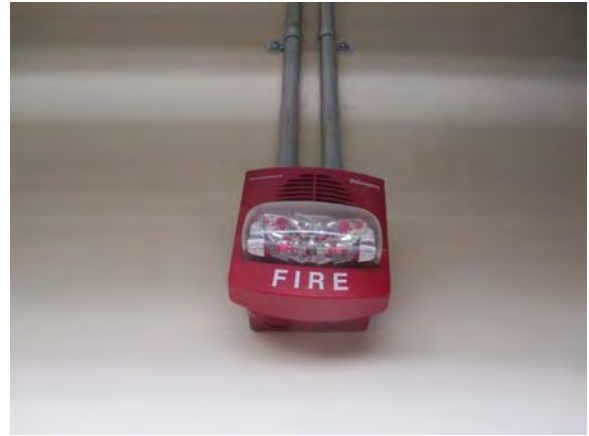
CARD004e 11/6/2018
Modern audible/visible fire alarm device
Northeast mezzanine

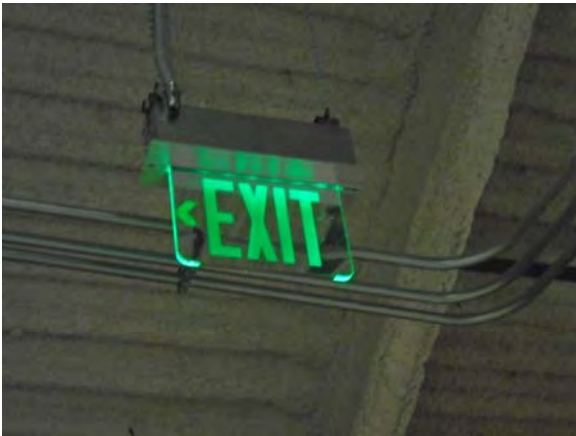
CARD005a 11/6/2018
Illuminated emergency exit sign
Penthouse

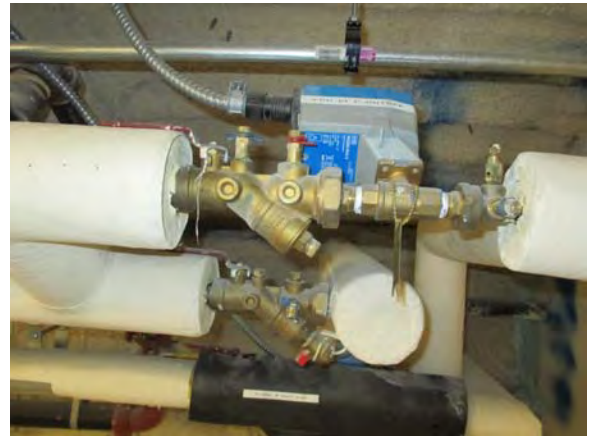
CARD005e 11/6/2018
Electric actuator on the heating hot water return
Northeast mezzanine

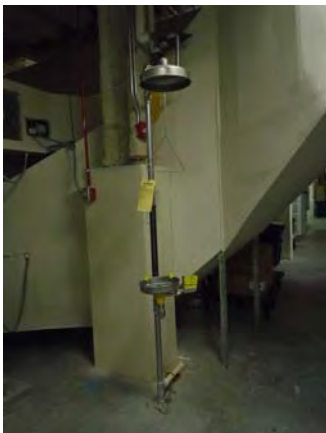
CARD006a 11/6/2018
Emergency eyewash station
Penthouse

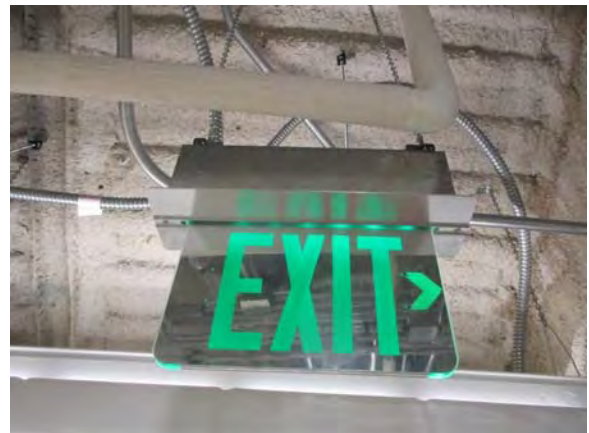
CARD006e 11/6/2018
Edge-lit LED exit sign
Northeast mezzanine

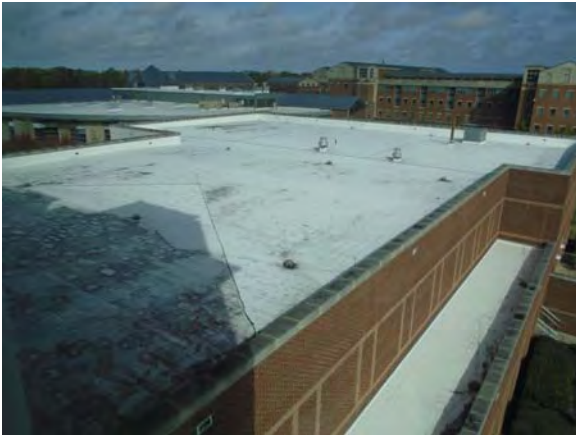
The building has a central white TPO single-ply membrane roof and a perimeter pitched blue/grey standing seam metal roof. Both are original and in good condition. While neither should require replacement within the next ten years, it should be expected that the membrane roof will need to be replaced shortly after the report scope.

CARD007a 11/6/2018
Original membrane roof
Lower northeast wing roof

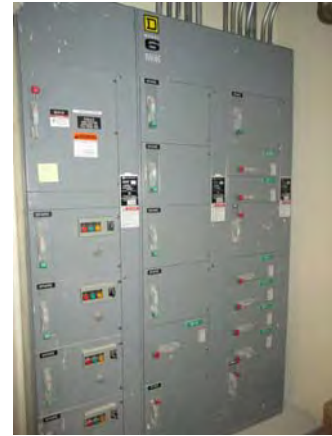
CARD007e 11/6/2018
Square D motor control center
Northeast mezzanine

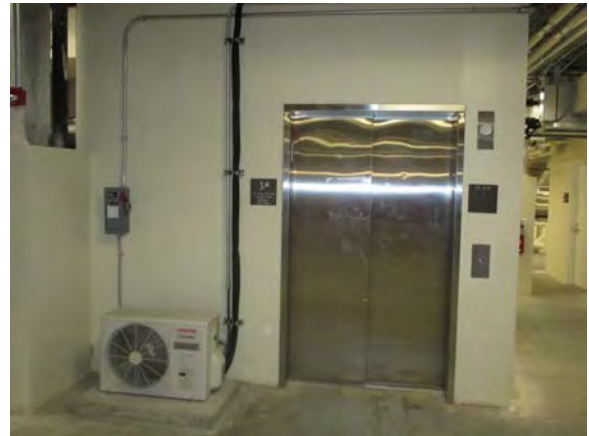
CARD008e 11/6/2018
Toshiba split DX condensing unit adjacent to elevator door
Northeast mezzanine

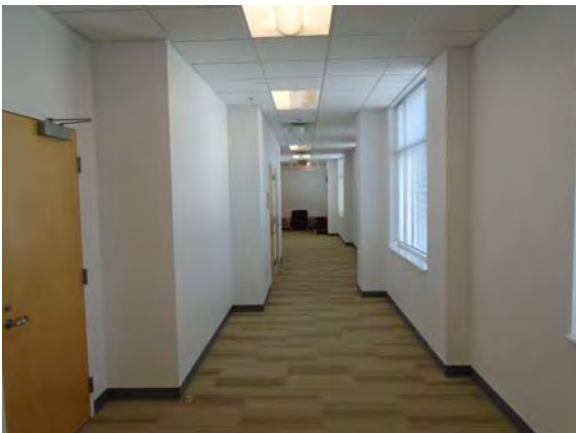
The interior finishes are mostly original and in good condition. The office suites, public waiting rooms, conference rooms, and administrative support areas typically have carpeting. While in good condition, the carpeting dating to 2009 will likely require replacement within the next ten years. The newer carpeting should outlast the scope of this report. Carpeting in higher traffic areas will always need more frequent replacement. Labs and exam rooms have 12-inch vinyl tile or sheet vinyl, and the main lobby and auditorium prefunction area have terrazzo flooring. Restrooms typically have ceramic tile on the floors and lower wall section. Some of the smaller single-occupant restrooms in the patient areas have vinyl floor tile. The original sheet vinyl has some areas with separating seams and should be replaced within the next ten years.

CARD009a 11/6/2018
Carpeting, painted walls, and suspended grid ceiling
Fourth floor corridor

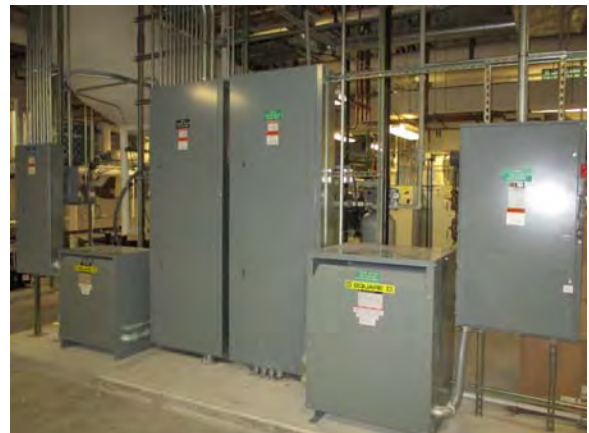
CARD009e 11/6/2018
Square D secondary electrical panels and branch
transformers
East mezzanine

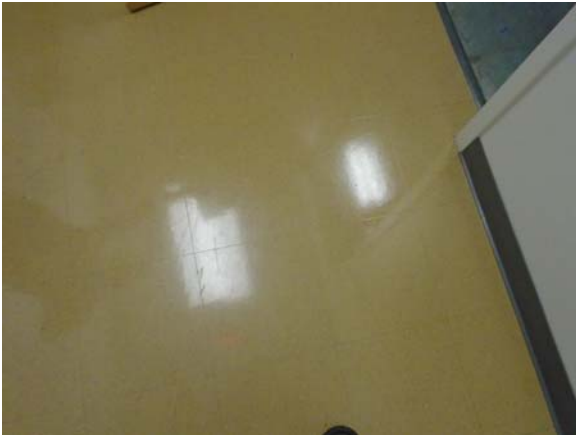
CARD010a 11/6/2018
Vinyl tile floor
Fourth floor corridor

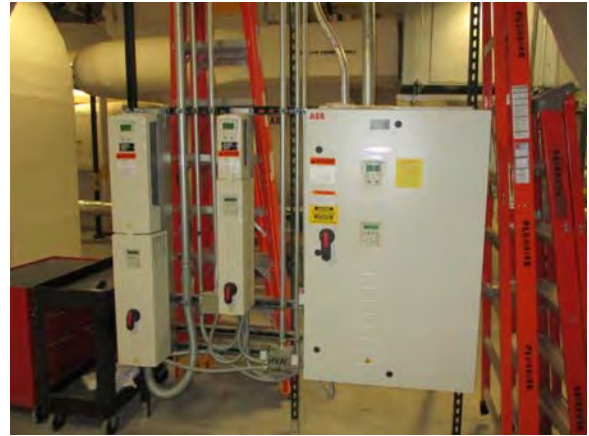
CARD010e 11/6/2018
Group of three ABB variable frequency drives
East mezzanine

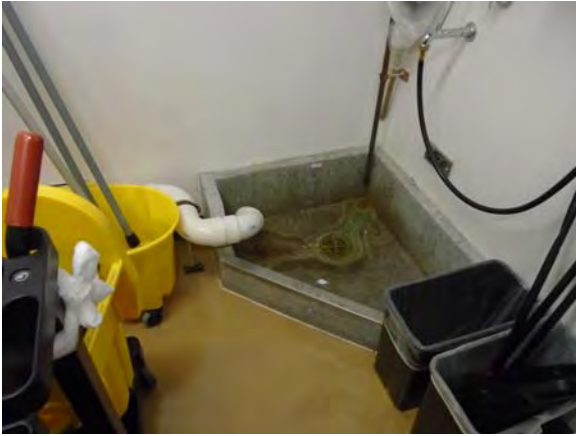
CARD011a 11/6/2018
Custodial floor sink
Fourth floor

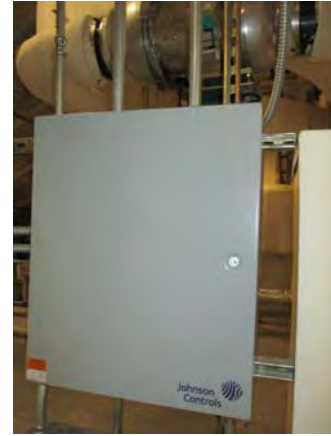
CARD011e 11/6/2018
Enclosure for Johnson Controls HVAC controls
East mezzanine

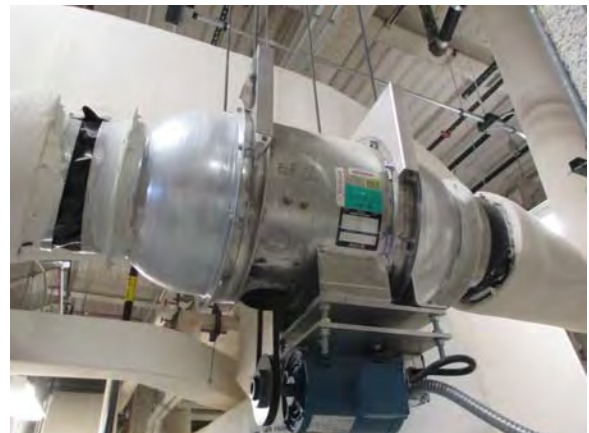
CARD012e 11/6/2018
1.5 hp Loren Cook exhaust fan EF-1
East mezzanine

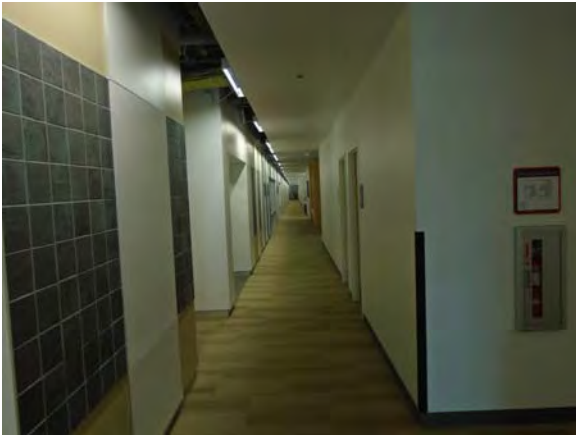
CARD013a 11/6/2018
Carpeting, painted and tiled walls, and painted ceiling
(some unfinished areas)
Fourth floor corridor

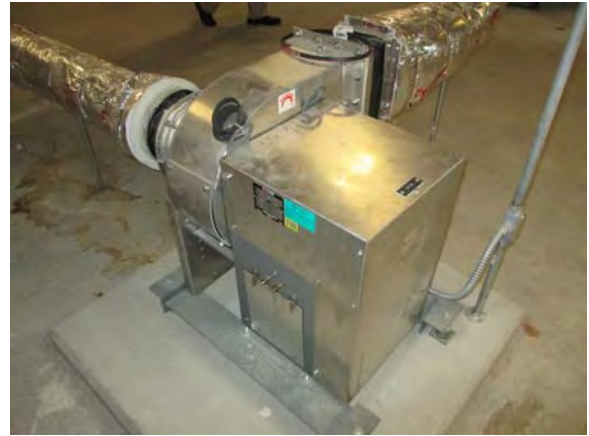
CARD013e 11/6/2018
1/2 hp Loren Cook exhaust fan EF-6
East mezzanine

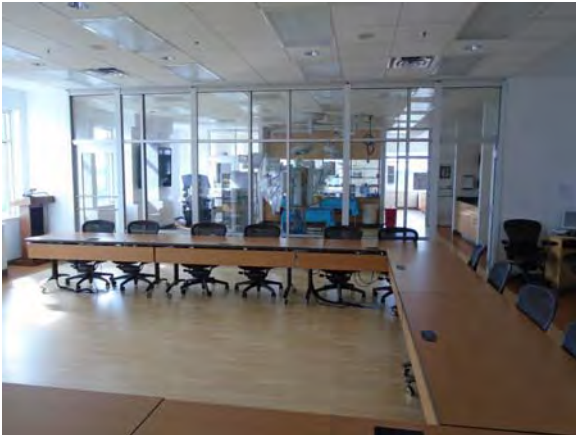
CARD014a 11/6/2018
Wood laminate flooring, suspended ceiling, and glazed
interior wall partitions
Fourth floor

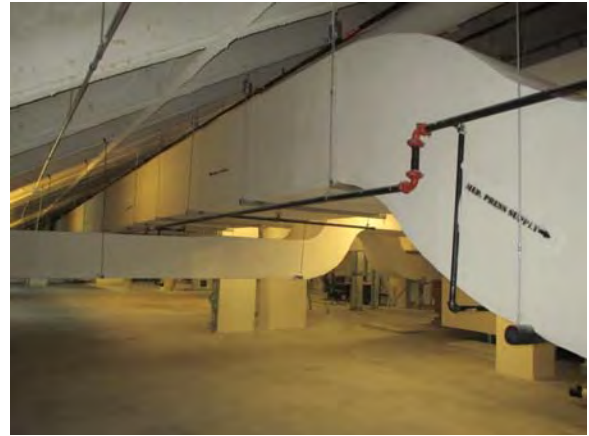
CARD014e 11/6/2018
HVAC ductwork
South mezzanine

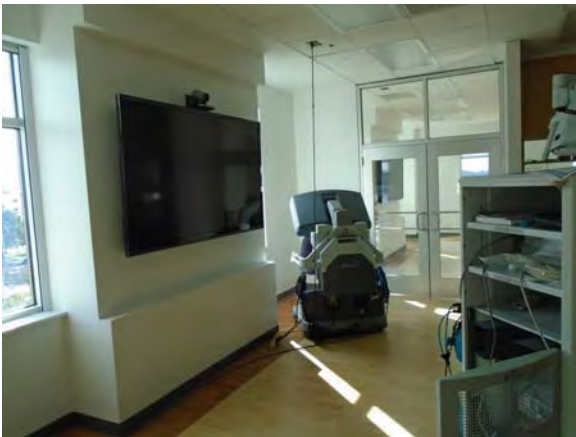
CARD015a 11/6/2018
Wood laminate flooring, suspended ceiling, and glazed
interior doors
Fourth floor

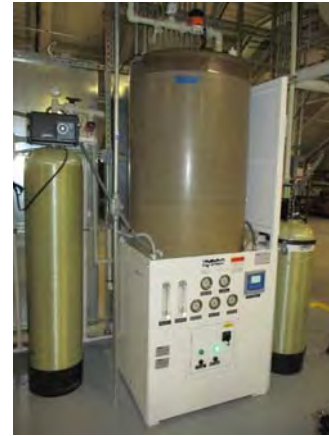
CARD037e 11/6/2018
Hydro RO/DI water treatment system
East mezzanine

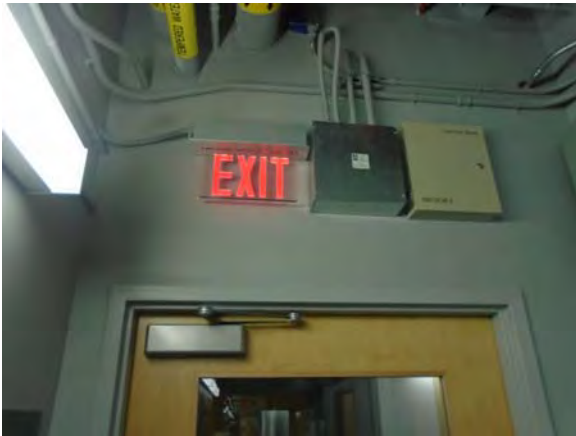
CARD038a 11/6/2018
Illuminated emergency exit signage
Fourth floor

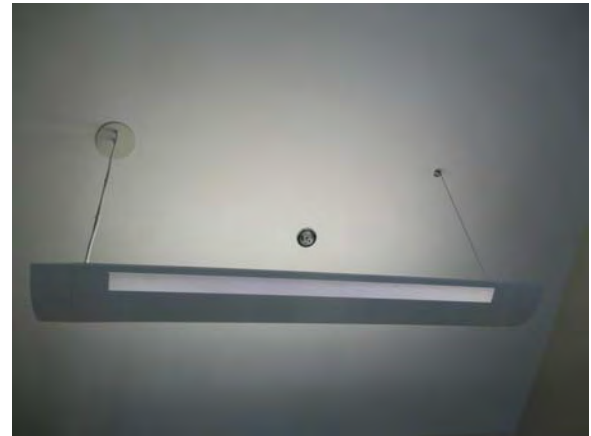
CARD038e 11/6/2018
Pendent fluorescent light fixture and sprinkler head
East stairwell

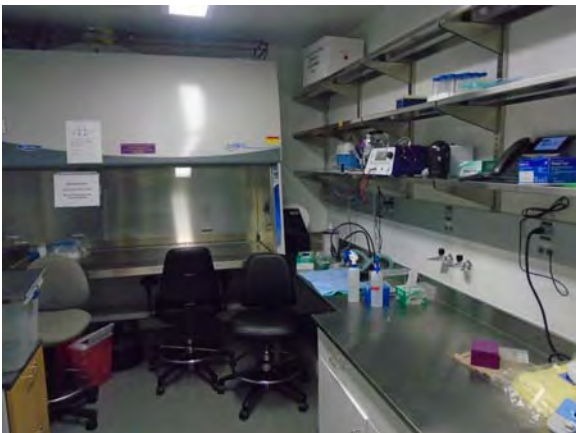
CARD039a 11/6/2018
Vinyl floor, painted walls, and metal shelving and
cabinetry
Fourth floor lab

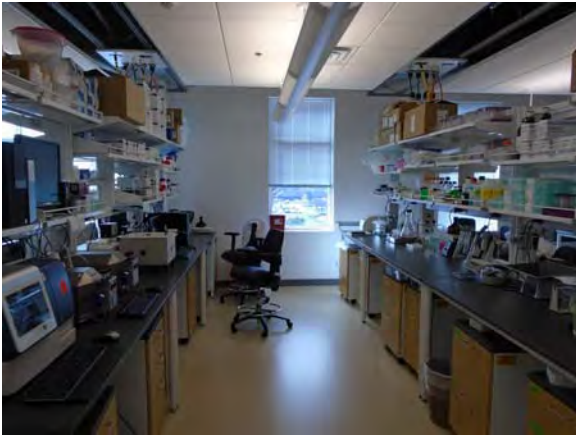
CARD040a 11/6/2018
Sheet vinyl flooring, painted walls, suspended grid ceiling,
and wood and metal lab cabinetry
Fourth floor lab

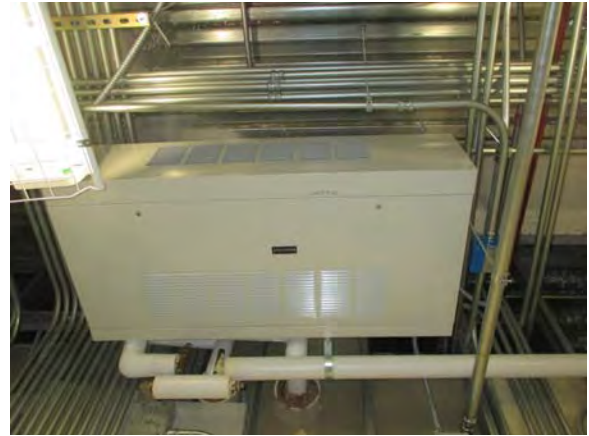
CARD040e 11/6/2018
Fan coil unit cooling the fourth floor electrical room
Room 4004

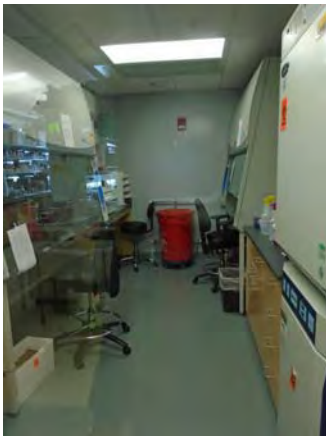
CARD042a 11/6/2018
Sheet vinyl flooring, painted walls, suspended grid ceiling,
and wood and metal lab cabinetry
Fourth floor

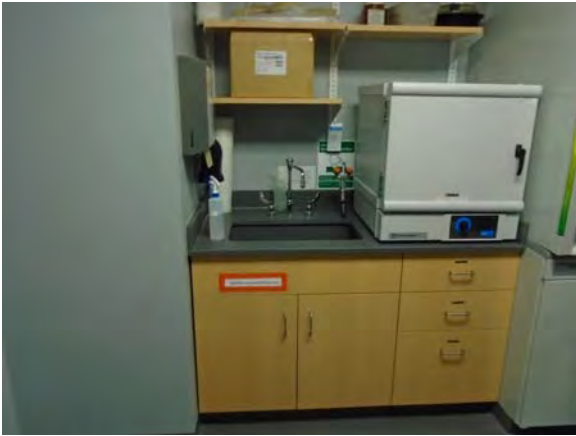
CARD043a 11/6/2018
Built-in wood lab cabinetry with sink
Fourth floor

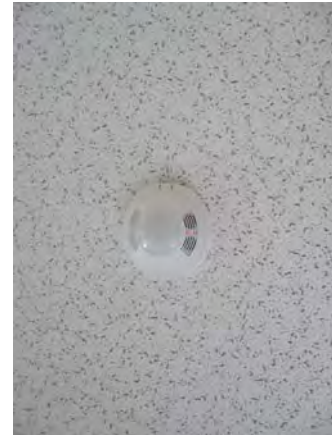
CARD043e 11/6/2018
Modern occupancy sensor
Fourth floor corridor

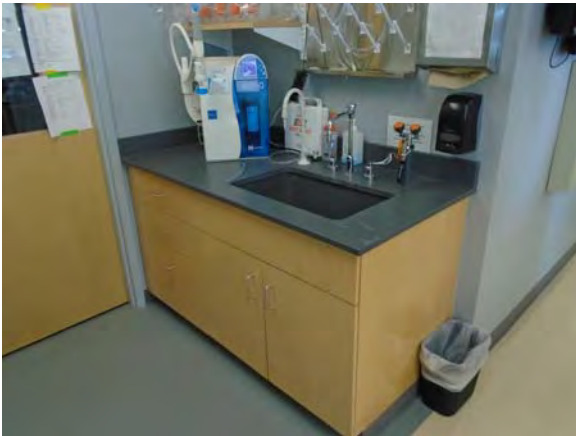
CARD044a 11/6/2018
Built-in wood lab cabinetry with sink
Fourth floor

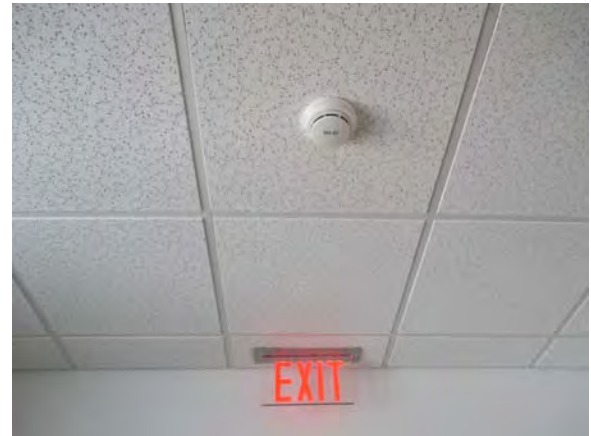
CARD044e 11/6/2018
Modern smoke/heat detector
Fourth floor corridor

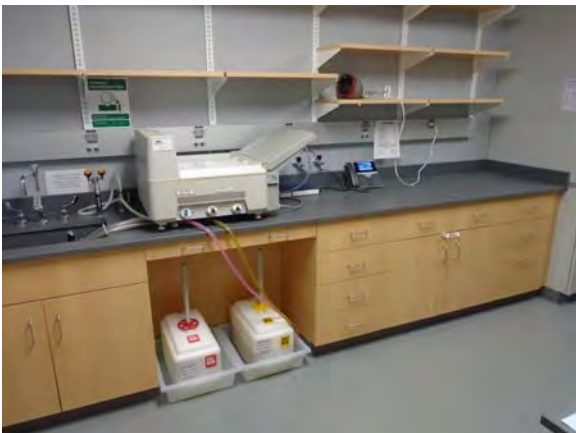
CARD045a 11/6/2018
Built-in wood lab cabinetry with sink
Fourth floor

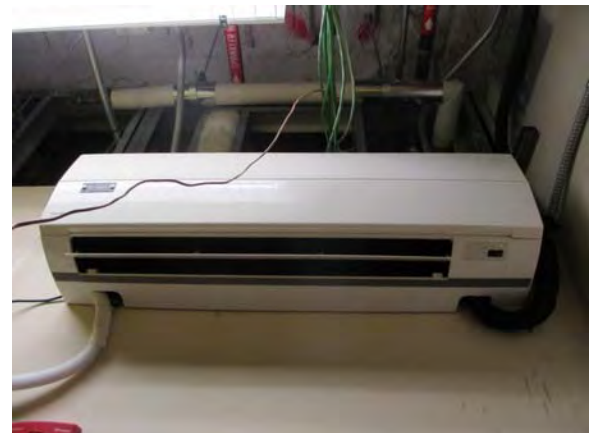
CARD045e 11/6/2018
Evaporator unit for the Toshiba split DX system
Room 4003

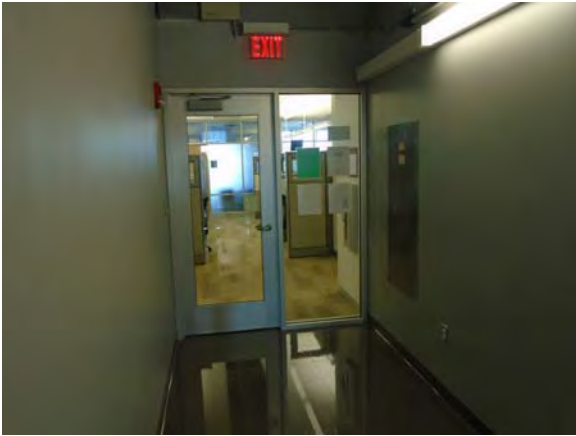
CARD046a 11/6/2018
Vinyl tile floor, painted walls, and painted ceiling (some unfinished areas)
Fourth floor corridor

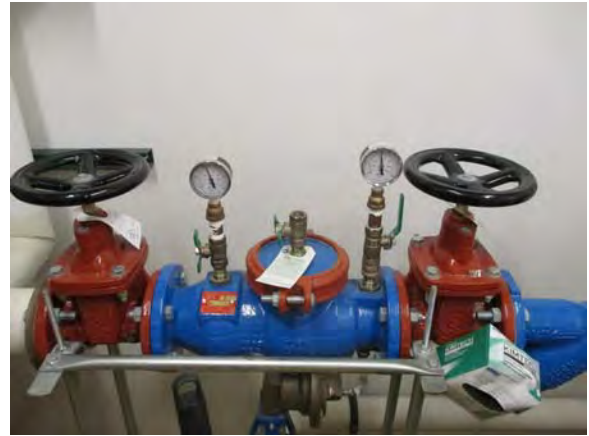
CARD046e 11/6/2018
2 inch domestic water backflow preventer
Room 4005

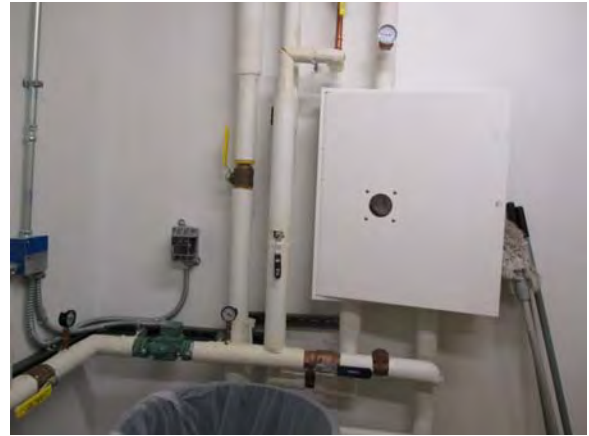
CARD047e 11/6/2018
Mixing valve for the hot/cold water piping
Room 4005

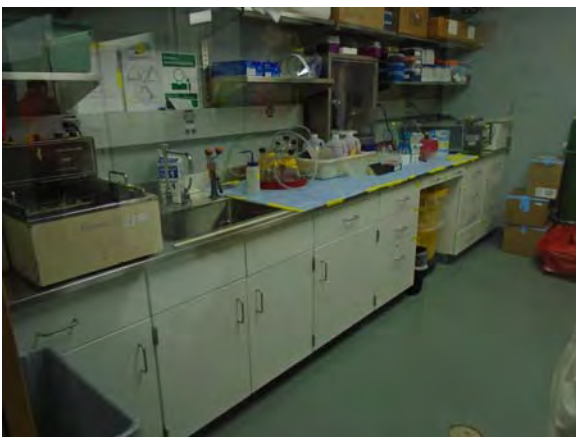
CARD048a 11/6/2018
Vinyl floor, painted walls, and metal shelving and cabinetry
Fourth floor

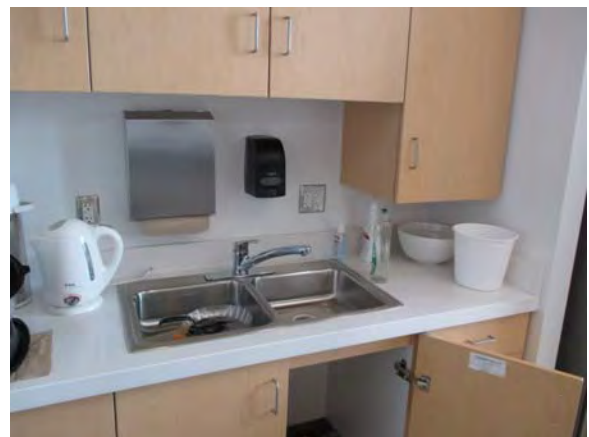
CARD048e 11/6/2018
GFCI protection on electrical outlet near sink
Break room 4201

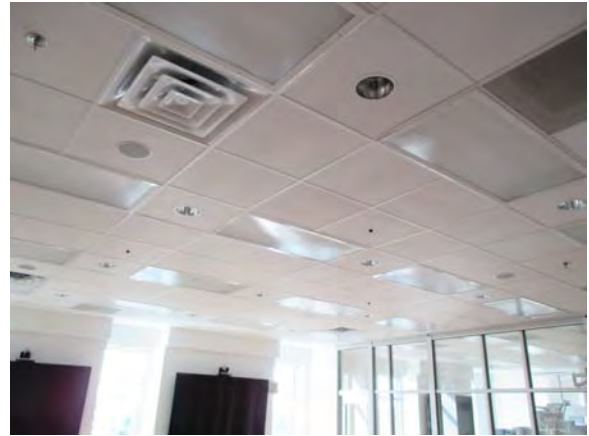
CARD049e 11/6/2018
Modern lay-in fluorescent light fixtures
Conference room 4200

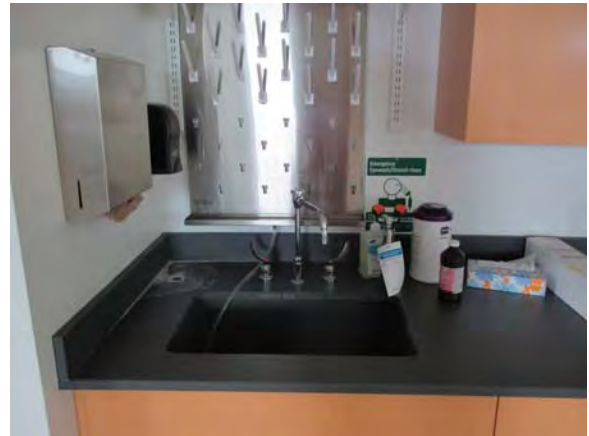
CARD050e 11/6/2018
Emergency eyewash station next to the lab sink
Fourth floor surgery room

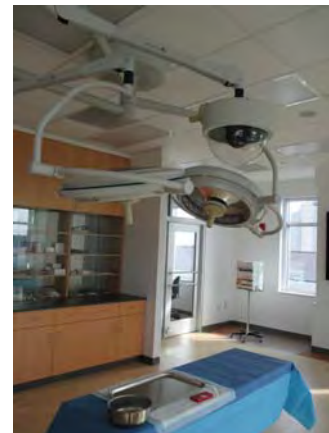
CARD051e 11/6/2018
Special light fixture above surgical table
Fourth floor surgery room

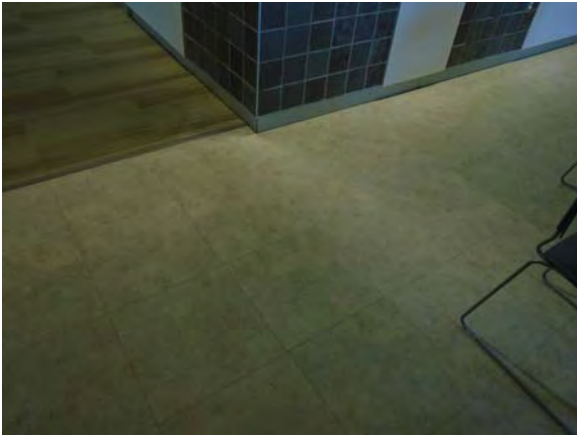
CARD052a 11/6/2018
Ceramic tile floor and painted and tiled walls
Fourth floor break room

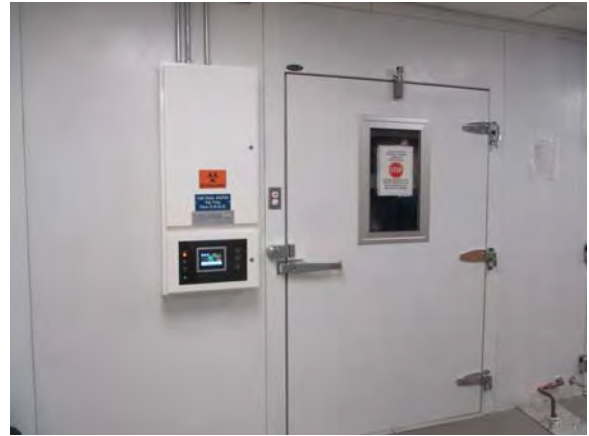
CARD052e 11/6/2018
Walk-in cold room
Room 4210B

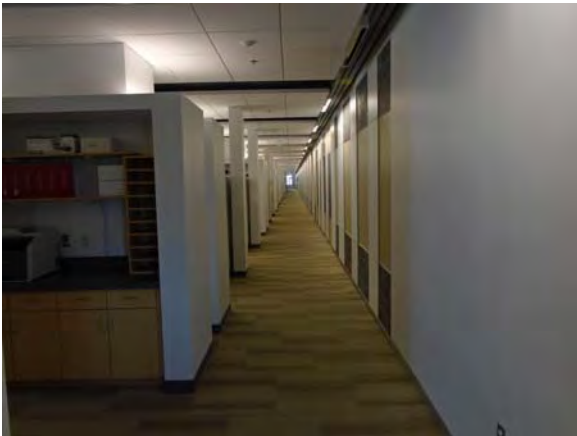
CARD053a 11/6/2018
Carpeting, painted and tiled walls, and suspended ceiling
Fourth floor

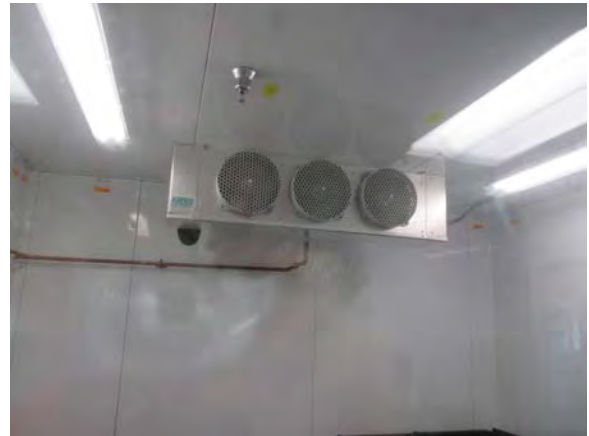
CARD053e 11/6/2018
Three evaporator units inside walk-in cold room
Room 4210B

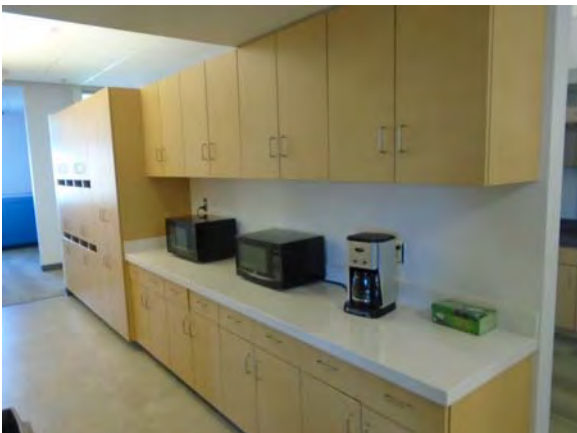
CARD054a 11/6/2018
Ceramic tile floor, painted walls, and wood cabinetry
Fourth floor

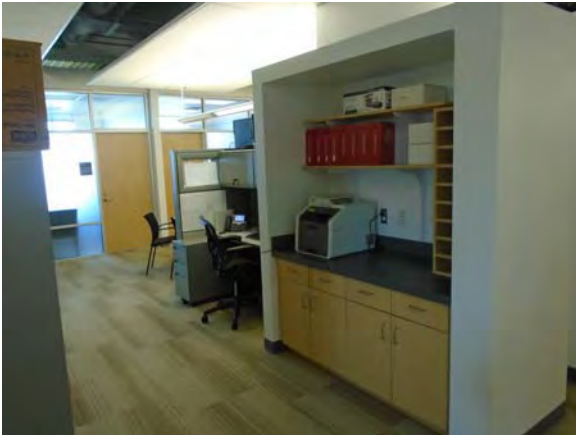
CARD055a 11/6/2018
Carpeting, glazed interior walls, and suspended grid ceiling
Fourth floor

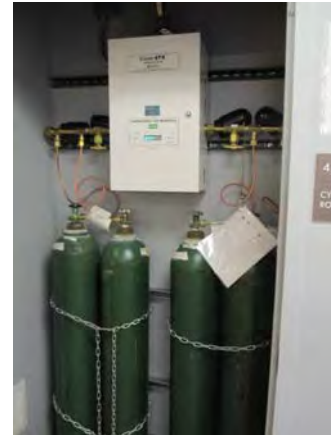
CARD055e 11/6/2018
Cylinder storage with a medical gas control panel
Room 4212A

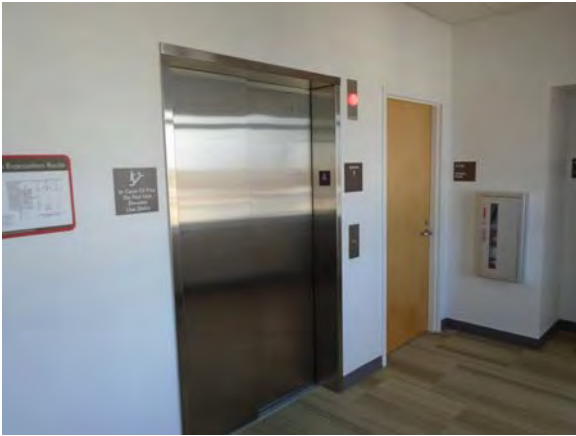
CARD056a 11/6/2018
Carpeting, lever hardware, and accessible signage
Fourth floor

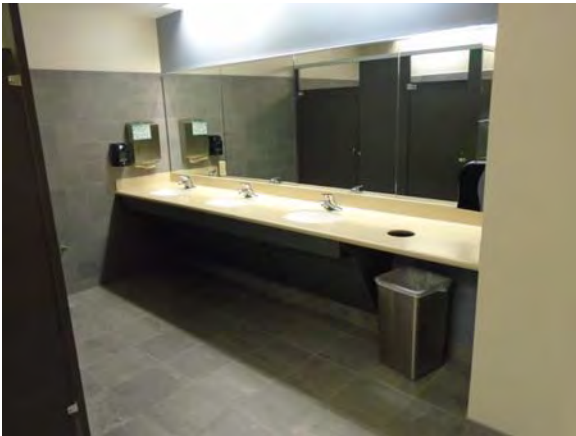
CARD077a 11/6/2018
Tiled floor and walls and accessible sinks
Third floor men's restroom

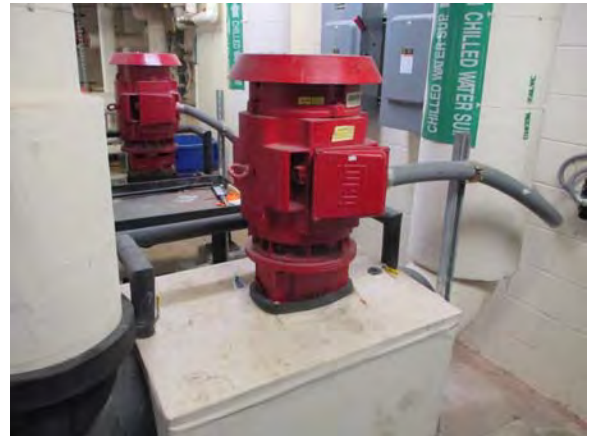
CARD077e 11/6/2018
Two 40 hp chilled water pumps
Room 1418

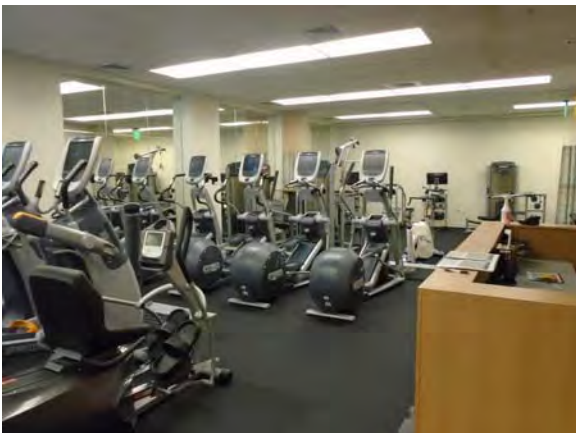
CARD078a 11/6/2018
Rubber floor mats and suspended ceiling
Third floor workout room

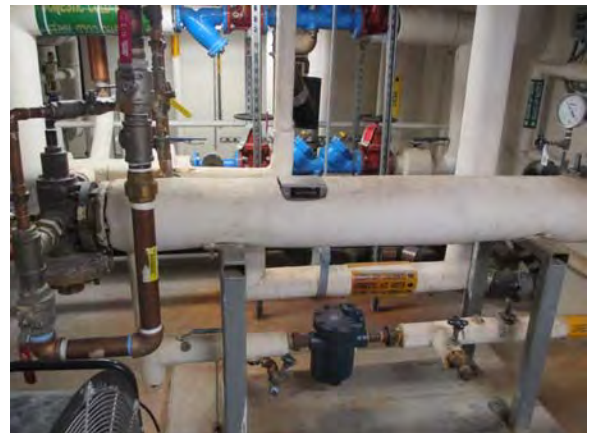
CARD078e 11/6/2018
ThermaFlo domestic water heat exchanger
Room 1418

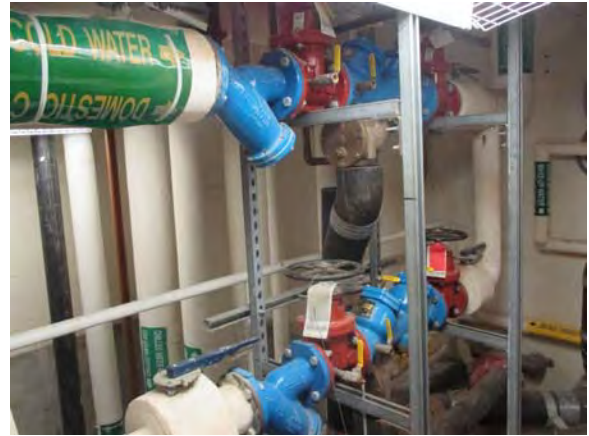
CARD079e 11/6/2018
Two 3 inch backflow preventers for domestic water
Room 1418

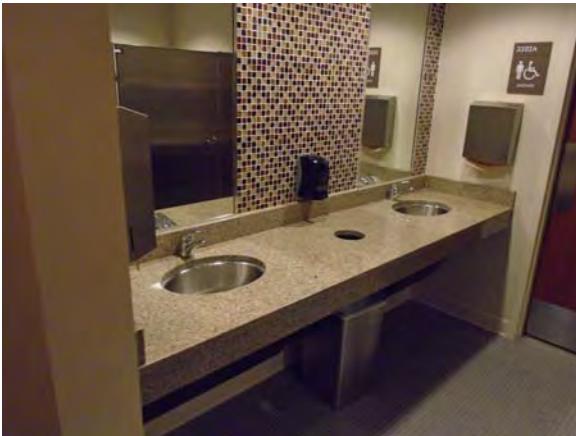
CARD080a 11/6/2018
Tiled floor and walls and accessible sinks
Third floor staff shower/restroom

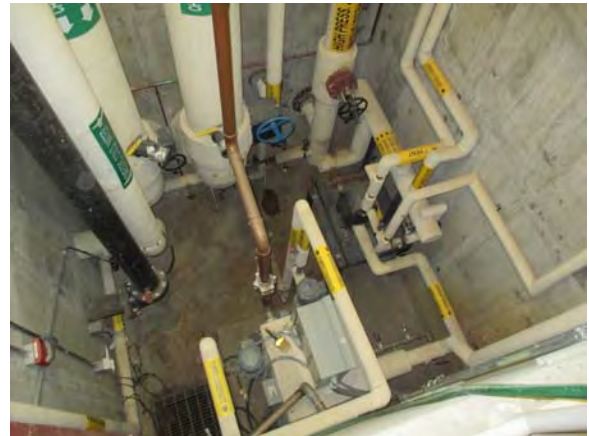
CARD080e 11/6/2018
Pit for chilled water and steam/condensate piping
Room 1418

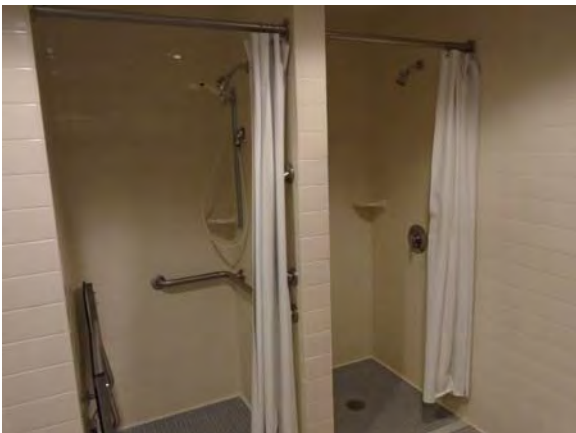
CARD081a 11/6/2018
Tiled floor and walls and accessible shower
Third floor staff shower/restroom

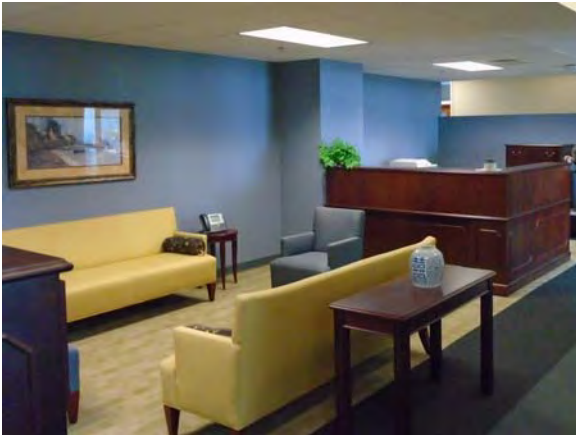
CARD085a 11/6/2018
Carpeting, painted walls, and suspended grid ceiling
Second floor waiting area

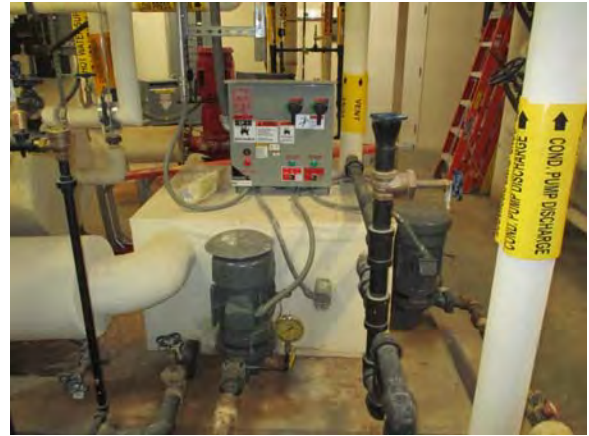
CARD085e 11/6/2018
Condensate pump CP-1
Room 1418

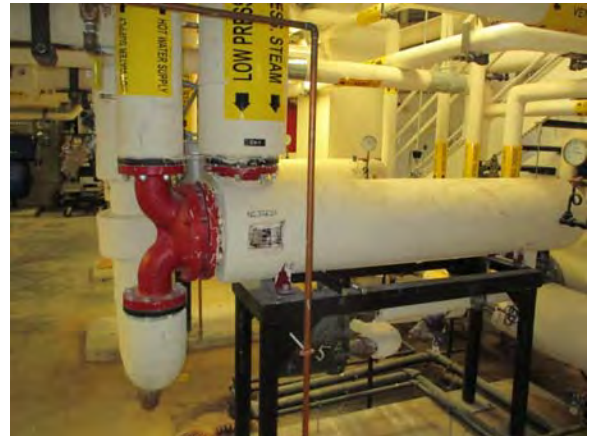
CARD086e 11/6/2018
CV-1 heat exchanger producing heating hot water
Room 1418

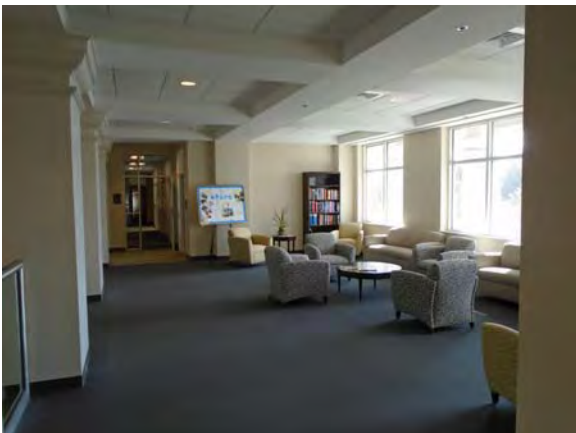
CARD087a 11/6/2018
Carpeting, painted walls, and suspended grid ceiling
Second floor waiting area

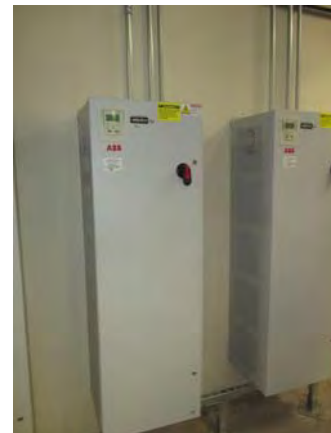
CARD087e 11/6/2018
ABB variable frequency drive for heating hot water P2-1
Room 1418

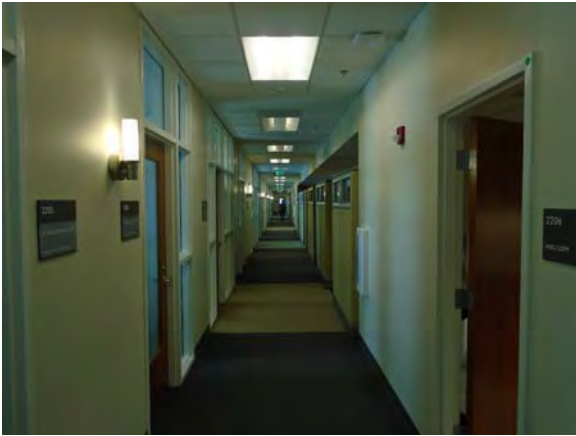
CARD088a 11/6/2018
Carpeting, painted walls, and suspended grid ceiling
Second floor corridor

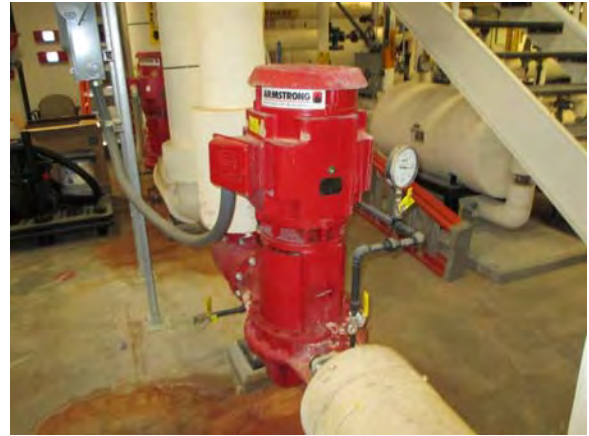
CARD088e 11/6/2018
25 hp heating hot water pump P2-1
Room 1418

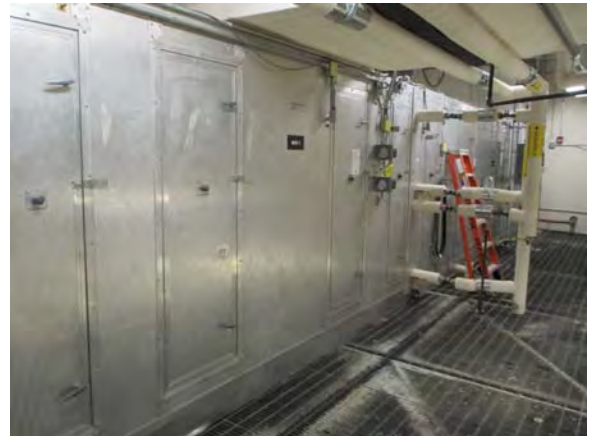
CARD089e 11/6/2018
Air handling unit AHU-1
Room 1418

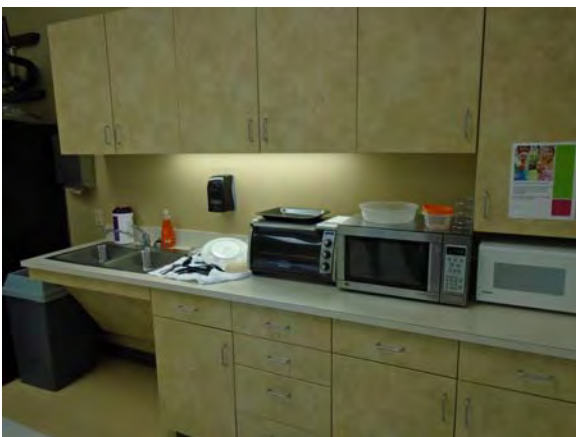
CARD090a 11/6/2018
Built-in wood cabinetry with accessible sink
Second floor

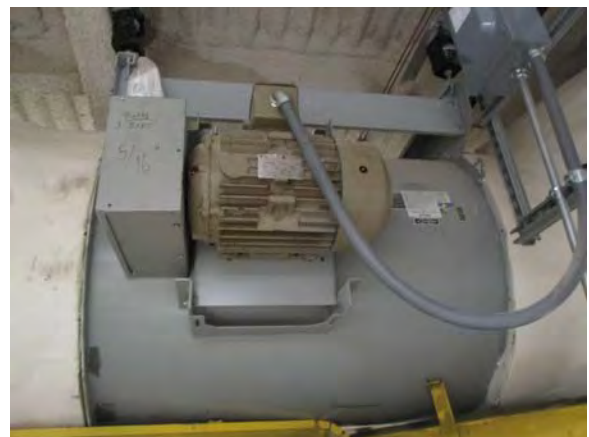
CARD090e 11/6/2018
20 hp return fan for AHU-1
Room 1418

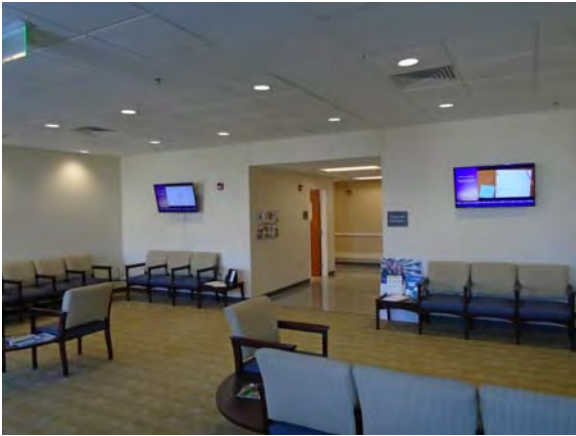
CARD091a 11/6/2018
Carpeting, painted walls, and suspended grid ceiling
Second floor waiting area

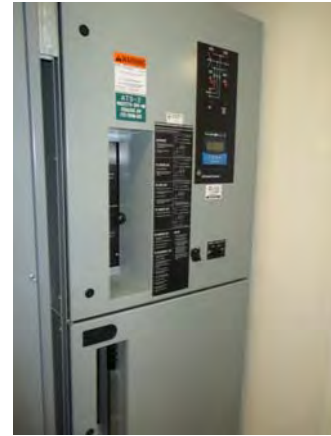
CARD091e 11/6/2018
GE Zenith automatic transfer switch ATS-2
Room 1419E

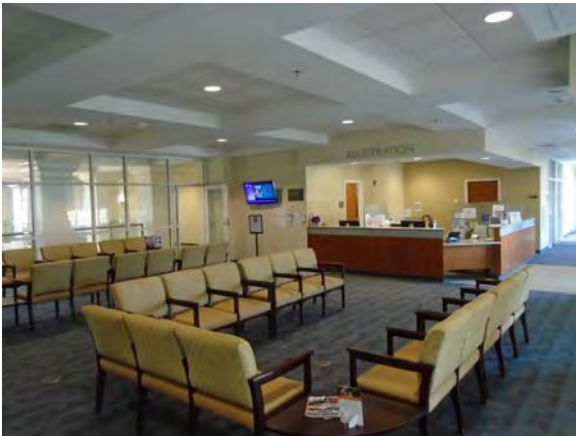
CARD092a 11/6/2018
Carpeting, painted walls, and suspended grid ceiling
Second floor waiting area

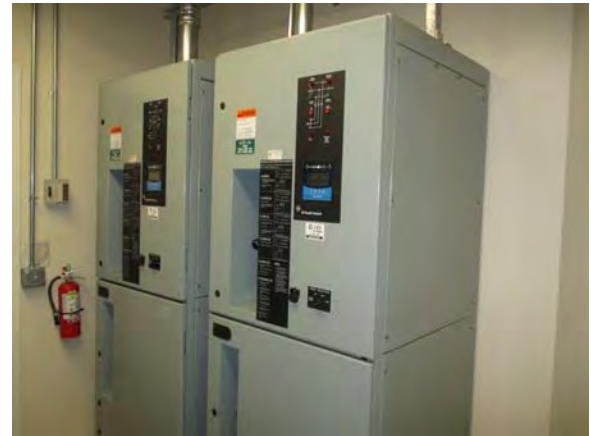
CARD092e 11/6/2018
GE Zenith automatic transfer switches ATS-1A and ATS-1B
Room 1419E

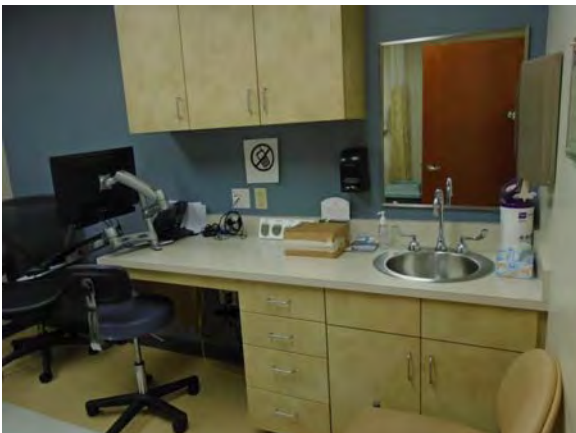
CARD093a 11/6/2018
Vinyl tile floor, painted walls, suspended ceiling, and base
and overhead cabinetry with sink
Second floor exam room

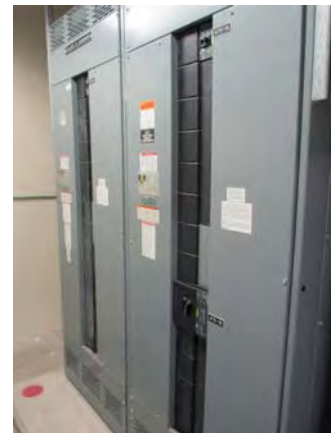
CARD093e 11/6/2018
Square D generator switchboard
Room 1419E

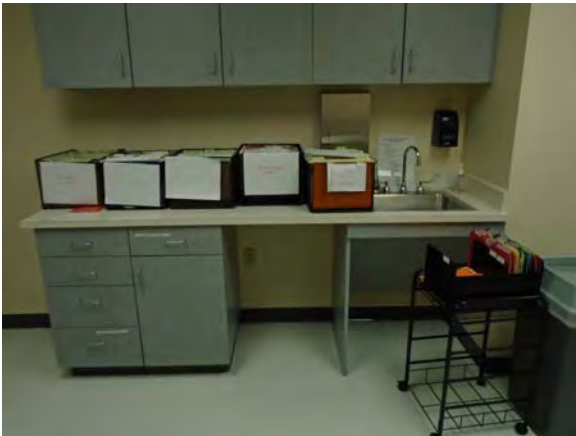
CARD098a 11/6/2018
Vinyl tile floor, painted walls, suspended ceiling, and base
and overhead cabinetry with sink
Second floor

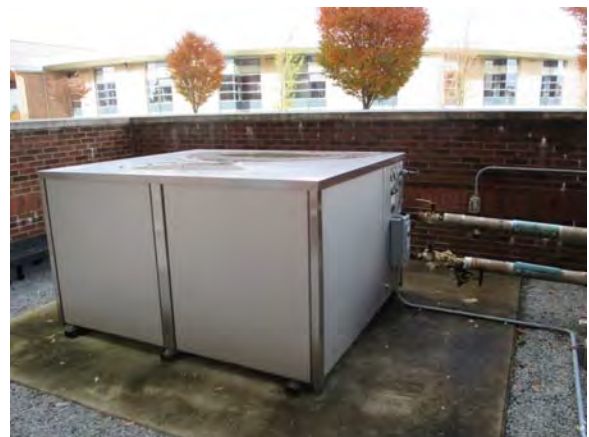
CARD099e 11/6/2018
Chiller for CT scan equipment
West exterior

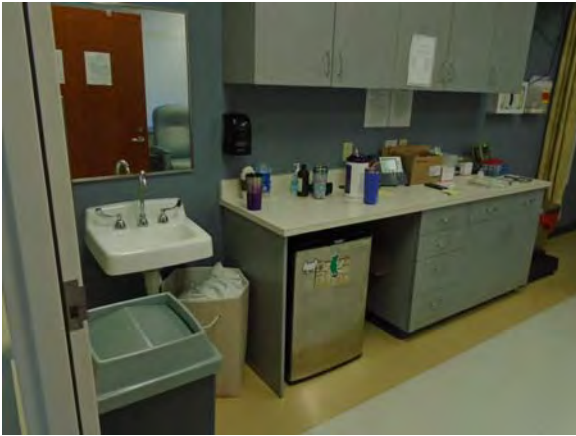
CARD100a 11/6/2018
Vinyl tile floor, painted walls, suspended ceiling, base and overhead cabinetry, and wall-mounted sink
Second floor exam room

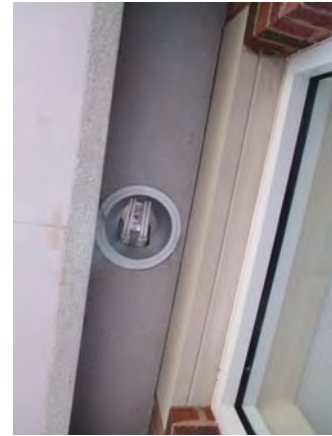
CARD100e 11/6/2018
Ceiling recessed CFL exterior light
West exterior

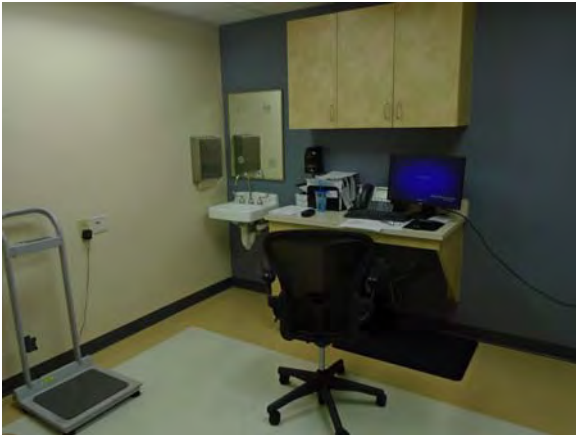
CARD101a 11/6/2018
Vinyl tile floor, painted walls, suspended ceiling, base and overhead cabinetry, and wall-mounted sink
Second floor exam room

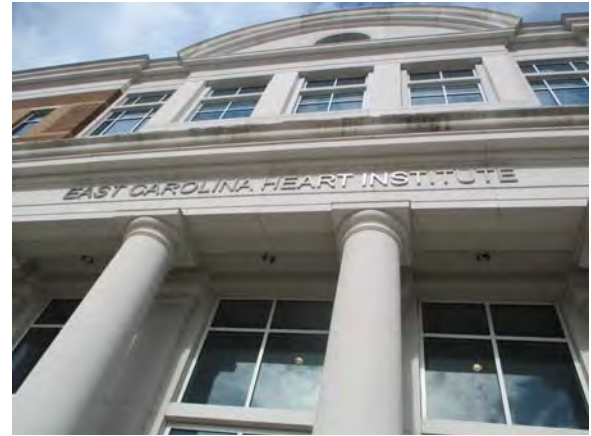
CARD101e 11/6/2018
Ceiling recessed CFL exterior lights
South exterior

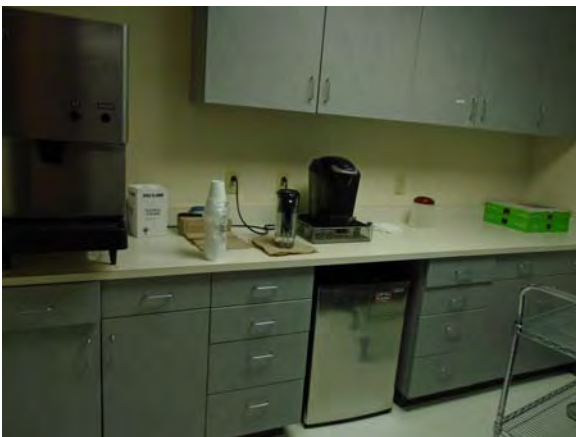
CARD102a 11/6/2018
Vinyl tile floor, painted walls, suspended ceiling, and base and overhead cabinetry
Second floor

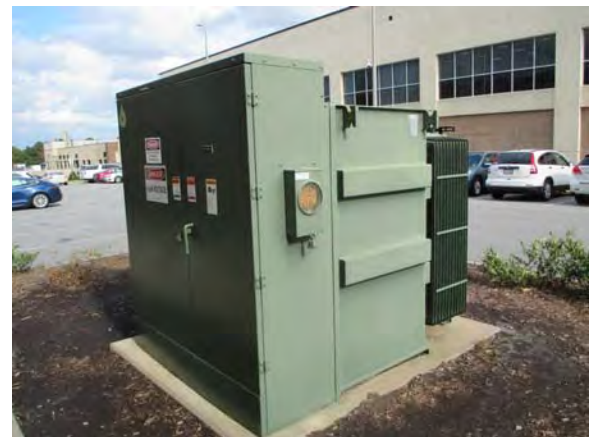
CARD102e 11/6/2018
2,000 kVA oil-filled transformer TX-19
East exterior

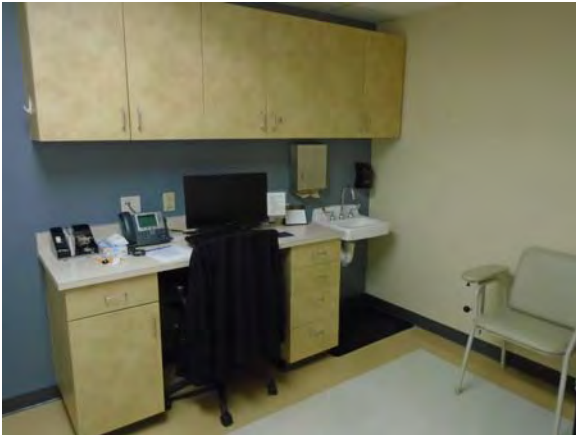
CARD103a 11/6/2018
Vinyl tile floor, painted walls, suspended ceiling, base and overhead cabinetry, and wall-mounted sink
Second floor exam room
