EAST CAROLINA UNIVERSITY

Facility Condition Assessment

Cardiovascular Building
Asset CARD

Inspected November 6, 2018

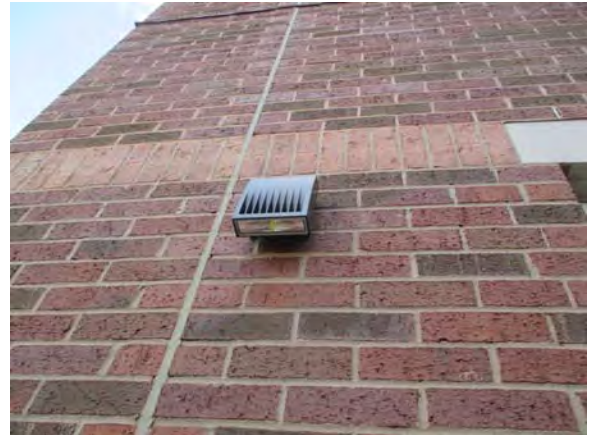
CARD103e 11/6/2018
Wall-mounted LED exterior light
East exterior

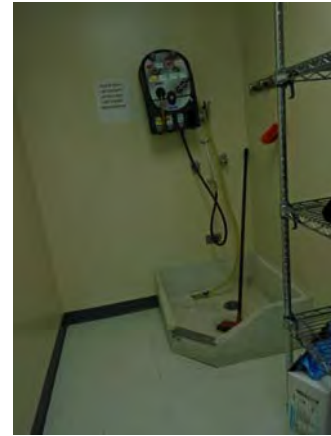
CARD107a 11/6/2018
Vinyl tile floor and custodial floor sink
First floor

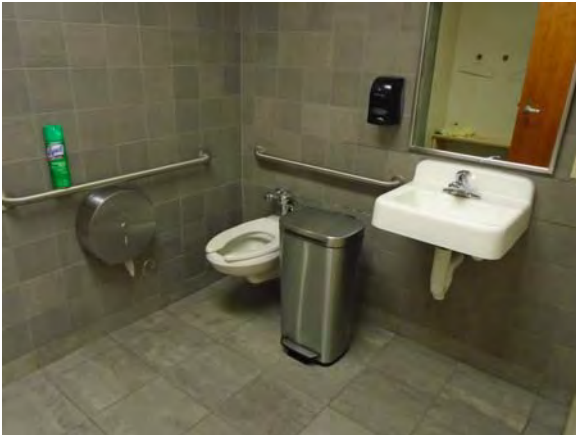
CARD108a 11/6/2018
Tiled floor and walls and accessible fixtures
First floor accessible unisex restroom

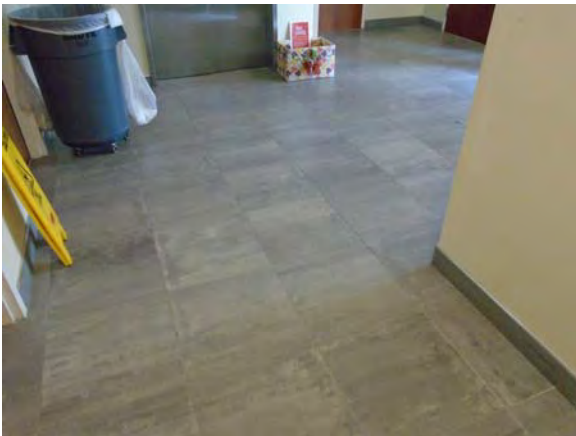
CARD110a 11/6/2018
Tiled floor
First floor elevator lobby

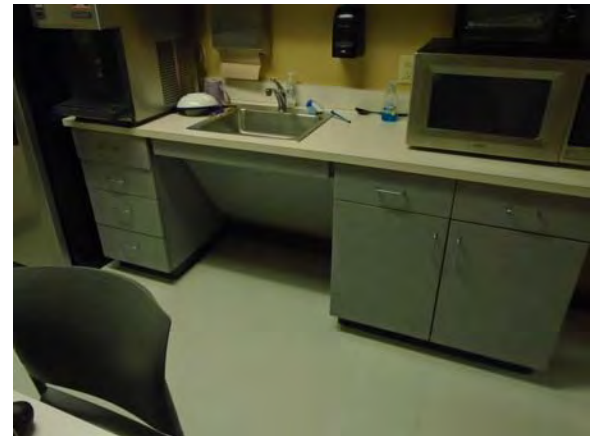
CARD111a 11/6/2018
Vinyl tile floor and accessible sink and cabinetry
First floor

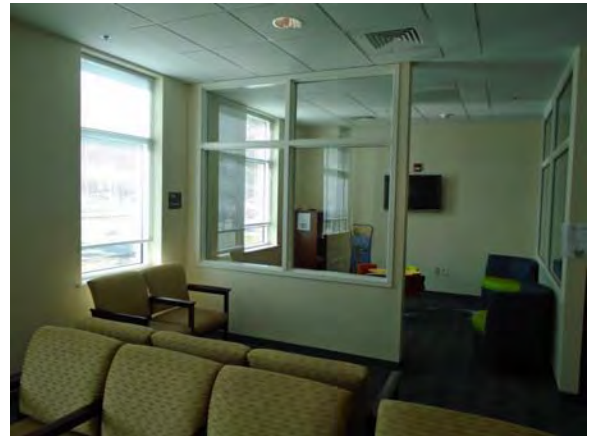
CARD115a 11/6/2018
Carpeting, painted walls, and suspended grid ceiling
First floor waiting area

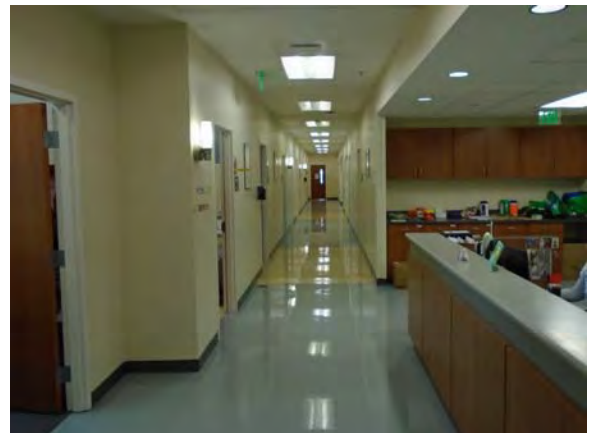
CARD117a 11/6/2018
Vinyl flooring, painted walls, and suspended grid ceiling
First floor

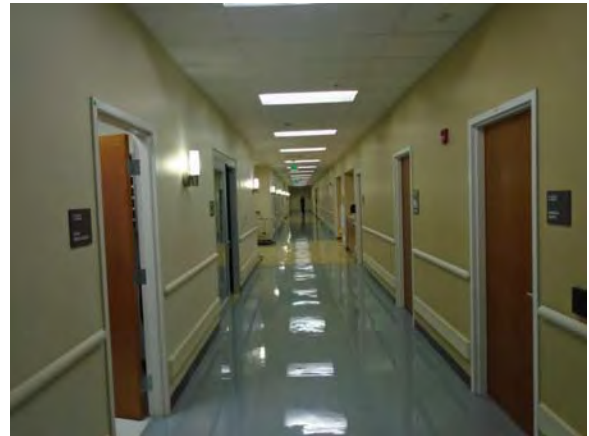
CARD127a 11/6/2018
Vinyl flooring, painted walls, and suspended grid ceiling
First floor

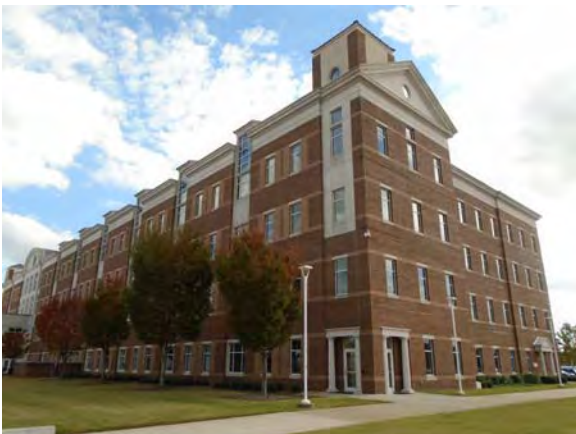
CARD169a 11/6/2018
Concrete exterior panels, dual-pane windows, and glass
doors
Northeast courtyard

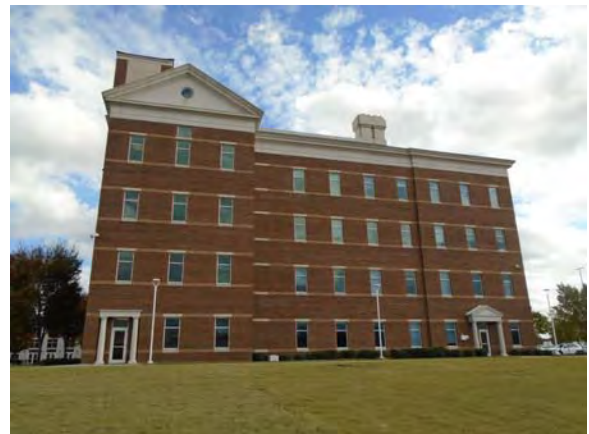
CARD170a 11/6/2018
Brick masonry exterior, dual-pane windows, and metal
standing seam roof
Northwest corner

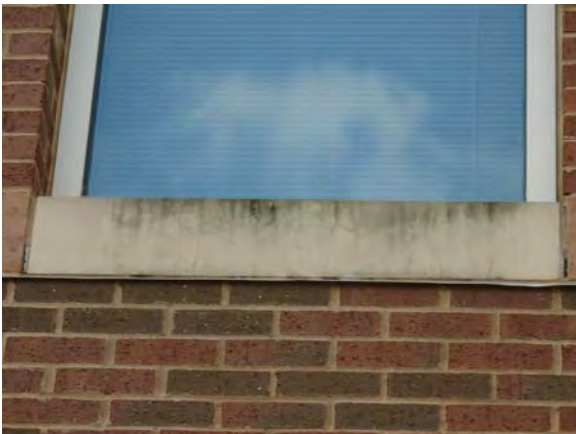
CARD179a 11/6/2018
Brick masonry exterior, dual-pane windows, and metal
standing seam roof
Southeast exterior

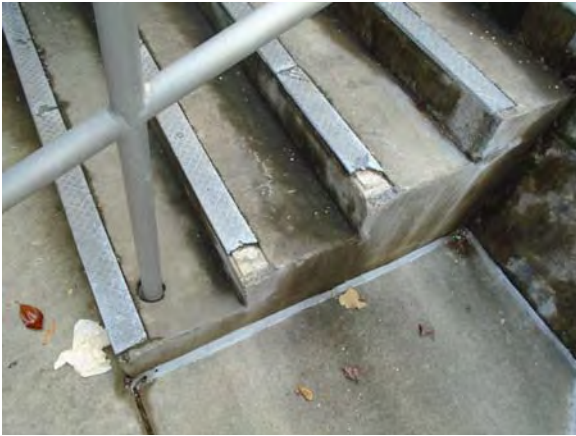
CARD183a 11/6/2018
Handrails on exterior steps to loading dock
Southeast exterior

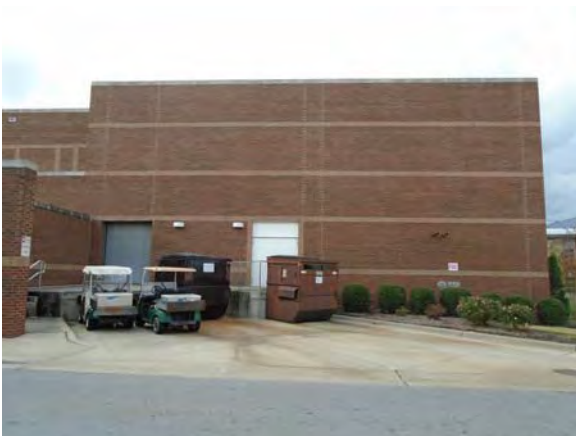
CARD185a 11/6/2018
Brick masonry exterior, dual-pane windows, and metal
standing seam roof
Southeast exterior

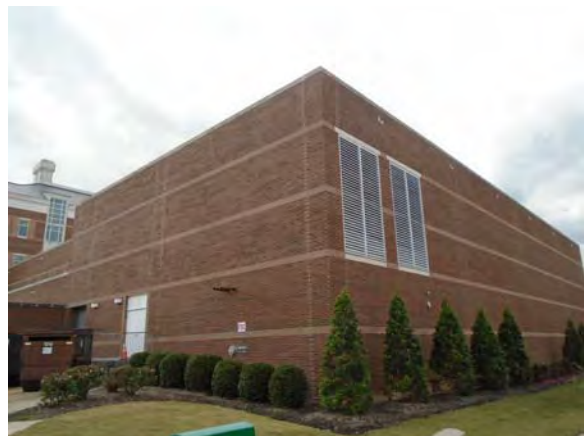
CARD186a 11/6/2018
Brick masonry exterior, overhead service door, and metal
personnel doors
Southeast exterior
