EAST CAROLINA UNIVERSITY

Facility Condition Assessment

Family Medicine Center

Inspected May 11, 2021

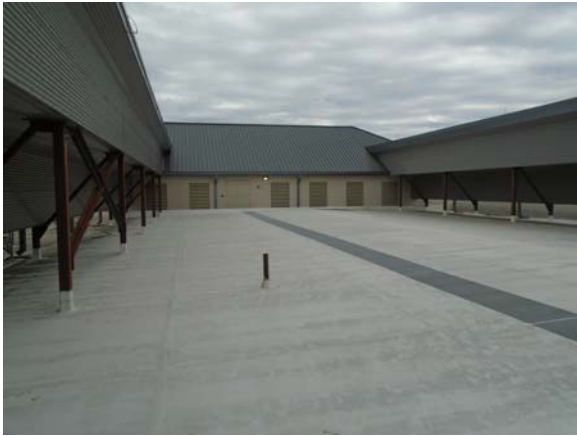
255001a 5/11/2021
Single-ply membrane roof
Center roof area

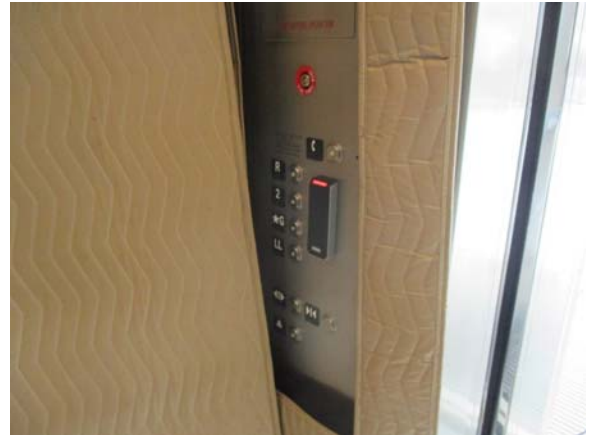
255001e 5/11/2021
Elevator control panel inside the service elevator
Service elevator cab

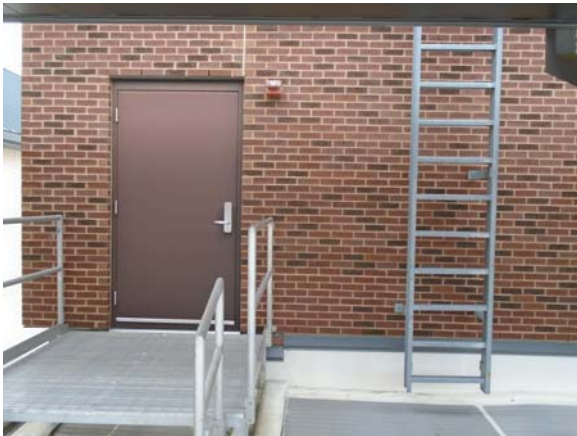
255002a 5/11/2021
Roof service door
Center roof area

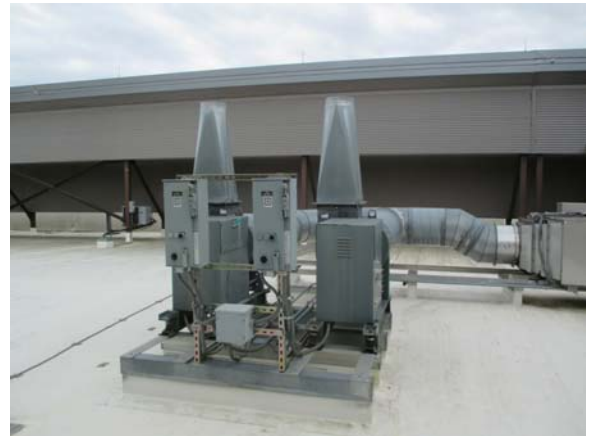
255002e 5/11/2021
5 hp exhaust fans EF-1A and EF-1B
Center roof

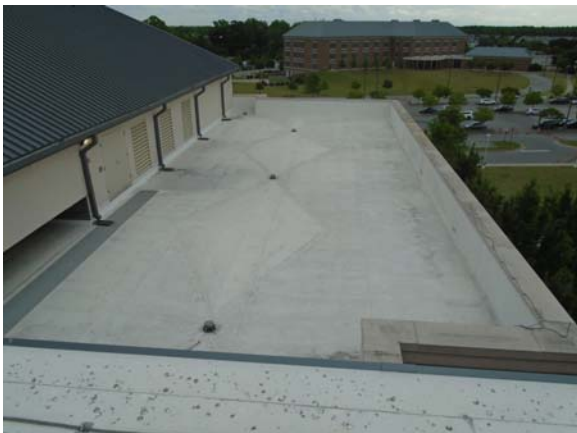
255003a 5/11/2021
Single-ply membrane roof
Northeast roof

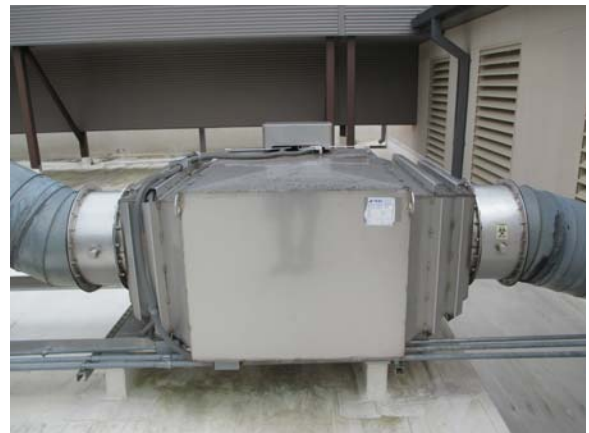
255003e 5/11/2021
HEPA filter connected to EF-1A and EF-1B ductwork
Center roof

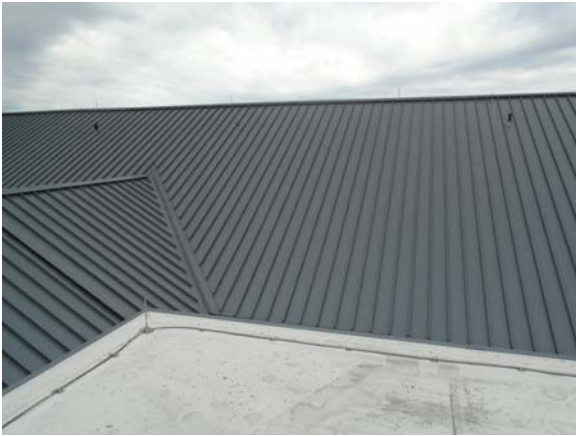
255004a 5/11/2021
Standing seam metal roof
Pitched roof over mechanical penthouse

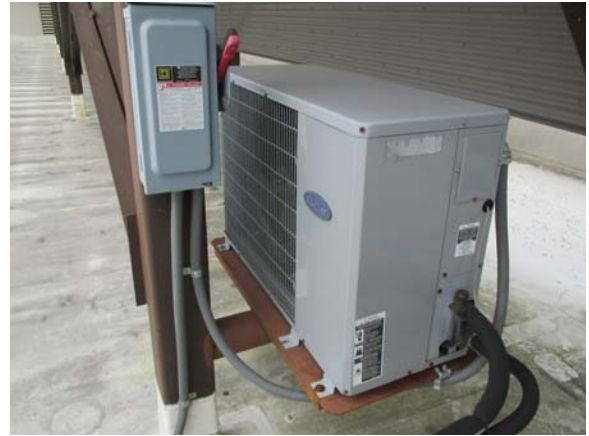
255004e 5/11/2021
1.5 ton Carrier condensing unit
Center roof

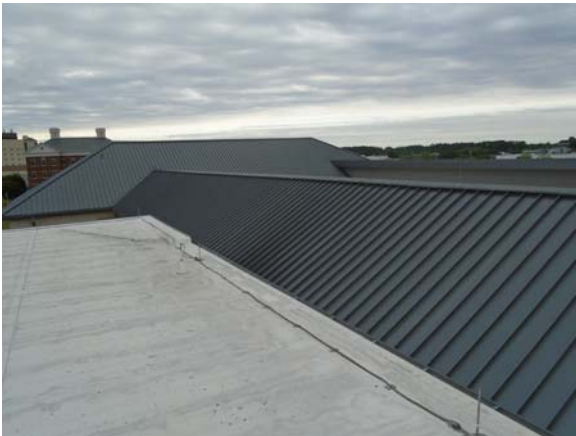
255005a 5/11/2021
Standing seam metal roof
Pitched roof over mechanical penthouse

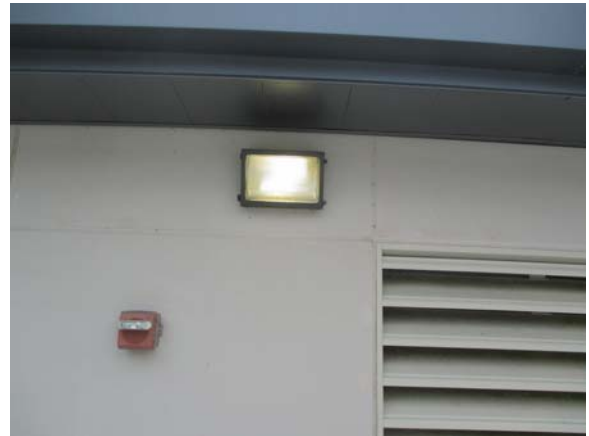
255005e 5/11/2021
Wall-mounted exterior light fixture and audible/visible
fire device
Center roof

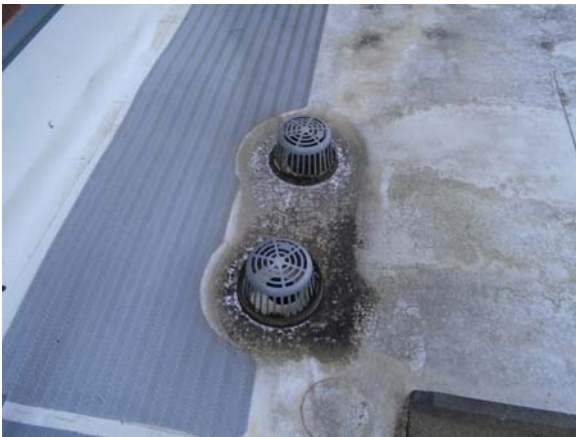
255006a 5/11/2021
Roof drains
Roof

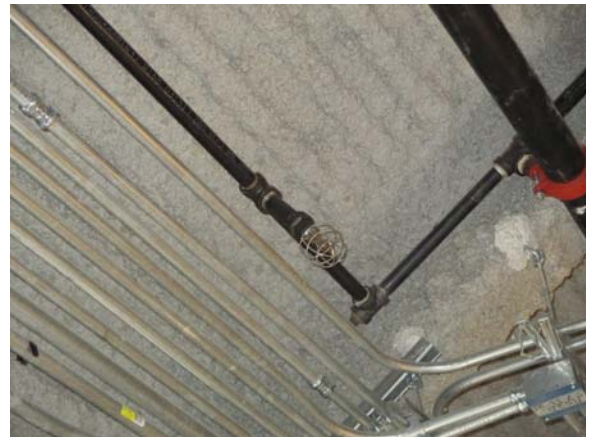
255006e 5/11/2021
Sprinkler head
East penthouse

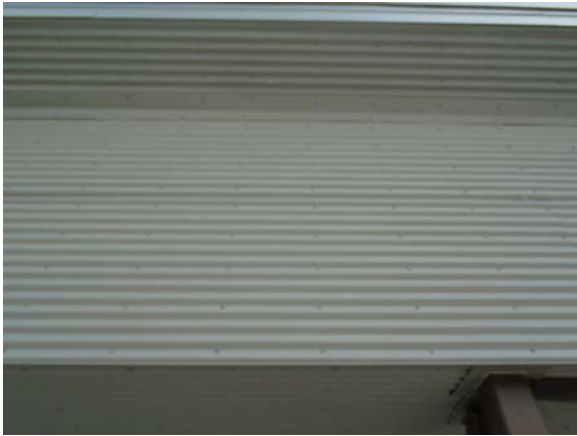
255007a 5/11/2021
Corrugated metal siding
Mechanical penthouse

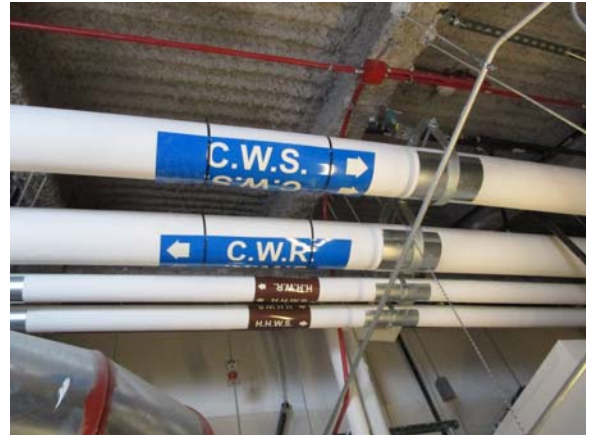
255007e 5/11/2021
Insulated piping with chilled water and heating hot water
East penthouse

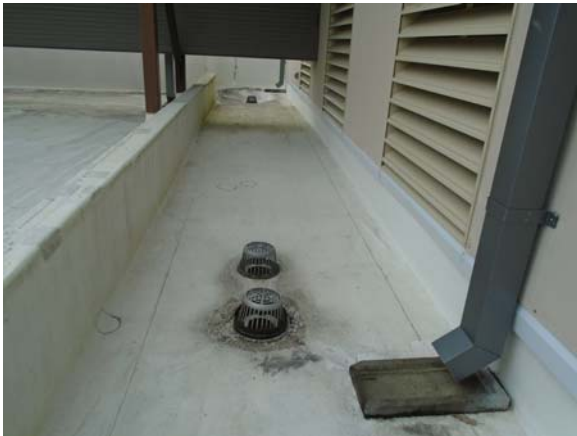
255008a 5/11/2021
Roof drains
Roof

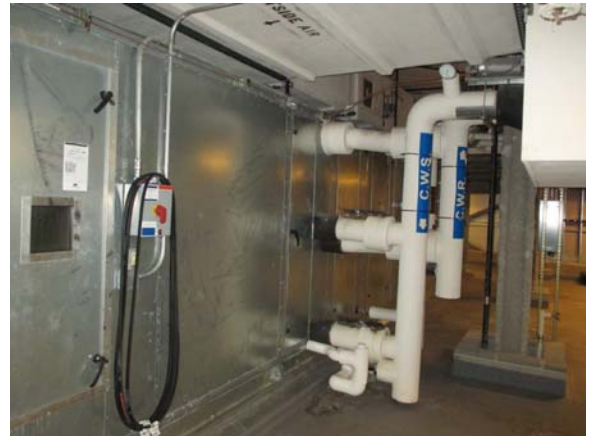
255008e 5/11/2021
Air handling unit AHU-3 with chilled water piping
East penthouse

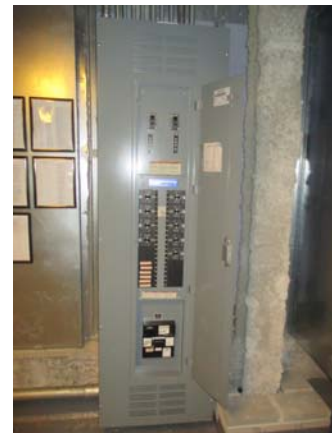
255009e 5/11/2021
Square D secondary electrical panel
East penthouse

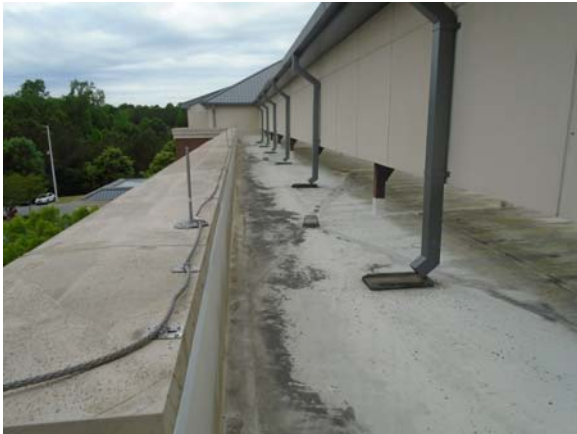
stormwater runoff from the upper pitched metal roofs have loosened the downspouts from the penthouse exterior wall. Repair these as necessary to eliminate the potential damage that an exterior leak may cause.

255010a 5/11/2021
Parapet wall and downspouts and drains
Roof

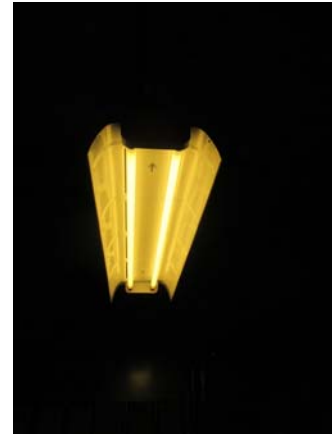
255010e 5/11/2021
Pendant fluorescent light fixture
East penthouse

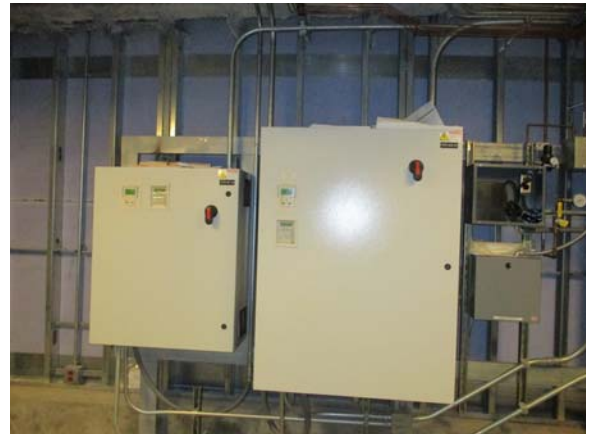
255011e 5/11/2021
Two variable frequency drives for AHU-3 supply and
return fans
East penthouse

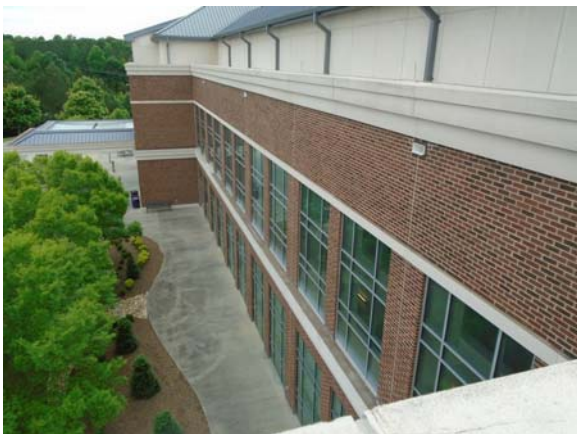
255012a 5/11/2021
Brick masonry exterior, dual-pane windows
South exterior

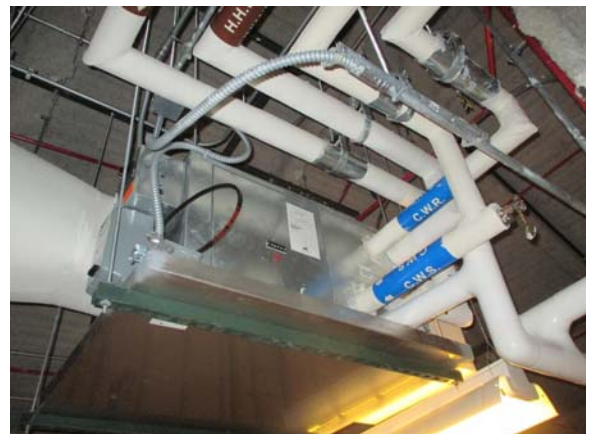
255012e 5/11/2021
Fan coil unit FCU-P-5 provides cooling and heating to the
penthouse
East penthouse

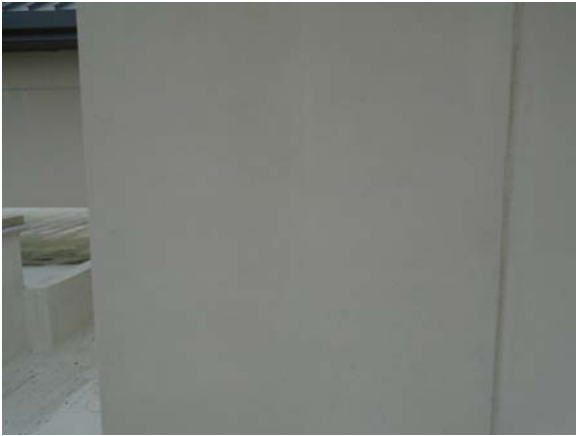
255013a 5/11/2021
Prefab exterior panels
Mechanical penthouse

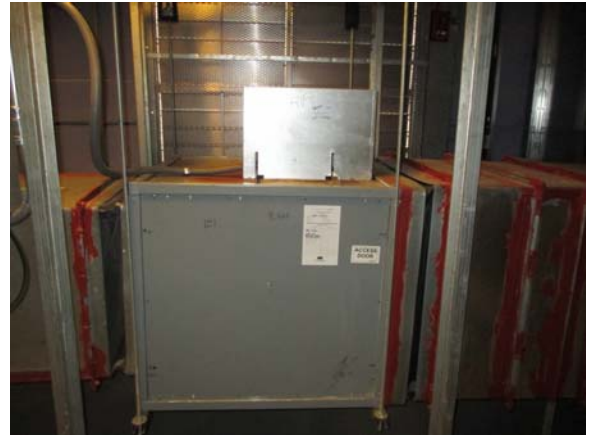
255013e 5/11/2021
5 hp exhaust fan EF-4
East penthouse

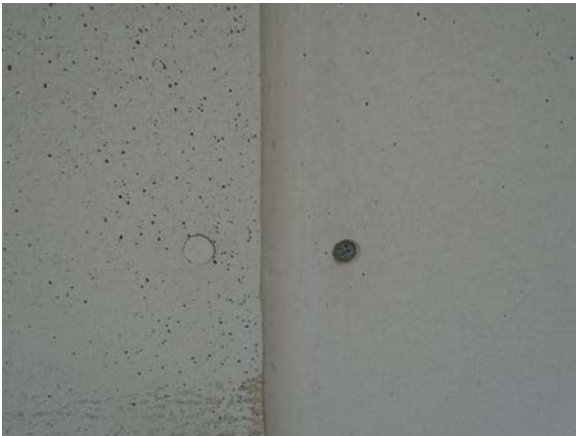
The brick veneer exterior walls are in good condition and require no repairs at this time. The EIFS accents, however, have become damaged due to exposure and cracking. Some of the EIFS mounting screws have corroded and stained the exterior. The EIFS will need some refinishing and resealing to restore a satisfactory aesthetic.

255014a 5/11/2021
Screws visible in panels
Mechanical penthouse

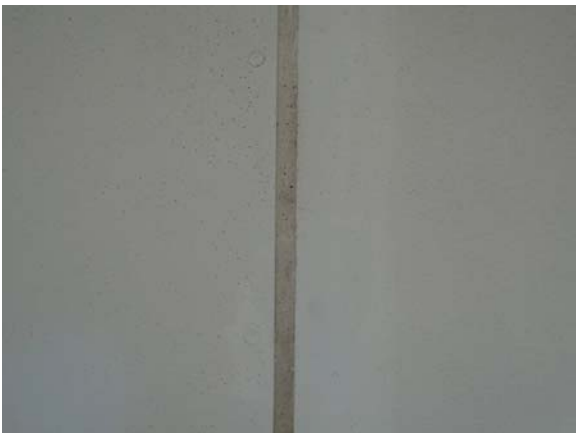
255015a 5/11/2021
Caulked joint with adjacent screws
Mechanical penthouse

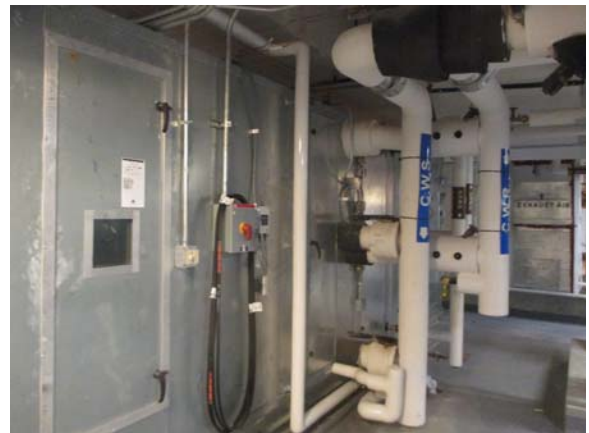
255015e 5/11/2021
Air handling unit AHU-5 with chilled water piping
East penthouse

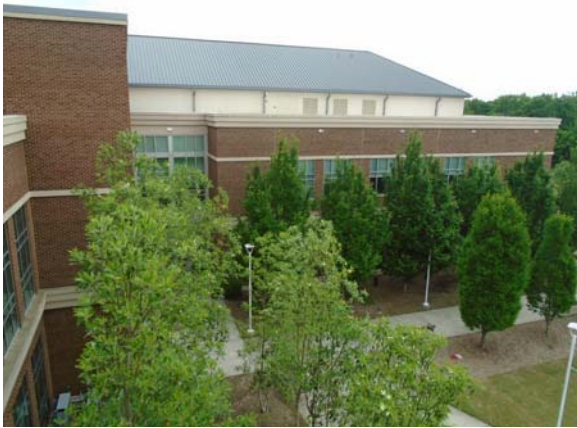
255016a 5/11/2021
Brick masonry, dual-pane windows, and paneled
penthouse
Northeast exterior

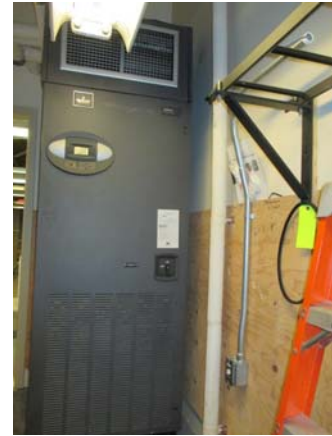
255016e 5/11/2021
Liebert computer room AC unit AHU-9 provides cooling
for data/telecom room
East penthouse

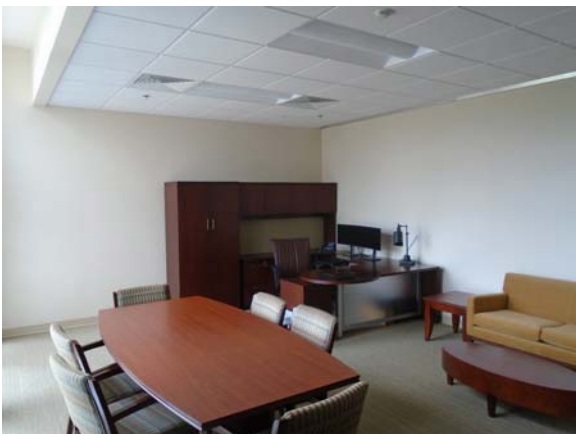
255039a 5/11/2021
Carpeting, painted walls, and suspended grid ceiling
Director's office 2419C

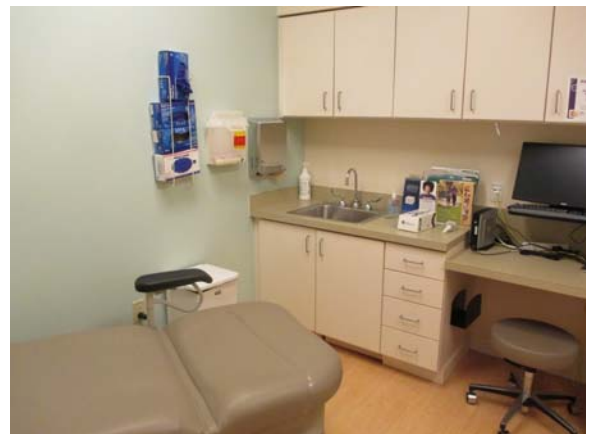
255039e 5/11/2021
Typical exam room bed and sink
Room 1412C

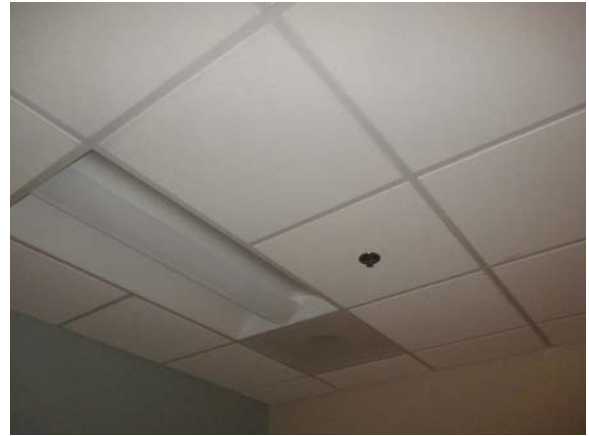
255040e 5/11/2021
2x4 fluorescent light fixture in typical exam room
Room 1412C

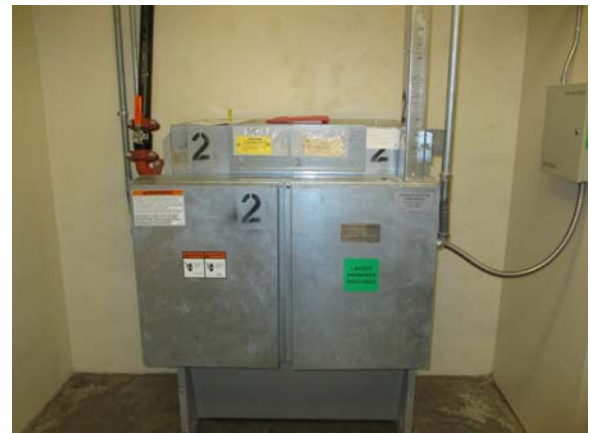
255045e 5/11/2021
Hydraulic pump and controls for one of the Schindler
passenger elevators
Room L910A

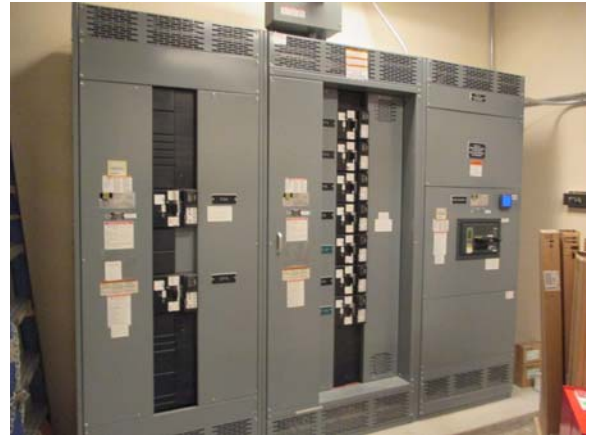
255046e 5/11/2021
Square D 2,000 amp main distribution panel
Room L906B

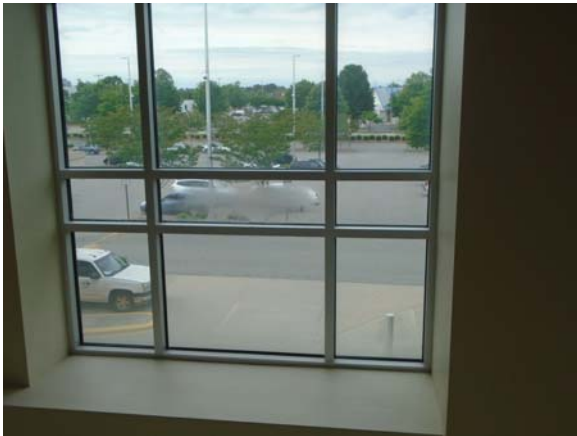
255047a 5/11/2021
Window condensation due to loss of seal
Second floor

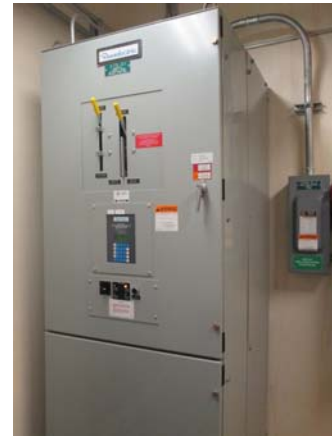
255047e 5/11/2021
Russelectric 600 amp automatic transfer switch ATS-G1
Room L907B

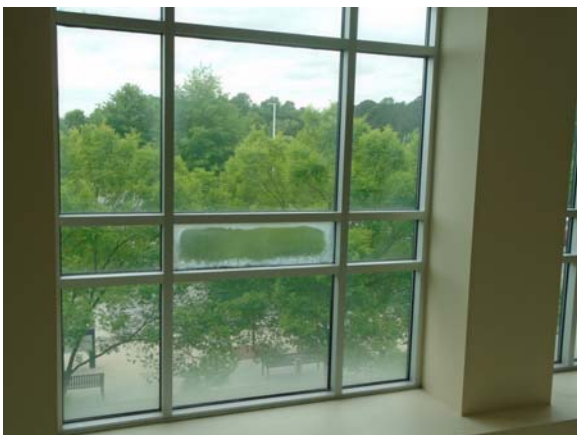
255048a 5/11/2021
Window condensation due to loss of seal
Second floor

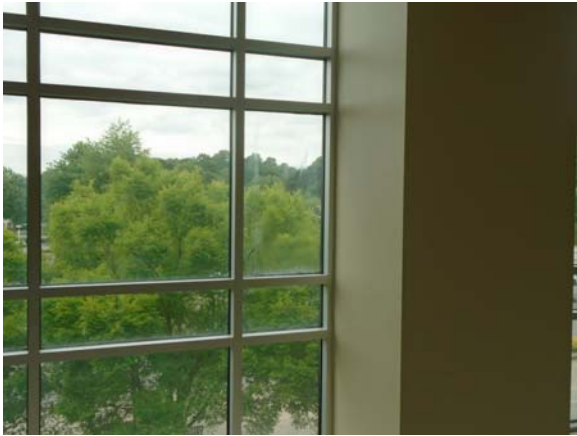
255049a 5/11/2021
Window condensation due to loss of seal
Second floor

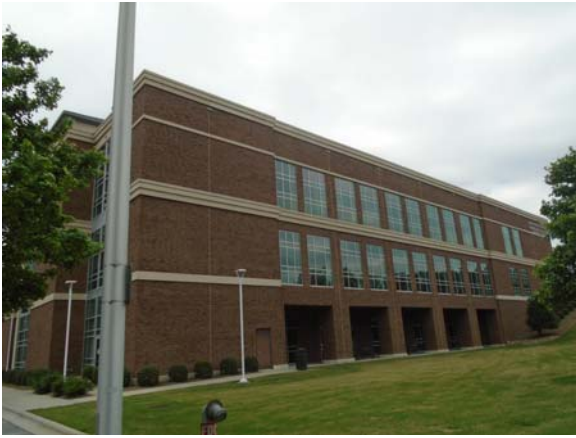
255124a 5/11/2021
Brick masonry, dual-pane windows, and EIFS accents
West exterior

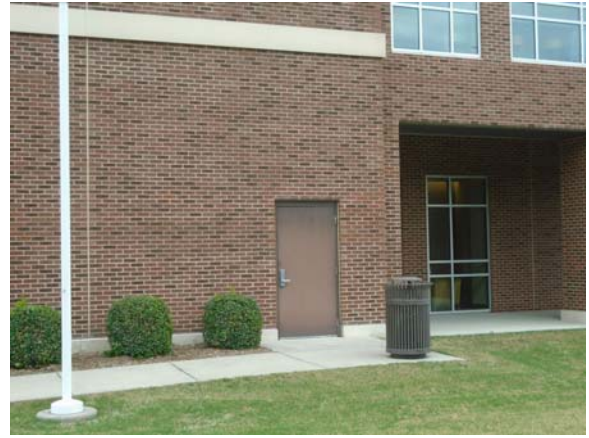
255125a 5/11/2021
Brick masonry, dual-pane windows, and EIFS accents
West exterior

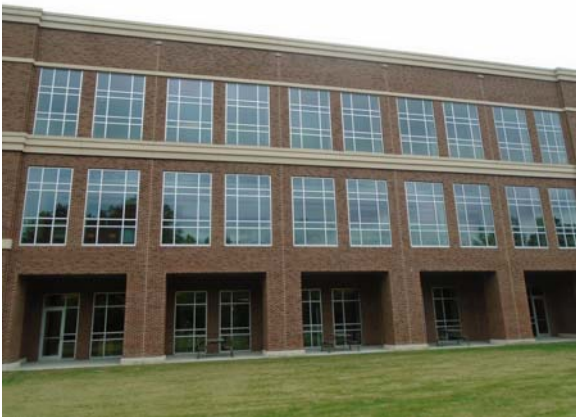
255126a 5/11/2021
Brick masonry, dual-pane windows, and EIFS accents
West exterior

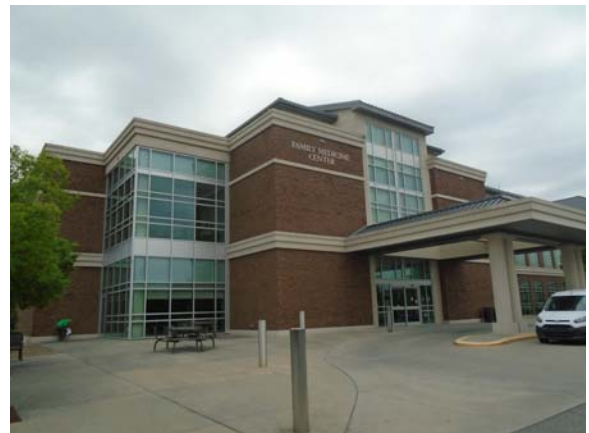
255129a 5/11/2021
Brick masonry, dual-pane windows, and EIFS accents
Southwest corner

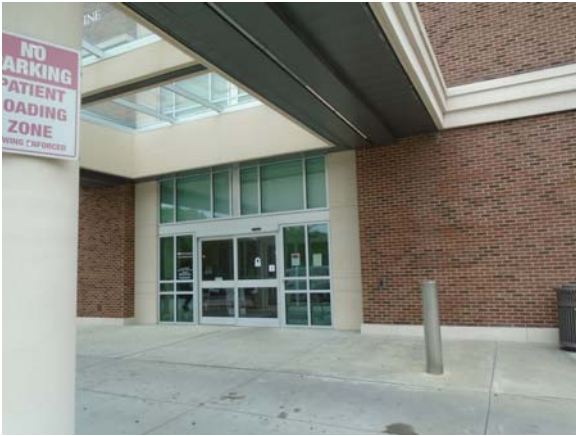
255130a 5/11/2021
Dual double glass airlock door system
Southwest entry

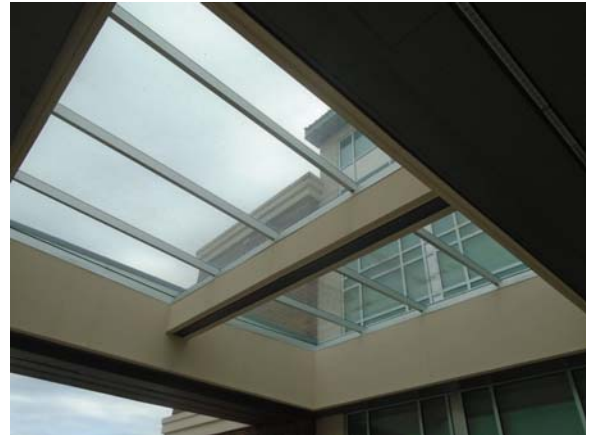
255131a 5/11/2021
Glassed skylights over entry canopies
Ground level entries

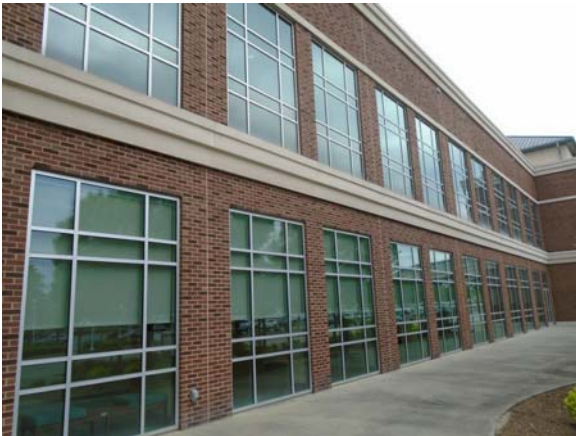
255132a 5/11/2021
Brick masonry, dual-pane windows, and EIFS accents
South exterior

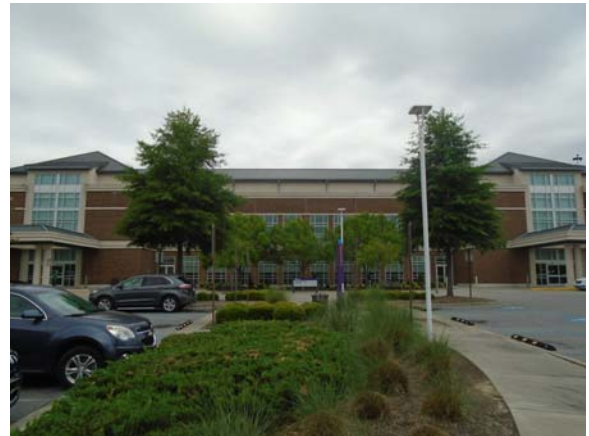
255133a 5/11/2021
Brick masonry, dual-pane windows, and EIFS accents
South exterior

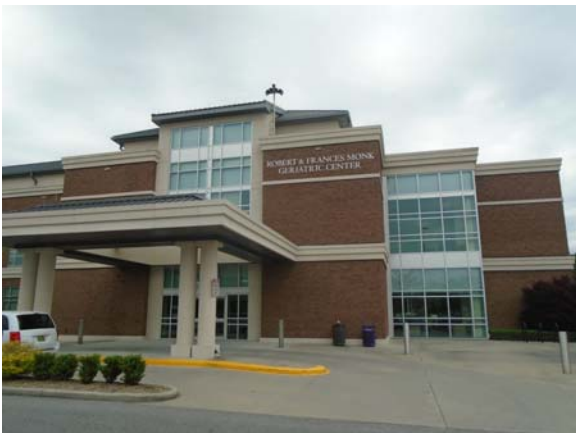
255134a 5/11/2021
Brick masonry, dual-pane windows, and EIFS accents
Southeast corner

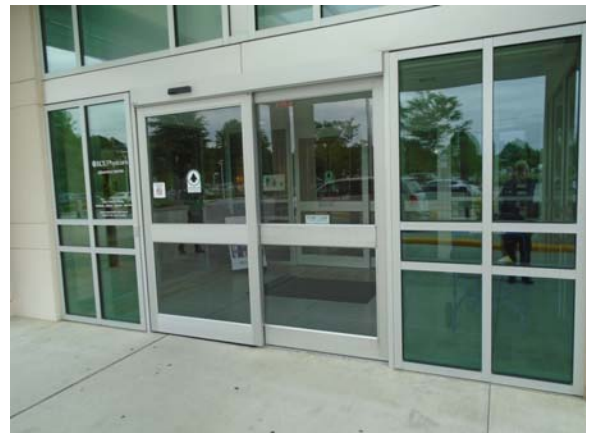
255135a 5/11/2021
Dual double glass airlock door system
Southeast entry

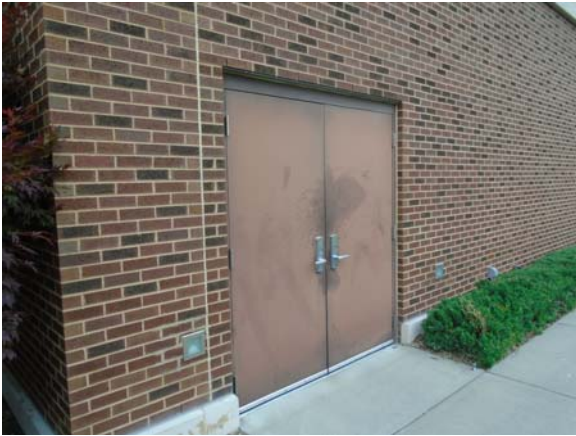
255136a 5/11/2021
Hollow metal service doors
East exterior

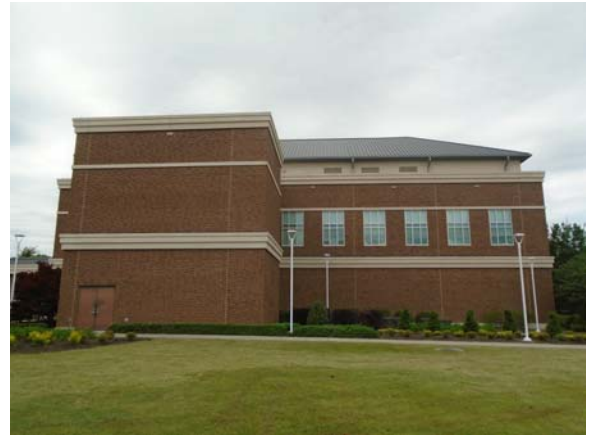
255137a 5/11/2021
Brick masonry, dual-pane windows, and EIFS accents
East exterior

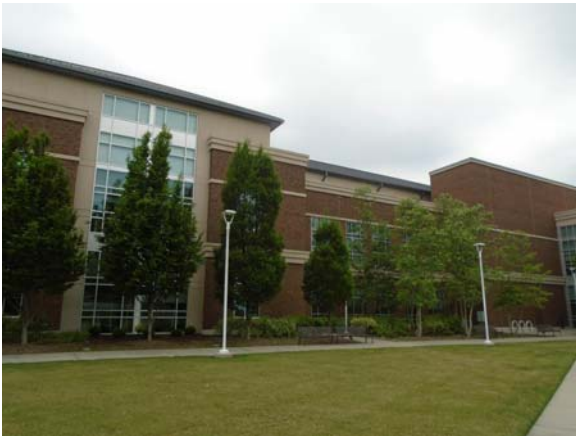
255138a 5/11/2021
Brick masonry, dual-pane windows, and EIFS accents
East exterior

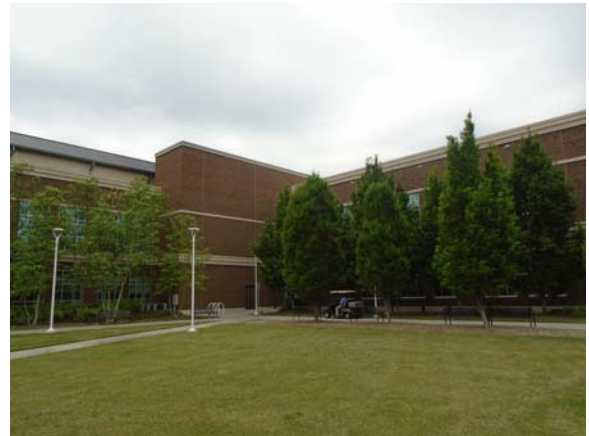
255139a 5/11/2021
Brick masonry, dual-pane windows, and EIFS accents
East exterior

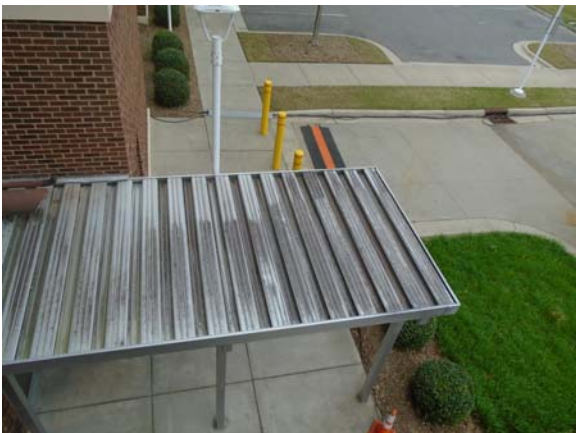
255140a 5/11/2021
Metal canopy
North entry
