EAST CAROLINA UNIVERSITY

Facility Condition Assessment

Allied Health Sciences Building
Asset AHSB

Inspected April 20, 2016

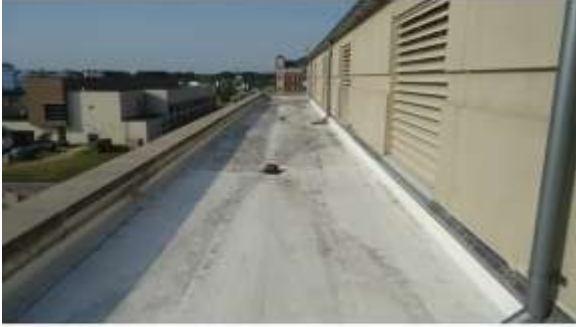
AHSB001a 4/20/2016
Single-ply TPO, flat roof
Lower level roof

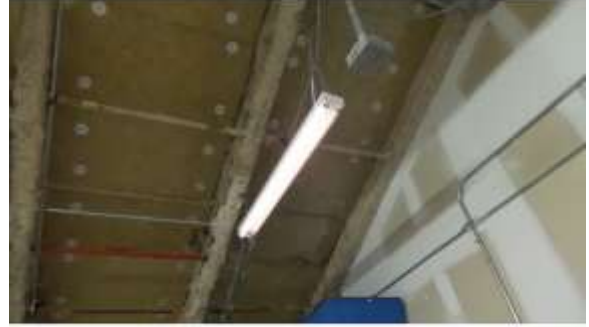
AHSB001e 4/20/2016
Interior light fixture
East penthouse

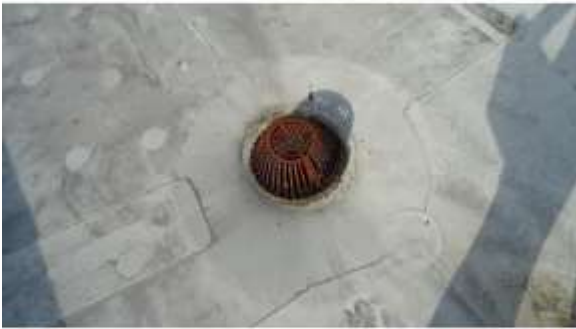
AHSB002a 4/20/2016
Single-ply TPO, flat roof with drain
Mid level roof

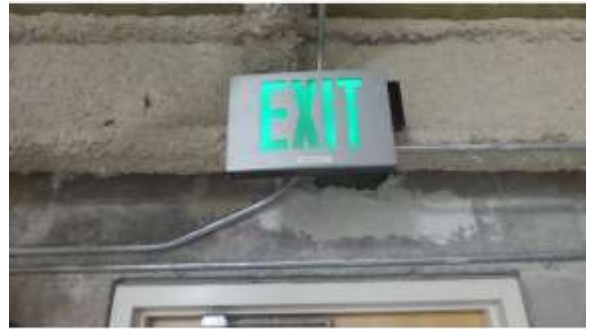
AHSB002e 4/20/2016
Typical exit signage
East penthouse

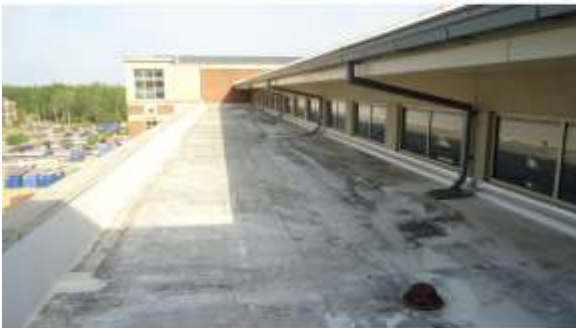
AHSB003a 4/20/2016
Single-ply TPO, flat roof and pitched standing seam metal
roof
Upper level roof

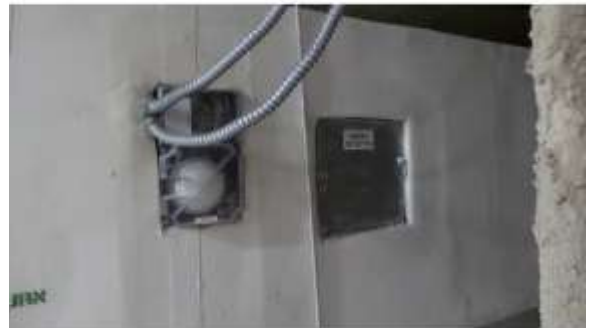
AHSB003e 4/20/2016
Duct-mounted smoke detector
East penthouse

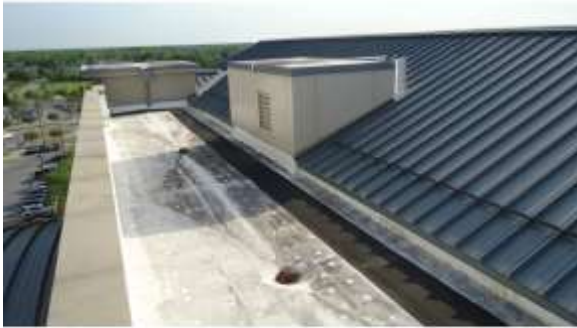
AHSB004a 4/20/2016
Single-ply TPO, flat roof and pitched standing seam metal
roof
Upper level roof

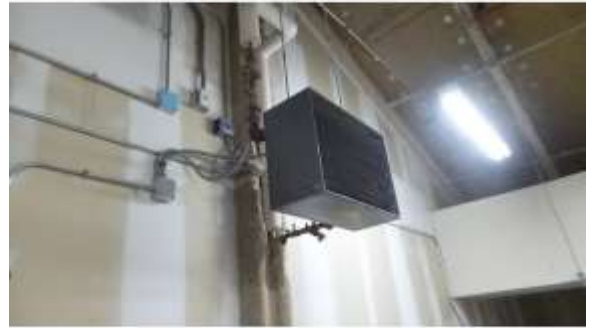
AHSB004e 4/20/2016
Hydronic unit heater
East penthouse

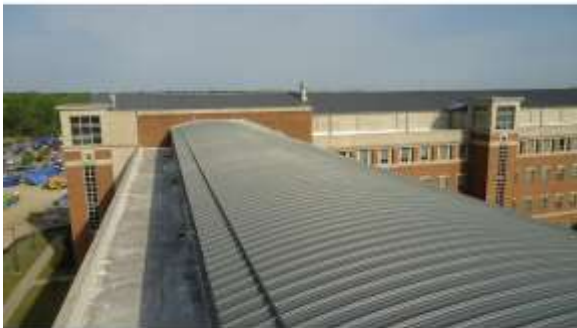
AHSB005a 4/20/2016
Pitched standing seam metal roof
Upper level roof

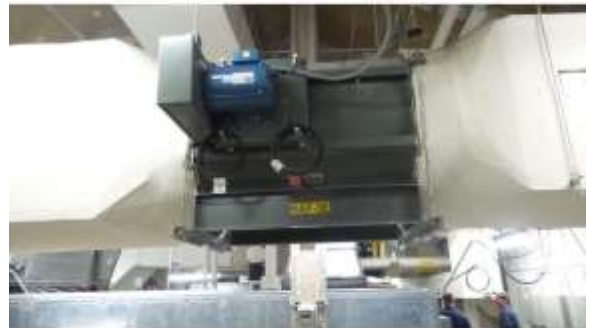
AHSB005e 4/20/2016
Inline return air fan RAF-3E
East penthouse

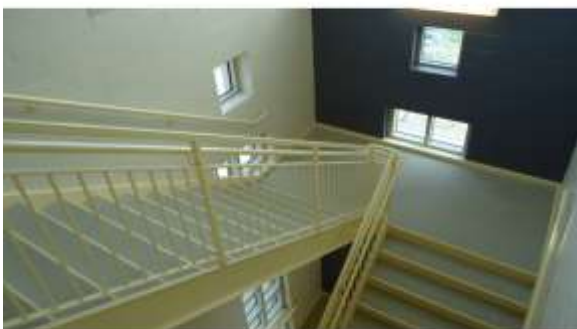
AHSB006a 4/20/2016
Typical stairwell with compliant handrails and
guardrailing
Stairwell

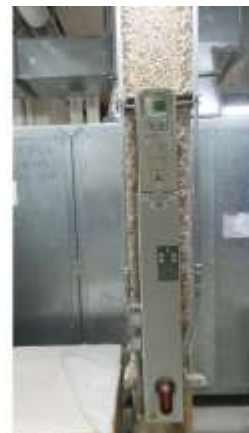
AHSB006e 4/20/2016
Variable frequency drive AHU-3E
East penthouse

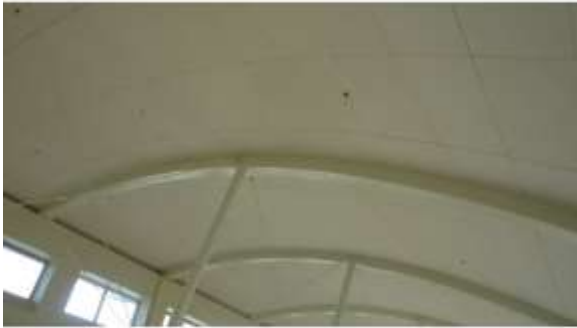
AHSB007a 4/20/2016
Adhered acoustical tile ceiling
Library

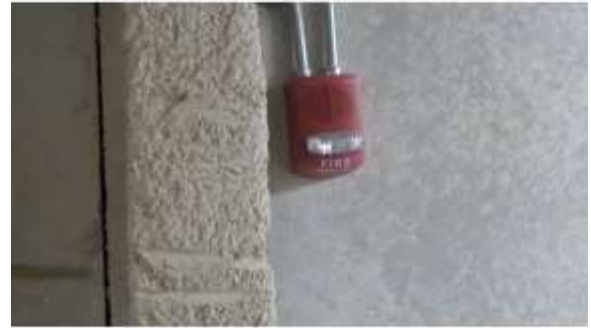
AHSB007e 4/20/2016
Fire alarm system device with visual and audible
annunciation
East penthouse

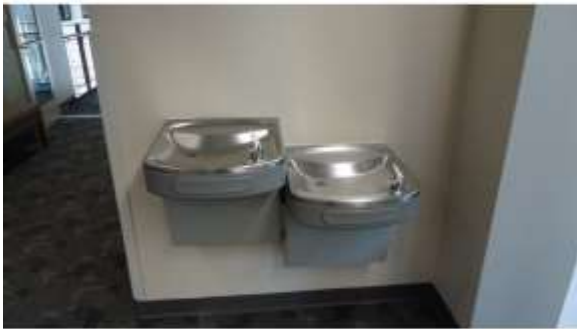
AHSB008a 4/20/2016
Compliant dual-level drinking fountain
Fourth floor

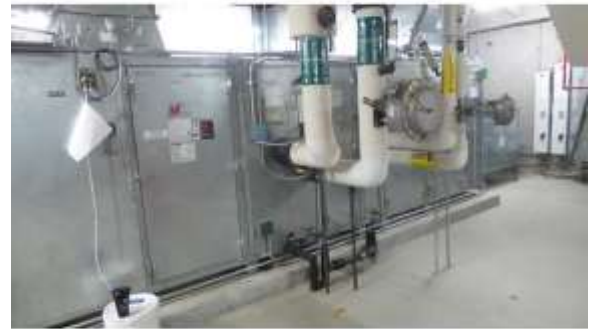
AHSB008e 4/20/2016
Air handler AHU-3E
East penthouse

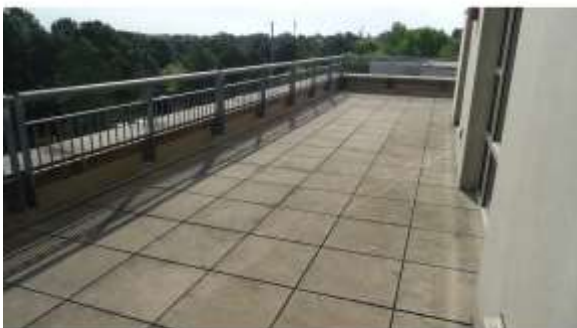
AHSB009a 4/20/2016
Exterior patio/roof
Fourth floor

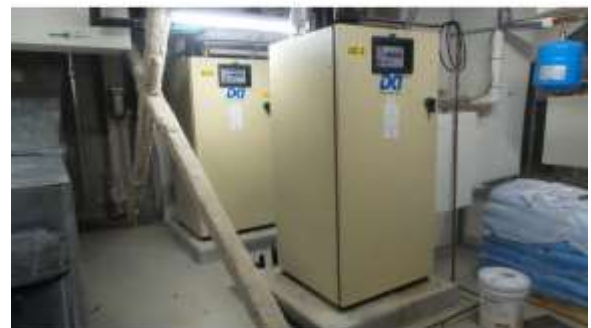
AHSB009e 4/20/2016
18 ton computer room air conditioner
East penthouse

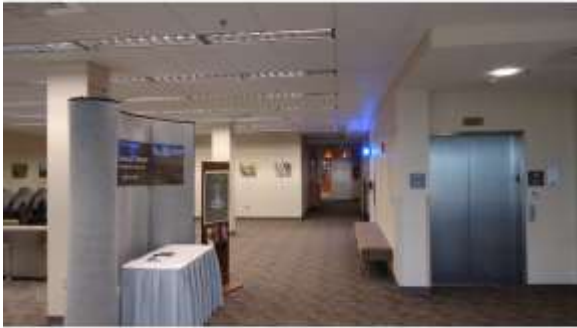
AHSB010a 4/20/2016
Suspended grid acoustical tile ceilings, painted walls, and
carpeted floors
Fourth floor

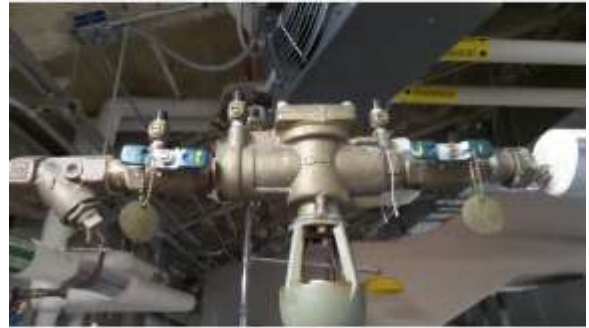
AHSB010e 4/20/2016
One-inch backflow preventer
East penthouse

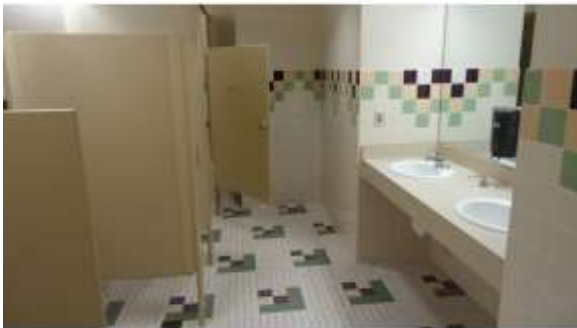
AHSB011a 4/20/2016
Ceramic tiled lower walls and floors and accessible
fixtures
Typical restrooms

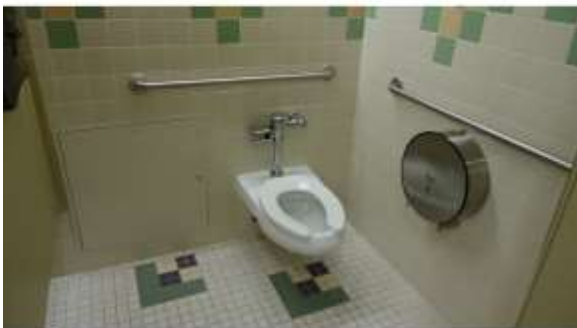
AHSB012a 4/20/2016
Ceramic tiled lower walls and floors and accessible
fixtures
Typical restrooms

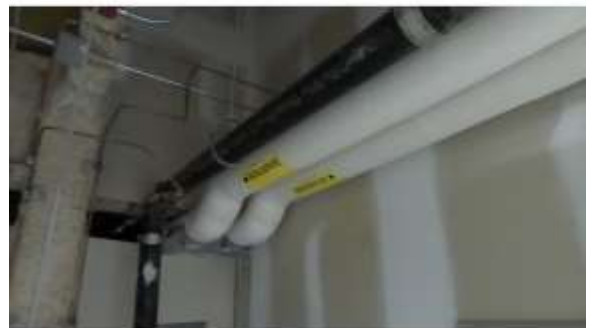
AHSB012e 4/20/2016
Heating water supply and return and waste water piping
East penthouse

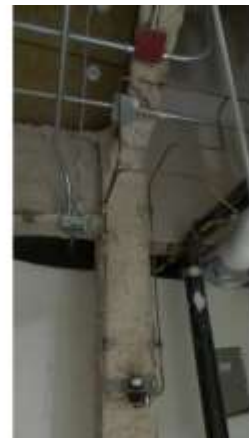
AHSB013e 4/20/2016
Pneumatic control system piping
East penthouse

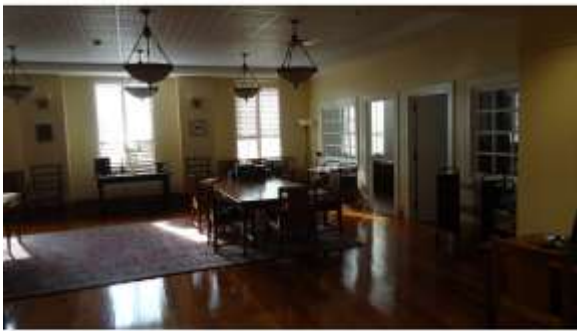
AHSB014a 4/20/2016
Heart of pine floors, replica tin ceiling panels, and
chandeliers
Historic Collections Reading Room

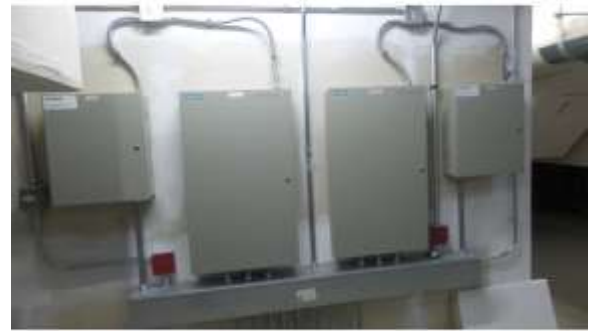
AHSB014e 4/20/2016
Various direct digital and pneumatic control panels
East penthouse

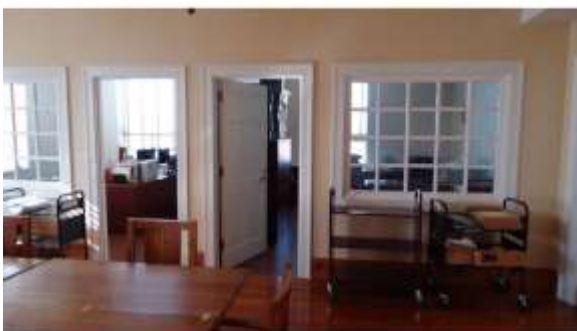
AHSB015a 4/20/2016
Heart of pine floors, painted walls, and fire rated glazing
Historic Collections Reading room

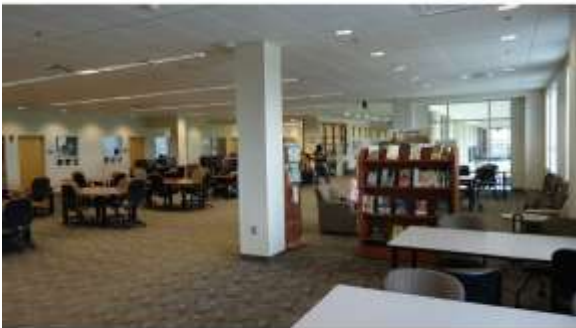
AHSB020e 4/20/2016
Recessed, 2x4 foot fluorescent lighting with T8 lamps
Room 4508

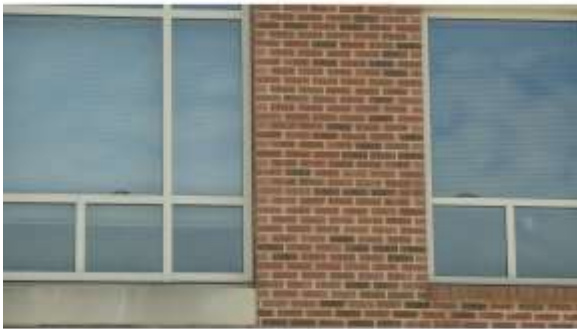
AHSB073a 4/20/2016
Rubber gasket seal coming out in interior
West elevation, A wing

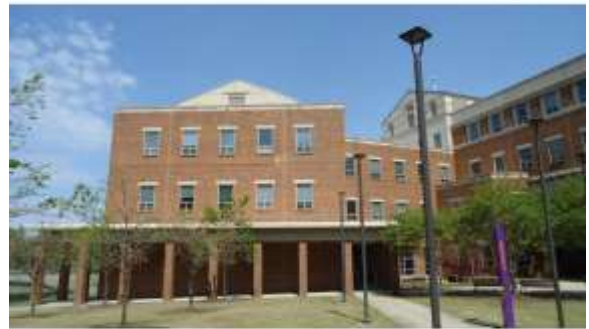
AHSB074a 4/20/2016
Brick masonry, dual-pane or tempered glazing, and
standing seam metal roof
East elevation, A wing

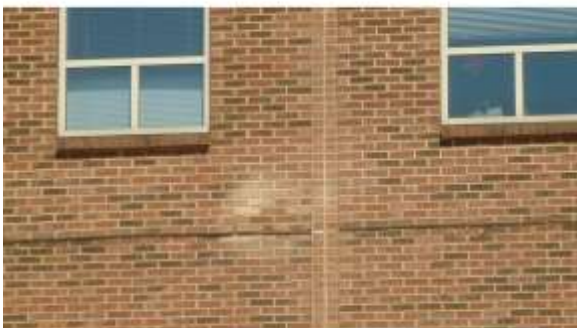
AHSB075a 4/20/2016
Deficient exterior brick masonry and a previous repair
Exterior envelope

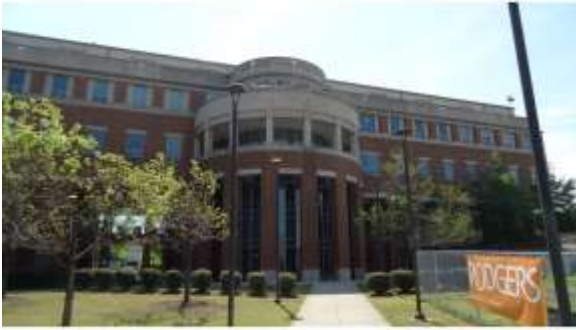
AHSB077a 4/20/2016
Brick masonry, dual-pane or tempered glazing, and
standing seam metal roof
West elevation, D wing

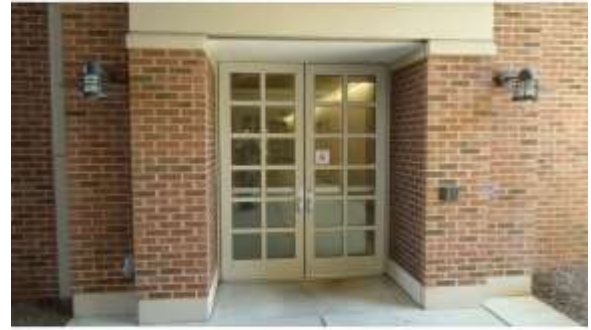
AHSB078a 4/20/2016
Aluminum-framed glass entrance doors
Exterior envelope

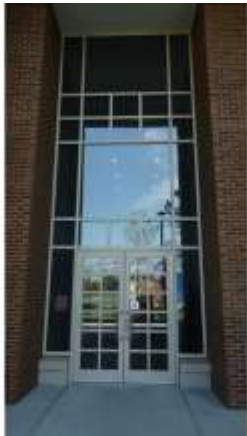
AHSB079a 4/20/2016
Aluminum-framed glass entrance doors
Exterior envelope

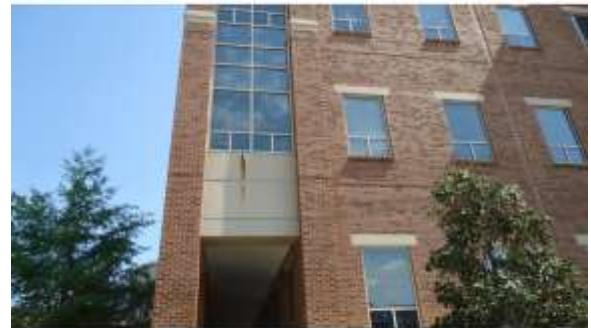
AHSB080a 4/20/2016
Corrosion stain on exterior concrete veneer
Exterior envelope

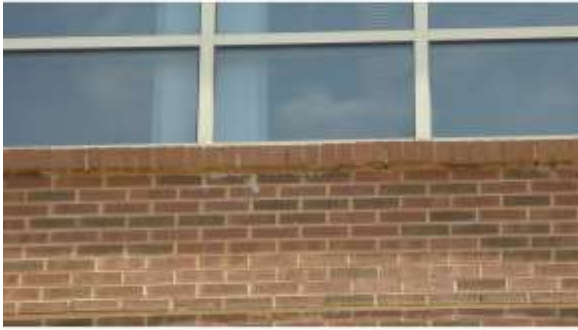
AHSB083a 4/20/2016
Deficient exterior brick masonry and a previous weep
repair
Exterior envelope

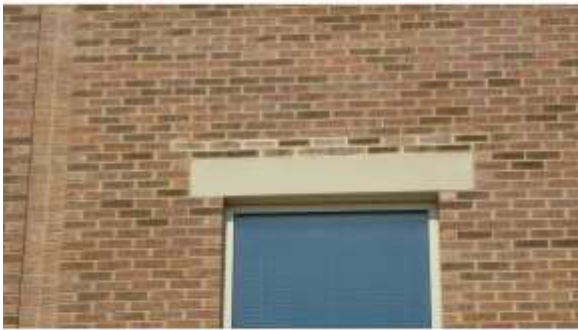
AHSB085a 4/20/2016
Deficient exterior brick masonry and a previous repair
Exterior envelope
