EAST CAROLINA UNIVERSITY

Facility Condition Assessment

Ross Hall
Asset 256

Inspected May 11, 2021

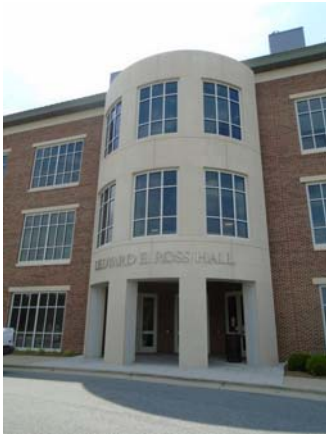
256001a 5/12/2021
Brick masonry exterior with cast concrete accents and
dual-pane windows
Second floor east entry

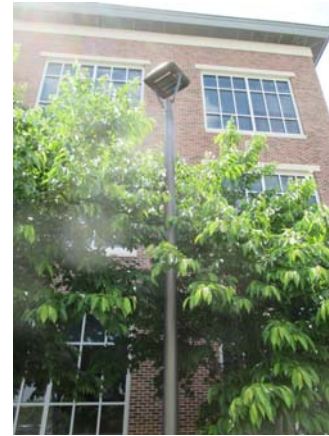
256001e 5/11/2021
LED light fixture on 15 foot stanchion
Northwest exterior

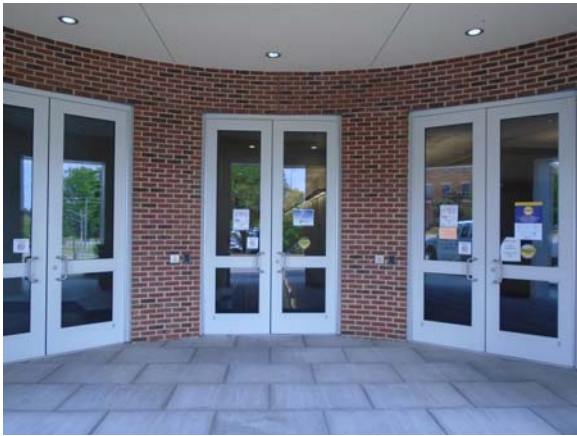
256002a 5/12/2021
Aluminum-framed glass entry doors with power openers
Second floor east entry

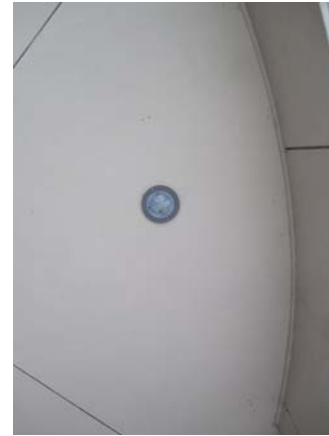
256002e 5/11/2021
Round recessed CFL light fixture
North exterior at second floor entrance

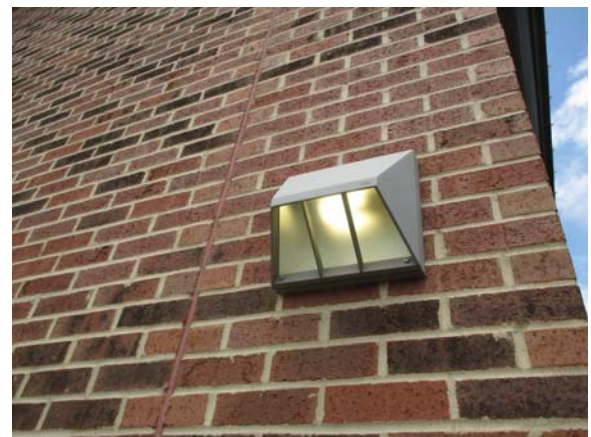
256003e 5/11/2021
Wall-mounted CFL light fixture
West exterior

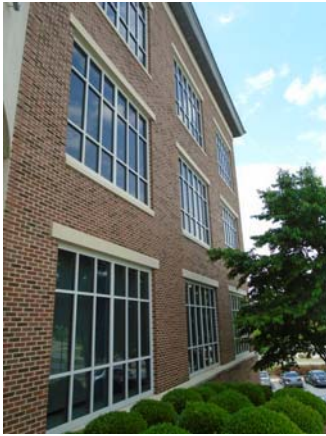
256004a 5/12/2021
Brick masonry exterior with cast concrete accents and
dual-pane windows
East exterior

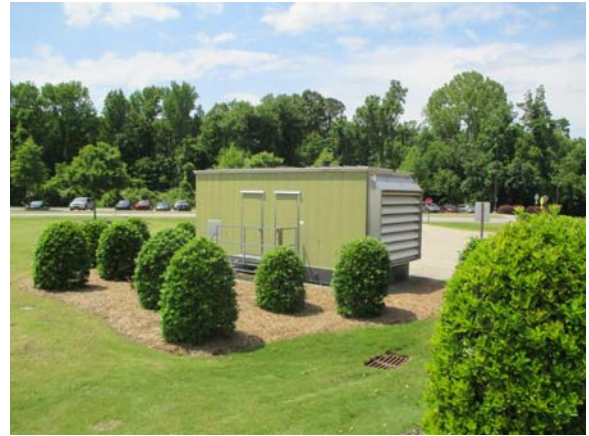
256004e 5/11/2021
750 kW emergency generator
Southwest exterior

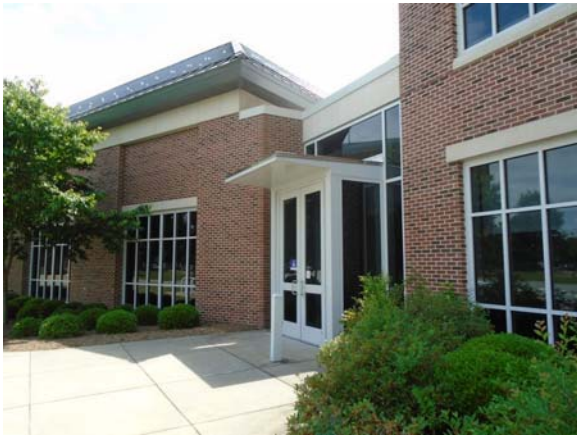
256005a 5/12/2021
Aluminum-framed glass entry doors with power openers
Southeast entry to lecture halls

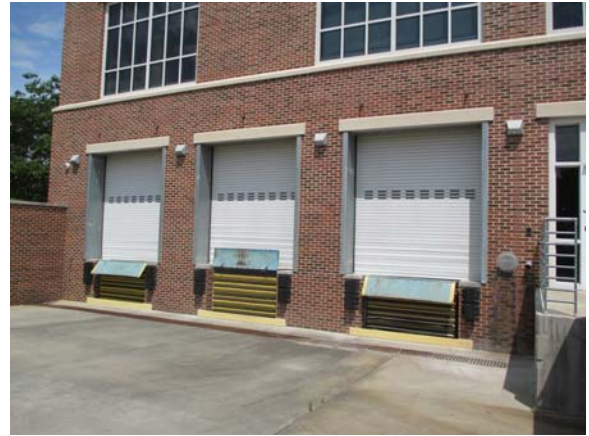
256005e 5/11/2021
Three dock levelers
West loading docks

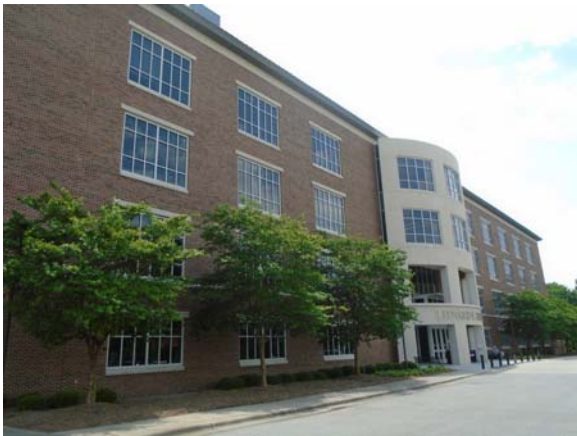
256006a 5/12/2021
Brick masonry exterior with cast concrete accents and
dual-pane windows
East exterior

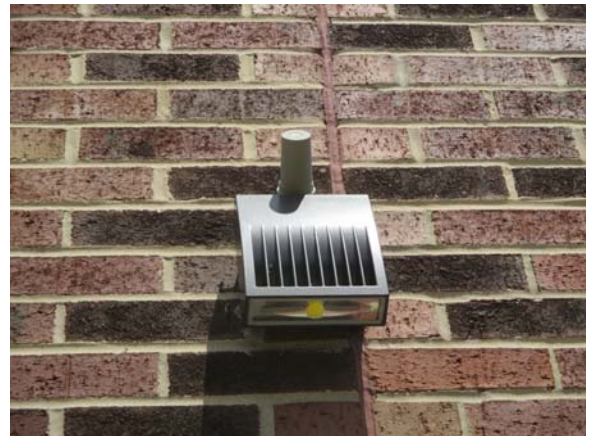
256006e 5/11/2021
Wall-mounted LED light fixture
West exterior

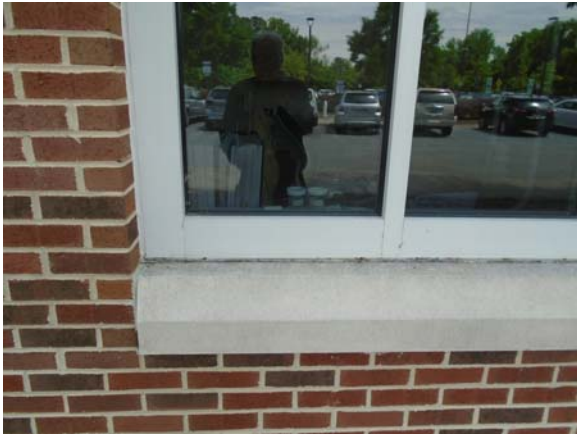
256007a 5/12/2021
Example of adequately caulked window
East exterior

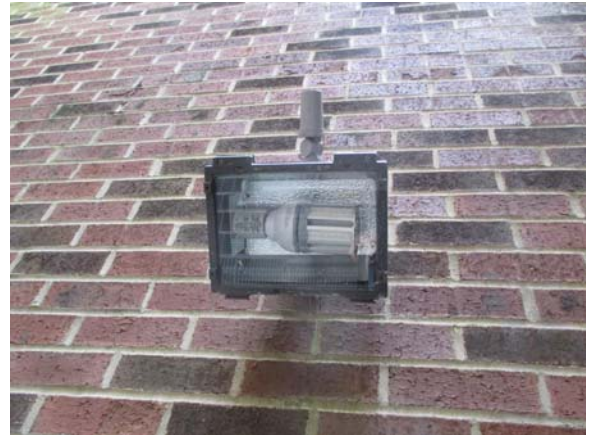
256007e 5/11/2021
Wall-mounted light fixture updated with LED bulb
North exterior (stairwell)

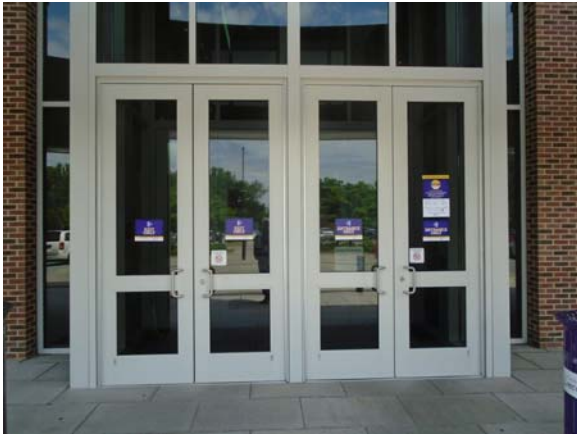
256008a 5/12/2021
Aluminum-framed glass entry doors
North first floor entry

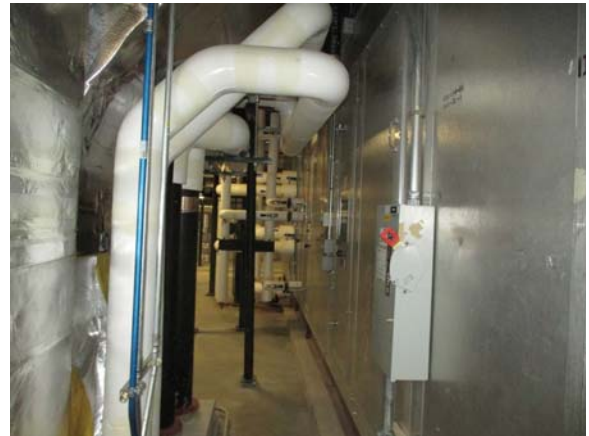
256029e 5/11/2021
Large air handling unit (AHU-CL-1) with chilled water and
heating hot water piping at far end
Penthouse

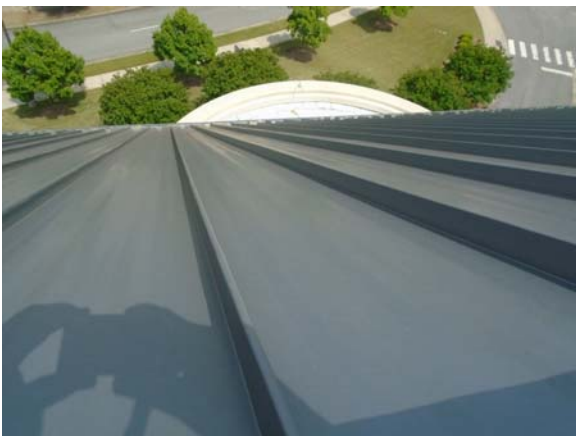
256030a 5/12/2021
Standing seam metal roof
Perimeter pitched roof

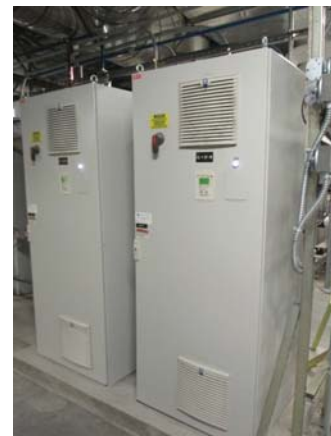
256030e 5/11/2021
Two VFDs for the supply fans (A and B) for AHU-CL-1
Penthouse

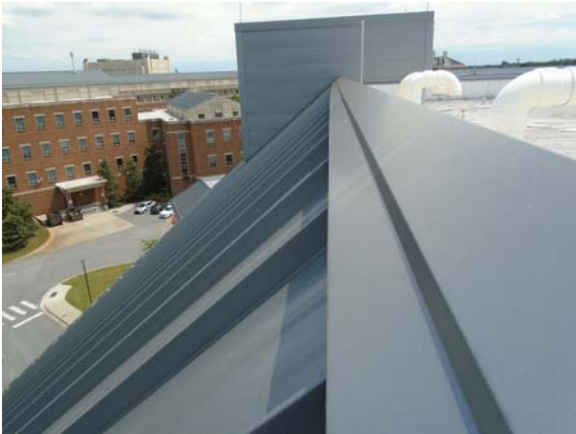
256031a 5/12/2021
Standing seam metal roof
Perimeter pitched roof

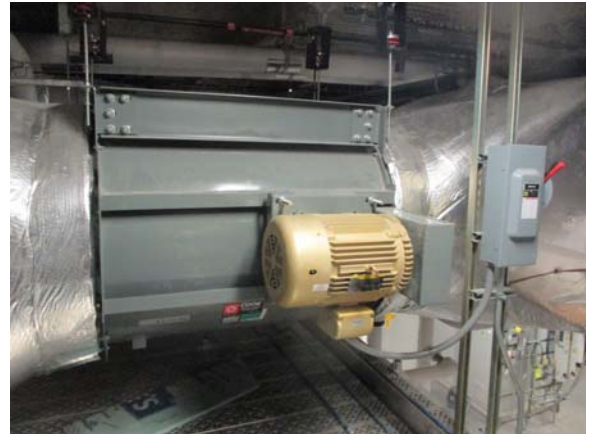
256031e 5/11/2021
One of two 25 hp return fans for AHU-CL-1
Penthouse

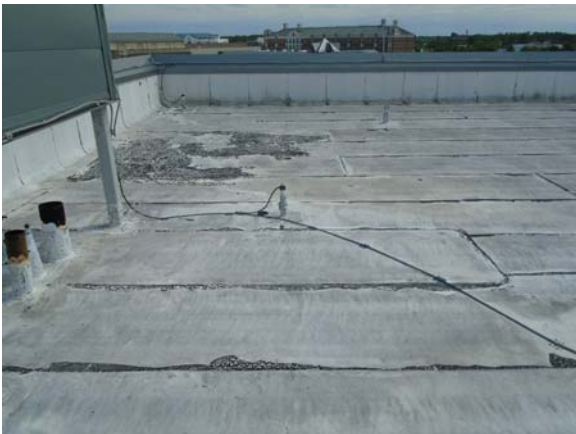
256032a 5/12/2021
Built-up asphalt roofing
Central flat roof

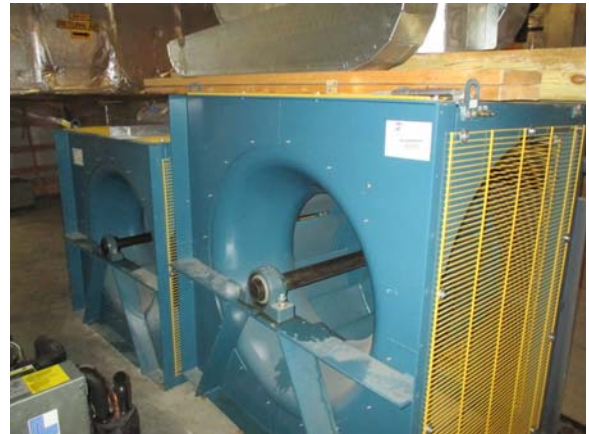
256032e 5/11/2021
Two original fans that were removed from AHU-L-1B
because they were oversized
Penthouse

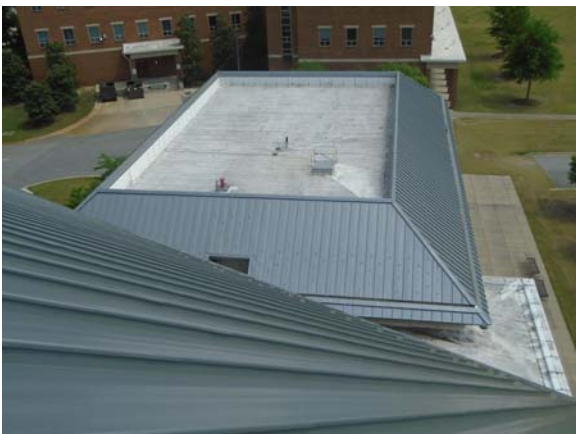
256033a 5/12/2021
Lower roof over the lecture halls
Lower south roof

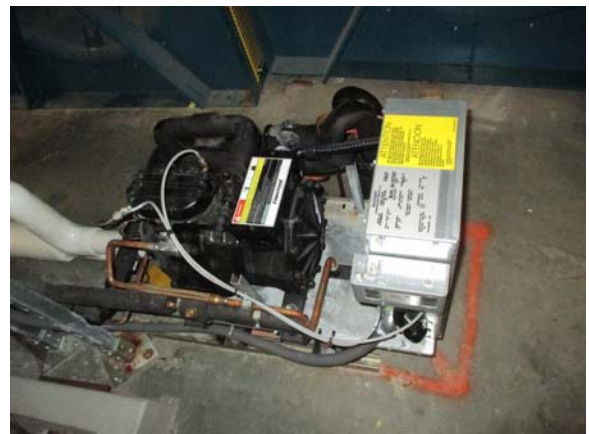
256033e 5/11/2021
Condensing unit for walk-in cold room
Penthouse

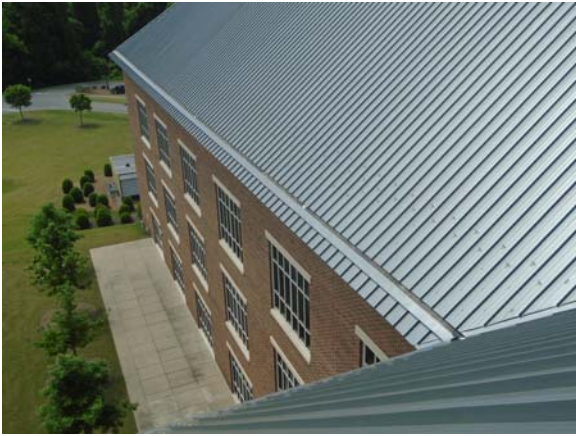
256034a 5/12/2021
Standing seam metal roof
Perimeter pitched roof

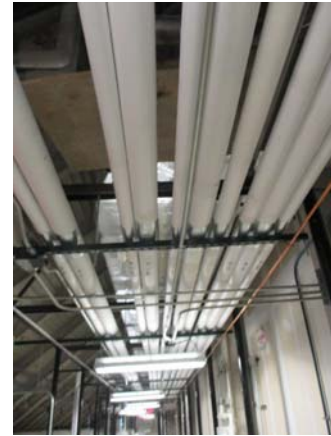
256034e 5/11/2021
Insulated piping running along the penthouse ceiling
Penthouse

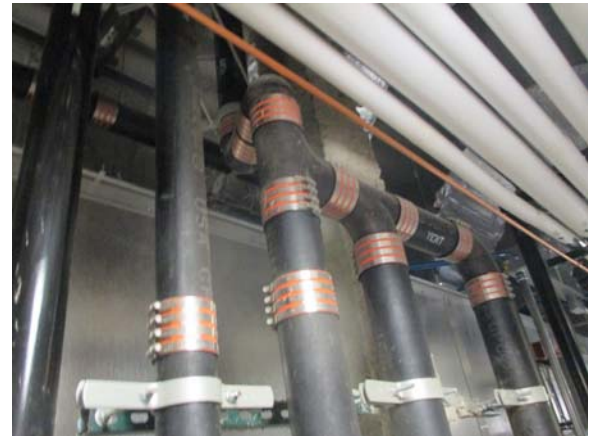
256035e 5/11/2021
No-hub cast-iron drain (vent) piping
Penthouse

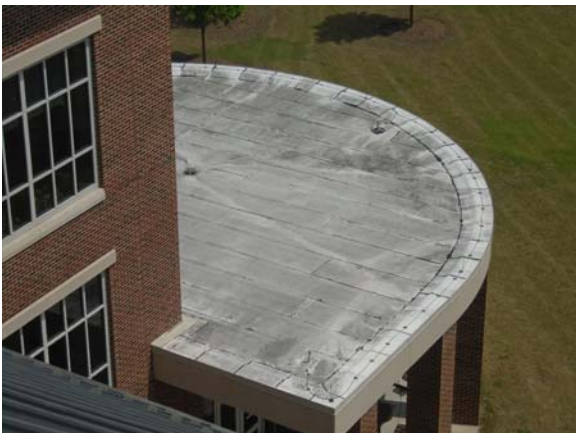
256036a 5/12/2021
Lower flat roof over the southern waiting area
Lower roof

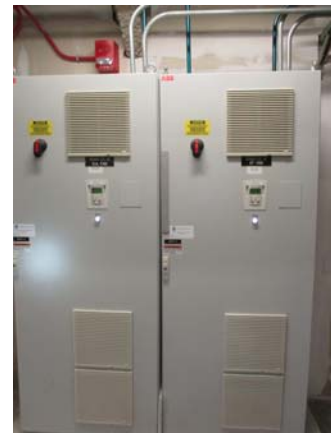
256036e 5/11/2021
VFDs for both the supply and return fans (A and B side) of
AHU-CL-2
Penthouse

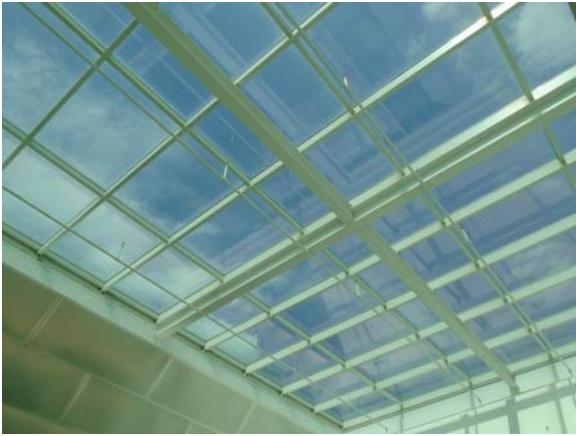
256037a 5/12/2021
Glass skylight system
Central flat roof

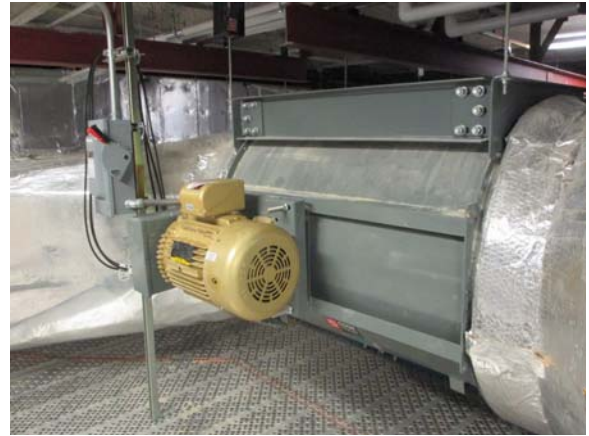
256037e 5/11/2021
25 hp return fan for the B side of AHU-CL-2
Penthouse

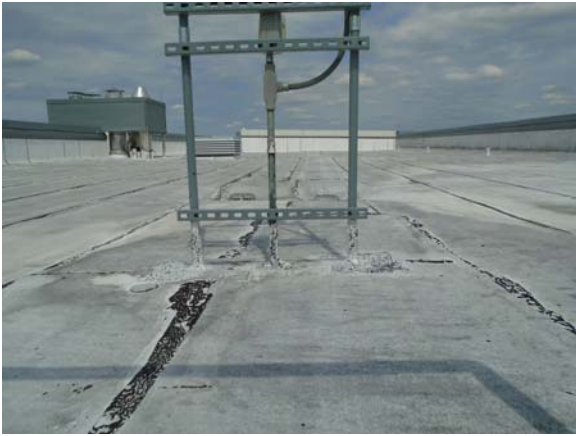
256038a 5/12/2021
Built-up asphalt roofing
Central flat roof

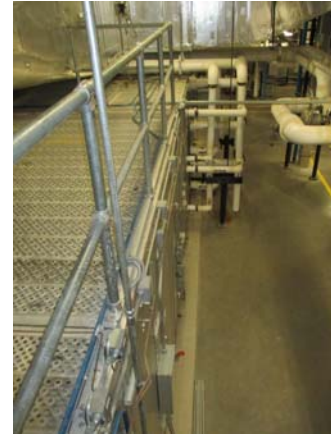
256038e 5/11/2021
A side of AHU-CL-2, with chilled water and heating hot
water piping at far end
Penthouse

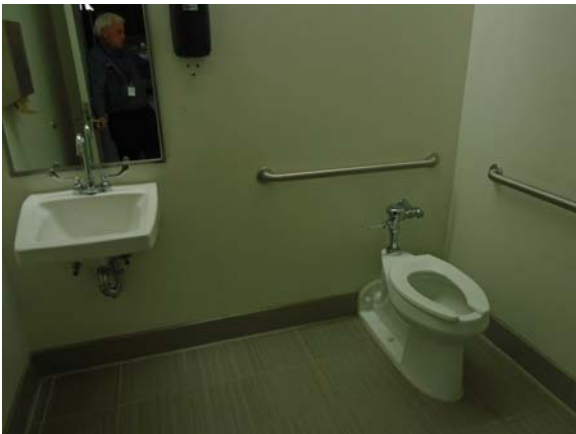
256039a 5/12/2021
Unisex accessible restroom
Fifth floor mechanical attic restroom

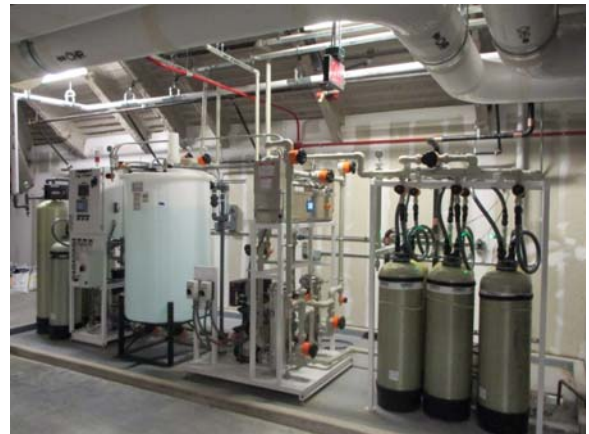
256039e 5/11/2021
RO/DI water system supplying DI water to the labs
Southeast end of penthouse

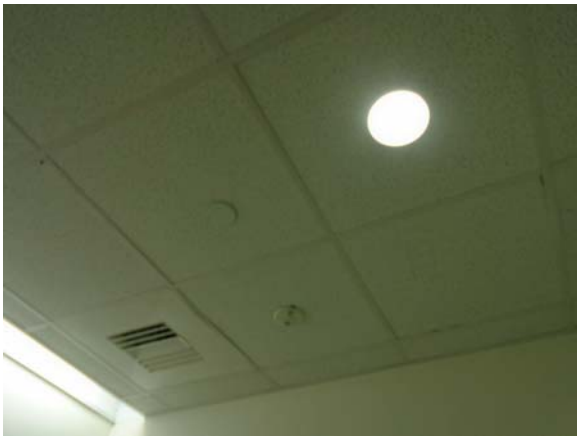
256040a 5/12/2021
Suspended grid ceiling system
Fifth floor mechanical attic restroom

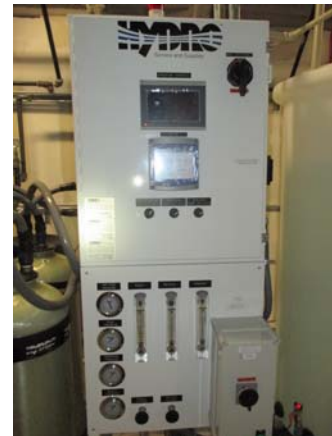
256040e 5/11/2021
Hydro control panel for RO/DI water system
Southeast end of penthouse

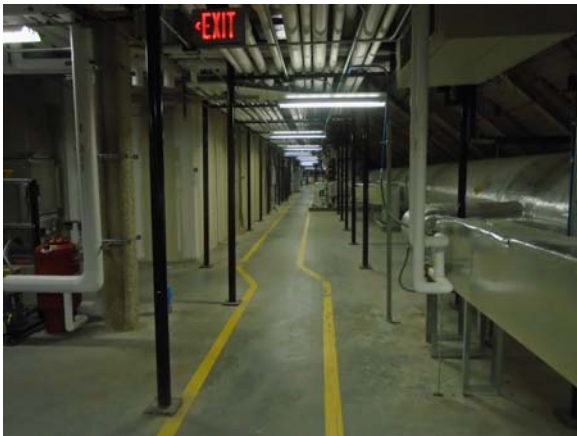
256041a 5/12/2021
Painted safety striping and adequate emergency exit
signage
Fifth floor mechanical attic

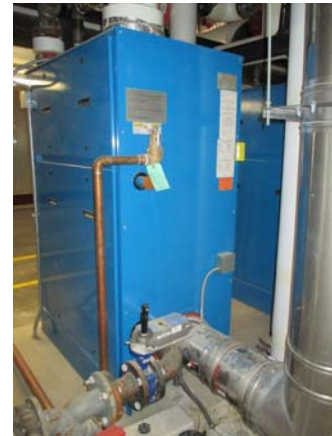
256041e 5/11/2021
One of four 2,500 MBH natural gas fired Harsco boilers
(back side)
East end of penthouse

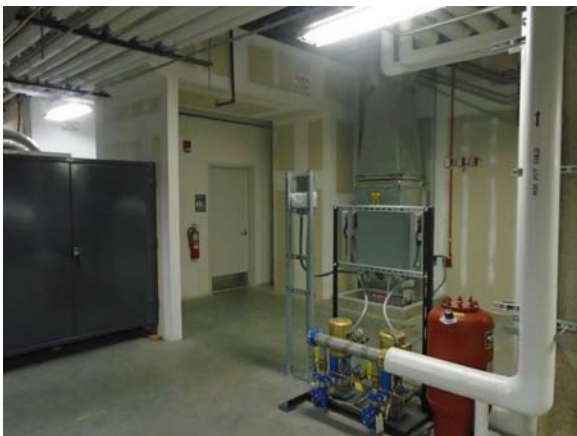
256042a 5/12/2021
Unfinished utilitarian space
Fifth floor mechanical attic

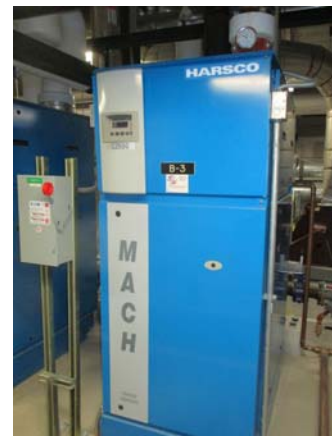
256042e 5/11/2021
Front side of Harsco B-3 boiler
East end of penthouse

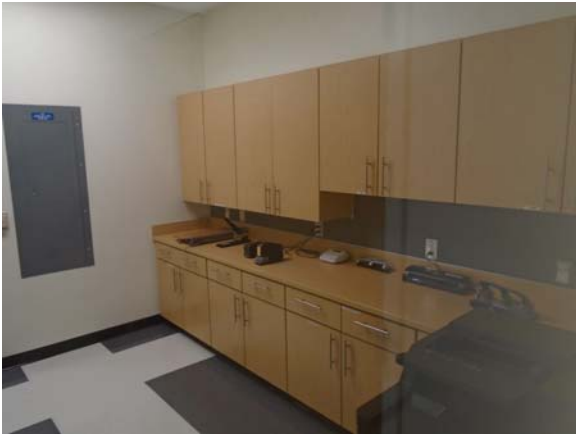
256043a 5/12/2021
Vinyl tile floor and wood base and overhead cabinetry
Workroom 4282

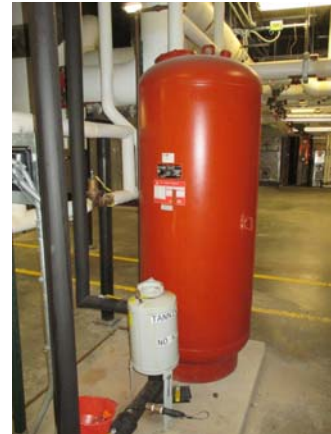
256043e 5/11/2021
Expansion tank (ET-1) for the heating hot water system
East end of penthouse

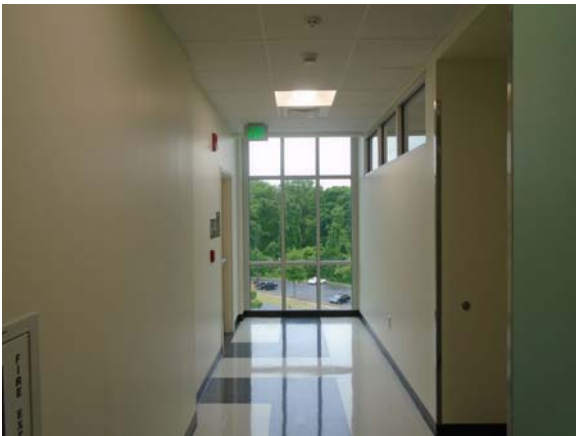
256044a 5/12/2021
Vinyl tile floor, painted walls, and suspended grid ceiling
Fourth floor corridor

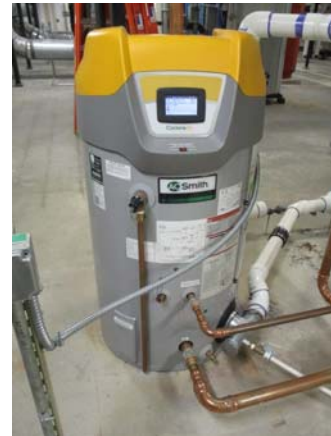
256044e 5/11/2021
Recently installed A. O. Smith domestic water heater
East end of penthouse

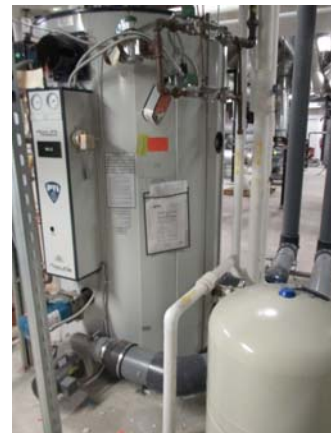
256045e 5/11/2021
Original 565 MBH PVI domestic water heater
East end of penthouse

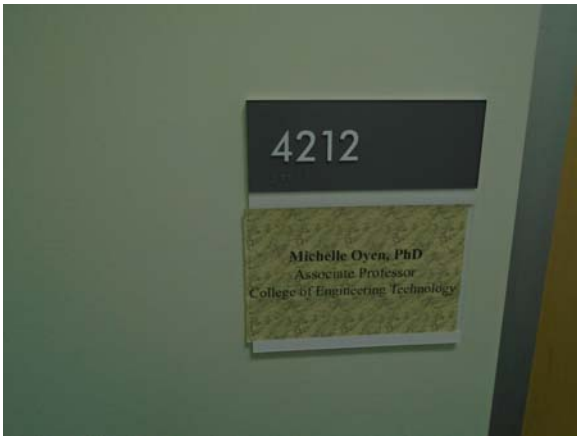
256046a 5/12/2021
Compliant room signage with Braille
Fourth floor corridor

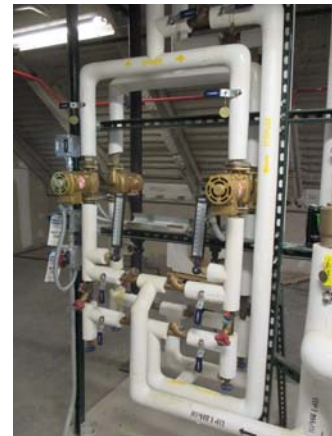
256046e 5/11/2021
Four fractional horsepower pumps for various water
piping
East end of penthouse

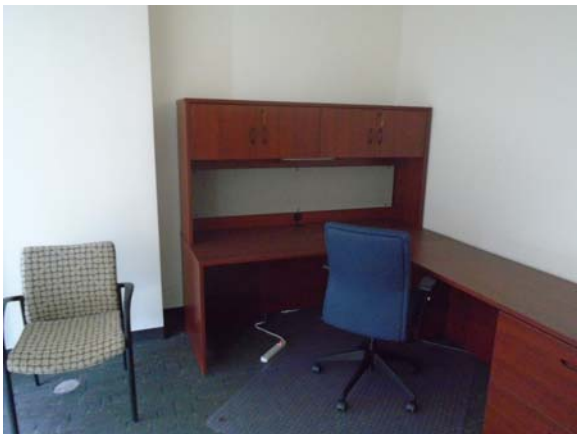
256047a 5/12/2021
Carpeting, painted walls, and suspended grid ceiling
Typical office

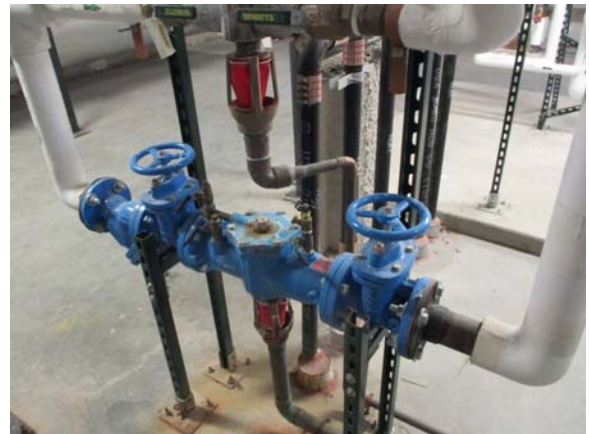
256047e 5/11/2021
3 inch backflow preventer on domestic water
East end of penthouse

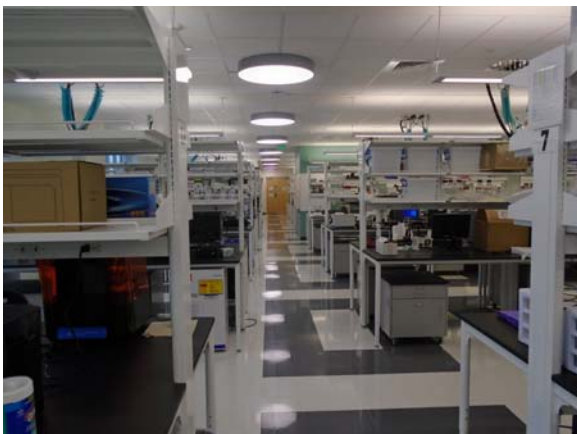
256048a 5/12/2021
Vinyl floor tile, suspended grid ceiling, and metal lab
furniture
Lab 4200

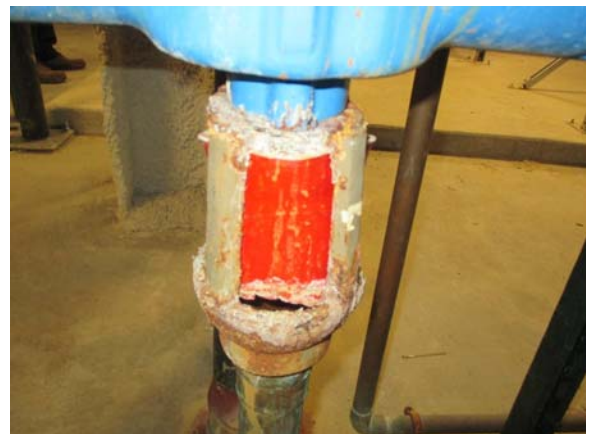
256048e 5/11/2021
Corrosion occurring at drain of backflow preventer
East end of penthouse

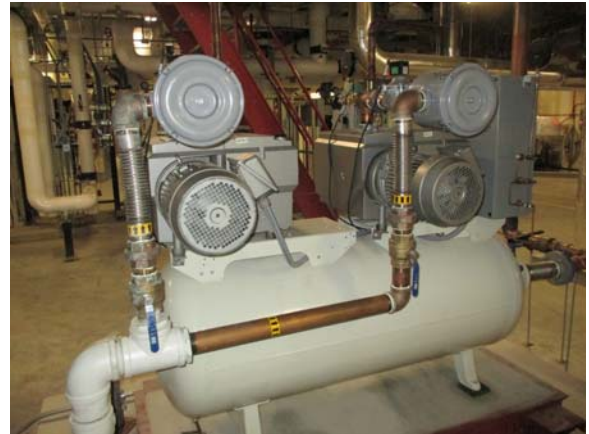
256049e 5/11/2021
Duplex vacuum system with two 5 hp motors
Penthouse

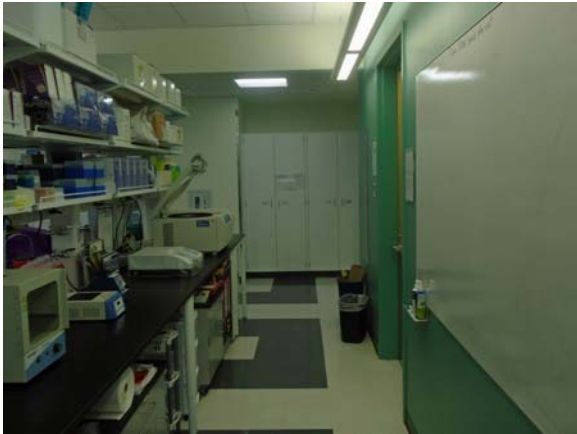
256050a 5/12/2021
Vinyl floor tile, suspended grid ceiling, and metal lab
furniture
Lab 4200

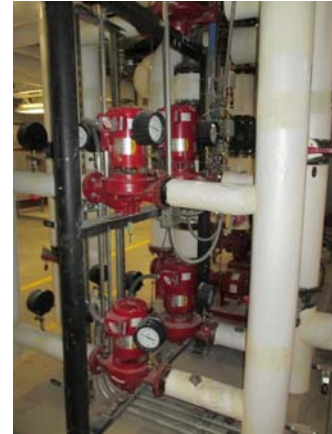
256050e 5/11/2021
Group of heating hot water pumps
Penthouse

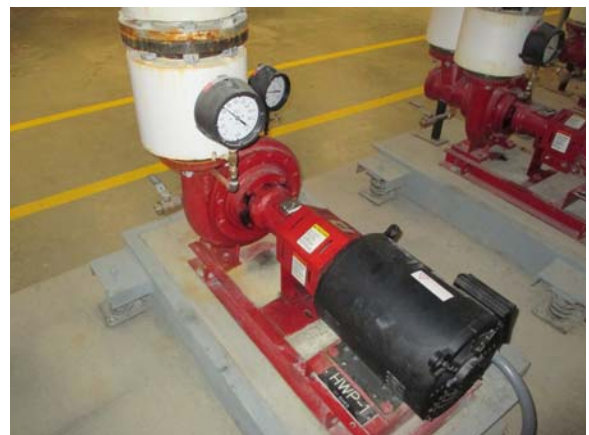
256051e 5/11/2021
Close-up of 10 hp HWP-1
Penthouse

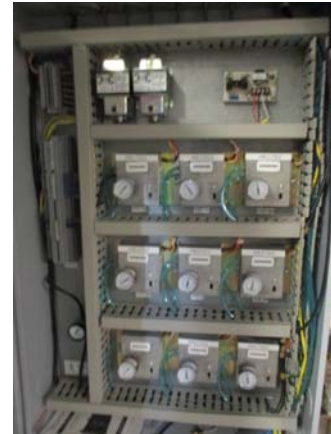
256052e 5/11/2021
Siemens control box for the pneumatic portion of HVAC
controls
Penthouse

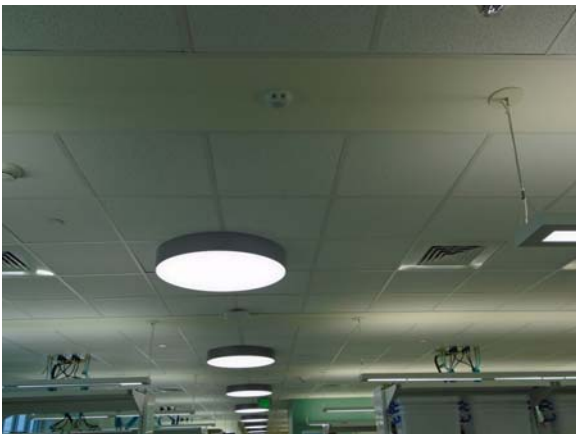
256053a 5/12/2021
Suspended grid ceiling
Fourth floor lab

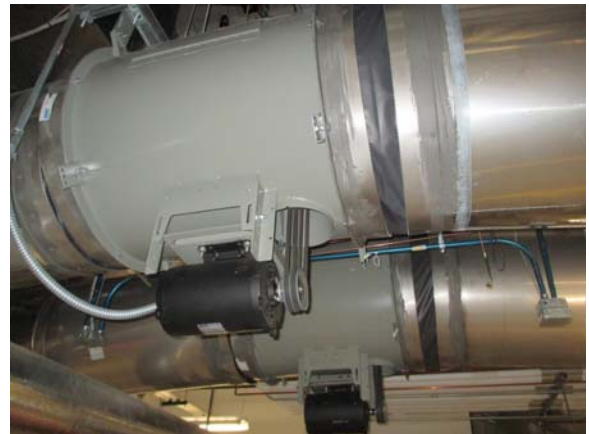
256053e 5/11/2021
Two 5 hp axial/mixed-air exhaust fans for fume hoods on
the fourth floor
Penthouse

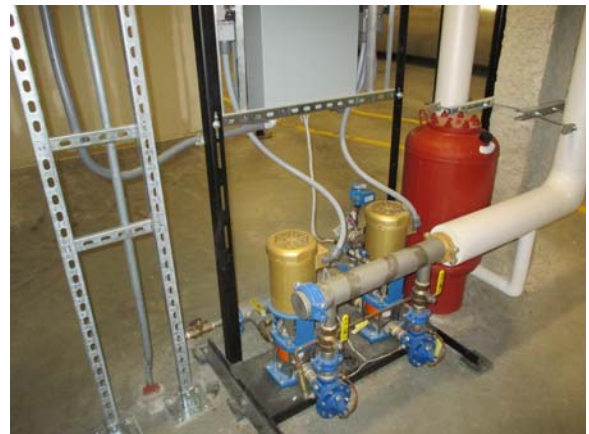
256054e 5/11/2021
Lab water booster pump system (PP1)
Penthouse

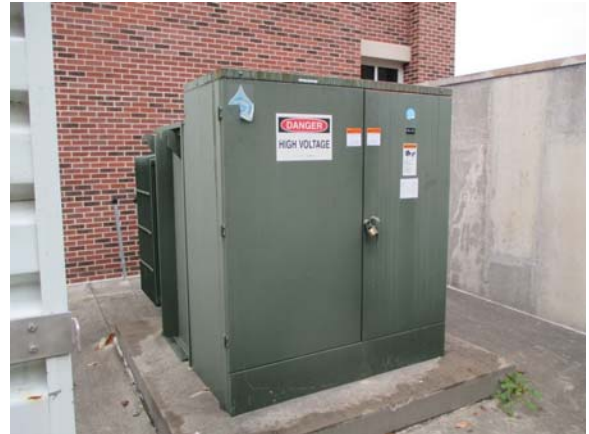
256055e 5/11/2021
2,000 KVA oil-filled transformer
Southeast exterior

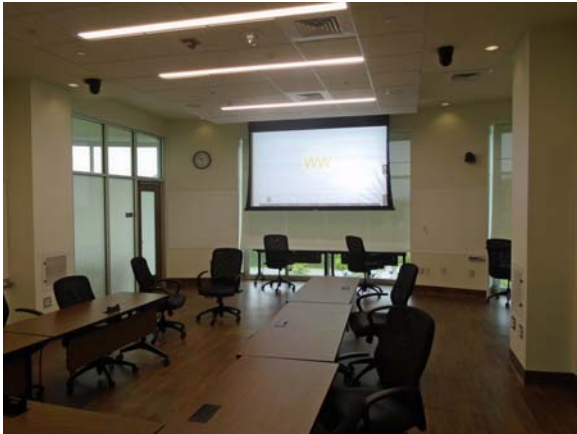
256056a 5/12/2021
Wood laminate flooring and suspended grid ceiling
Conference room 4001

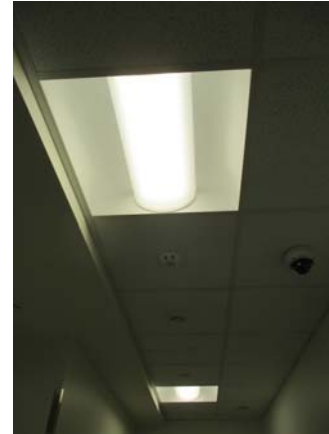
256056e 5/11/2021
Lay-in fluorescent light fixtures
Fourth floor corridor

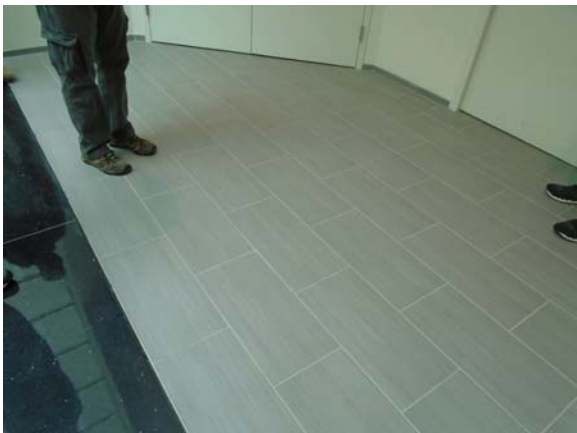
256057a 5/12/2021
Ceramic tile floor adjacent to a terrazzo floor
Fourth floor balcony area

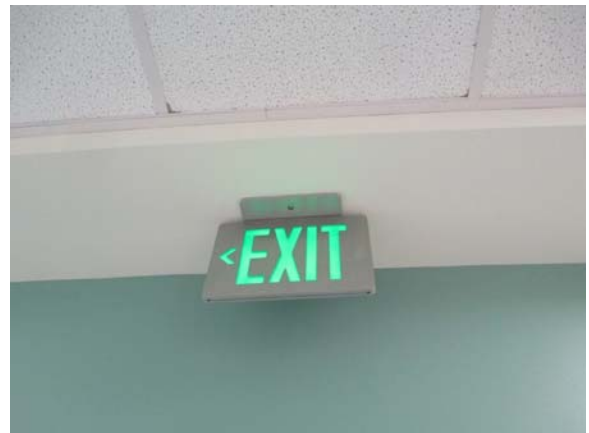
256057e 5/11/2021
LED exit sign
Fourth floor corridor

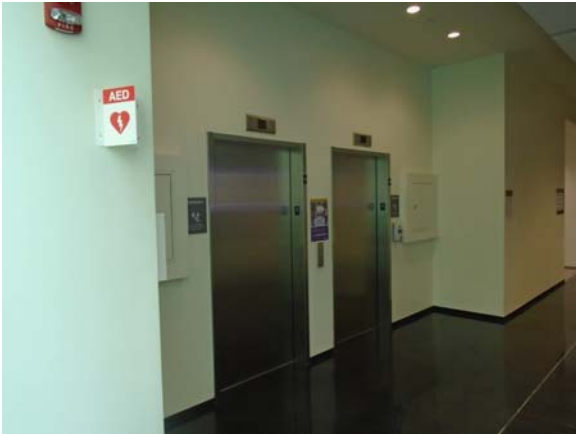
256058a 5/12/2021
Terrazzo floor and painted walls
Fourth floor elevator lobby

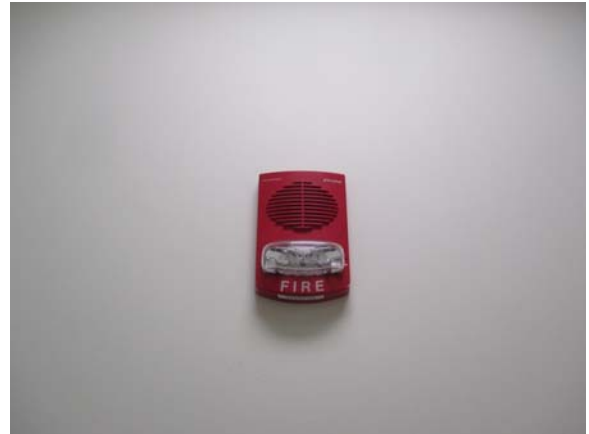
256058e 5/11/2021
Audible/visible fire device
Fourth floor corridor

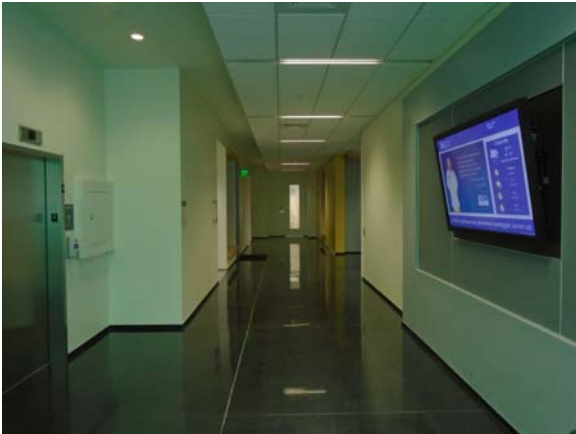
256059a 5/12/2021
Terrazzo floor and painted walls
Fourth floor corridor

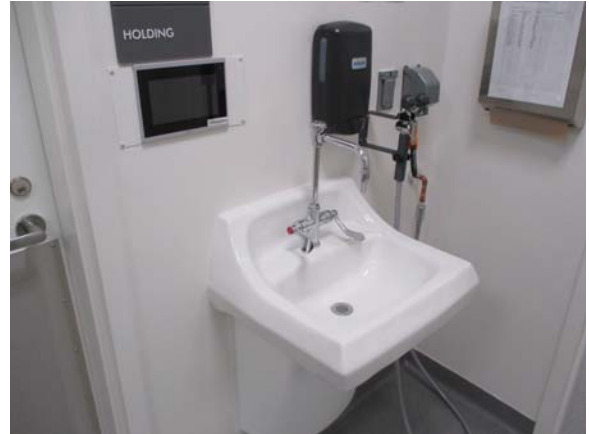
256059e 5/11/2021
Emergency eyewash mounted adjacent to wall-mounted
lavatory
Room 4210

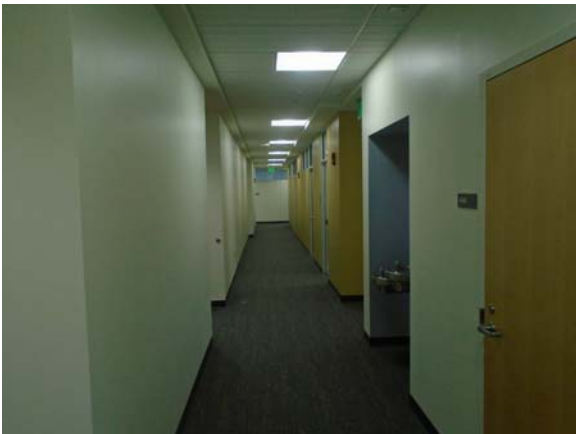
256060a 5/12/2021
Carpeting, painted walls, and suspended grid ceiling
Fourth floor office suite corridor

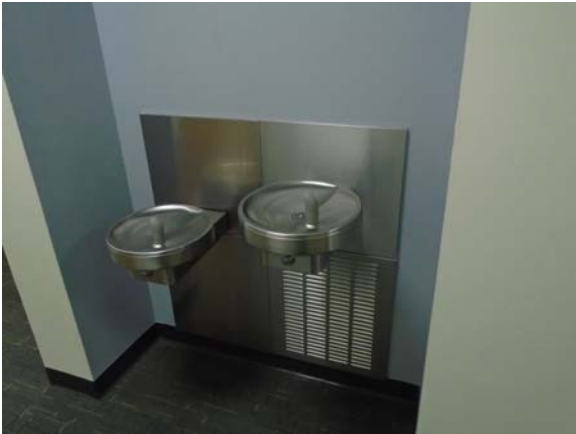
256061a 5/12/2021
Dual-level water fountain
Fourth floor office suite corridor

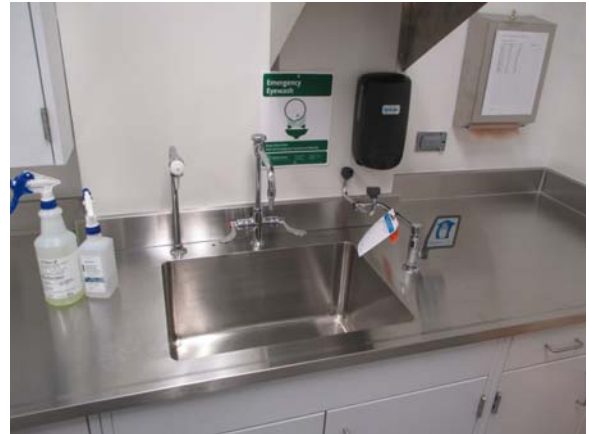
256061e 5/11/2021
Emergency eyewash adjacent to stainless steel lab sink
Room 4210C

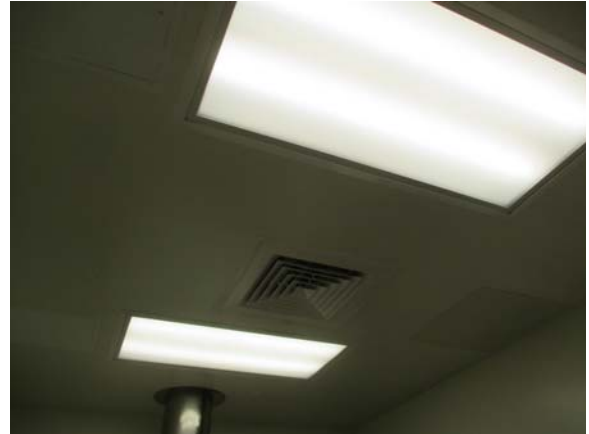
256062e 5/11/2021
2x4 lay-in LED light fixtures in lab area
Room 4210C

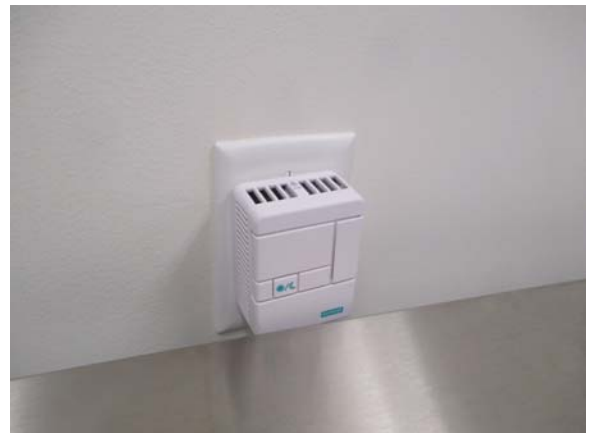
256063e 5/11/2021
Siemens thermostat for HVAC control
Room 4210C

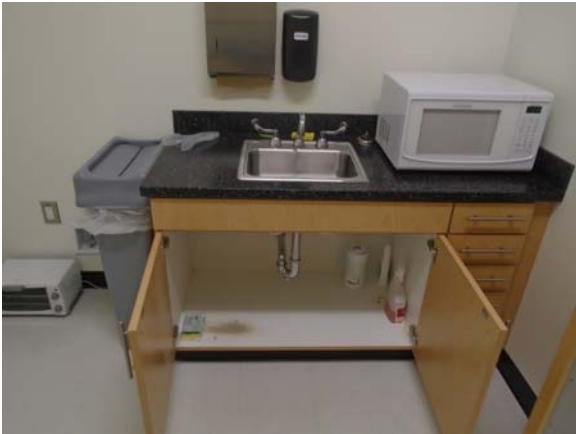
256064a 5/12/2021
Accessible kitchen sink
Break room 4107

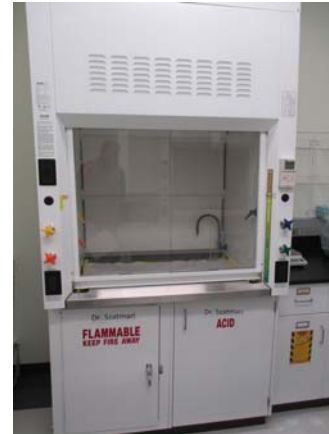
256064e 5/11/2021
Fume hood in lab area
Room 4200

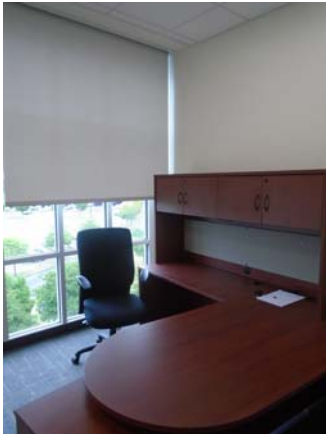
256065a 5/12/2021
Carpeting, painted walls, and suspended grid ceiling
Typical office

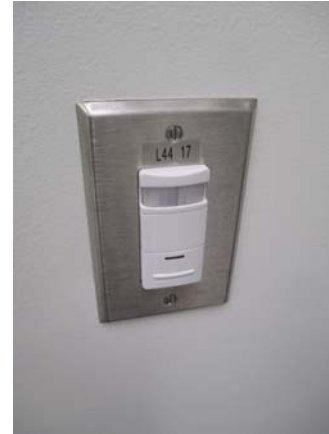
256065e 5/11/2021
Occupancy sensor built into light switch
Alcove in room 4200

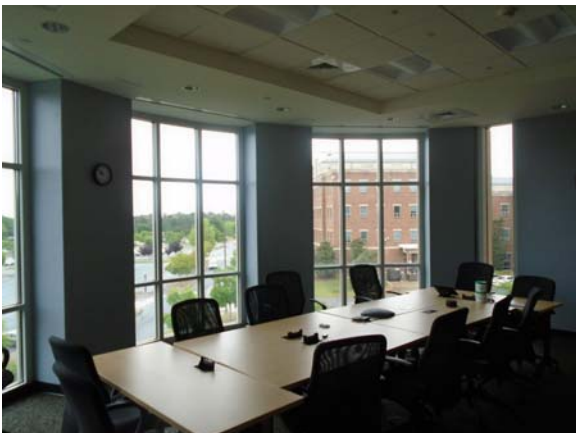
256066a 5/12/2021
Carpeting, painted walls, and suspended grid ceiling
Conference room 4130

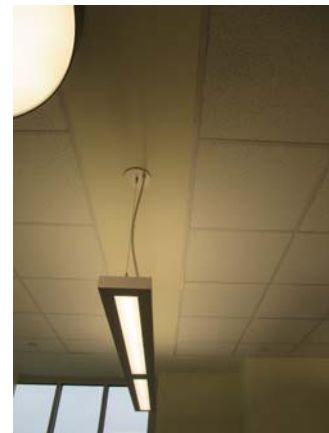
256066e 5/11/2021
Pendant LED light fixture in large lab area
Room 4200

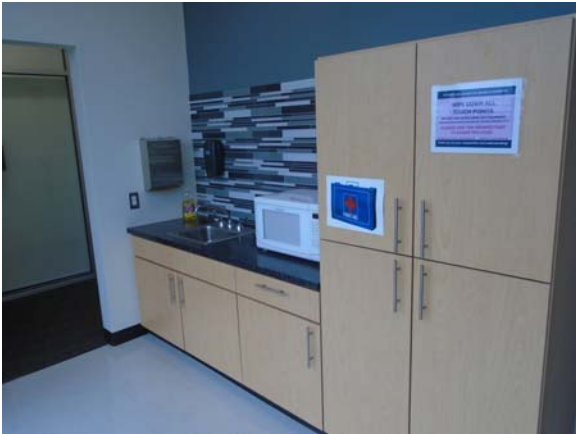
256067a 5/12/2021
Accessible kitchen sink and wood cabinetry
Kitchen 4132

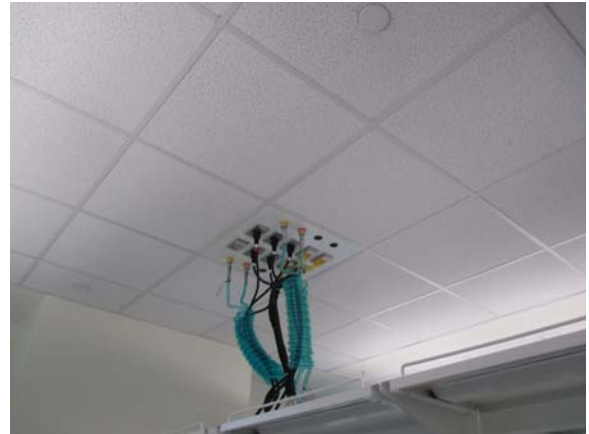
256067e 5/11/2021
Plumbing, power, and data connections enter the lab
through the ceiling
Room 4200

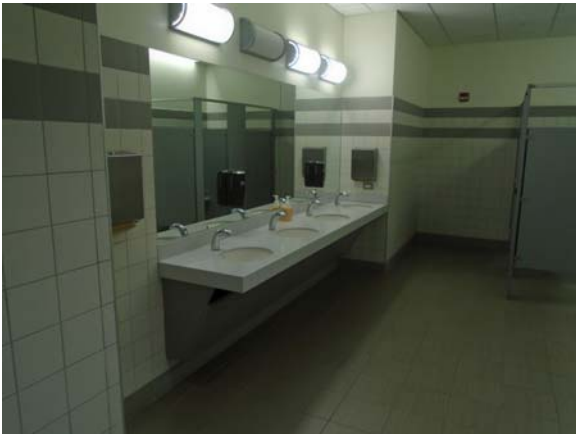
256068a 5/12/2021
Ceramic tile finishes and accessible sinks
Men's restroom 4170

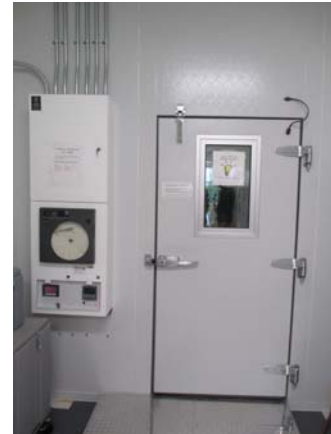
256068e 5/11/2021
Walk-in cold room
South end of room 4200

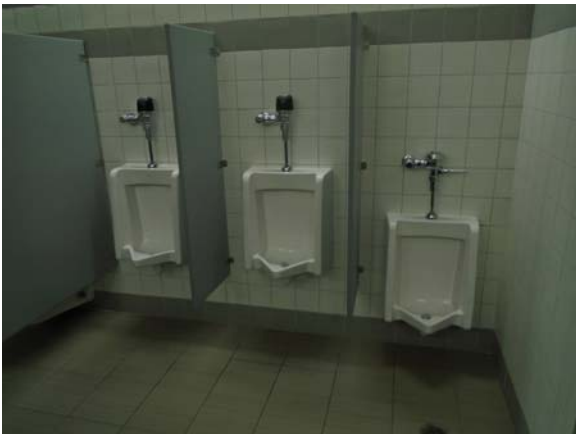
256069a 5/12/2021
Ceramic tile finishes and accessible urinals
Men's restroom 4170

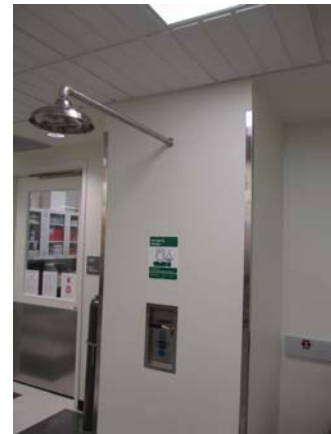
256069e 5/11/2021
Safety shower in large lab area
Room 4200

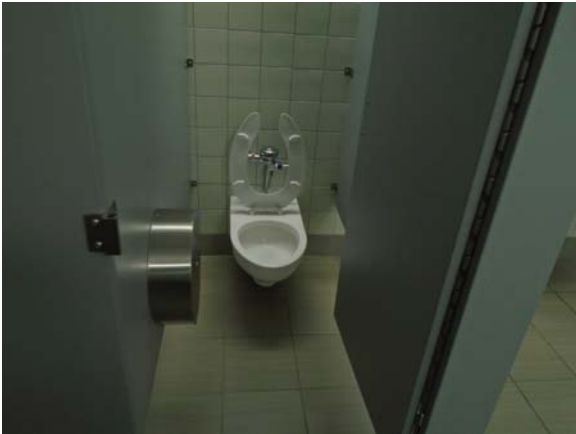
256070a 5/12/2021
Ceramic tile finishes and regular toilet stall
Men's restroom 4170

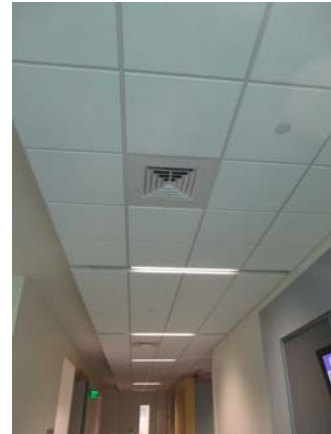
256070e 5/11/2021
T5 fluorescent light fixtures in the elevator lobby
Fourth floor corridor

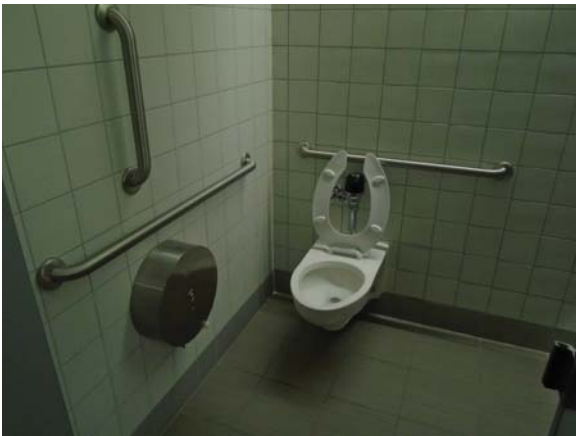
256071a 5/12/2021
Ceramic tile finishes and accessible toilet
Men's restroom 4170

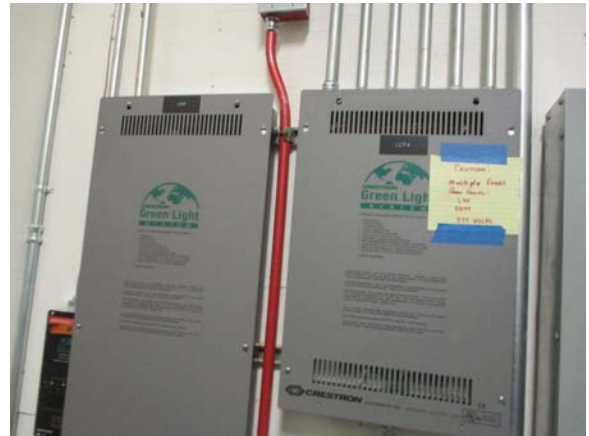
256071e 5/11/2021
Creston lighting control panels
Room 4101

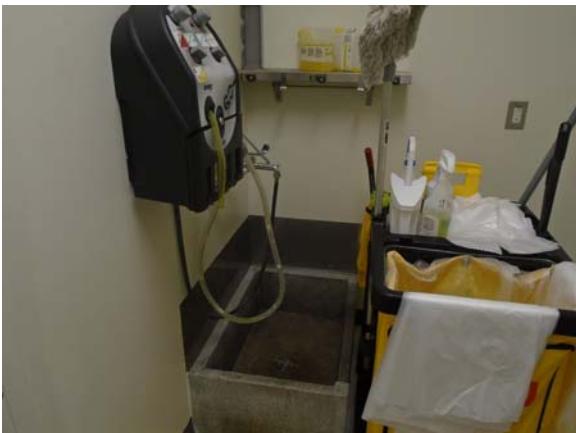
256072a 5/12/2021
Concrete molded floor sink
Janitorial closet 4060

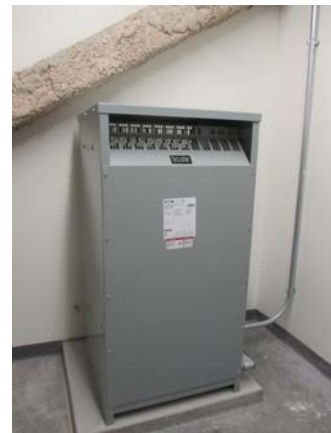
256072e 5/11/2021
Eaton dry-type step-down transformer
Room 4101A

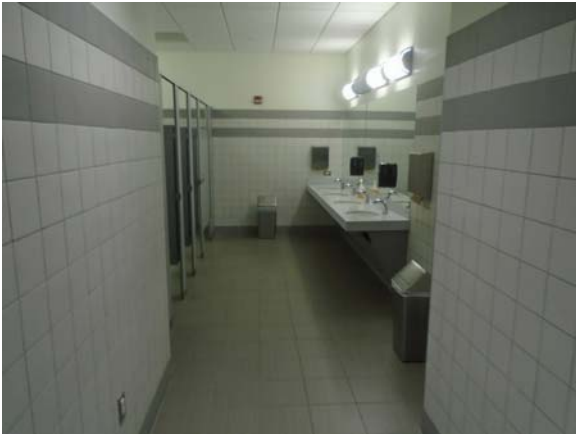
256073a 5/12/2021
Ceramic tile finishes and accessible sinks
Women's restroom 4171

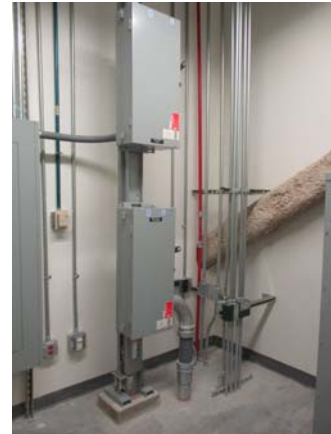
256073e 5/11/2021
480 volt electrical bus duct
Room 4101A

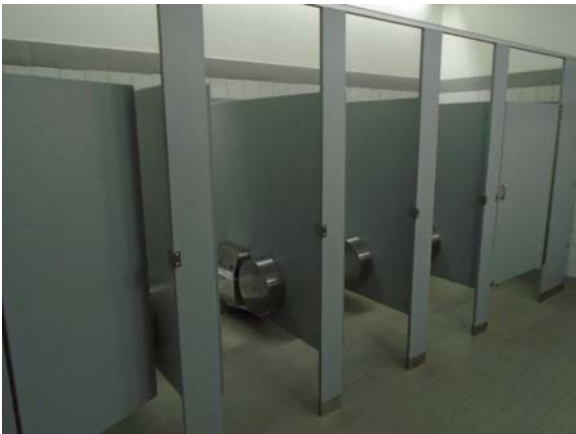
256074a 5/12/2021
Ceramic tile finishes and regular toilet stalls
Women's restroom 4171

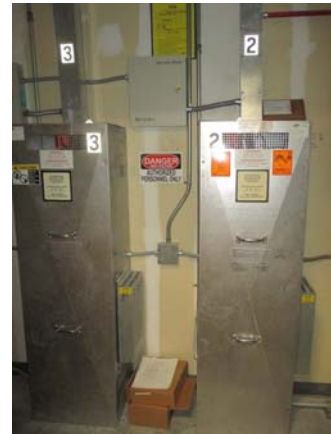
256074e 5/11/2021
Controls for the two passenger (traction) elevators
Room 4105
