EAST CAROLINA UNIVERSITY

Facility Condition Assessment

Ross Hall
Asset 256

Inspected May 11, 2021

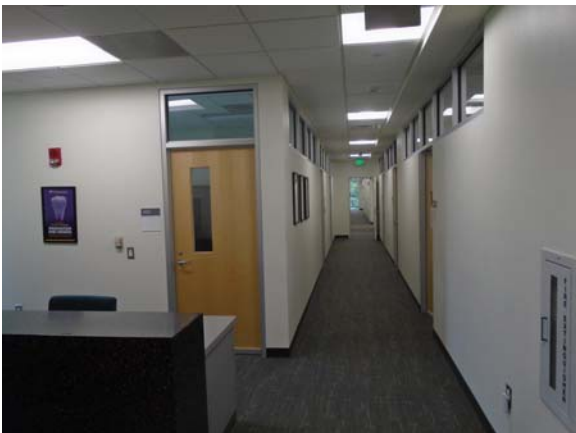
256075a 5/12/2021
Carpeting, painted walls, and suspended grid ceiling
Office suite 4250

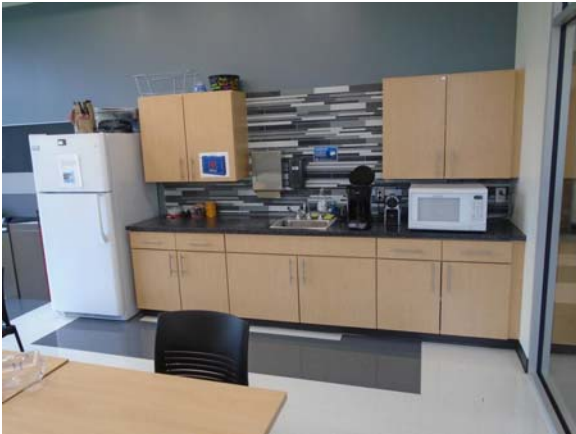
256076a 5/12/2021
Vinyl tile floor, accessible sink, and wood base and overhead cabinetry
Break room 4280

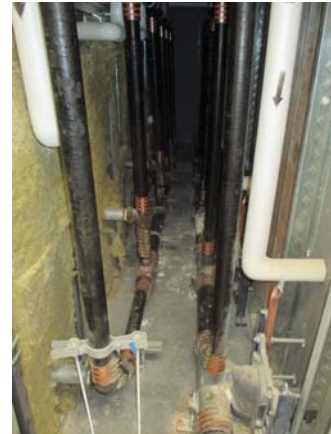
256076e 5/11/2021
Insulated supply piping and cast-iron drain piping
Pipe chase behind fourth floor restrooms

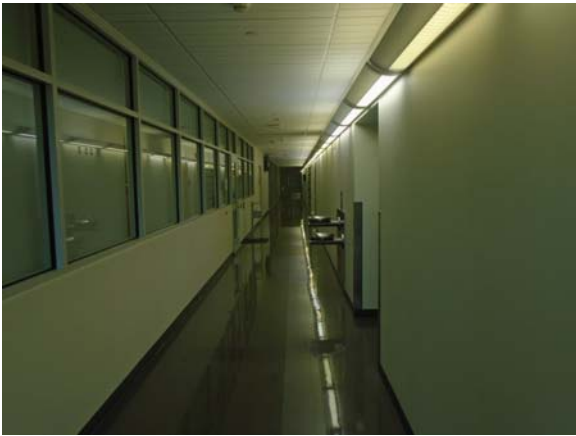
256077a 5/12/2021
Vinyl tile floor, painted walls, and suspended grid ceiling
Third floor lab corridor

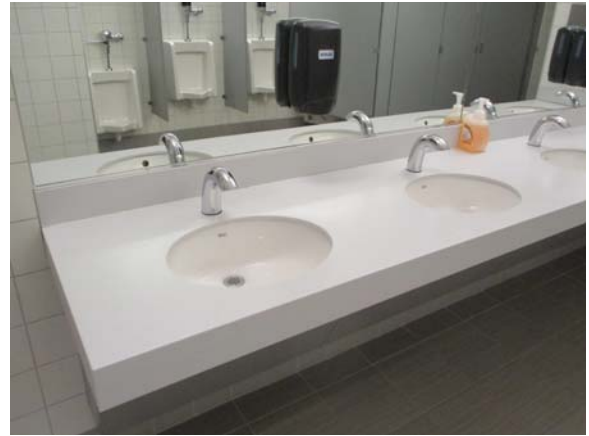
256077e 5/11/2021
Hands-free lavatories
Fourth floor restroom

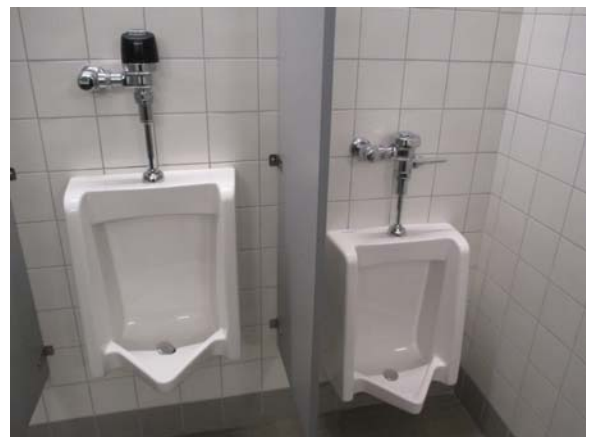
256078e 5/11/2021
Urinals in men's restroom
Fourth floor restroom

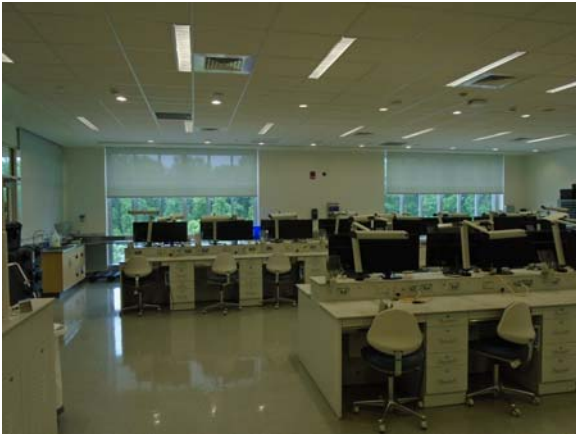
256079a 5/12/2021
Vinyl tile floor, painted walls, and suspended grid ceiling
Third floor labs

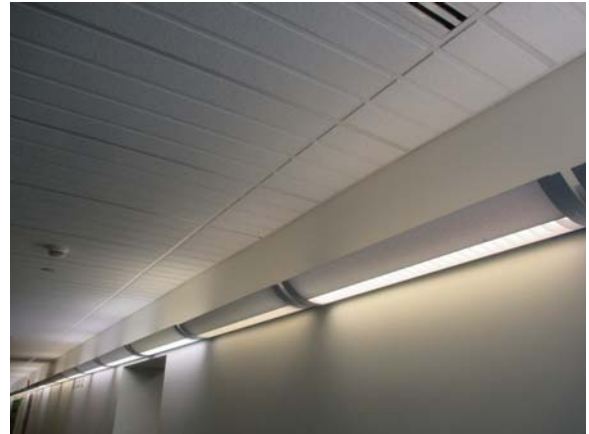
256079e 5/11/2021
Wall-mounted fluorescent light fixtures
Third floor corridor

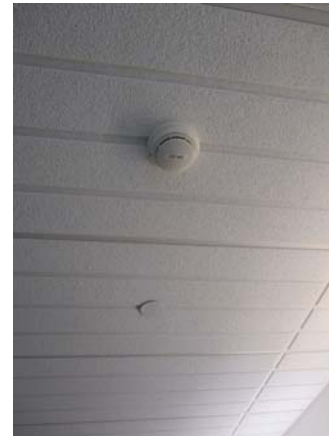
256080e 5/11/2021
Smoke/heat detector and recessed sprinkler head
Third floor corridor

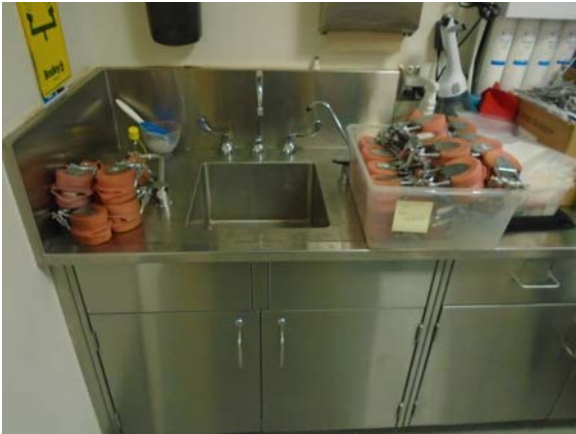
256082a 5/12/2021
Stainless steel lab sink
Third floor labs

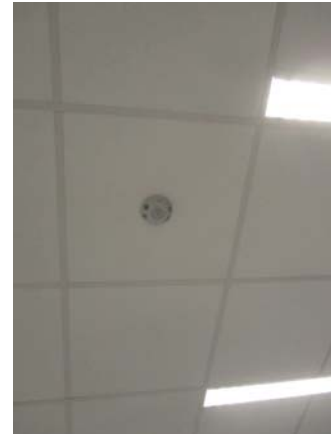
256082e 5/11/2021
Ceiling occupancy sensor
Room 3207

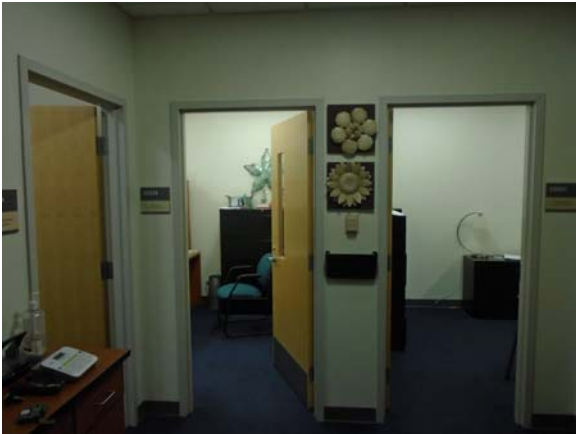
256083a 5/12/2021
Carpeting, painted walls, and suspended grid ceiling
Small office suite 3202

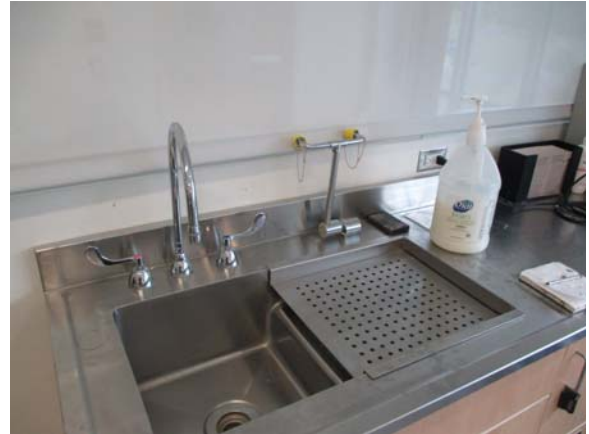
256083e 5/11/2021
Emergency eyewash adjacent to stainless steel lab sink
Room 3207

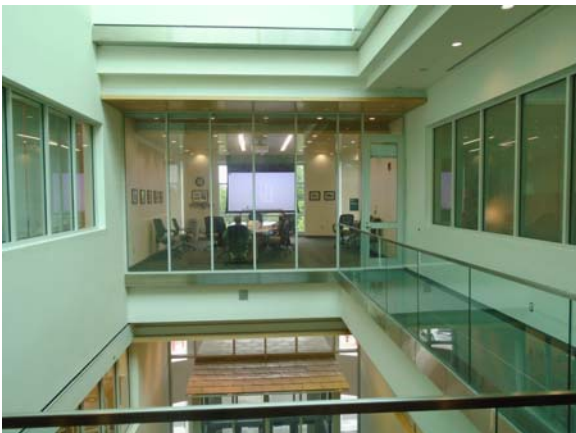
256084a 5/12/2021
Open to below with terrazzo balcony
Third floor

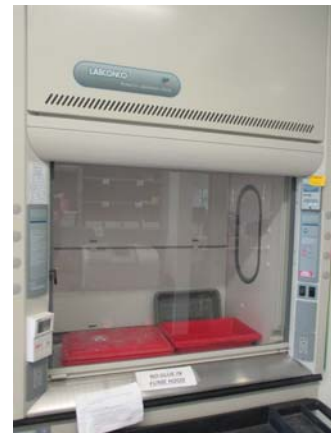
256084e 5/11/2021
Fume hood in lab area
Room 3205

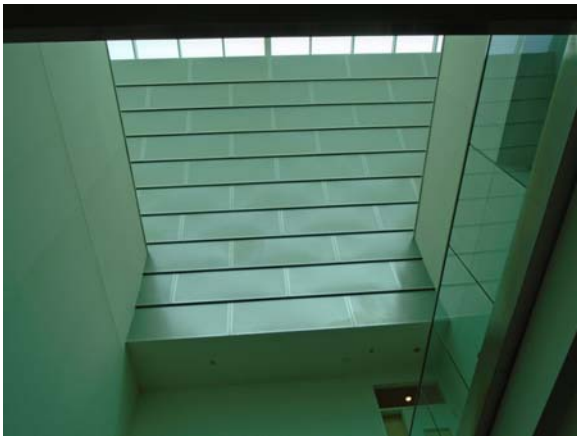
256085a 5/12/2021
Metal panel wall
Atrium

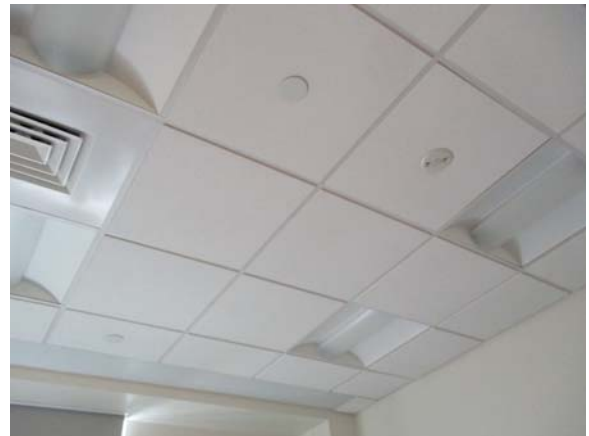
256085e 5/11/2021
Lay-in fluorescent light fixtures in office
Room 3170

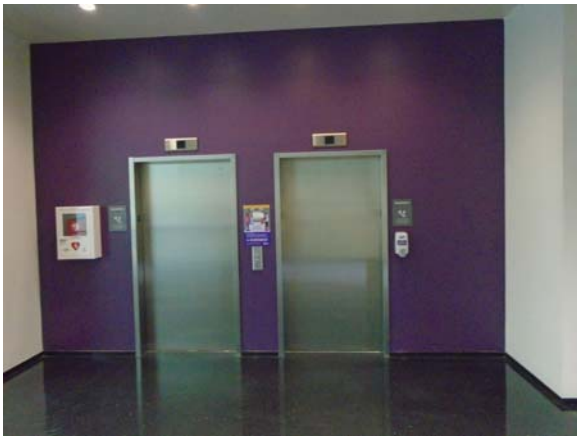
256086a 5/12/2021
Terrazzo floor and painted walls
Third floor elevator lobby

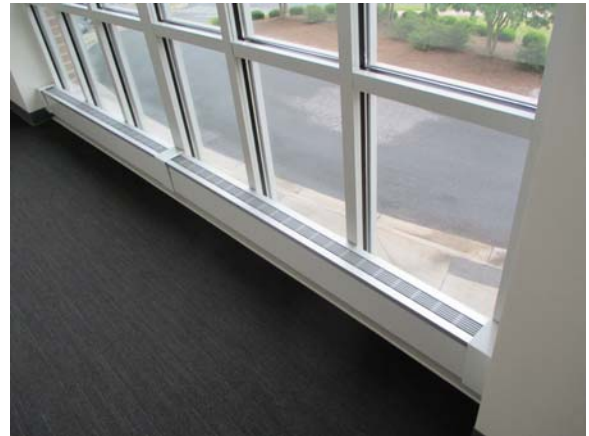
256086e 5/11/2021
Fin-tube radiators at base of windows
Third floor corridor

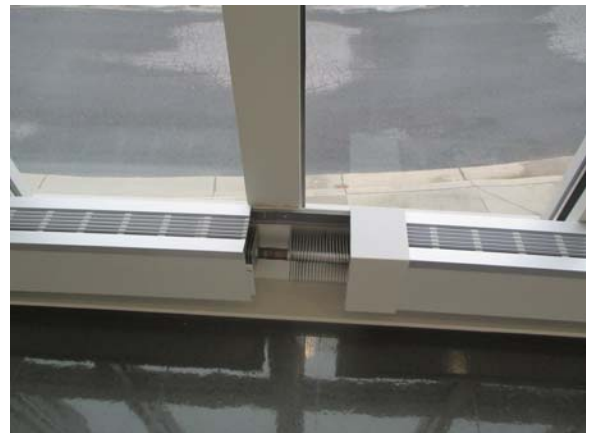
256087e 5/11/2021
Close-up of fin-tube radiator
Third floor corridor

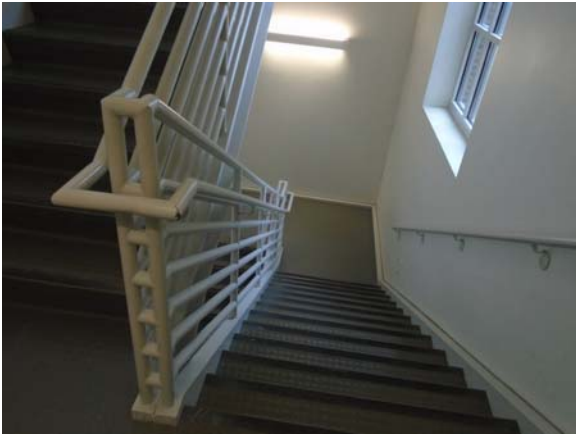
256088a 5/12/2021
Compliant handrails
Stairwell 2

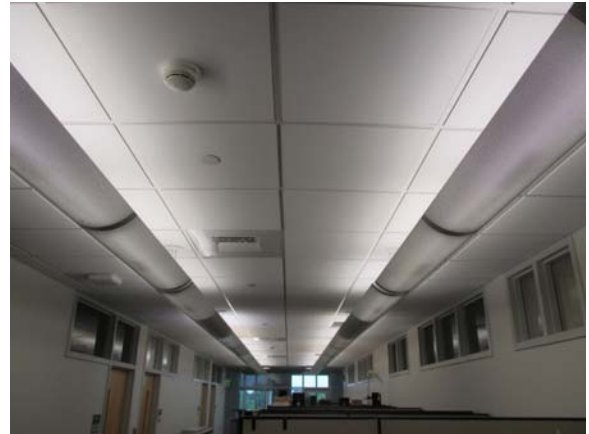
256088e 5/11/2021
Pendant fluorescent light fixtures above cubical office
area
Third floor corridor

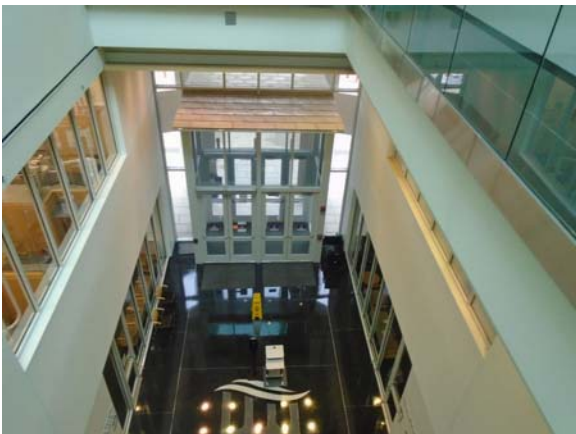
256089a 5/12/2021
Terrazzo floor and painted walls
Center atrium area

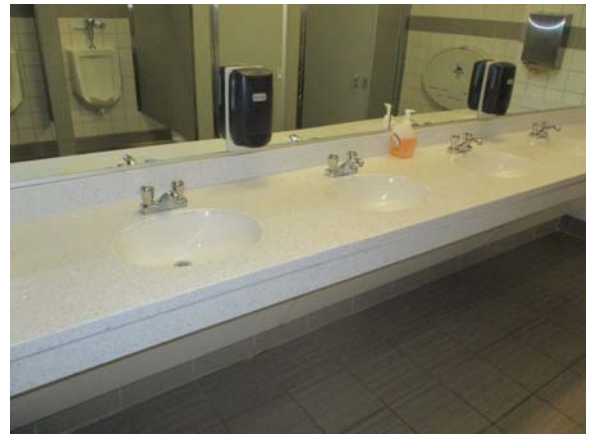
256089e 5/11/2021
Lavatories in original restroom
Third floor restroom

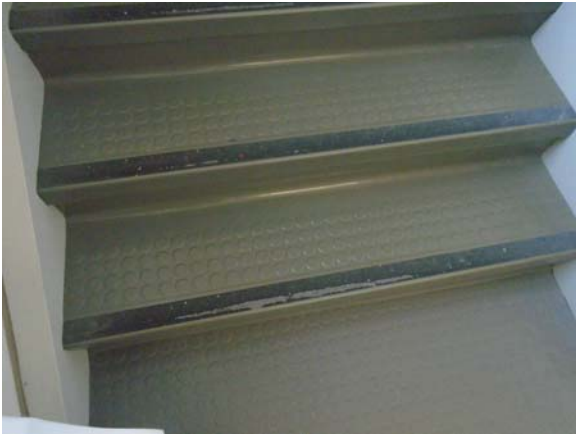
256091a 5/12/2021
Rubberized nosing and treads becoming worn
Stairwell 2

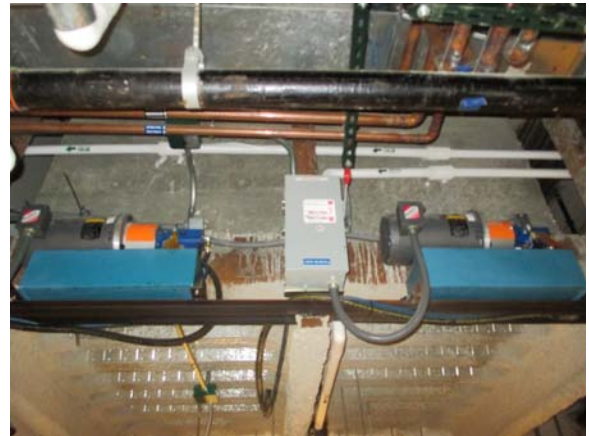
256110e 5/11/2021
Hydraulic pumps for two of the three dock levelers
Room B0100

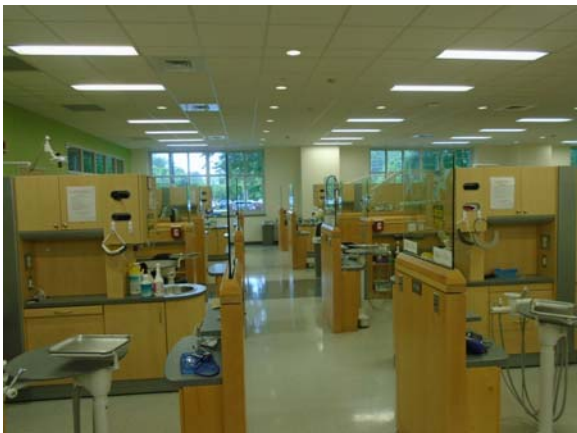
256111a 5/12/2021
Vinyl tile floor, painted walls, and suspended grid ceiling
First floor dental training area

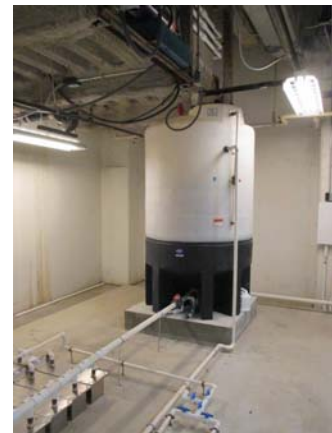
256111e 5/11/2021
Amalgam separator system
Room B0100

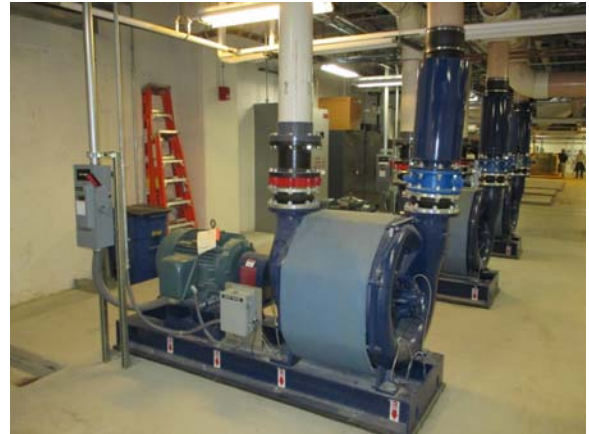
256112e 5/11/2021
Dental-mouth vacuum system with three 60 hp Spencer
Turbines
Room B0100

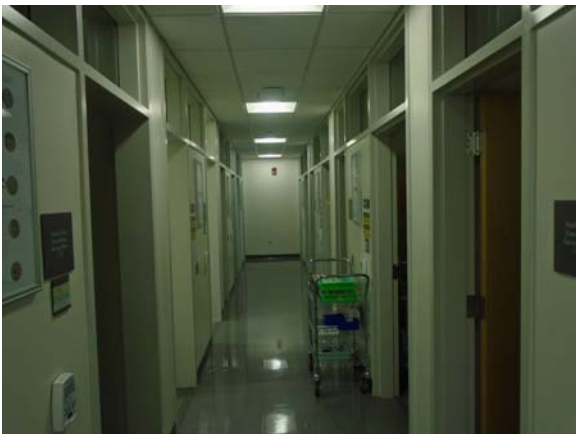
256113a 5/12/2021
Vinyl tile floor, painted walls, and suspended grid ceiling
First floor lab corridor

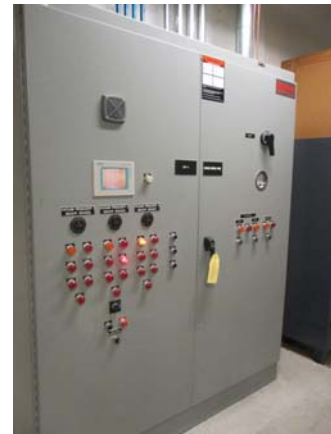
256113e 5/11/2021
Control panel for Spencer Turbines
Room B0100

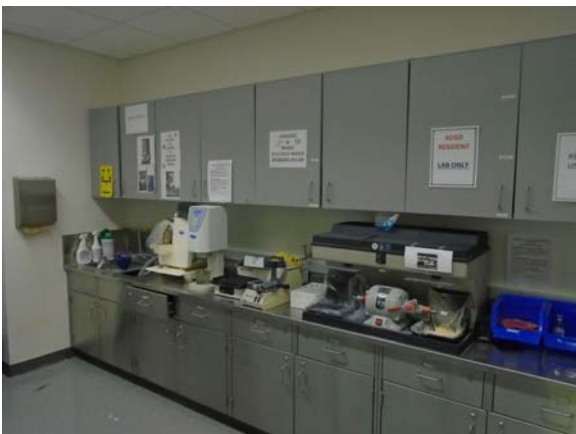
256114a 5/12/2021
Stainless steel lab cabinetry and sinks
Lab 1146

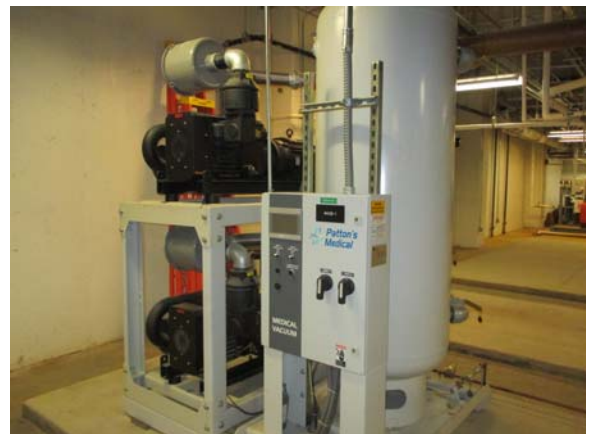
256114e 5/11/2021
Patton's Medical vacuum system with two 15 hp motors
(WAGD)
Room B0100

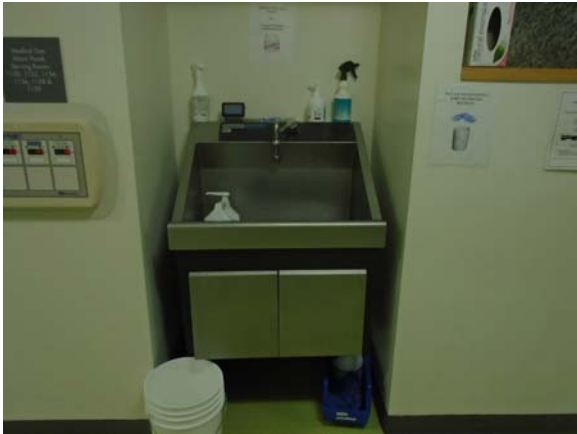
256115a 5/12/2021
Large stainless steel utility sink
First floor lab area

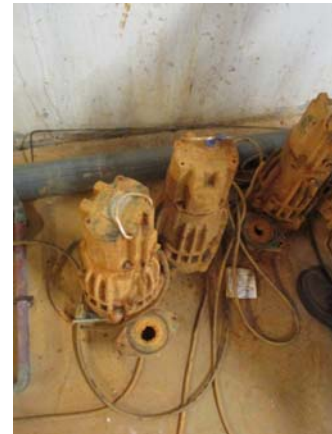
256116e 5/11/2021
Failed sump pumps, clogged with mud
Room B0100

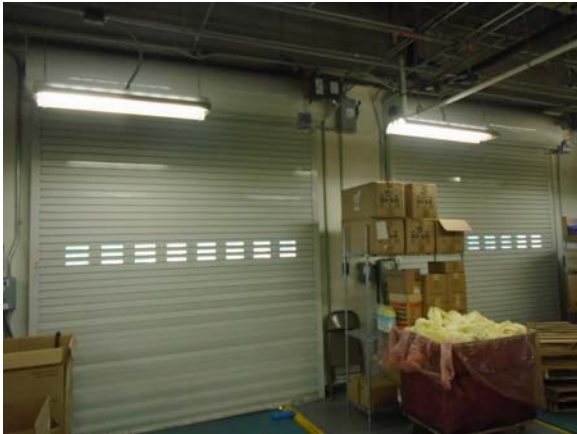
256118a 5/12/2021
Overhead garage doors
Loading dock and receiving

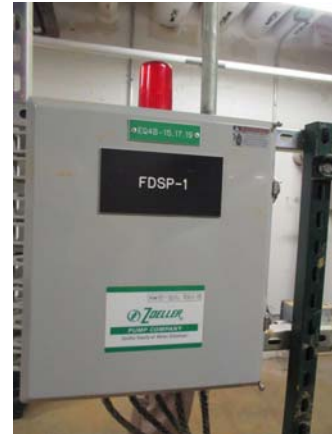
256118e 5/11/2021
Control panel for foundation sump pumps
Room B0100

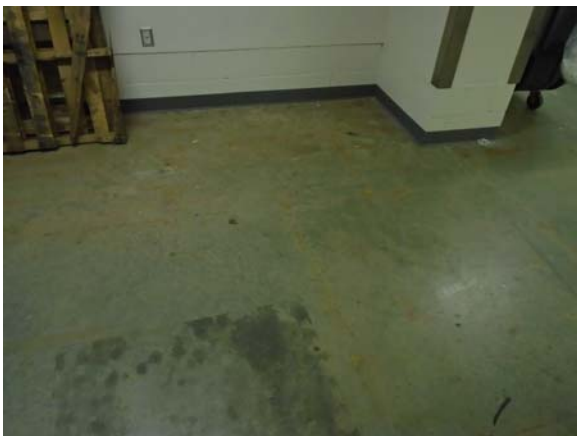
256120a 5/12/2021
Sealed concrete floor
Basement

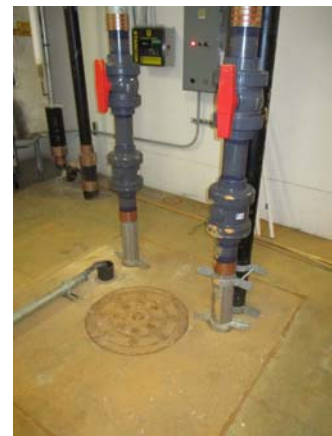
256120e 5/11/2021
Duplex sanitary lift station
Room B0100

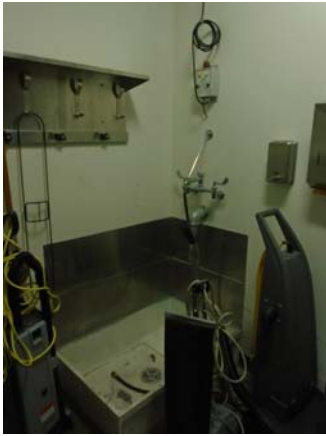
256121a 5/12/2021
Molded floor sink
Basement janitorial closet

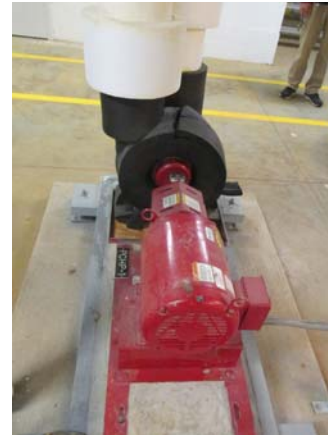
256121e 5/11/2021
7.5 hp PCHP-1 chilled water pump
Room B0100

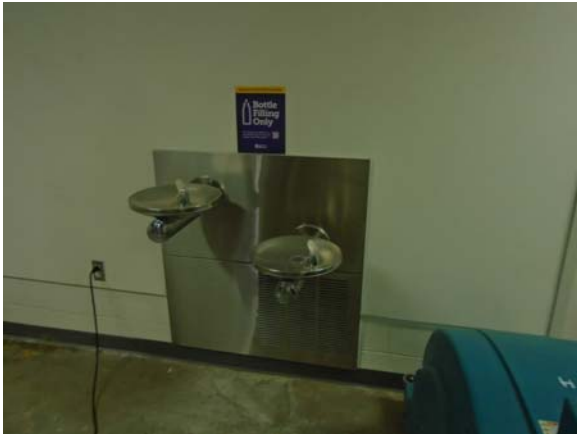
256122a 5/12/2021
Dual-level water fountain
Basement

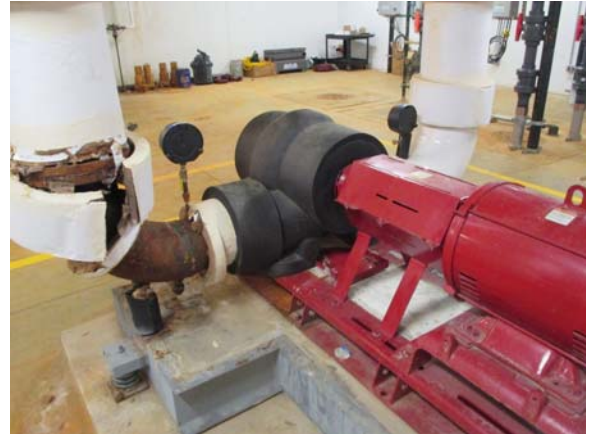
256122e 5/11/2021
40 hp CHP-1 chilled water pump
Room B0100

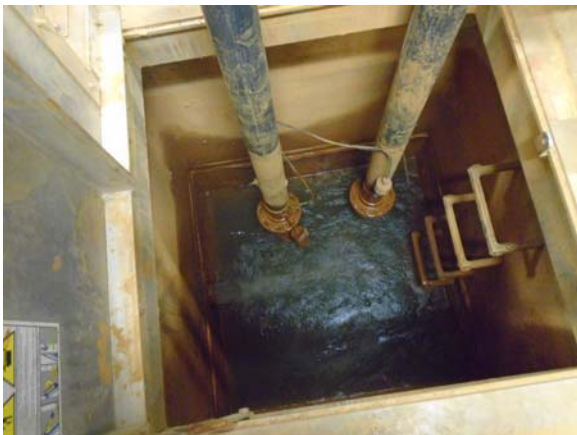
256123a 5/12/2021
Groundwater sump with two submerged pumps
Basement

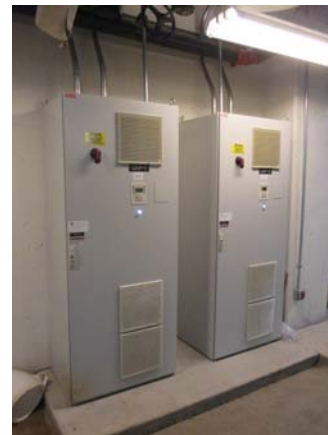
256123e 5/11/2021
VFDs for the two 40 hp chilled water pumps
Room B0100

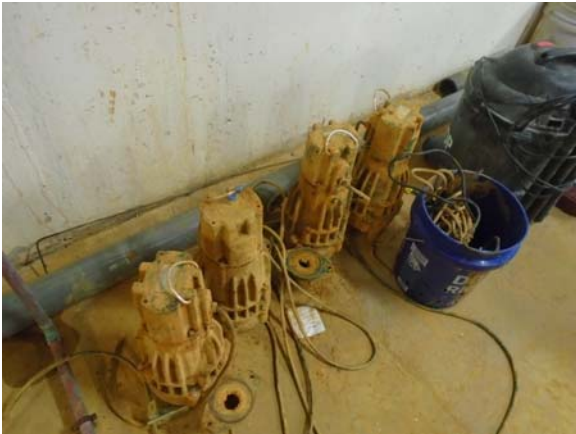
256124a 5/12/2021
Old groundwater pumps
Basement

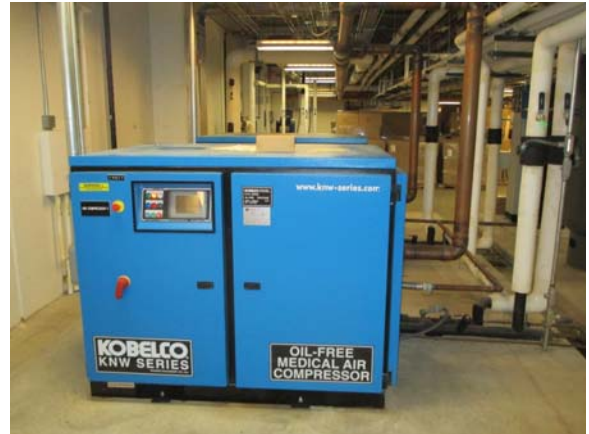
256124e 5/11/2021
One of two 75 hp Kobelco air compressor systems for
dental and lab areas
Room B0100

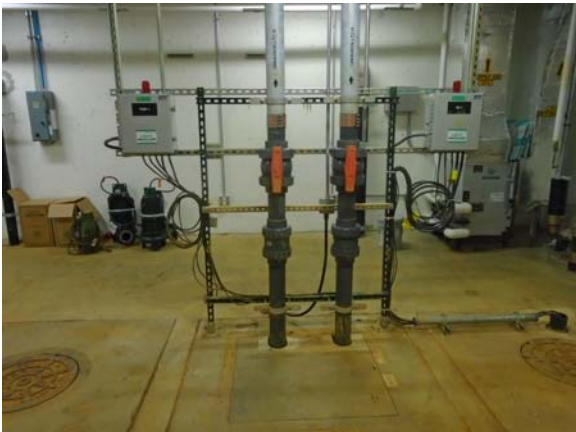
256125a 5/12/2021
Groundwater sump with two submerged pumps
Basement

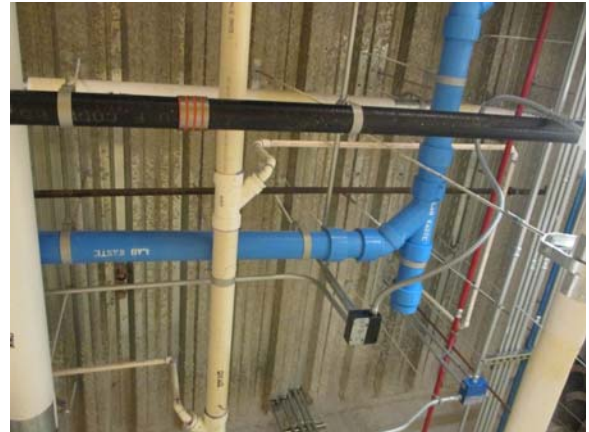
256125e 5/11/2021
Blue plastic lab waste drain piping
Room B0100

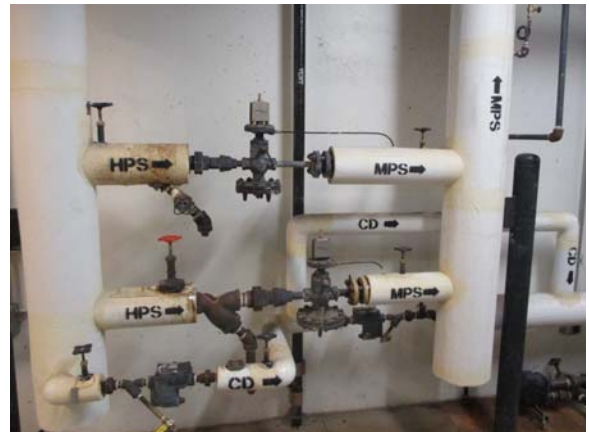
256126e 5/11/2021
Spirax Sarco pressure reducing valves
Room B0100

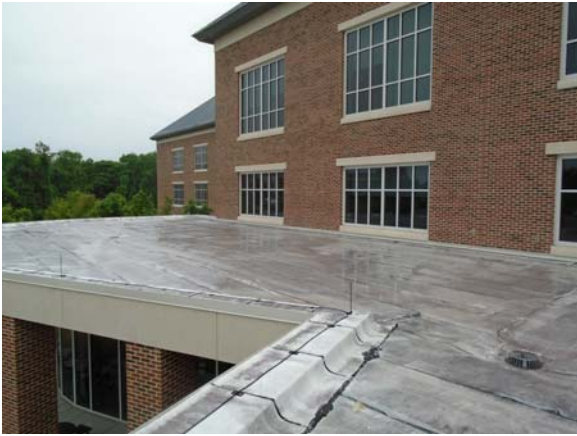
256127a 5/12/2021
Asphalt built-up roof over second floor
South lower roof

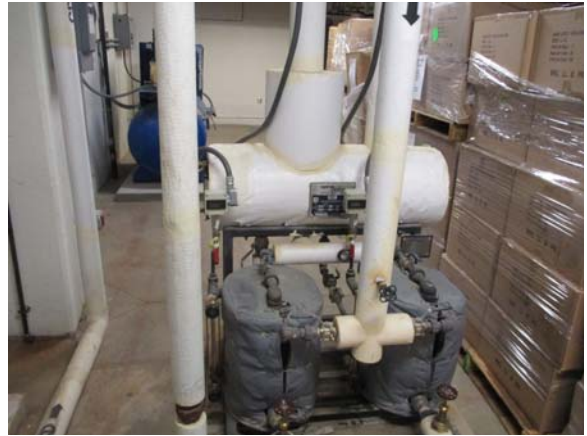
256127e 5/11/2021
Flash tank above condensate receiver
Room B0100

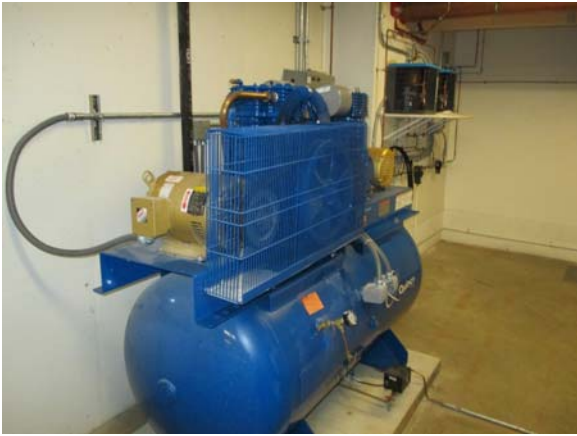
256128e 5/11/2021
Quincy air compressor with two 7.5 hp motors serving
the HVAC controls
Room B0100

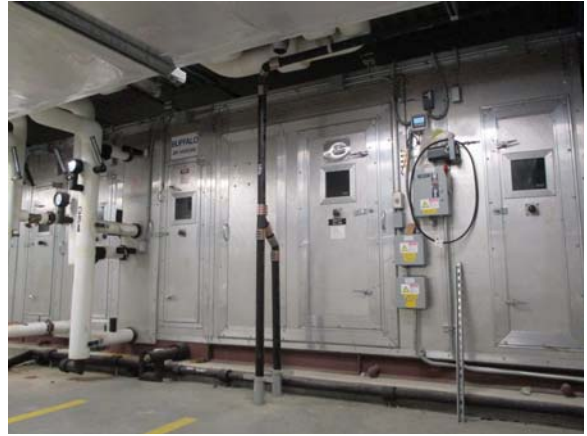
256129e 5/11/2021
Buffalo air handling unit (AHU-A-1) serving the lecture
halls
Room 3300

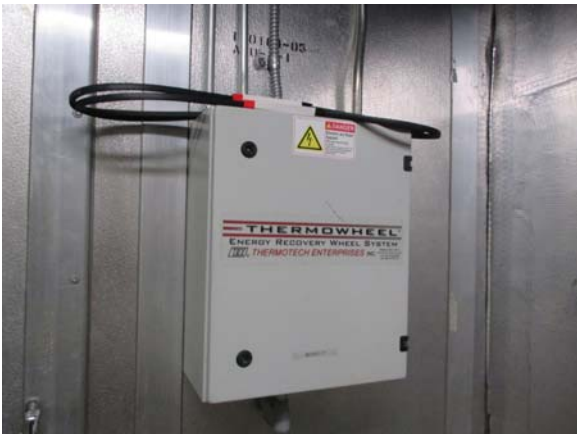
256130e 5/11/2021
Control box for the AHU-A-1 Thermotech Enterprises
enthalpy wheel
Room 3300
