# EAST CAROLINA UNIVERSITY

Facility Condition Assessment

Austin Building (006)

Inspected May 11, 2021

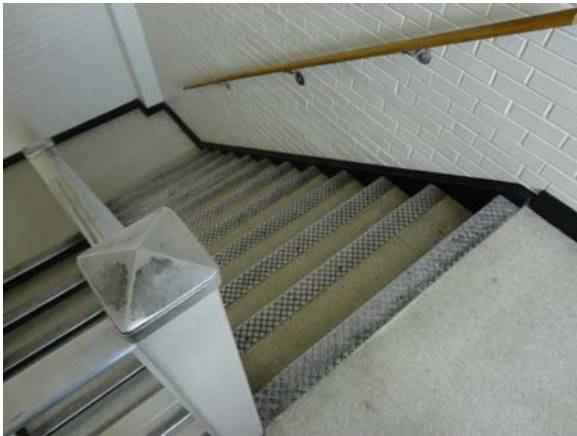
AUST005a 5/11/2021  
Aging vinyl stair treads need upgrade  
Third floor, stair tower

Access to the building is provided by ramp systems on the north and west. Both entrances are equipped with power-assisted door openers. The building has a fully accessible passenger elevator on the west end. However, the four stair towers lack accessible railing designs. Retrofit new accessible inner and outer railings on each stair flight and replace the stair treads once the existing tread finishes are properly removed.

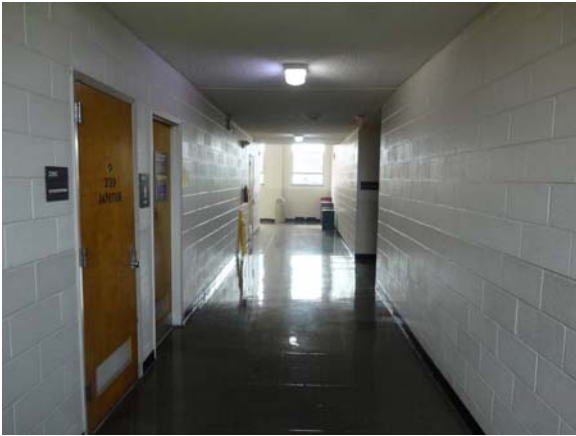
The nine-inch vinyl tile and mastics and the textured ceilings are suspected to contain asbestos, and it is assumed that nine-inch vinyl tile is present under the carpeting and that textured ceilings are present above the acoustical lay-in ceilings. Asbestos insulation was also observed on mechanical piping. Prior to any future renovation efforts, it is recommended that any asbestos material be properly abated.

AUST007a 5/11/2021  
Nine-inch vinyl floor tile, textured ceiling, and painted  
CMU walls  
Third floor corridor

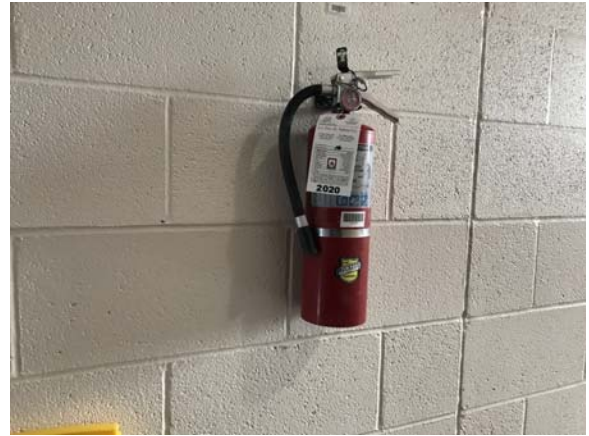
This facility is not protected by an automatic fire suppression system. Fire suppression is handled manually via strategically placed dry-type handheld fire extinguishers. As a part of future renovation efforts, it is recommended that an automatic wet-pipe fire suppression system be installed.

AUST008e 5/11/2021  
Fire extinguisher  
Third floor corridor

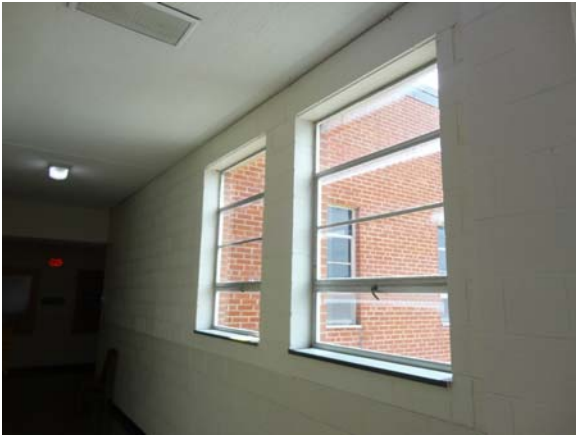
The brick facades have a good overall appearance other than some surface staining on upper elevations. The cut stone accents around the main entry are in satisfactory condition. The original single-pane glazing is in poor condition and should be considered for replacement with new thermal-pane, metal-framed glazing. The newer brick veneer and thermal-pane glazing on the west tower addition is in good condition and no upgrades are warranted.

AUST013a 5/11/2021  
Aging original single-pane, metal-framed windows  
Third floor corridor

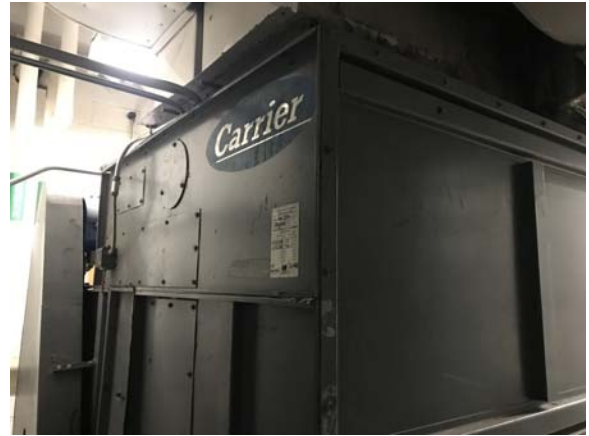
The main HVAC system provides heating and cooling via three constant air volume (CAV) air handling units with a hot and cold deck and thirteen fan coil units. An outdoor air handling unit serves a former computer/server area and was installed in 2003. Exhaust for the restrooms is handled by two centrifugal exhaust fans, and a propeller exhaust fan serves the main mechanical room. The air handling units, fan coil units, and exhaust fan have exceeded their respective statistical service lives and should be considered for removal and replacement with modern systems. Variable air volume (VAV) capable air handling units are recommended.

AUST013e 5/11/2021  
Air handling unit AHU-003  
Room 237

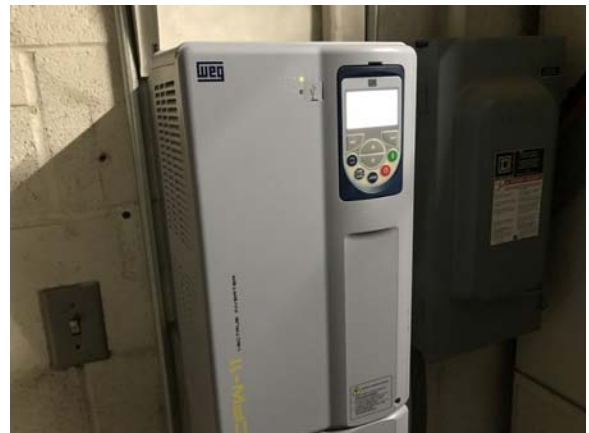
Variable frequency drives (VFDs) are associated with the air handling units. The drives are currently used as soft starts for the motors and not able to provide throttling due to the current HVAC controls. It is recommended that they be replaced during any future HVAC renovations.

AUST015e 5/11/2021  
VFD for AHU-003  
Room 237

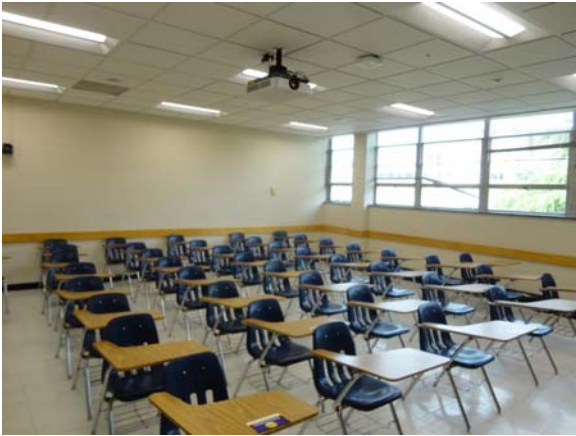
installed on all three floors. The older vinyl composite floor tile is worn and should be replaced in the near future. Ceramic floor and wall finishes in the standard restrooms are older and should be upgraded when these restrooms are updated. The newer accessible all-gender restrooms have ceramic floor and wall tile that is in good condition. Painted wall finishes are showing signs of wear and contact damage and should be repainted in the near future on all floors. Lay-in acoustical ceilings are in average condition and should be adequate for the near future. The nine-inch vinyl flooring and textured ceilings are suspected to contain asbestos and should be properly abated. Corridor doors for classrooms are new rated doors with lever hardware, but the office areas still have older doors with knob hardware. These older doors should be replaced with properly rated assemblies.

AUST016a 5/11/2021  
Older vinyl composite floor tile and lay-in acoustical ceiling  
Third floor, classroom

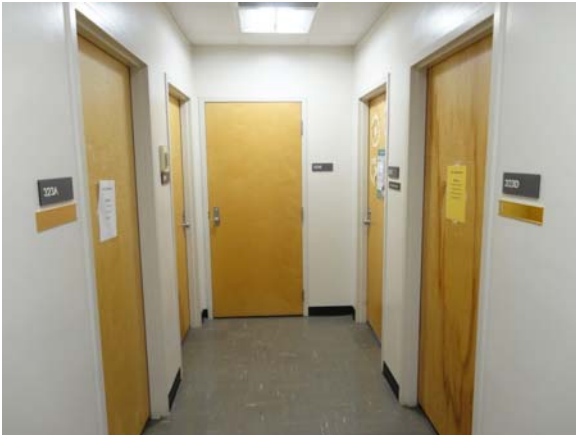
Dual-level drinking fountains have been installed in the corridors of the east and west wings on each floor. Newer interior doors for the classrooms have lever hardware and all of the floors have wall-mounted room signage with Braille. The remaining older doors, typically located in office areas, are recommended for replacement in the Fire/Life Safety section. If this door upgrade is not implemented, then new accessible lever hardware should be installed on these original doors.

AUST017a 5/11/2021  
Older doors with nonaccessible knob hardware  
Third floor, office suite

While the building appears to have adequate egress pathways, not all of the interior doors have been upgraded with new fire-rated assemblies. Areas like classrooms have had rated corridor door upgrades, but administrative areas still have older nonrated doors with knob hardware. Replace these older doors with new similar flush wood fire rated doors with metal frames and lever hardware.

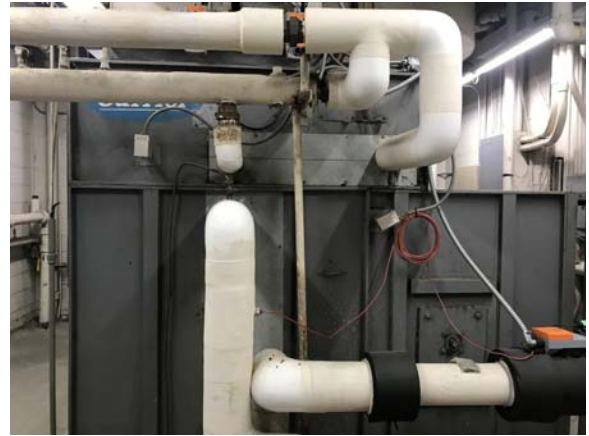
AUST017e 5/11/2021  
Air handling unit AHU-002  
Room 144

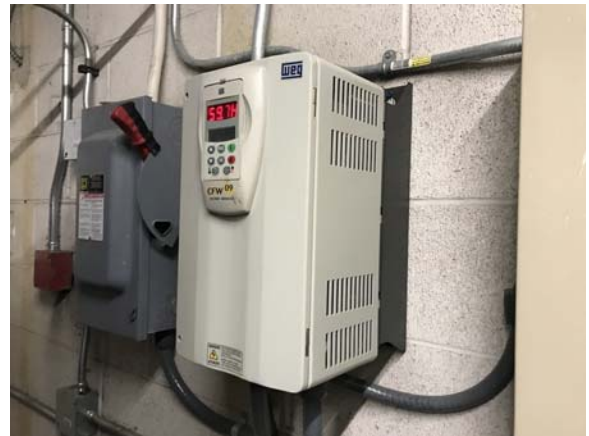
AUST018e 5/11/2021  
VFD for AHU-002  
Room 144

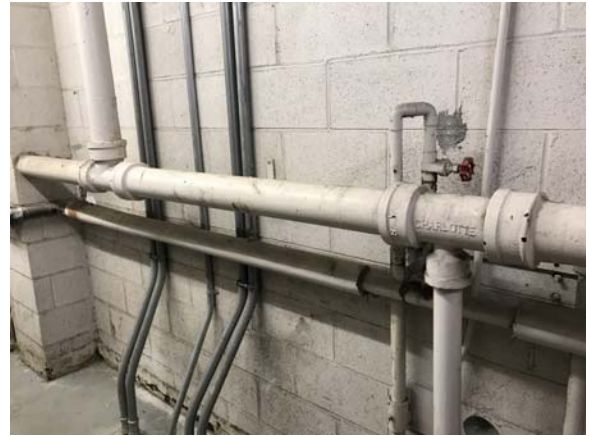
AUST019e 5/11/2021  
Cast-iron piping with bell-and-spigot connections  
Room 144

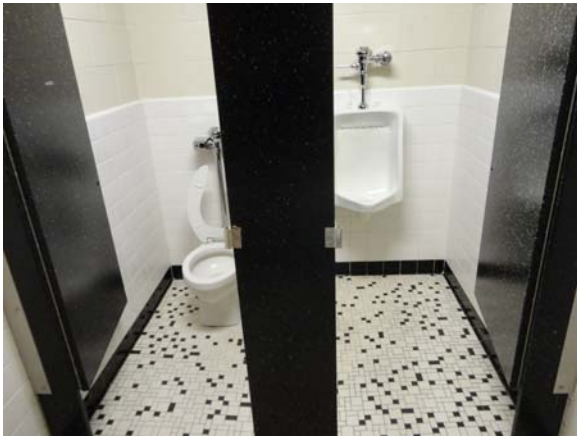
AUST020a 5/11/2021  
Standard fixtures  
Third floor, men's restroom

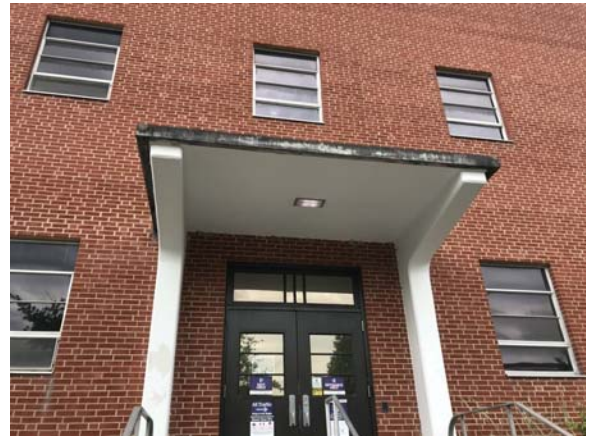
AUST020e 5/11/2021  
Ceiling-mounted HID lighting fixture  
Entrance

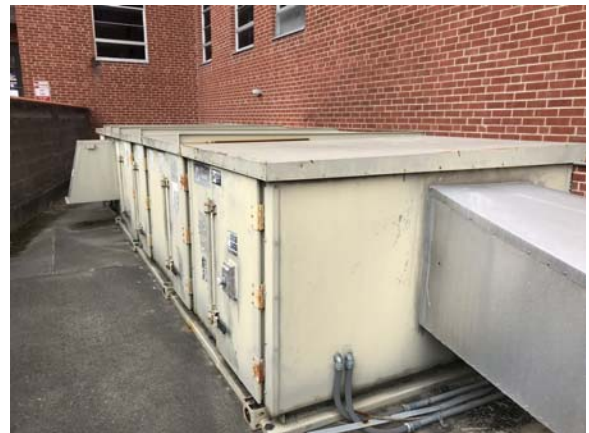
AUST021e 5/11/2021  
Air handling unit AHU-004  
Site

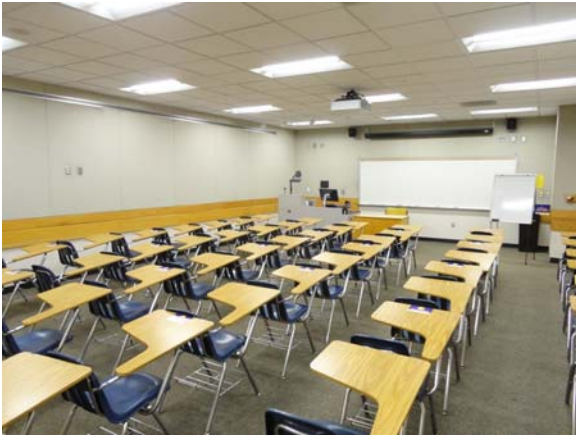
AUST022a 5/11/2021  
Broadloom carpeting and lay-in acoustical ceiling  
Third floor, classroom

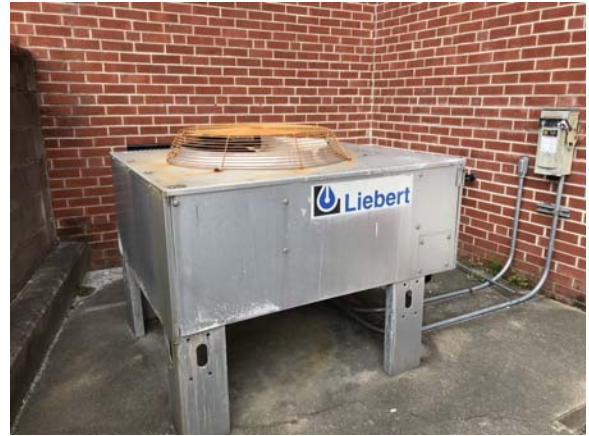
AUST022e 5/11/2021  
Dry-cooler for computer AC unit  
Site

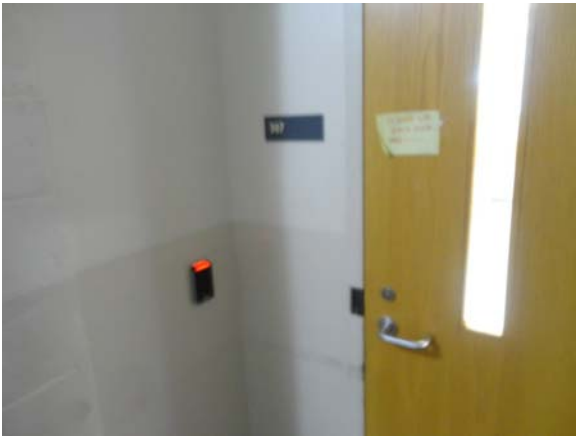
AUST023a 5/11/2021  
Newer corridor doors and lever hardware  
Third floor

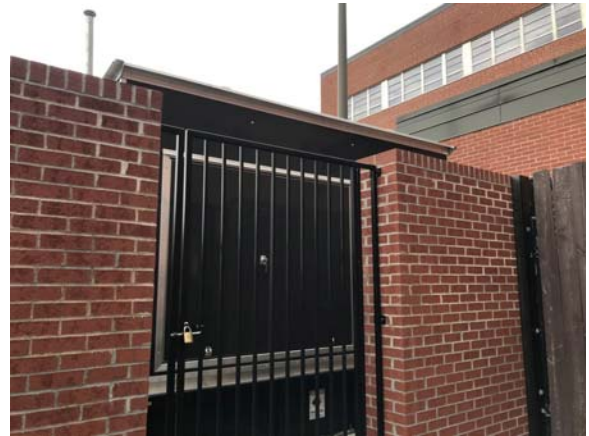
AUST023e 5/11/2021  
Diesel-fired emergency generator  
Courtyard

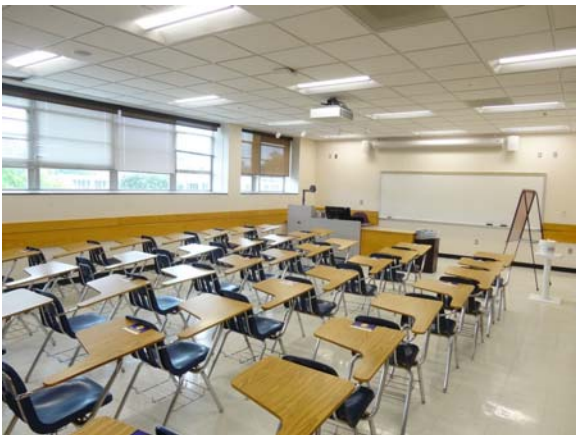
AUST024a 5/11/2021  
Vinyl composite floor tile and lay-in acoustical ceiling  
Third floor, classroom

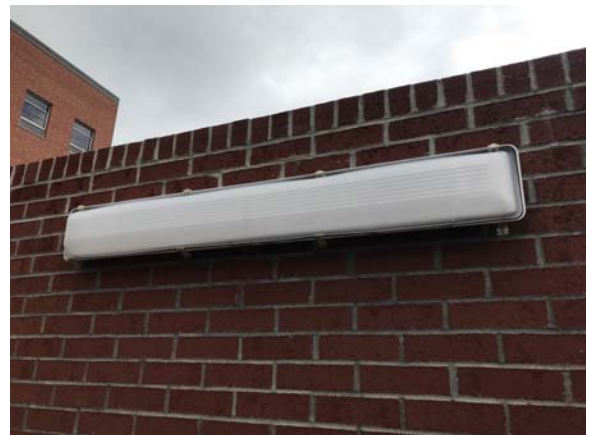
AUST024e 5/11/2021  
Wall-mounted T8 lighting fixture  
Courtyard

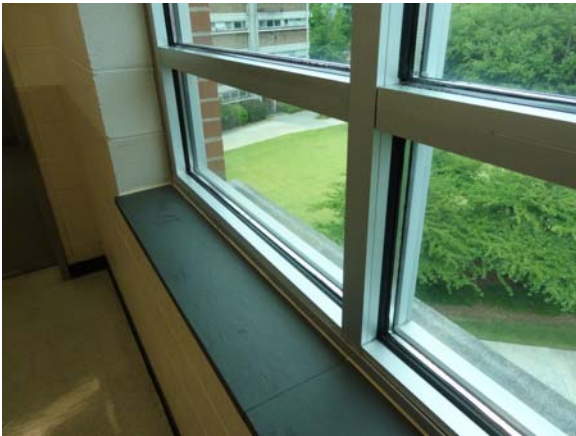
AUST026a 5/11/2021  
Newer thermal-pane fixed glazing  
Third floor, west elevator tower addition

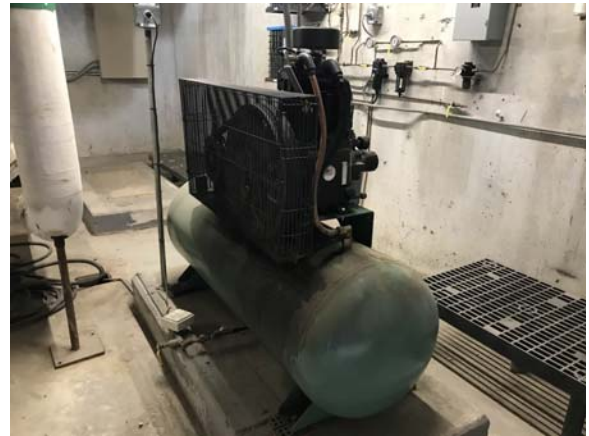
AUST026e 5/11/2021  
Controls air compressor  
Room 149

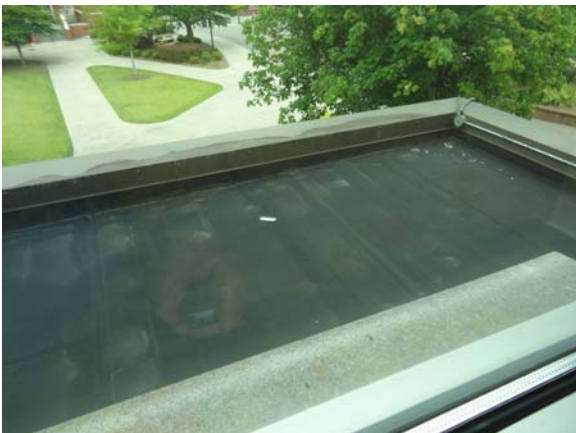
AUST027a 5/11/2021  
Unballasted membrane roof  
Third floor, west elevator tower addition

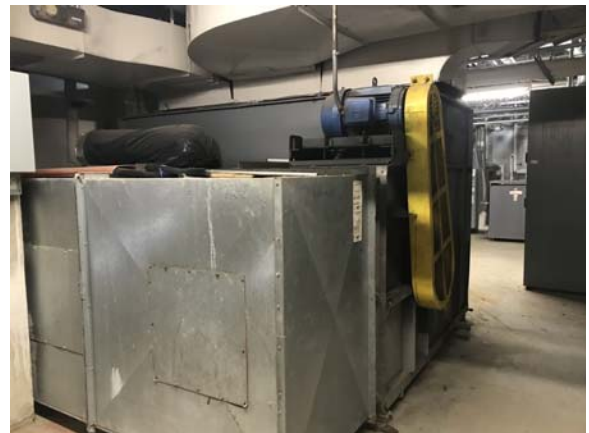
AUST027e 5/11/2021  
Air handling unit AHU-001  
Room 149

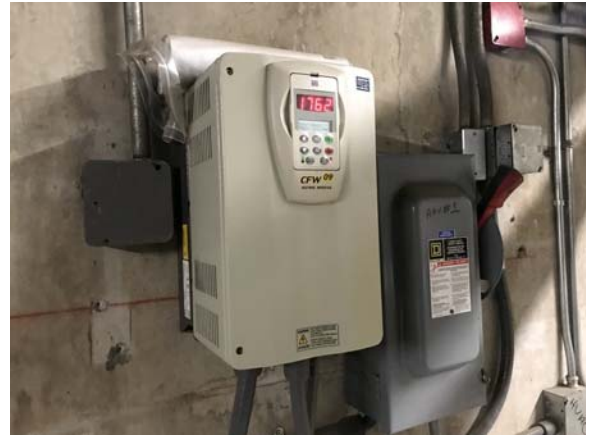
AUST028e 5/11/2021  
VFD for AHU-001  
Room 149

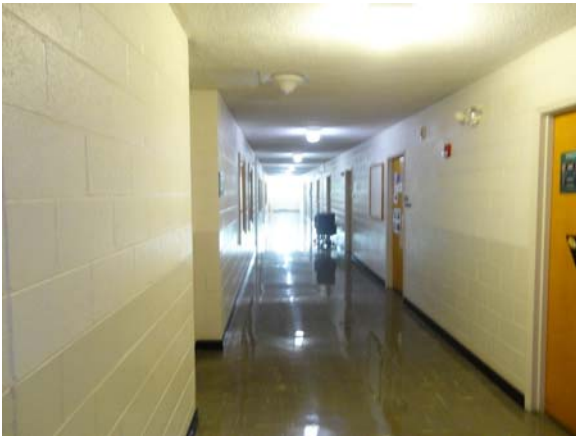
AUST029a 5/11/2021  
Nine-inch vinyl floor tile, textured ceiling, and painted  
CMU walls  
Second floor corridor

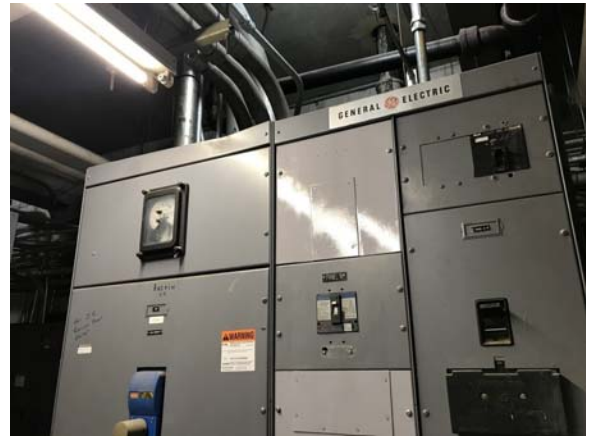
AUST029e 5/11/2021  
Main switchboard  
Room 149

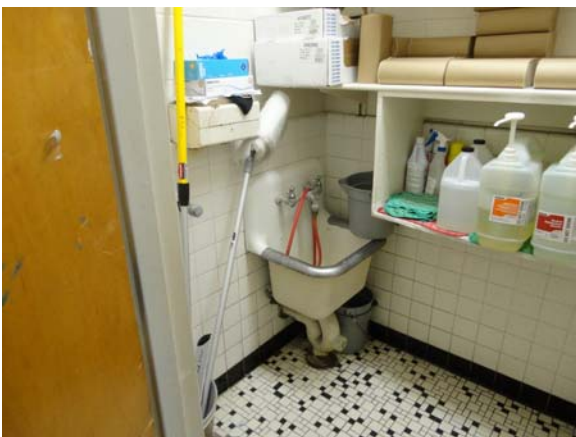
AUST030a 5/11/2021  
Older wall-mounted service sink  
Second floor, janitor's closet

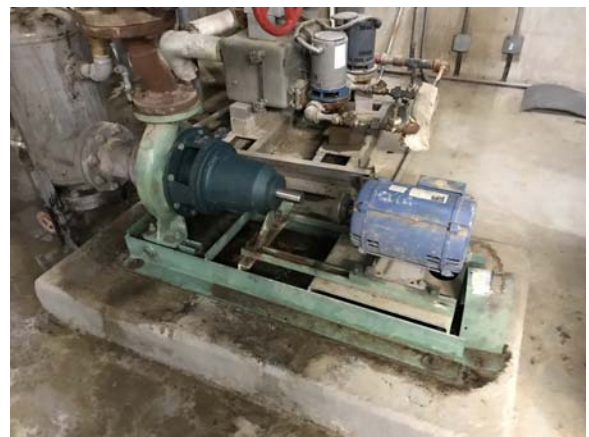
AUST030e 5/11/2021  
Heating hot water pump  
Room 149

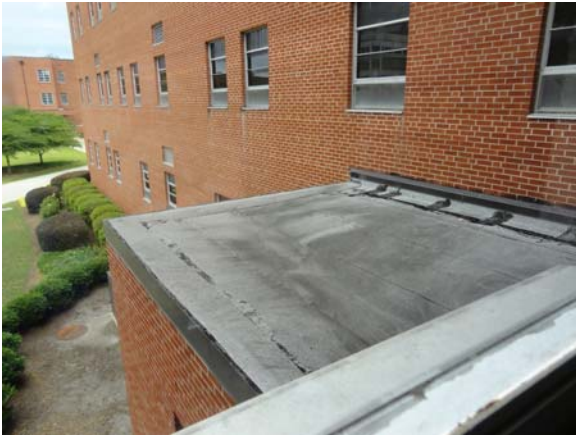
AUST031a 5/11/2021  
Lower built-up roof  
South center of building

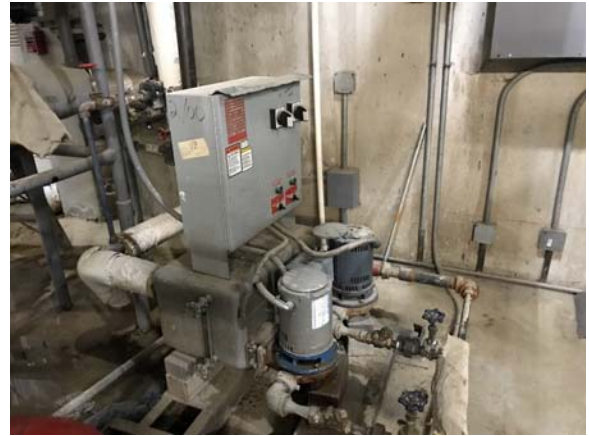
AUST031e 5/11/2021  
Condensate receiver  
Room 149

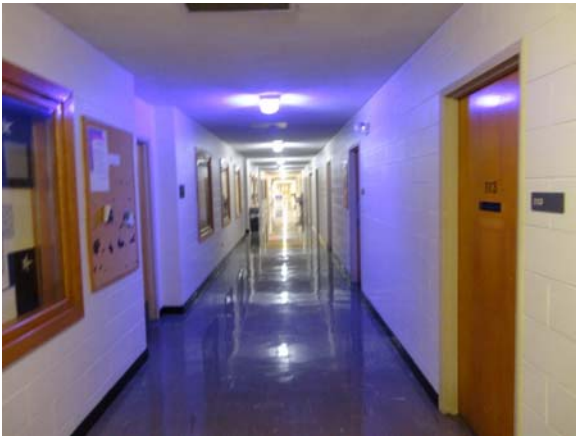
AUST032a 5/11/2021  
Nine-inch vinyl floor tile, textured ceiling, and painted  
CMU walls  
First floor corridor

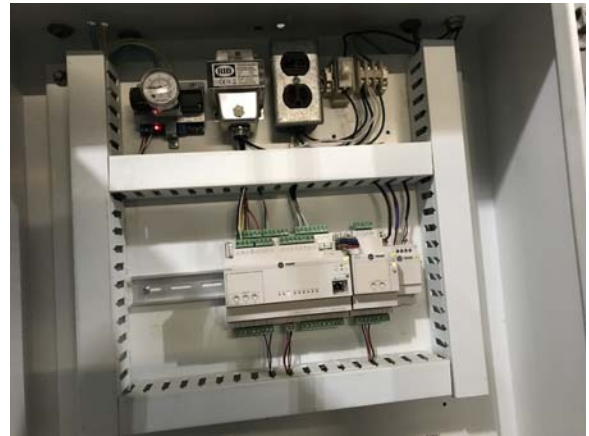
AUST032e 5/11/2021  
HVAC field panel  
Room 149

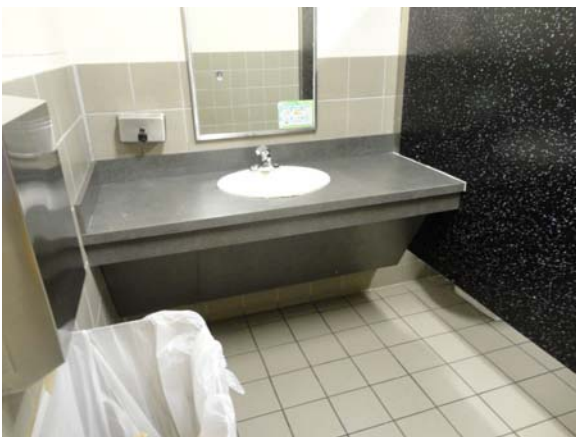
AUST033a 5/11/2021  
Accessible counter lavatory  
First floor, men's restroom

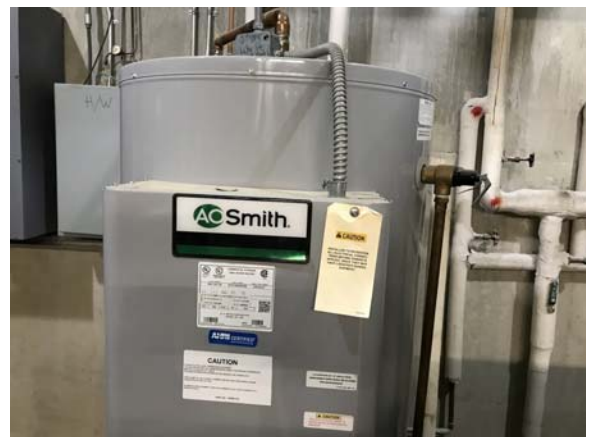
AUST033e 5/11/2021  
Residential electric water heater  
Room 149

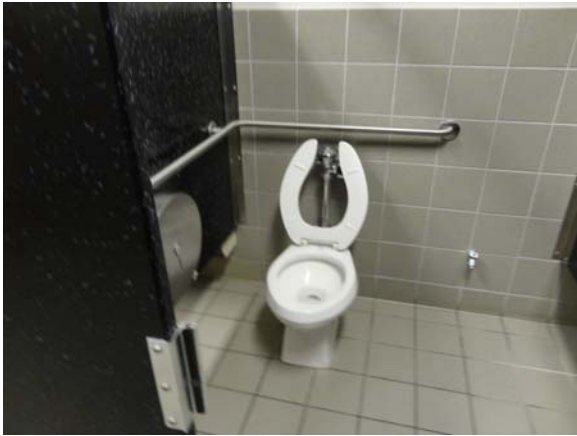
AUST034a 5/11/2021  
Accessible toilet stall  
First floor, men's restroom

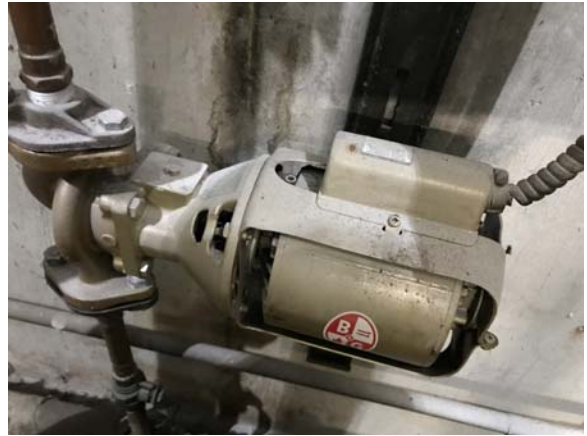
AUST034e 5/11/2021  
Fractional horsepower domestic hot water pump  
Room 149

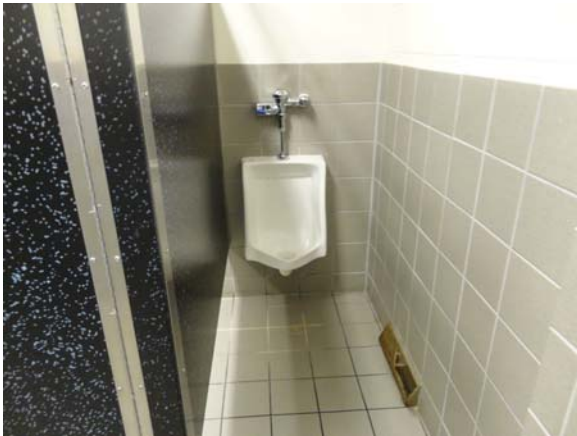
AUST035a 5/11/2021  
Urinal area  
First floor, men's restroom

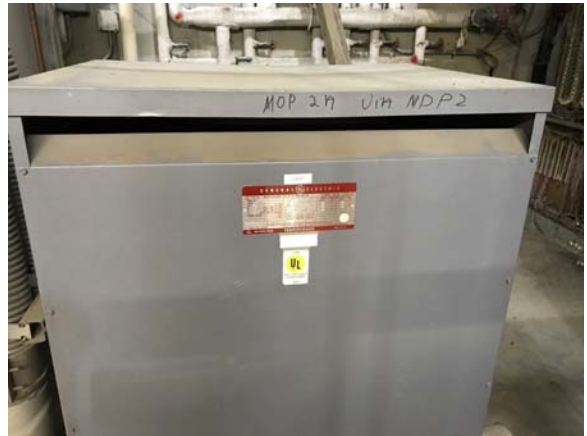
AUST035e 5/11/2021  
Step-down transformer  
Room 149

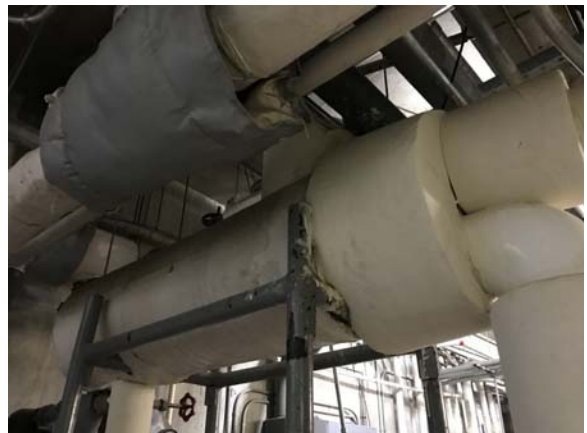
AUST036e 5/11/2021  
Heating hot water shell-and-tube heat exchanger  
Room 149

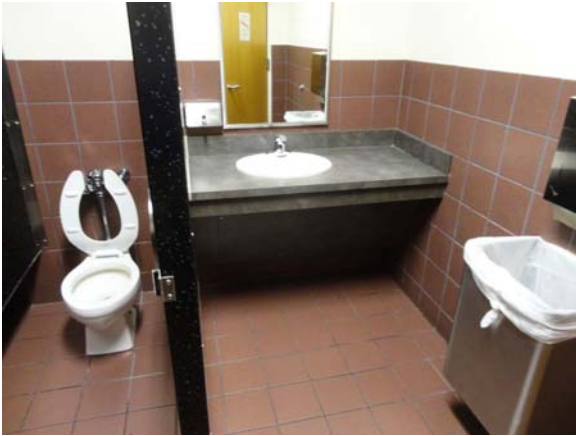
AUST037a 5/11/2021  
Accessible counter sink  
First floor, women's restroom

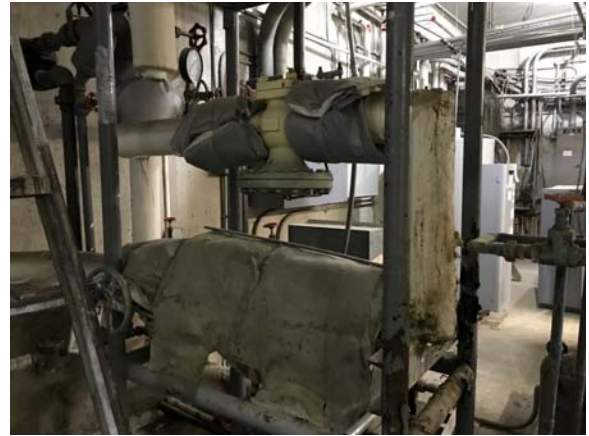
AUST037e 5/11/2021  
Pressure reducing valves  
Room 149

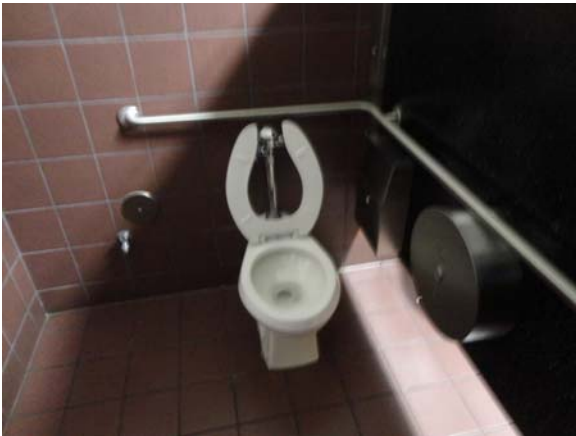
AUST038a 5/11/2021  
Accessible toilet stall  
First floor, women's restroom

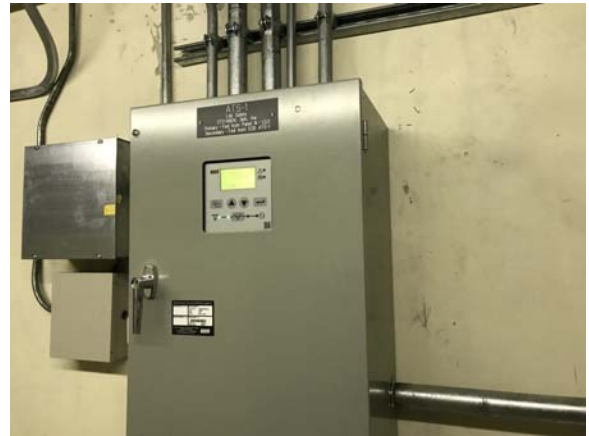
AUST038e 5/11/2021  
Automatic transfer switch  
Room 149

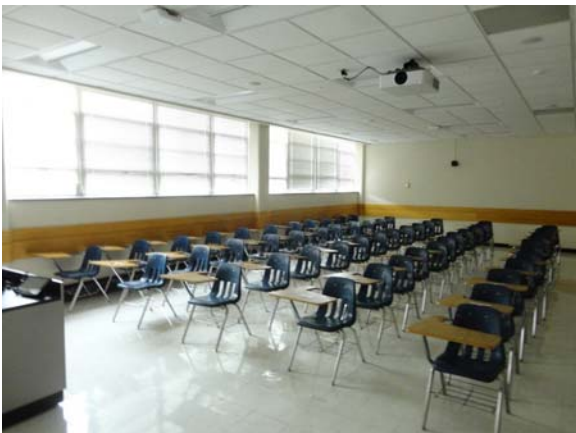
AUST039a 5/11/2021  
Older vinyl composite floor tile and lay-in acoustical  
ceiling  
First floor, classroom

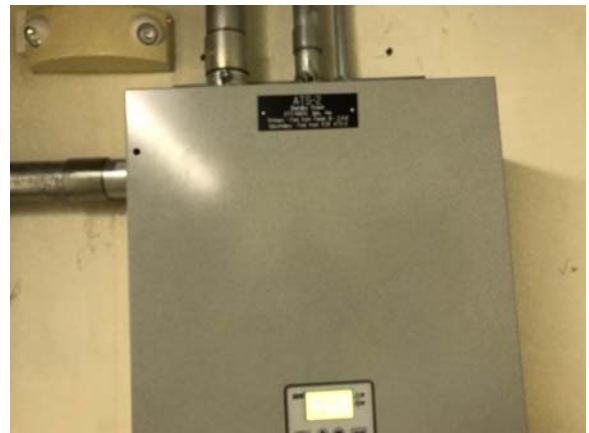
AUST039e 5/11/2021  
Automatic transfer switch  
Room 149

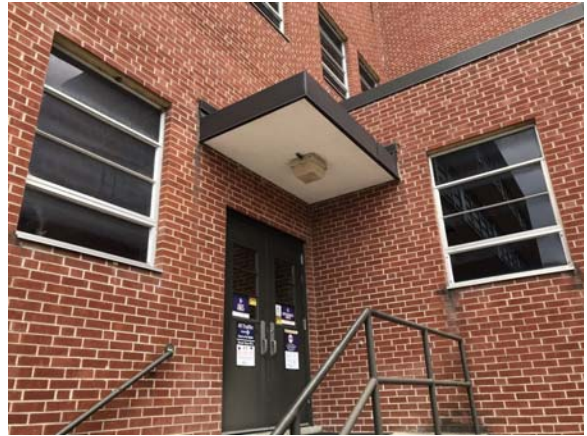
AUST040e 5/11/2021  
Ceiling-mounted HID lighting fixture  
Entrance

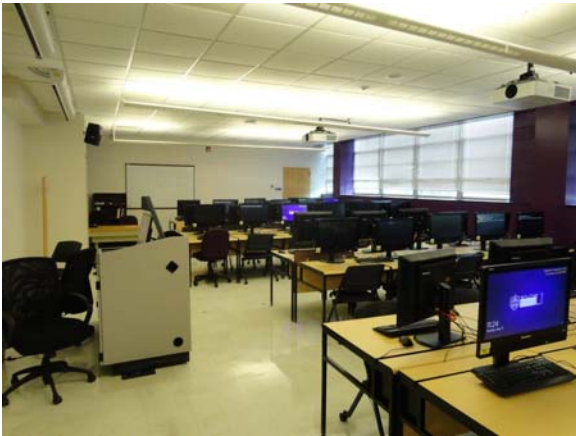
AUST041a 5/11/2021  
Newer vinyl flooring and acoustical ceiling  
First floor, computer lab

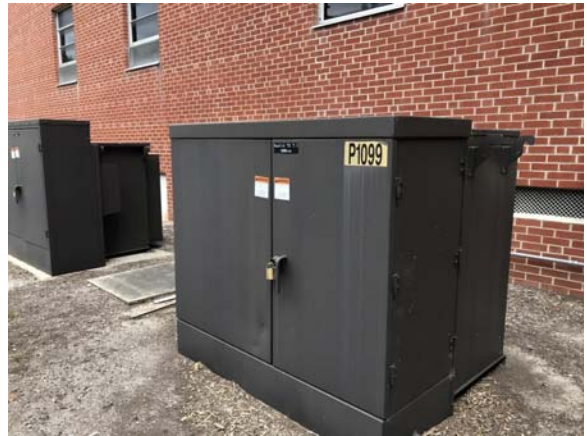
AUST041e 5/11/2021  
Oil-filled transformer  
Site

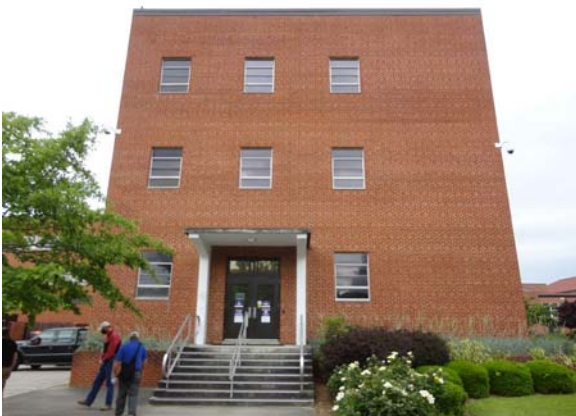
AUST042a 5/11/2021  
Hollow-metal doors at end elevation  
East end elevation

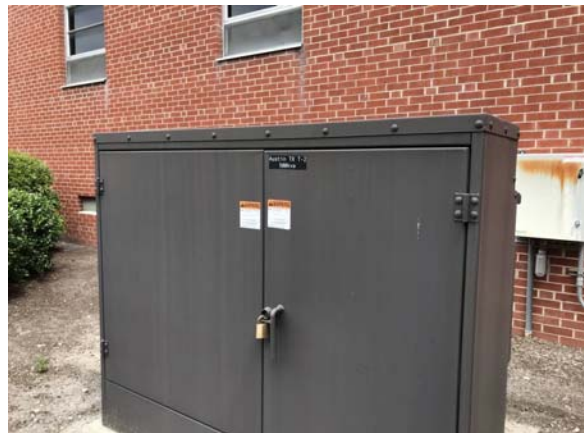
AUST042e 5/11/2021  
Oil-filled transformer  
Site

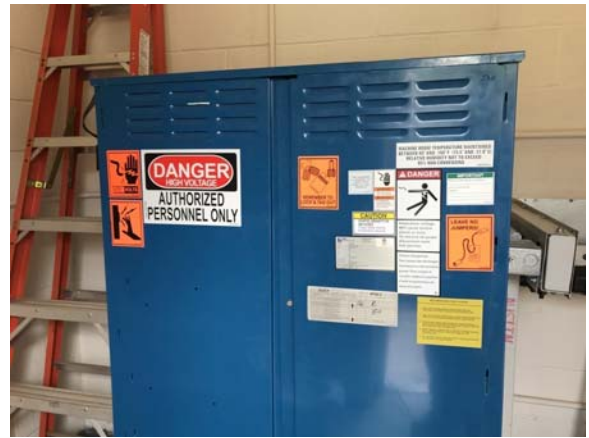
AUST043e 5/11/2021  
Elevator controls  
Room 151

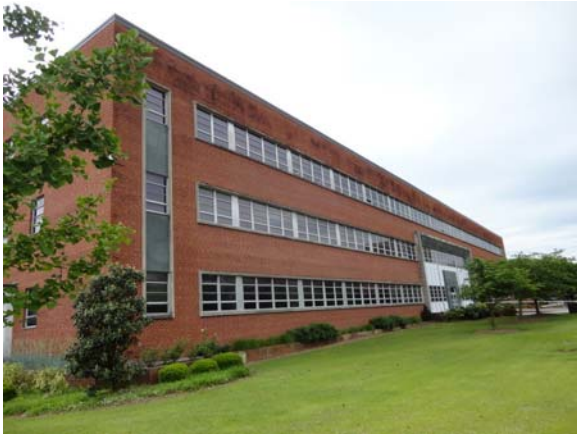
AUST044a 5/11/2021  
Brick and glazing  
Northeast corner elevation

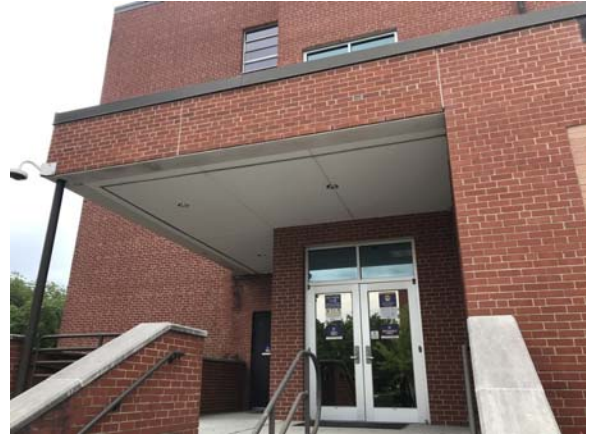
AUST044e 5/11/2021  
Recessed can exterior lighting fixtures  
Soffit

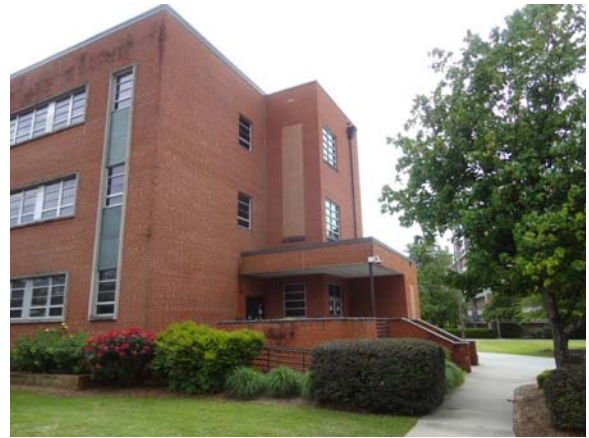
AUST048a 5/11/2021  
Elevator tower addition  
West elevation

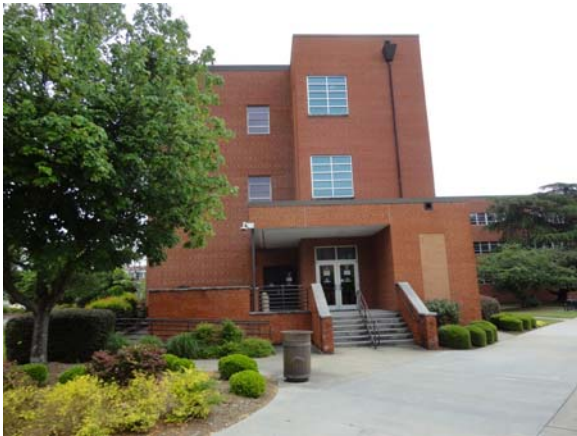
AUST049a 5/11/2021  
Newer glass entry doors and newer tower windows  
West elevation

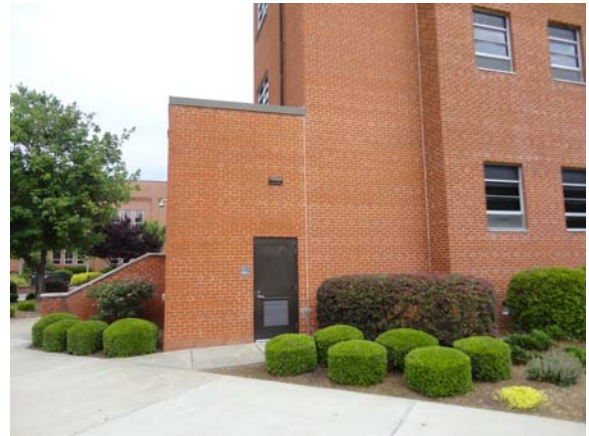
AUST050a 5/11/2021  
Newer hollow-metal service door  
West elevation

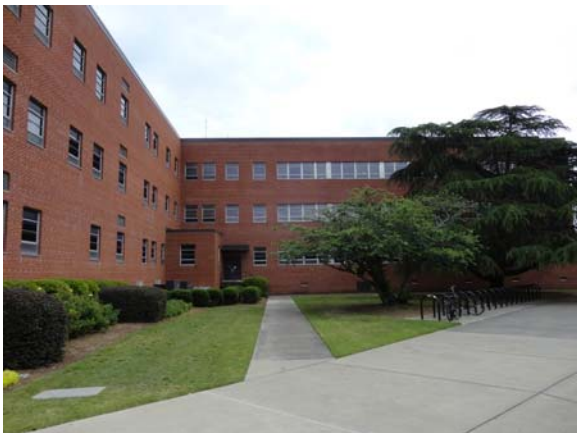
AUST051a 5/11/2021  
Brick finishes and glazing  
Southwest elevation

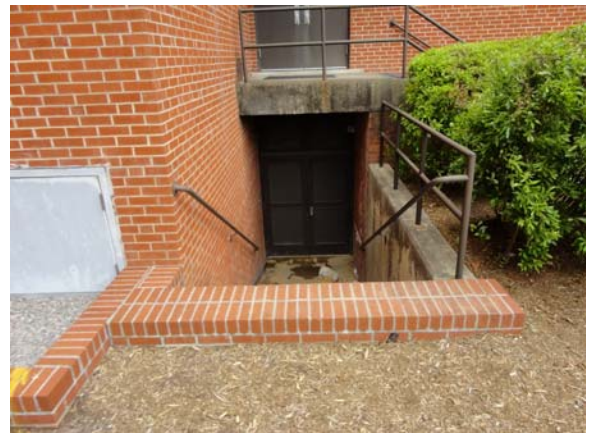
AUST052a 5/11/2021  
Hollow-metal service doors at areaway  
Southwest elevation

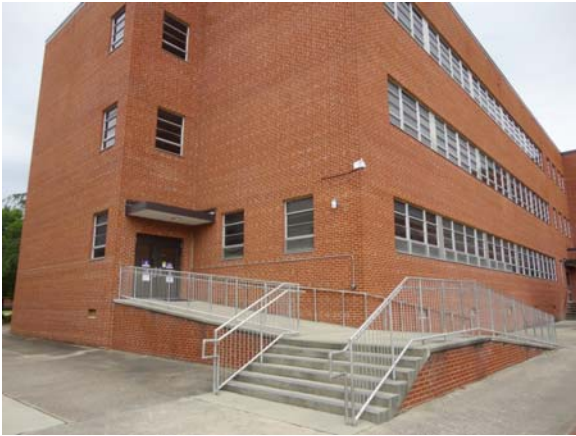
AUST053a 5/11/2021  
Ramped access to first floor  
South end elevation

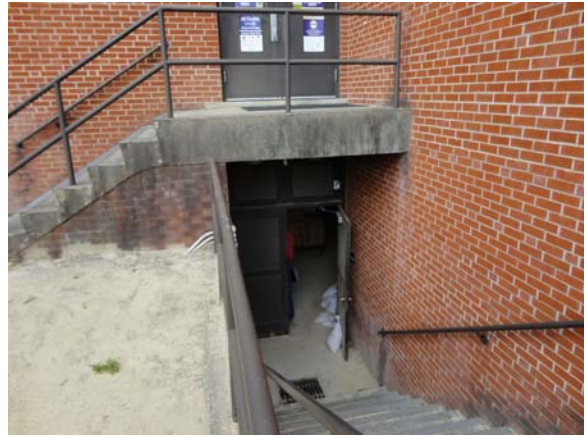
AUST054a 5/11/2021  
Hollow-metal service doors at areaway  
Southeast elevation
