EAST CAROLINA UNIVERSITY

Facility Condition Assessment

Harold H. Bate Building (095)

Inspected May 11, 2021

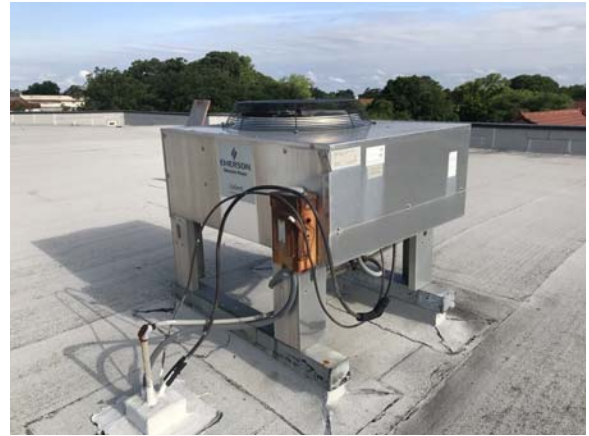
BATE001e 5/11/2021
Dry-cooler condensing unit for computer AC unit
Roof

Two computer AC units with associated dry-coolers provide cooling for the server room. Installed in 2007 and 2015, the dry-coolers and 2015 computer AC unit are expected to remain viable for the next ten years. The 2007 computer AC unit should be evaluated for replacement within the next ten years due to lifecycle depletion.

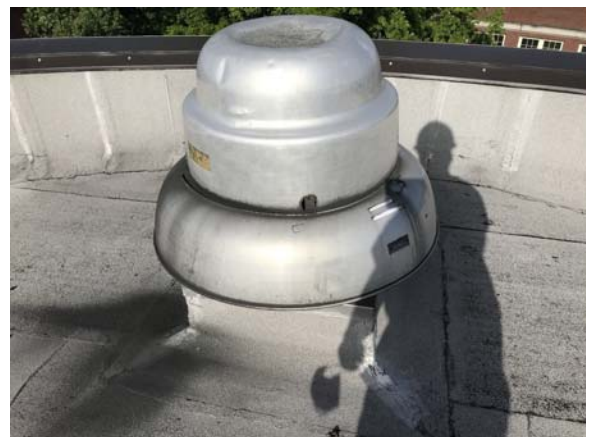
BATE003e 5/11/2021
Centrifugal rooftop exhaust fan
Roof

Exhaust for the restrooms is handled by two centrifugal exhaust fans. A propeller exhaust fan serves the main mechanical room and a utility exhaust fan serves the elevator machine room. The air handling unit, fan coil units, and the exhaust fans have exceeded their respective statistical service lives and should be considered for removal and replacement with modern systems. Variable air volume (VAV) capable air handling units are recommended.

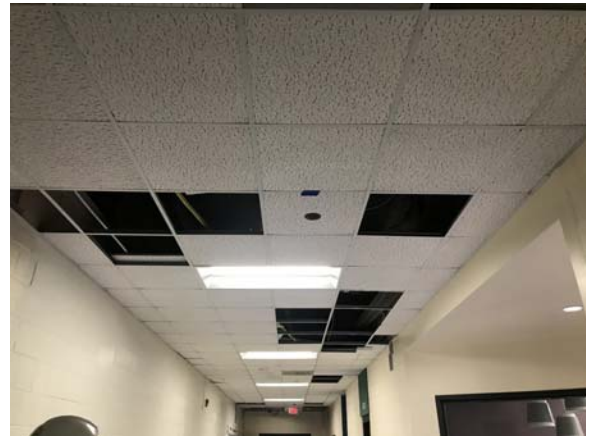
BATE005e 5/11/2021
Recessed LED lighting fixtures
Third floor corridor

The interior lighting was replaced in 2017 and consists of recessed lay-in LED fixtures and recessed can fixtures with lighting controls. LED retrofits were observed in select spaces. No issues were observed or reported, and the lighting is expected to remain viable for the next ten years.

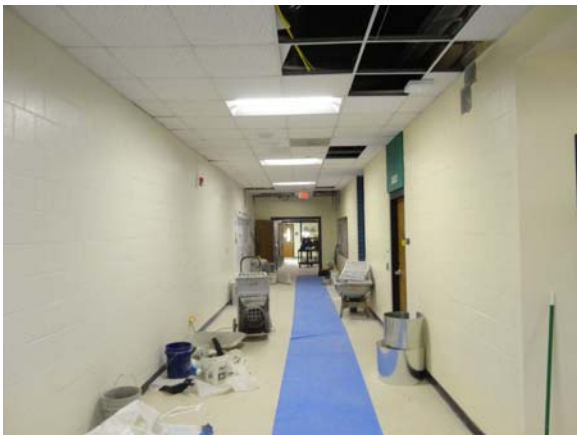
BATE006a 5/11/2021
Older VCT, acoustical ceiling, and painted block walls
Third floor corridor

Interior finishes are in average condition. Carpeting in the offices and meeting rooms varies in age and condition. Due to a short lifecycle, all of the existing broadloom carpeting and carpet tile will need to be replaced. Most of the vinyl composite tile flooring is older and should also be replaced in kind. The newer vinyl and LVT flooring is adequate and no upgrades are warranted. Ceramic floor and wall tile finishes in the upgraded restrooms are in good condition and no finish upgrades are needed at this time.

Walls are painted and vary in condition. Repaint the interior walls in phases over the next few years. Slat wood acoustical wall treatments in the tiered seminar rooms are original but still functional and no upgrades are recommended. Acoustical ceiling systems also vary in age and condition but most are newer and should be serviceable for the near future. The remaining older acoustical ceilings should be replaced in kind.

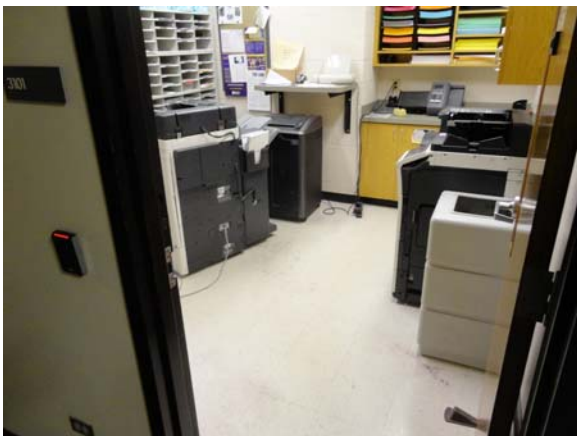
BATE012a 5/11/2021
Casework
Third floor, typical workroom

The interior corridor and standard interior doors are aging original flush wood assemblies that are due for replacement. Casework in the break areas and workstations is older and also due for replacement. The molded plastic fixed seating in the seminar rooms is showing wear and should be upgraded. Replace this seating with new fixed seats in a similar row configuration. Ensure that ADA requirements are followed with the new seating layout.

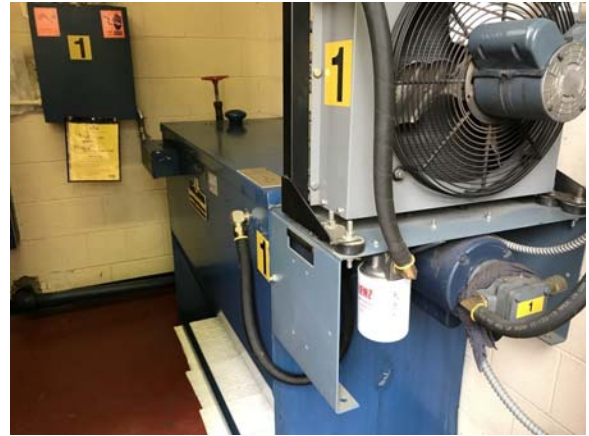
BATE040e 5/11/2021
Elevator 1 hydraulic controls
Room 1036

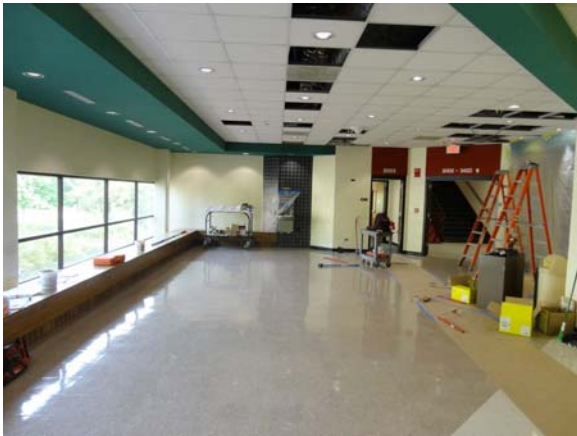
BATE041a 5/11/2021
Older vinyl flooring and acoustical ceiling
Second floor, commons

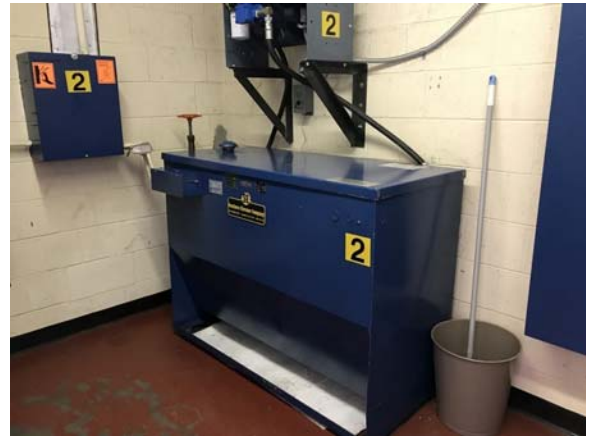
BATE041e 5/11/2021
Elevator 2 hydraulic controls
Room 1036

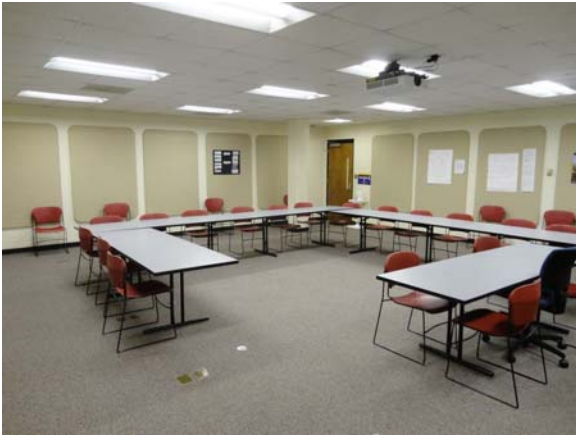
BATE043a 5/11/2021
Older broadloom carpeting and acoustical ceiling
Second floor, meeting room

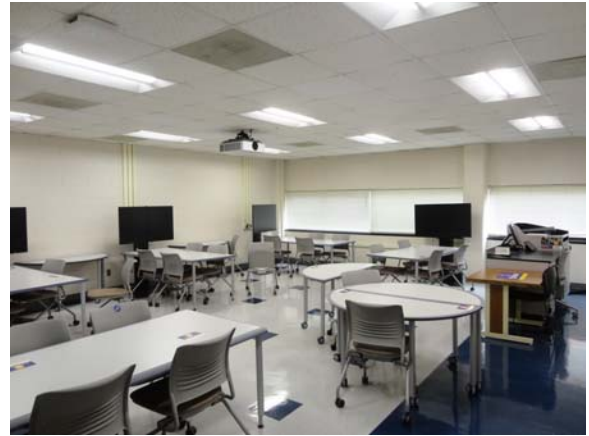
BATE044a 5/11/2021
Older VCT and acoustical ceiling
Second floor, class lab

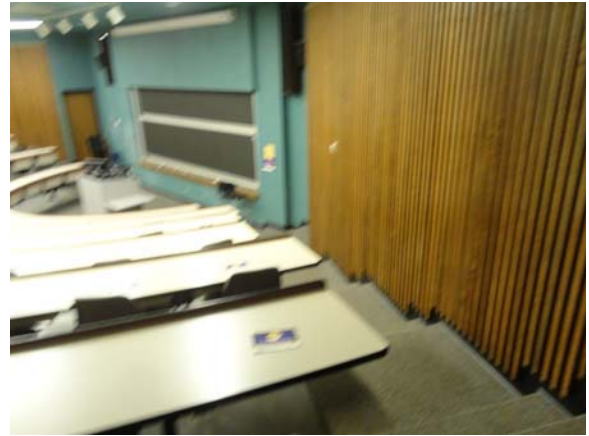
BATE050a 5/11/2021
No side aisle handrails
First floor, larger tiered classroom

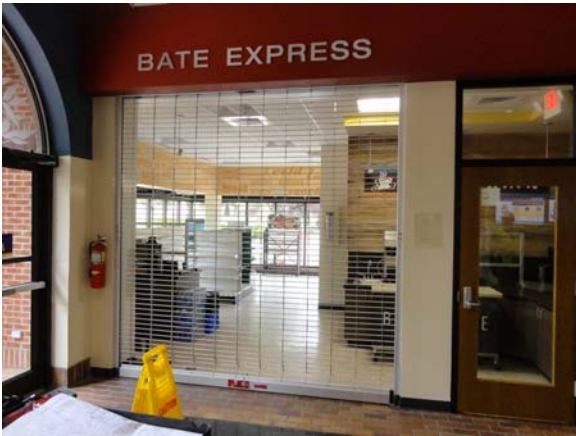
BATE051a 5/11/2021
Roll down shutter for food service area
First floor, Bate Express

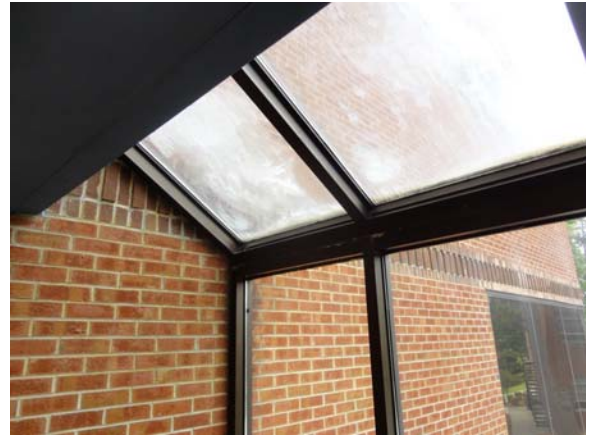
BATE056a 5/11/2021
Fogging on atrium glass
First floor
