EAST CAROLINA UNIVERSITY

Facility Condition Assessment

Rawl Building (004)

Inspected May 10, 2021

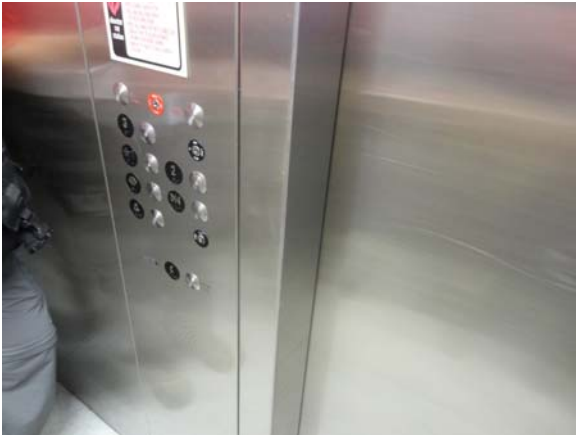
RAWL001a 5/10/2021
Accessible elevator control panel
East elevator tower addition

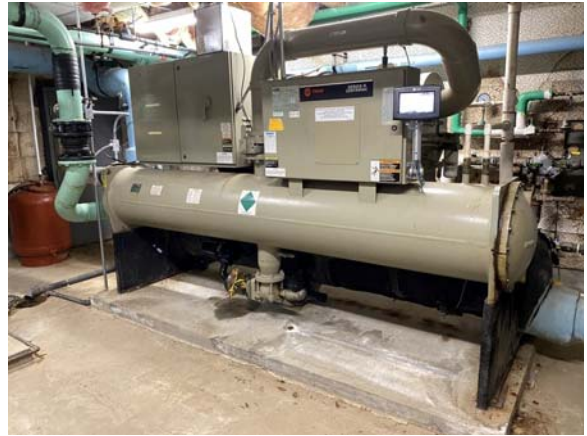
RAWL001e 5/10/2021
Water-cooled centrifugal chiller
Room 12A

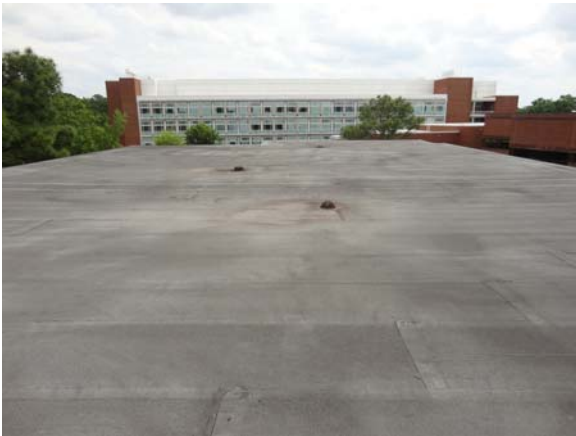
RAWL002a 5/10/2021
Main built-up roof
Main roof

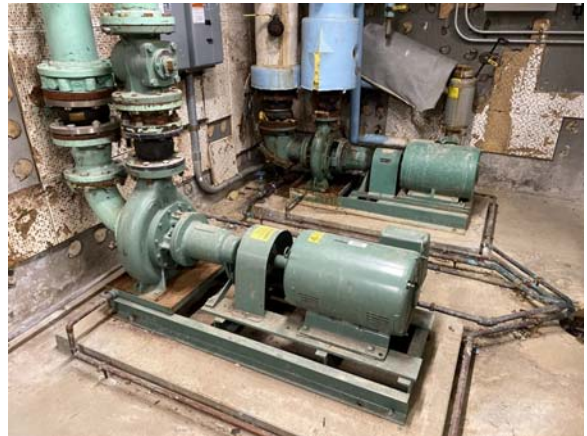
RAWL002e 5/10/2021
Chilled water and condenser water pumps
Room 12A

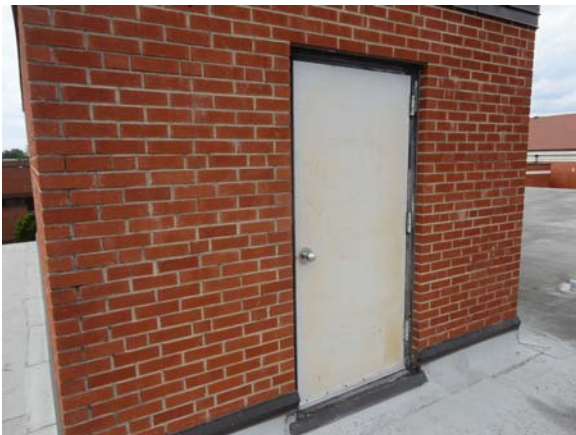
RAWL003a 5/10/2021
Hollow metal roof access door
Main roof

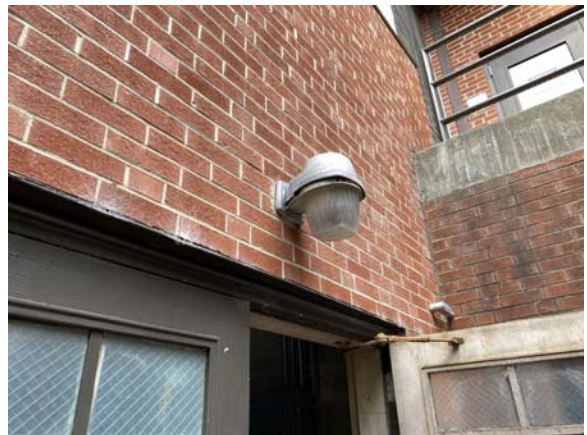
RAWL003e 5/10/2021
HID sconce lighting fixture
Exterior entrance

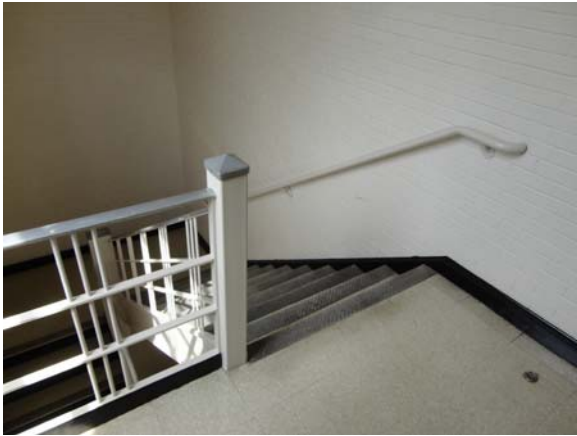
The building has a fully accessible passenger elevator on the east end. The four stair towers have compliant wall-mounted handrails but lack accessible inner switchback railings. Retrofit new accessible inner railings on each stair flight, and replace the stair treads. Also, install metal riser panels and a lower cane guard on the exterior egress stair at the south end of the annex to meet current accessibility standards.

RAWL004a 5/10/2021
Accessible wall rail but wide picket spacing on inner railing
Third floor, stair tower

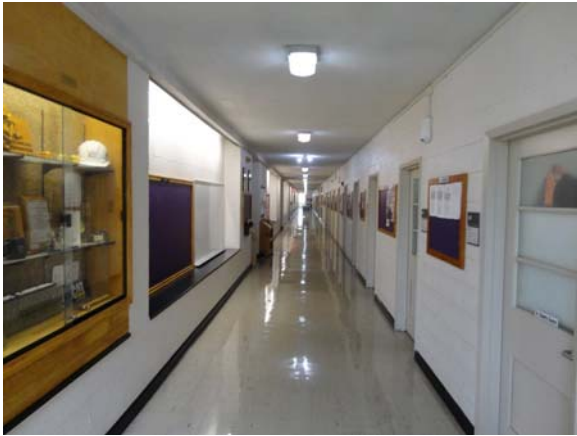
RAWL005a 5/10/2021
9x9 vinyl floor tile and textured ceiling
Third floor corridor

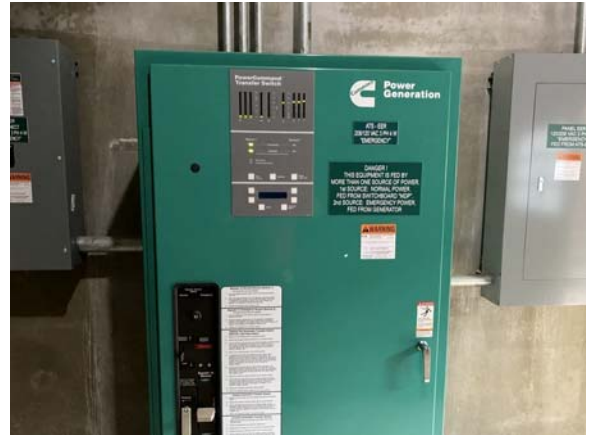
Two automatic transfer switches (150 and 225 amps) transfer emergency power to life safety devices and the elevator. These get emergency power from the Bate building generator. No issues with these switches were observed or reported, and they are expected to remain viable for the next ten years.

RAWL005e 5/10/2021
Automatic transfer switch
Room 146

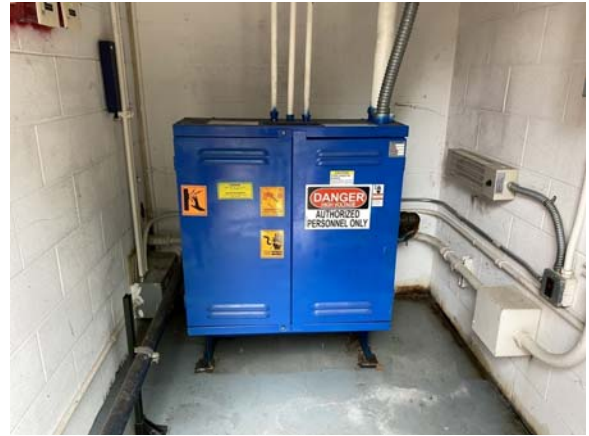
RAWL007e 5/10/2021
Hydraulic elevator controls
Room 101

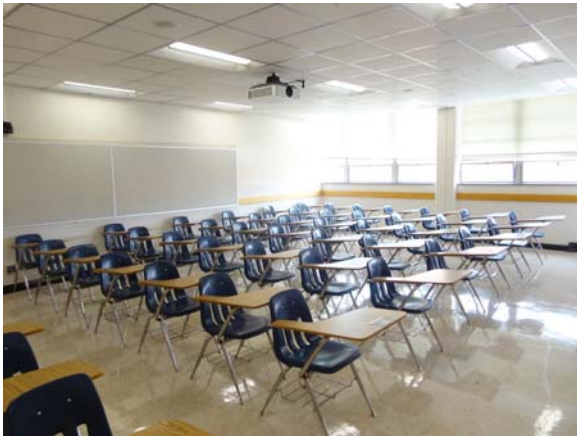
RAWL008a 5/10/2021
Older vinyl composite floor tile and acoustical ceiling
Third floor classroom

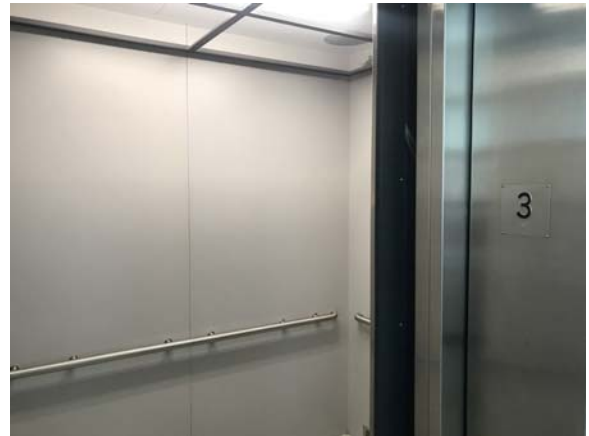
RAWL008e 5/10/2021
Elevator interior
Elevator

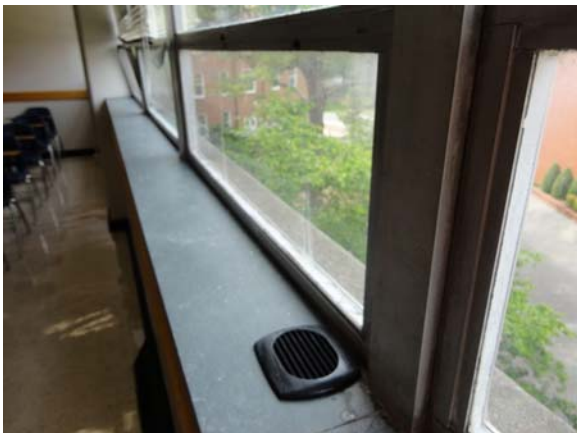
RAWL009a 5/10/2021
Original single-pane glazing
Third floor glazing

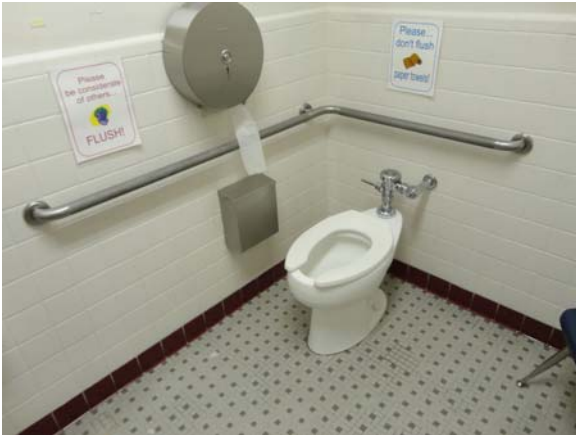
RAWL010a 5/10/2021
Accessible tankless toilet
Third floor all-gender restroom

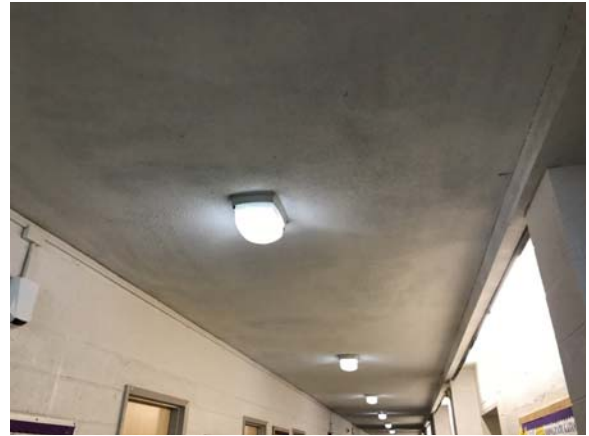
RAWL010e 5/10/2021
Ceiling-mounted sconce lighting fixture
Third floor corridor

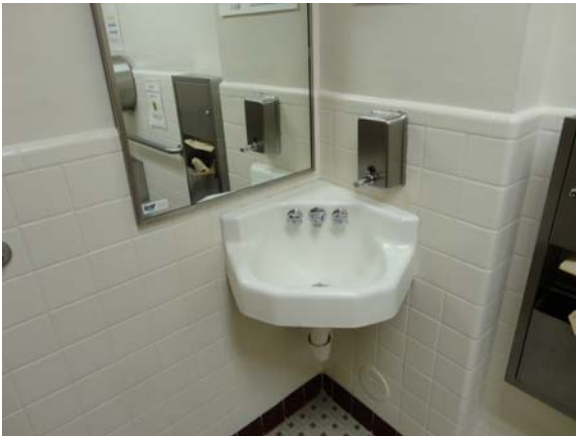
RAWL011a 5/10/2021
Nonaccessible corner wall sink
Third floor all-gender restroom

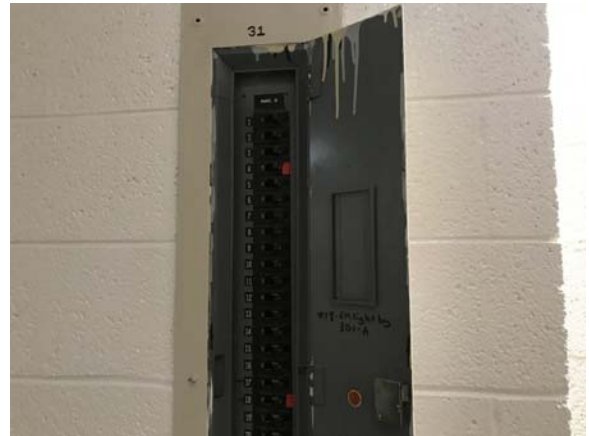
RAWL011e 5/10/2021
Local panelboard
Third floor corridor

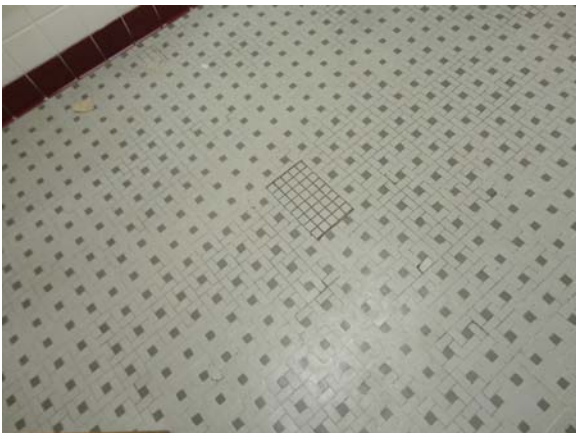
RAWL012a 5/10/2021
Dissimilar ceramic tile floor repair
Third floor all-gender restroom

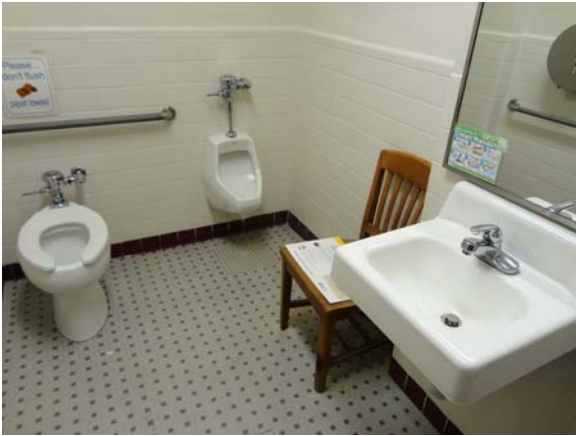
RAWL013a 5/10/2021
Three-fixture accessible restroom
Third floor all-gender restroom

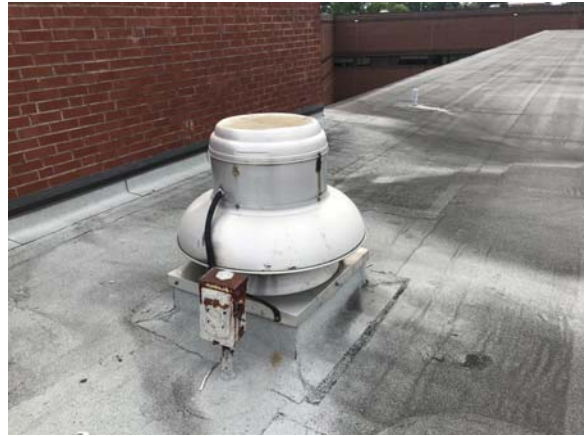
RAWL013e 5/10/2021
Centrifugal rooftop exhaust fan
Roof

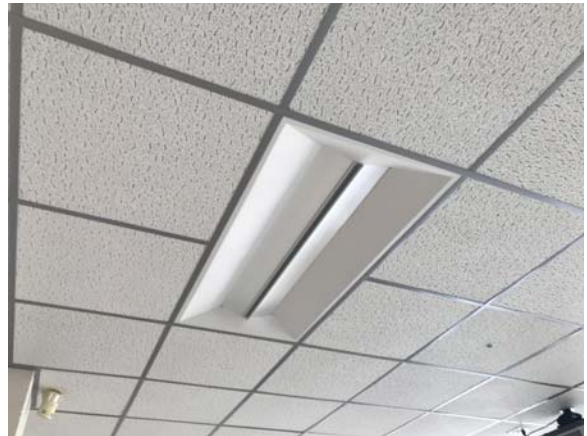
RAWL014e 5/10/2021
Recessed lay-in LED lighting
Room 339

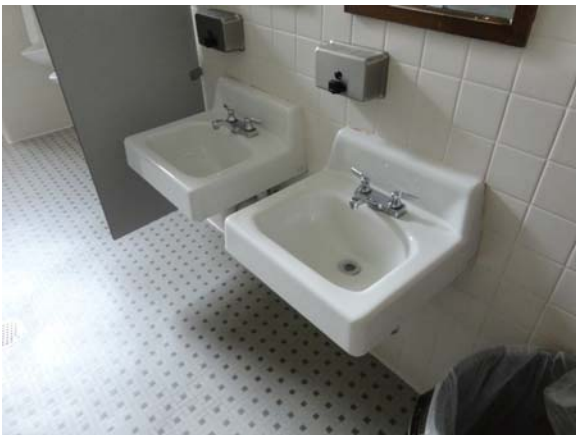
RAWL015a 5/10/2021
Two older wall-mounted sinks
Third floor men's restroom

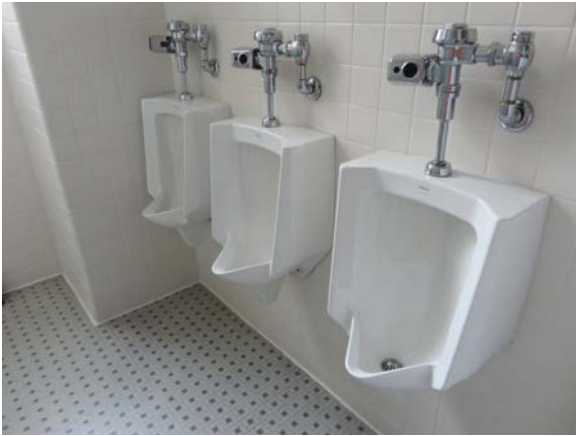
RAWL016a 5/10/2021
Three newer wall-mounted urinals
Third floor men's restroom

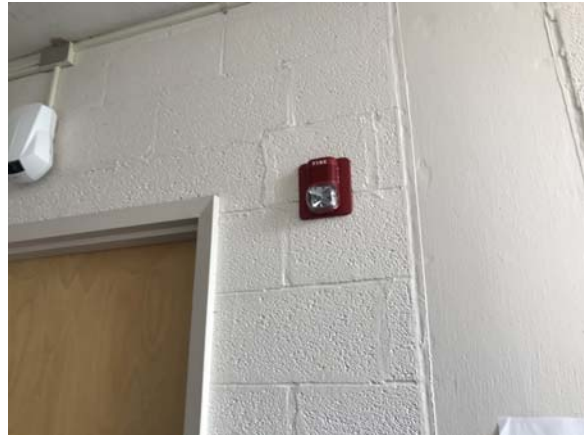
RAWL016e 5/10/2021
Horn strobe fire alarm device
Third floor corridor

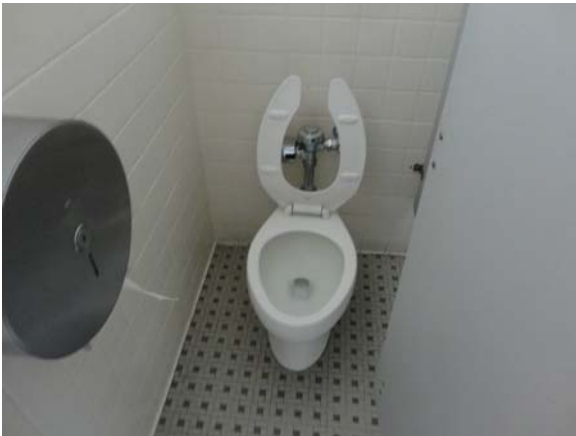
RAWL017a 5/10/2021
Standard tankless toilet
Third floor men's restroom

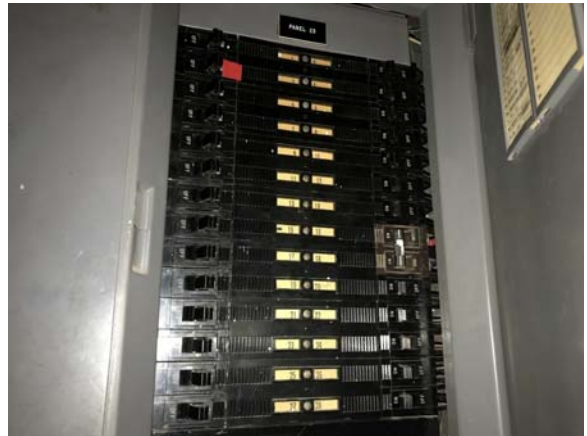
RAWL017e 5/10/2021
Local panelboard
Classroom

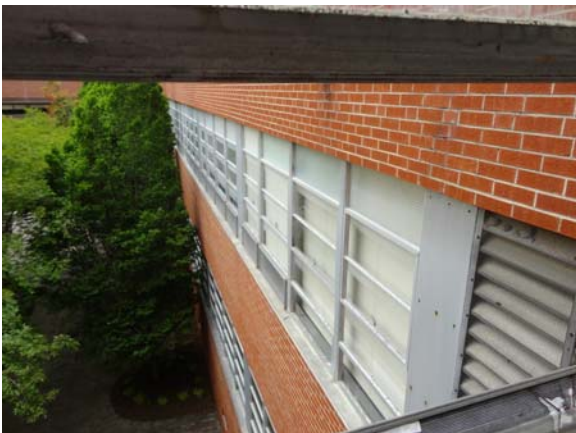
RAWL018a 5/10/2021
Aging original upper glazing
Upper elevation

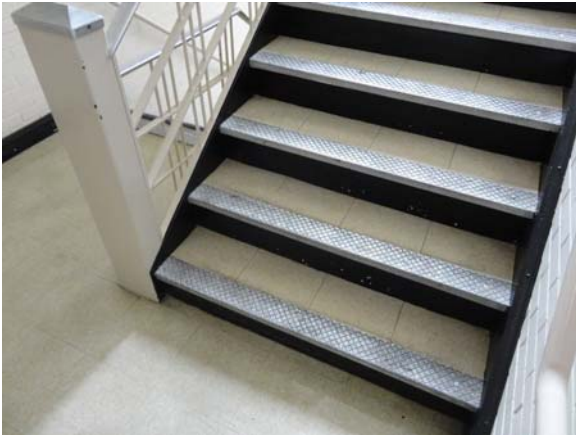
RAWL019a 5/10/2021
Loose metal stair nosing and aging vinyl tile treads
Second floor, stair tower

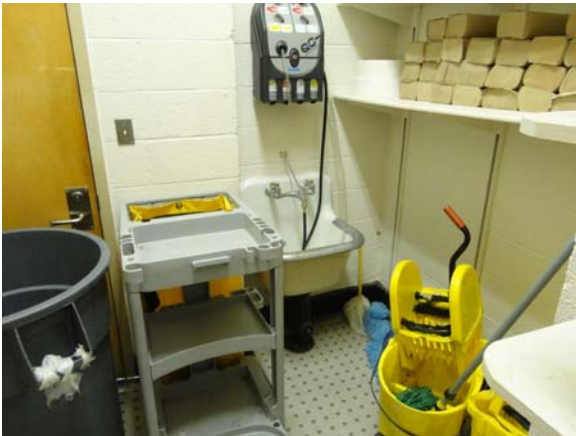
RAWL020a 5/10/2021
Typical original wall-mounted service sink
Second floor janitors closet

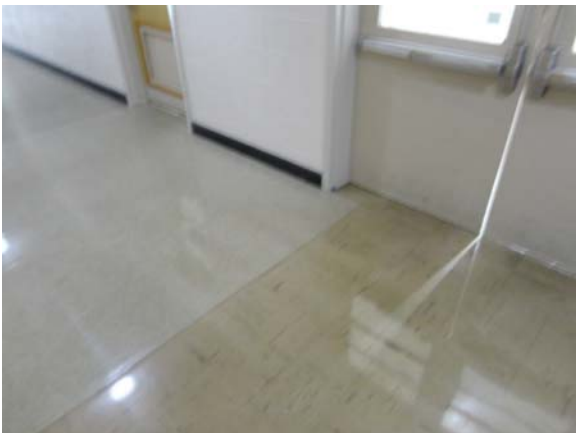
RAWL021a 5/10/2021
Dissimilar vinyl floor tile repairs
Second floor corridor

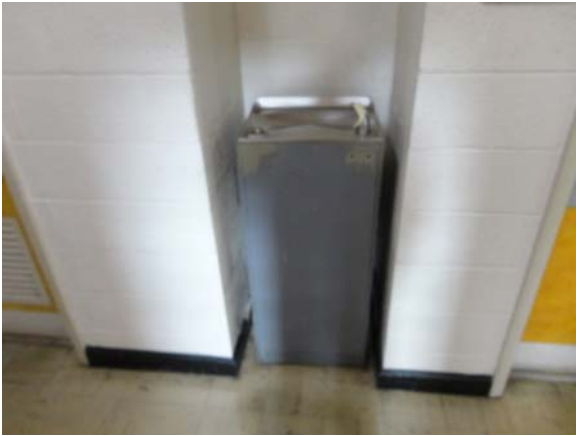
RAWL022a 5/10/2021
Aging freestanding water fountain
Second floor corridor

RAWL021e 5/10/2021
Potential asbestos insulation on mechanical piping
Room 246

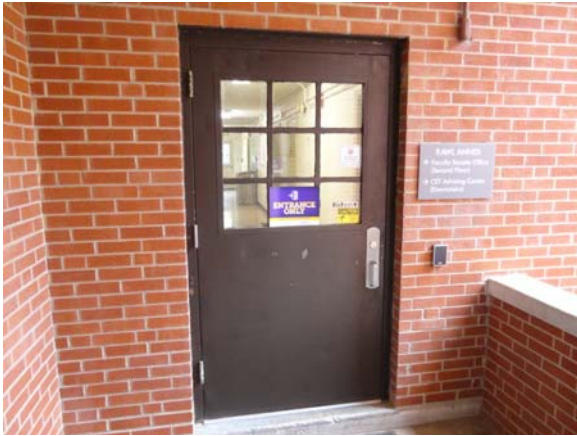
RAWL043a 5/10/2021
Hollow metal entry door
Annex first floor north entry

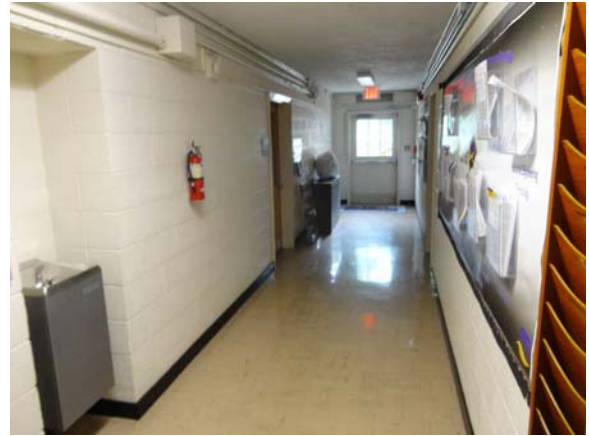
RAWL044a 5/10/2021
9x9 vinyl floor tile and textured ceiling
Annex basement corridor

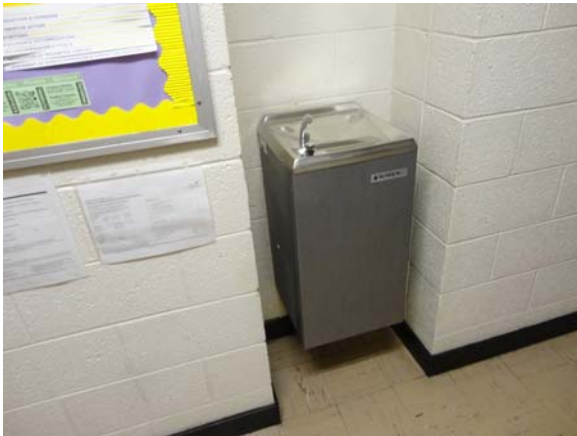
RAWL045a 5/10/2021
Aging single-level water fountain
Annex basement corridor

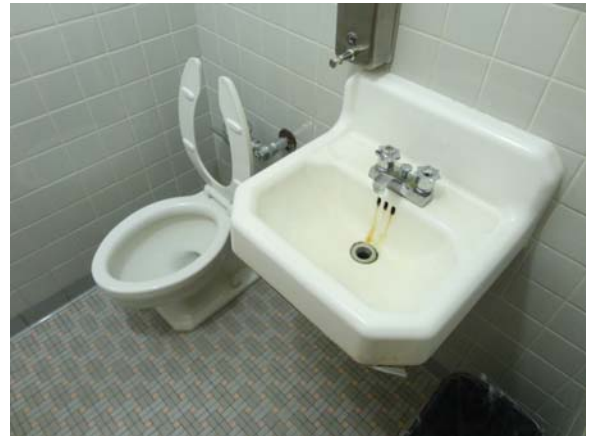
RAWL046a 5/10/2021
Aging standard fixturing
Annex basement restroom

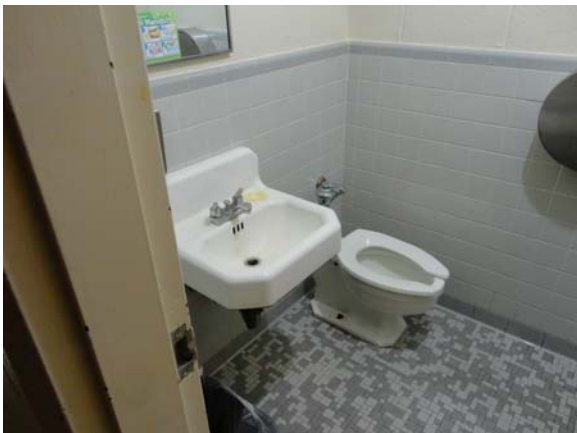
RAWL047a 5/10/2021
Aging standard fixturing
Annex basement restroom

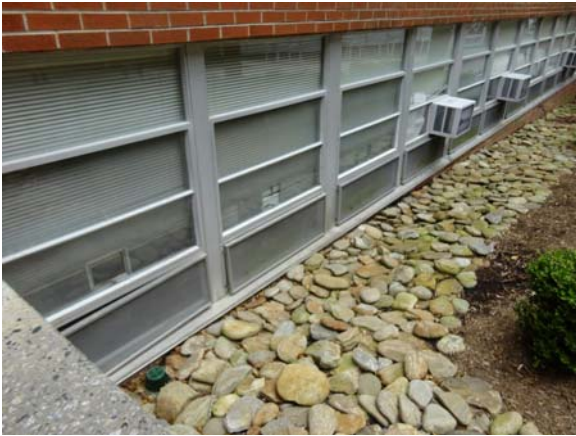
RAWL049a 5/10/2021
Exterior window too close to grade
Annex

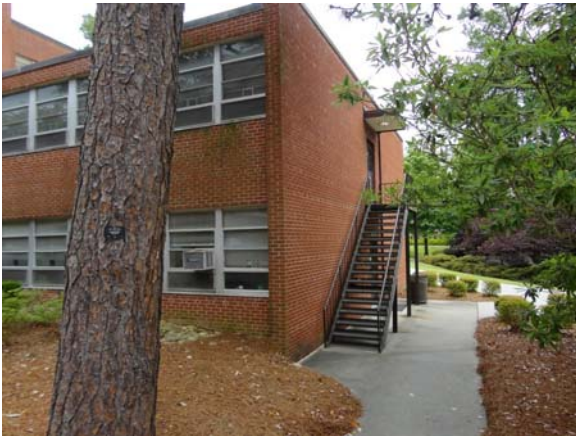
RAWL051a 5/10/2021
Exterior metal stair with open risers
South end of south annex wing

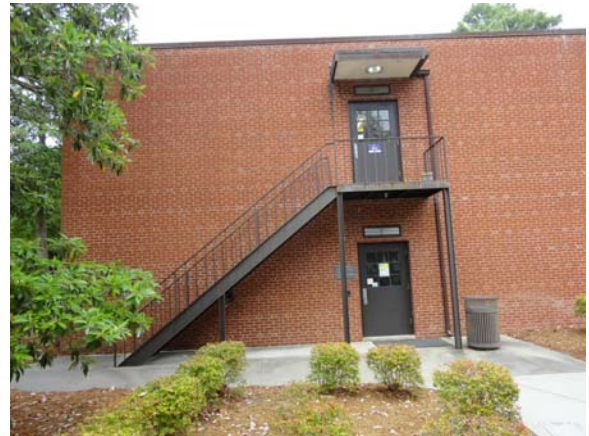
RAWL052a 5/10/2021
Hollow metal exterior egress doors
South end of south annex wing

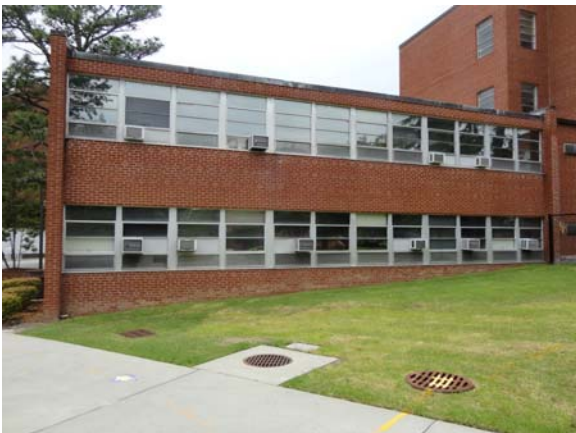
RAWL053a 5/10/2021
Exterior finishes
East elevation of south annex wing

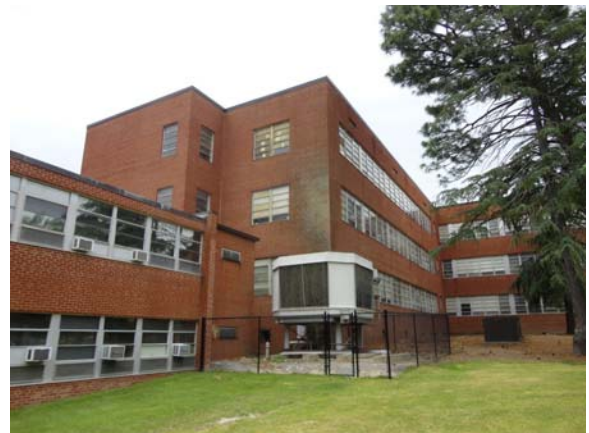
RAWL054a 5/10/2021
Exterior finishes
Southeast corner of main building

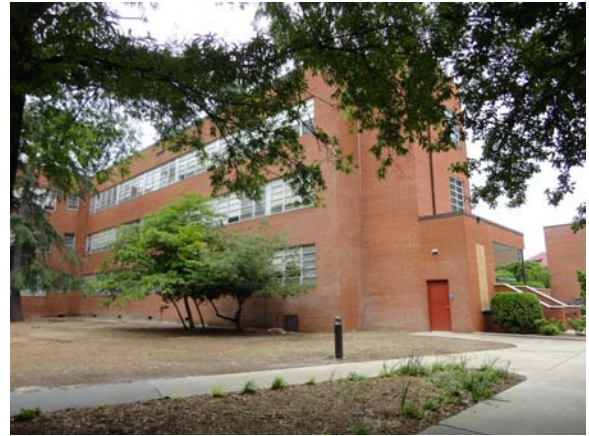
RAWL056a 5/10/2021
Hollow metal service door
East elevator tower mechanical room

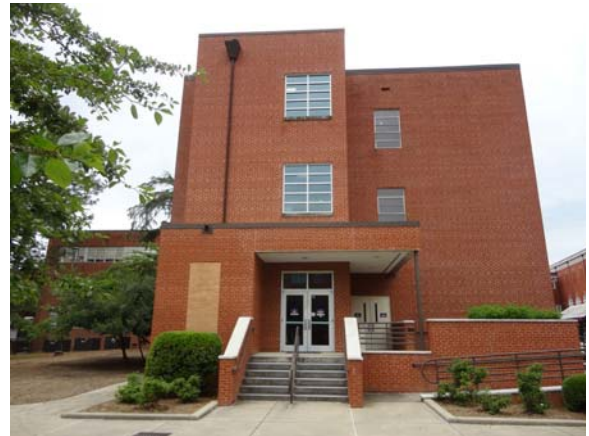
RAWL058a 5/10/2021
End elevation, noting new glazing on elevator tower
East elevation

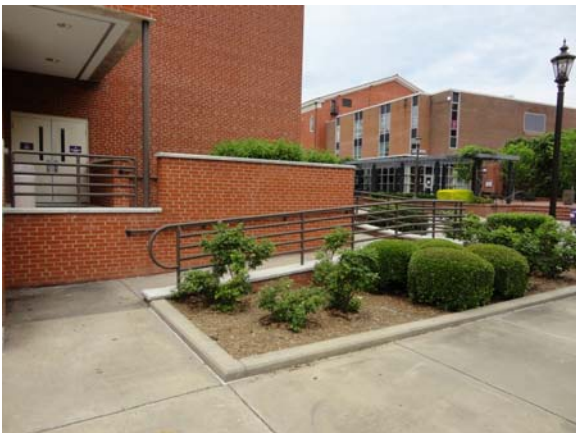
RAWL059a 5/10/2021
Accessible entry ramp
East elevation

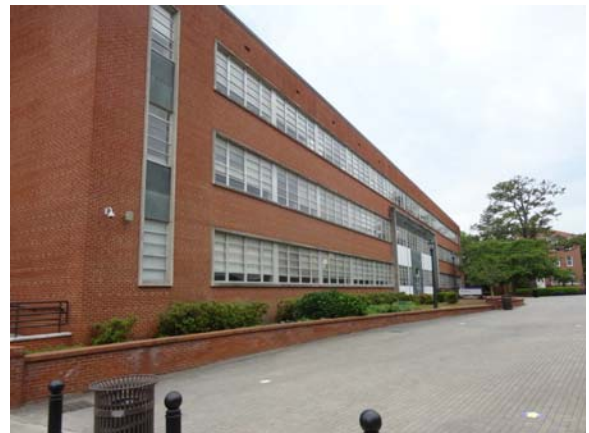
RAWL060a 5/10/2021
Exterior corner elevation
Northeast corner elevation

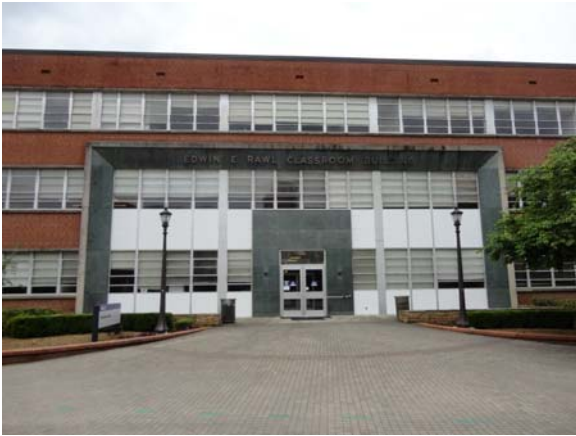
RAWL061a 5/10/2021
On-grade access to main entry
Main north building entry

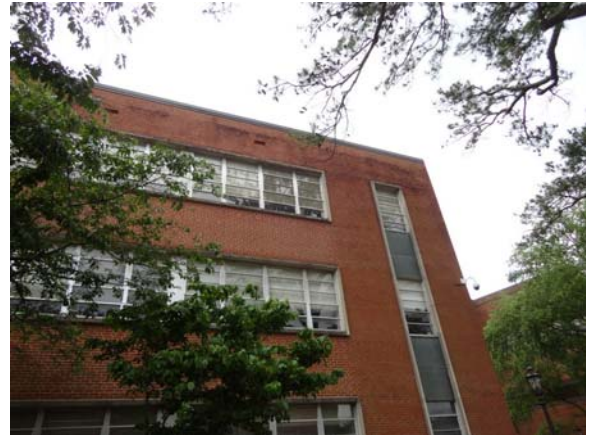
RAWL062a 5/10/2021
Light staining on upper brick
Upper north elevation

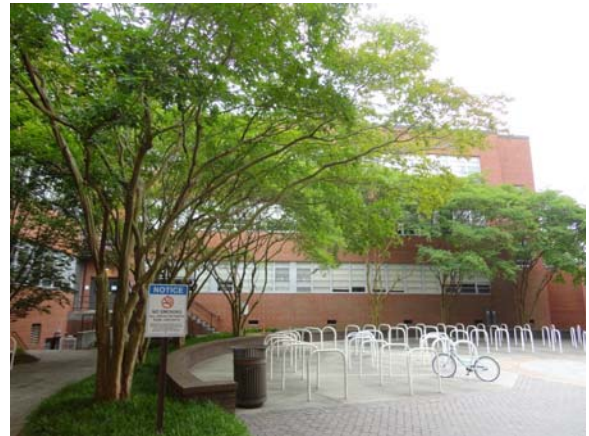
RAWL064a 5/10/2021
Exterior finishes
West elevation of south main building

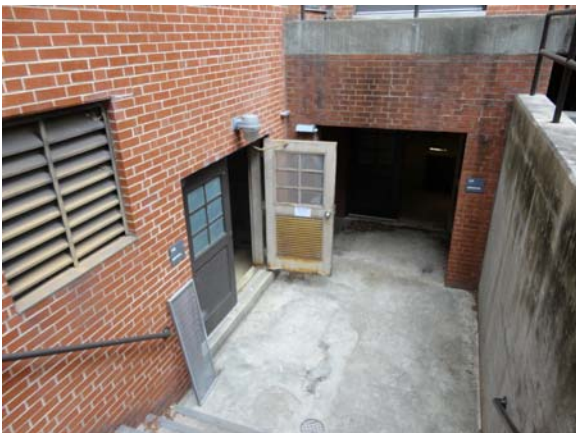
RAWL065a 5/10/2021
Aging hollow metal service doors in areaway
Southwest areaway
