EAST CAROLINA UNIVERSITY

Facility Condition Assessment

Rivers West

Inspected May 12, 2021

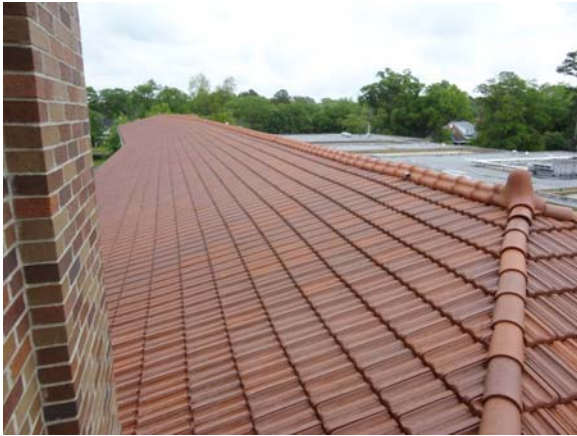
RIVW001a 5/12/2021
Clay tile roof ridge line
Main roof

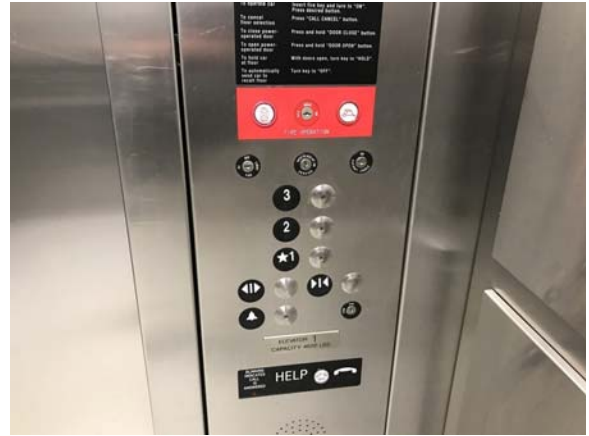
RIVW001e 5/12/2021
Elevator control panel
Elevator

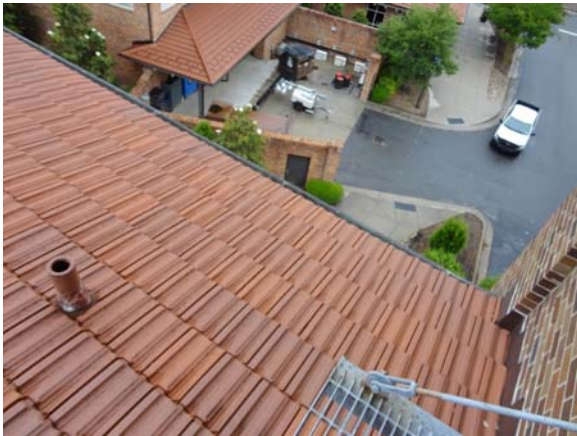
The hipped, terra cotta tile main upper and south tower roofs are in good condition and no upgrades appear to be needed. The lower east flat, built-up roofs are also in adequate condition for their age but will reach the end of their normal lifecycle within the next few years and should be replaced in kind.

RIVW002a 5/12/2021
Clay tile roof
Main roof

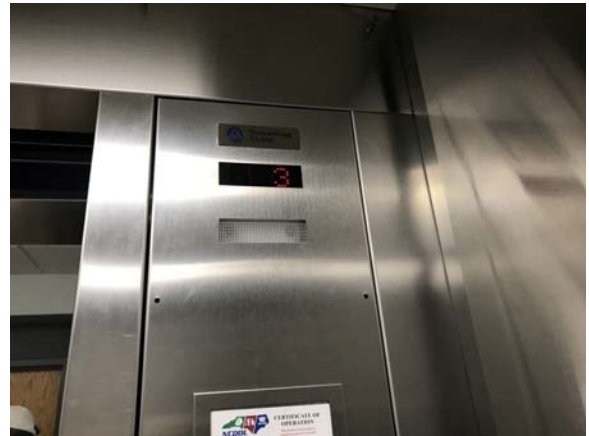
RIVW002e 5/12/2021
Elevator interior
Elevator

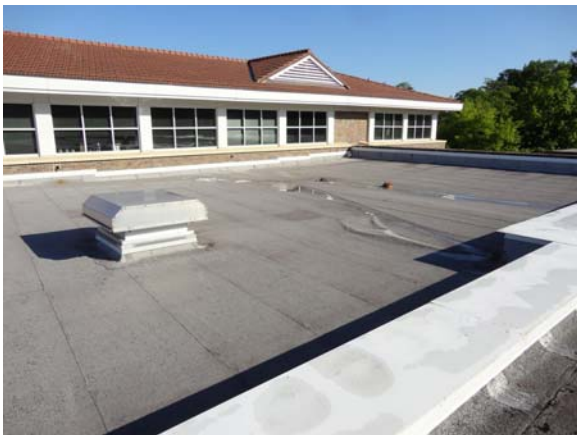
RIVW003a 5/12/2021
Lower built-up roof
Lower east roof

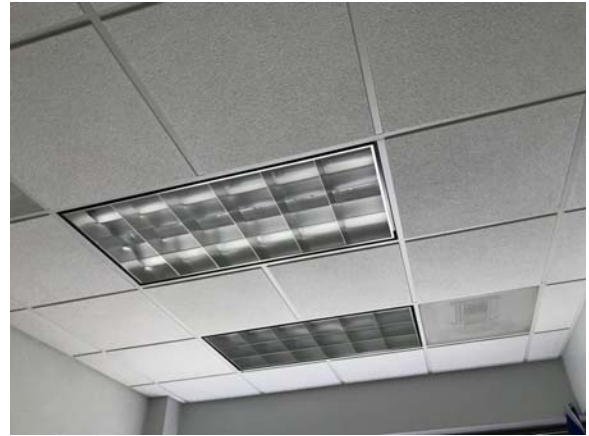
RIVW004e 5/12/2021
Open-cell grid recessed, lay-in T8 lighting fixtures
Room RW-338

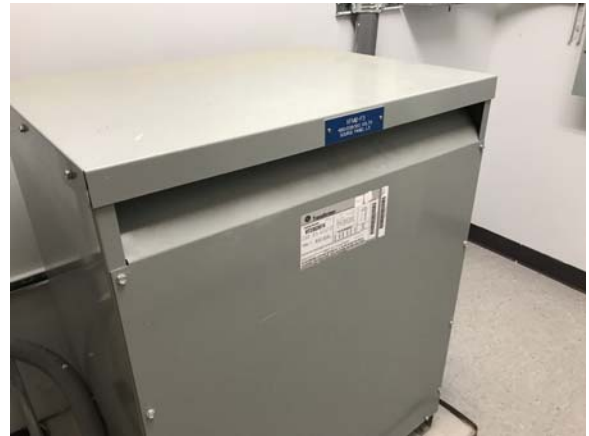
RIVW005e 5/12/2021
Secondary step-down transformer
Room RW-321

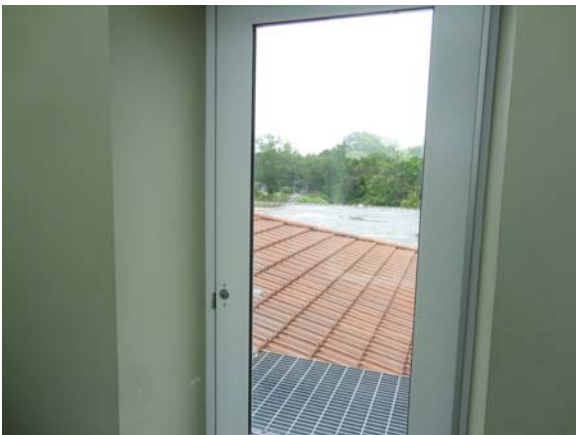
The majority of the exterior doors are glass and aluminum assemblies, including the upper tower roof access door. These doors are still in adequate condition and no upgrades should be needed. The few hollow-metal secondary egress and service doors are also in good condition and no upgrades are warranted other than hardware. The thermal-pane, metal-framed glass curtainwall on the stair tower and some of the assembly areas is in good condition as are the fixed, thermal-pane glazing on the main elevations. No glazing upgrades are needed in the near future.

RIVW006a 5/12/2021
Glass roof access door
Corner stair tower

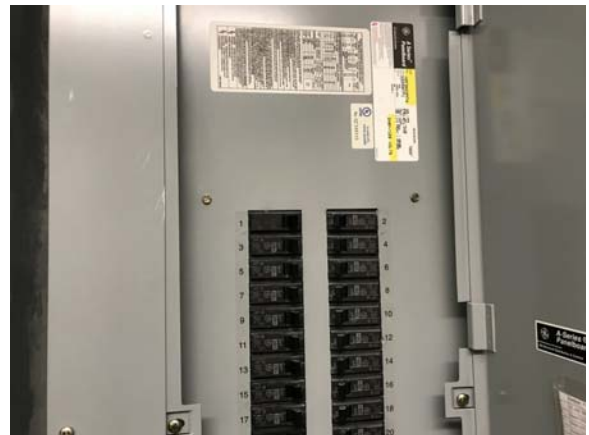
RIVW006e 5/12/2021
Local panelboard
Room RW-321

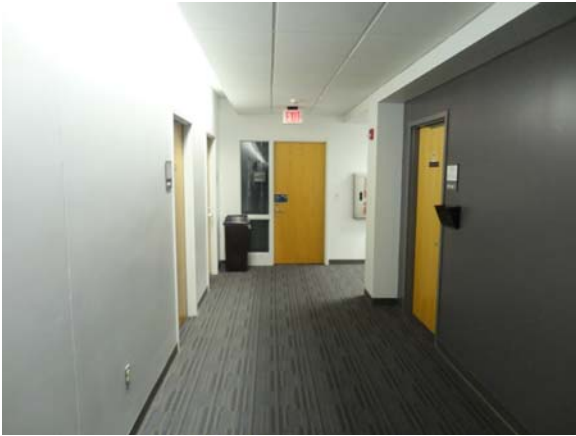
RIVW007a 5/12/2021
Broadloom carpet and acoustical ceiling
Third floor corridor

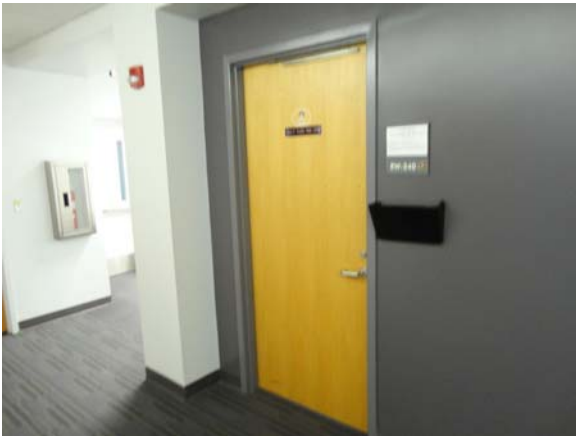
RIVW008a 5/12/2021
Flush wood door with lever hardware and accessible
signage
Third floor corridor

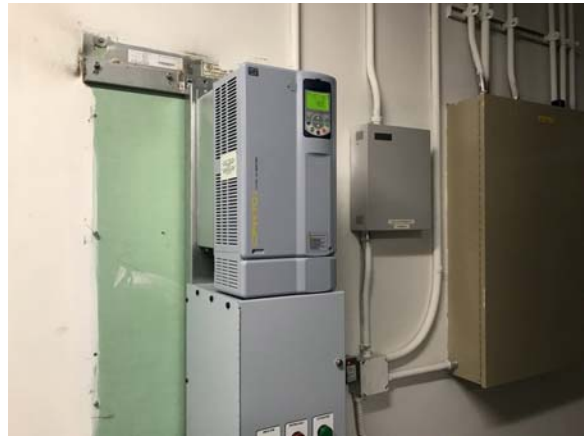
Variable frequency drives (VFDs) are associated with the air handling units, fan coil units, and the heating hot water pumps. It is recommended that they be replaced during any future HVAC renovations.

RIVW008e 5/12/2021
VFD for AHU-002 supply fan
Room RW-222

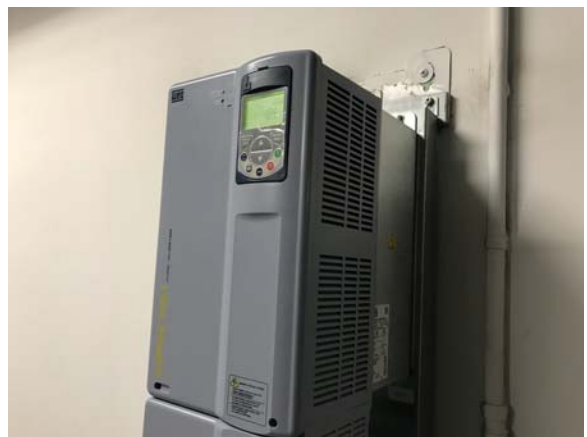
RIVW009e 5/12/2021
VFD for AHU-002 return fan
Room RW-222

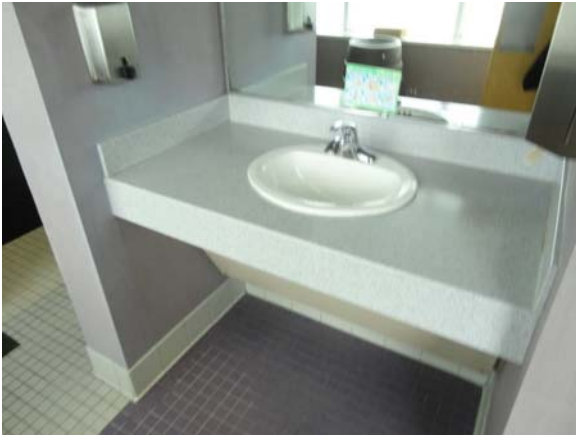
RIVW010a 5/12/2021
Counter lavatory
Third floor, men's restroom

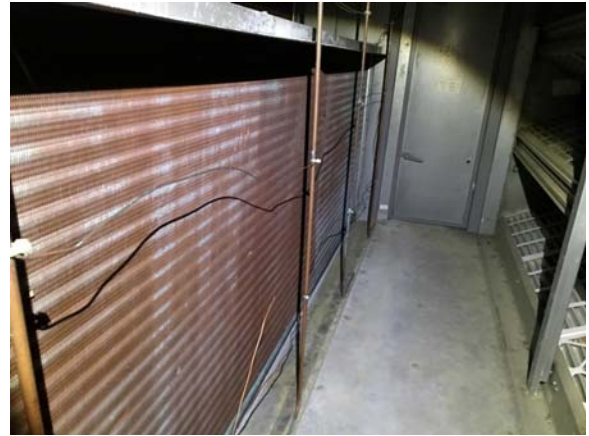
RIVW010e 5/12/2021
Interior coils of AHU-002
Room RW-222

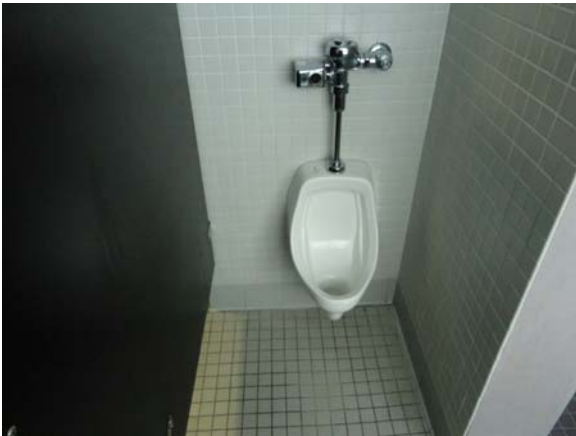
RIVW011a 5/12/2021
Wall-hung urinal
Third floor, men's restroom

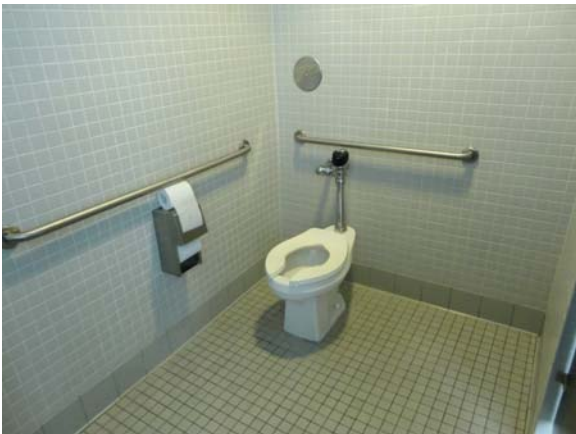
RIVW012a 5/12/2021
Accessible toilet stall
Third floor, men's restroom

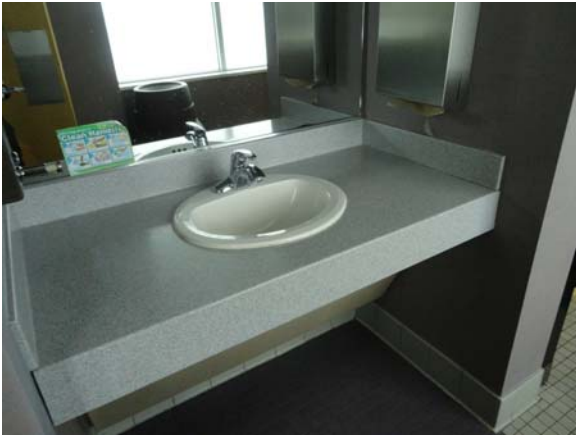
RIVW013a 5/12/2021
Counter lavatory
Third floor, women's restroom

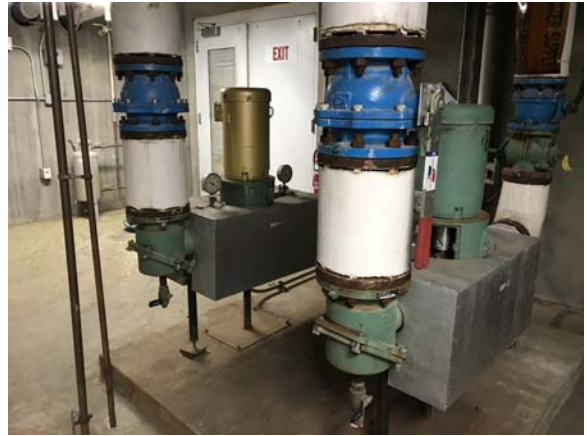
RIVW013e 5/12/2021
Heating hot water pumps
Room RW-006

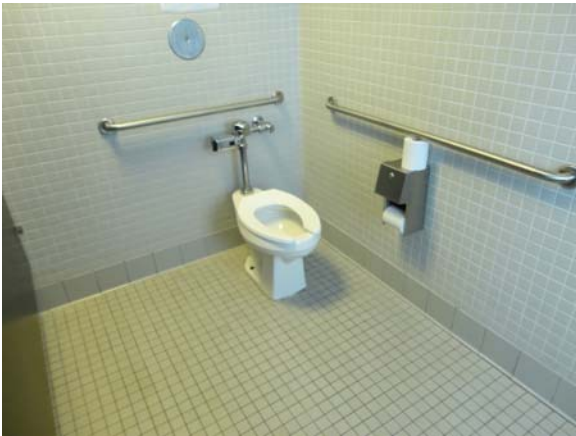
RIVW014a 5/12/2021
Accessible toilet stall
Third floor, women's restroom

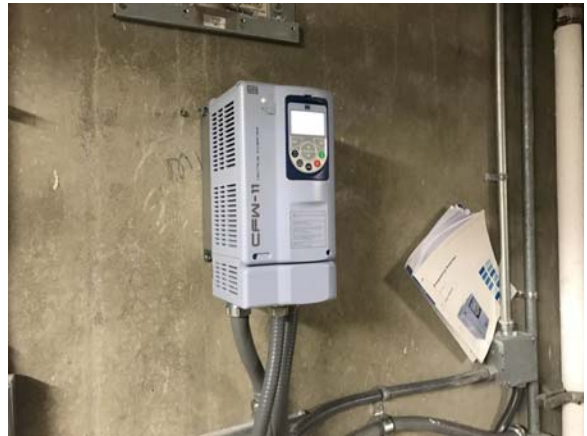
RIVW014e 5/12/2021
VFD for heating hot water pump
Room RW-006

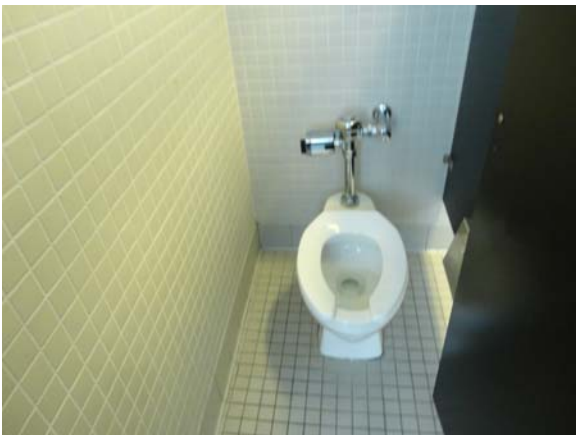
RIVW015a 5/12/2021
Standard toilet stall
Third floor, women's restroom

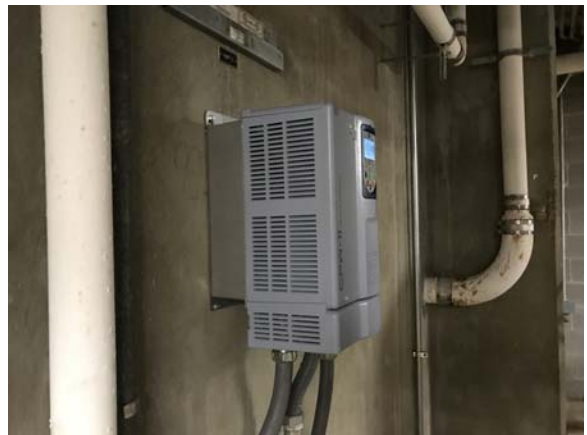
RIVW015e 5/12/2021
VFD for heating hot water pump
Room RW-006

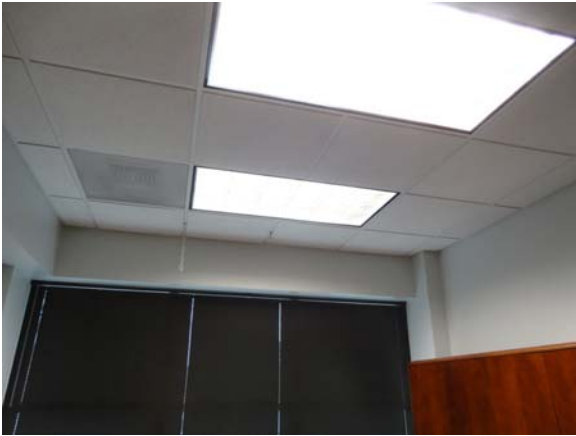
RIVW016a 5/12/2021
Acoustical lay-in ceiling
Third floor, office

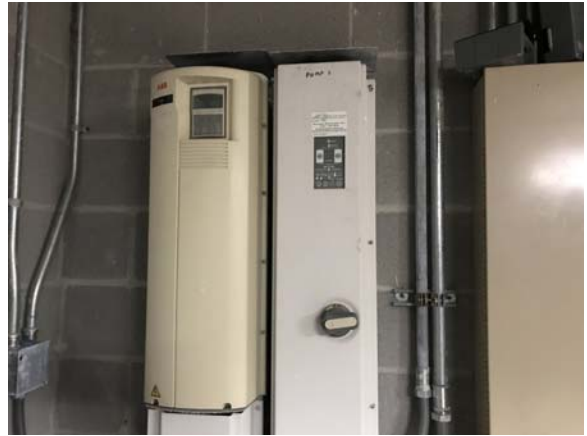
RIVW016e 5/12/2021
VFD for chilled water pump
Room RW-006

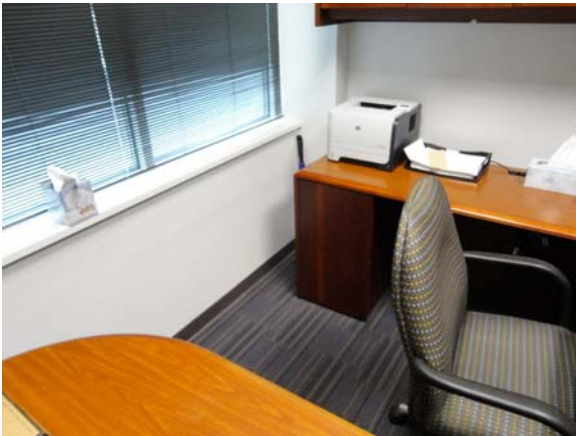
RIVW017a 5/12/2021
Broadloom carpet
Third floor, office

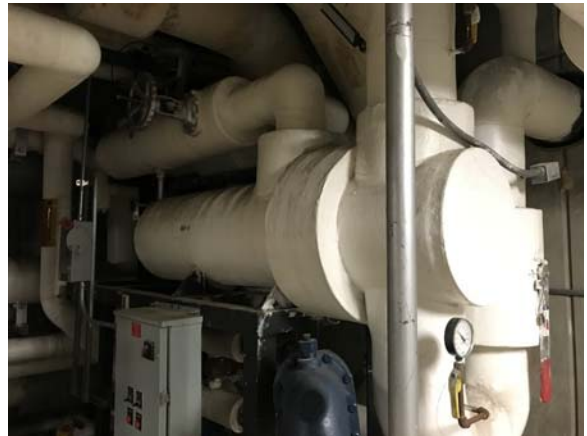
RIVW017e 5/12/2021
Heating hot water shell-and-tube heat exchanger
Room RW-006

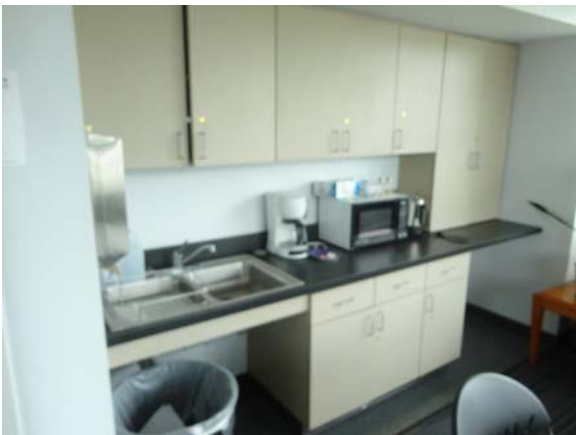
RIVW018a 5/12/2021
Casework
Third floor, office break room

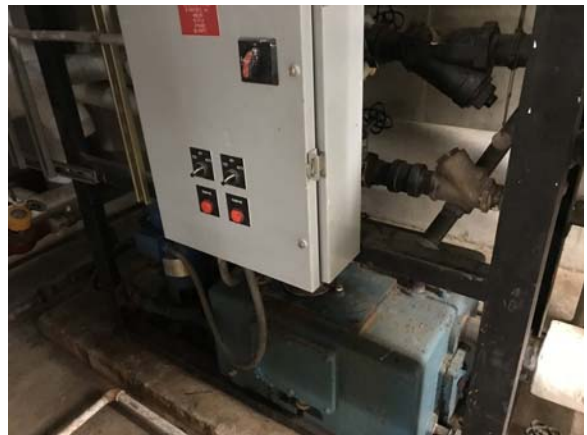
RIVW018e 5/12/2021
Condensate receiver
Room RW-006

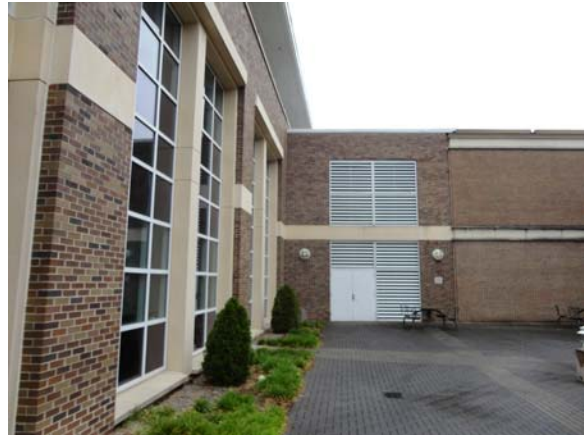
The building has indications of localized water infiltration and some selective repointing work is needed along with some recaulking of the cast stone detailing. Also, some finish spalling was noted on the plaza wall caps and this should be repaired as part of this upgrade.

RIVW046a 5/12/2021
Spalling finish on plaza wall
South plaza

Task Description	Unit	Qty	Material Unit Cost	Total Material Cost	Labor Unit Cost	Total Labor Cost	Total Cost
Selective exterior masonry repointing and plaza wall cap repairs	SF	3,000	\$0.55	\$1,650	\$3.05	\$9,150	\$10,800
Base Material/Labor Costs				\$1,650		\$9,150	
Indexed Material/Labor Costs				\$1,662		\$6,524	\$8,186
Construction Mark Up at 20.0%							\$1,637
Original Construction Cost							\$9,823
Date of Original Estimate:	6/8/2021					Inflation	\$0
Current Year Construction Cost							\$9,823
Professional Fees at 16.0%							\$1,572
TOTAL PROJECT COST							\$11,394
