EAST CAROLINA UNIVERSITY

Facility Condition Assessment

Rivers Building (010)

Inspected May 13, 2021

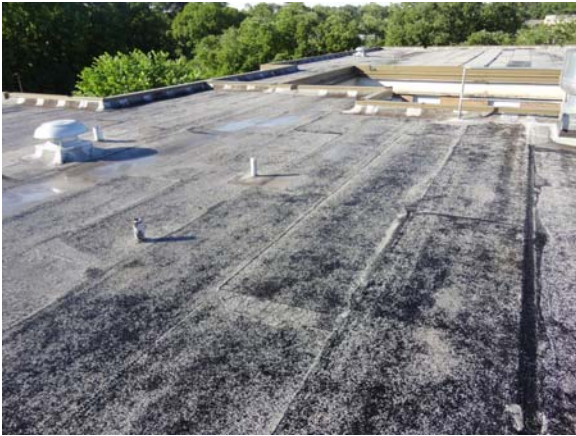
RIVE001a 5/13/2021
Weathered built-up roof with cap sheet
Main roof

The flat, built-up roofing system is heavily weathered and at, or past, its normal lifecycle. Replace the main roof in kind in the very near future. The small east addition has a much newer built-up roof that is in good condition and no upgrades are needed.

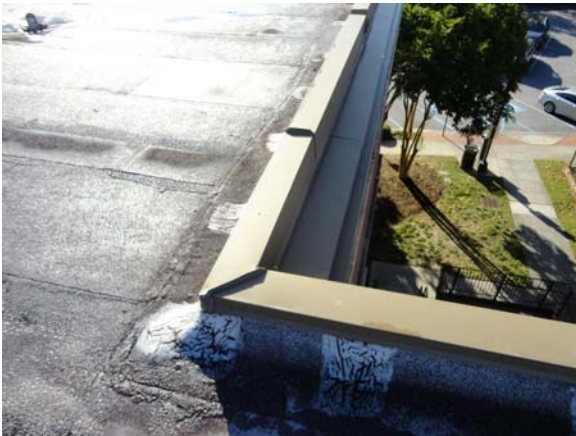
RIVE002a 5/13/2021
Low parapet with continuous metal cap
Main roof

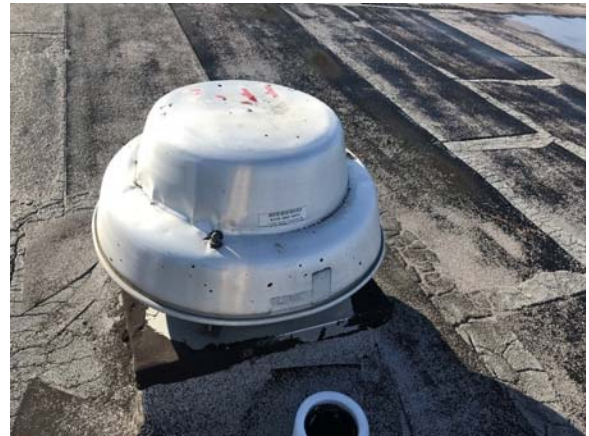
RIVE002e 5/13/2021
Centrifugal rooftop exhaust fan
Roof

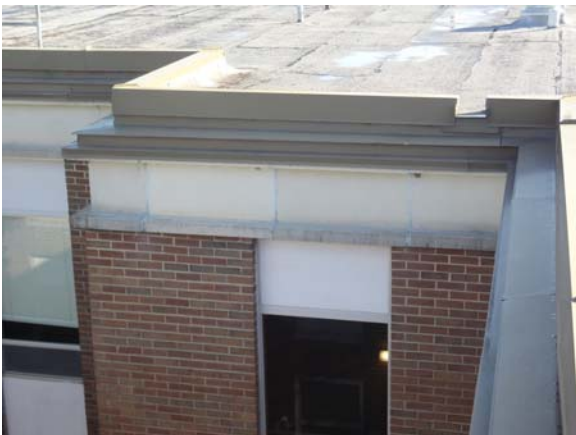
RIVE003a 5/13/2021
Staining and weathered caulking
Upper precast concrete banding

The brick facades and upper precast concrete banding are stained and the caulking along the banding is weathered. Some of the banding has stress cracks and select panels may require replacement. Cleaning, surface preparation, and selective repairs are recommended to restore the aesthetics and integrity of the building envelope.

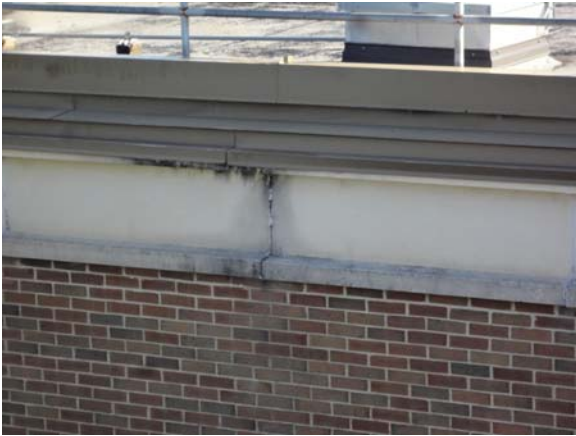
RIVE004a 5/13/2021
Stained and weathered caulking
Upper precast concrete banding

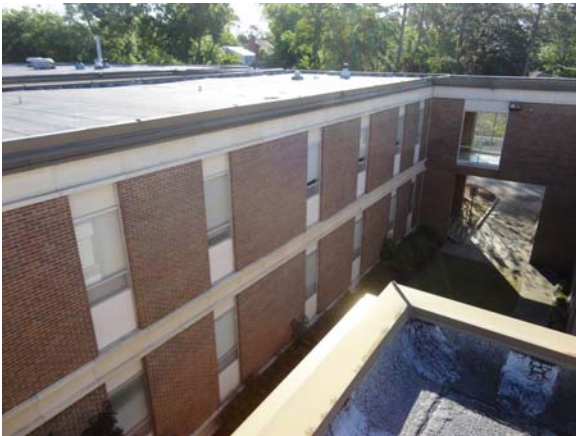
RIVE005a 5/13/2021
Brick facade and original single-pane glazing
Typical courtyard exterior

With the exception of some of the west glazing, which was upgraded as part of the Rivers West addition, all of the remaining exterior windows are in good condition and should be replaced with new metal-framed, thermal-pane units. Most of the exterior primary and secondary doors are older and due for in-kind replacement. The newer glass entry doors on the north end of the building and the new service doors on the small east addition are in good condition at this time. The areaway metal stair runs in some of the courtyards have weathered paint finishes and should be cleaned and repainted, as recommended in the Accessibility section, to better maintain these areas.

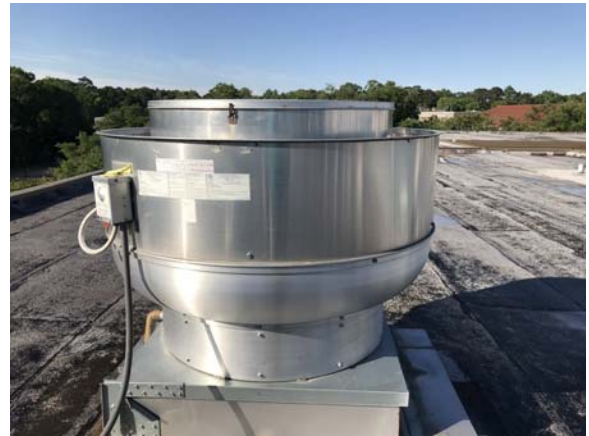
RIVE005e 5/13/2021
Kitchen exhaust fan
Roof

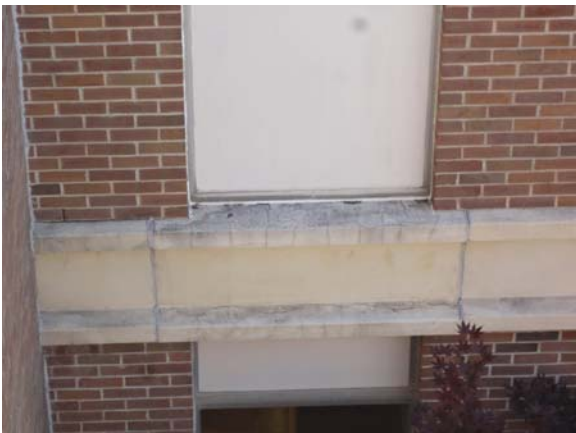
RIVE006a 5/13/2021
Some stress cracks in precast banding
Upper facade exterior precast

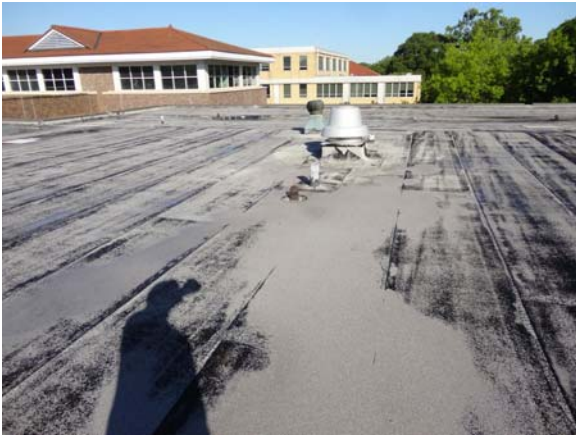
RIVE007a 5/13/2021
Heavy weathering of granular finish on cap sheet
Main roof

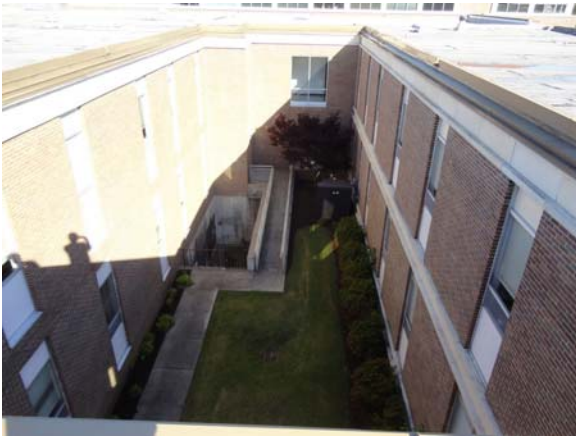
RIVE008a 5/13/2021
View of areaway in one of the courtyards
Exterior courtyard

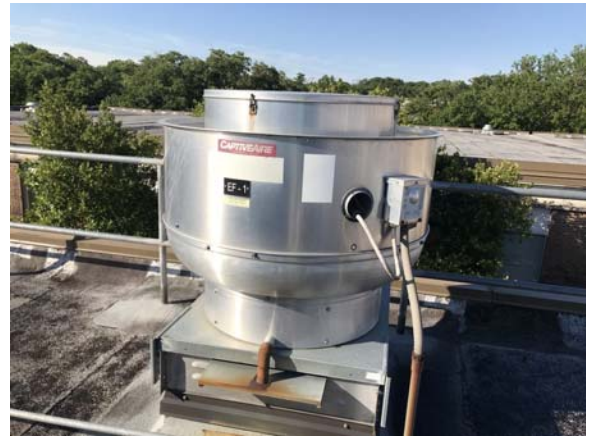
RIVE008e 5/13/2021
Kitchen exhaust fan
Roof

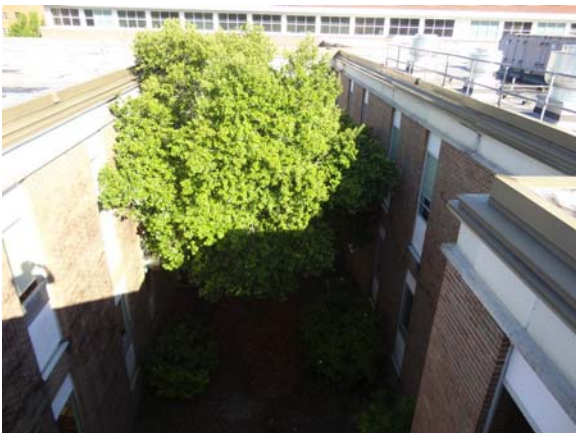
RIVE009a 5/13/2021
Tree in courtyard restricting access for facade cleaning
Exterior courtyard

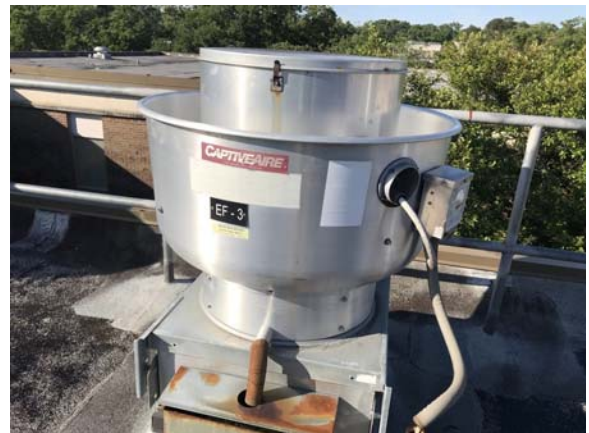
RIVE009e 5/13/2021
Kitchen exhaust fan
Roof

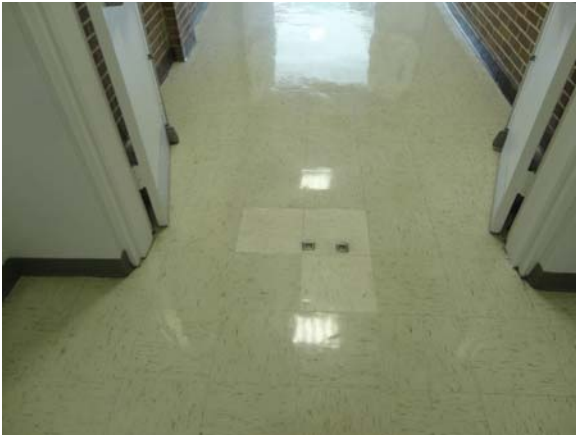
RIVE010a 5/13/2021
Older vinyl flooring with dissimilar tile repair
Second floor corridor

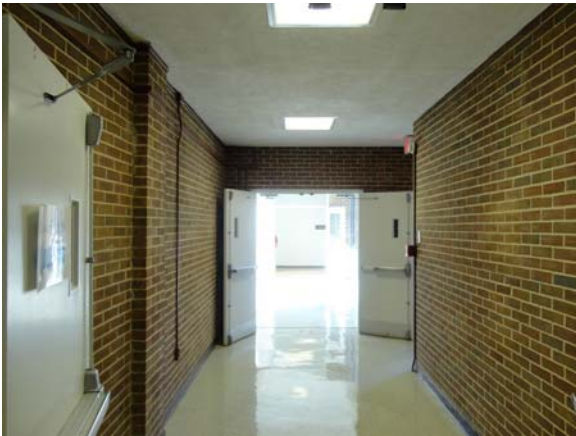
RIVE011a 5/13/2021
Exterior doors to breezeway link
Second floor corridor

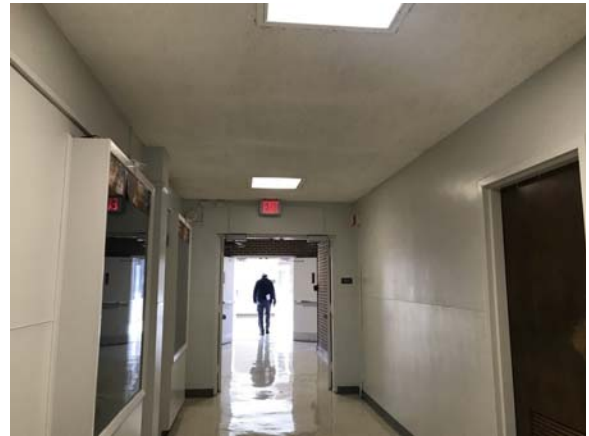
RIVE011e 5/13/2021
Retrofitted LED lighting fixtures
Second floor corridor

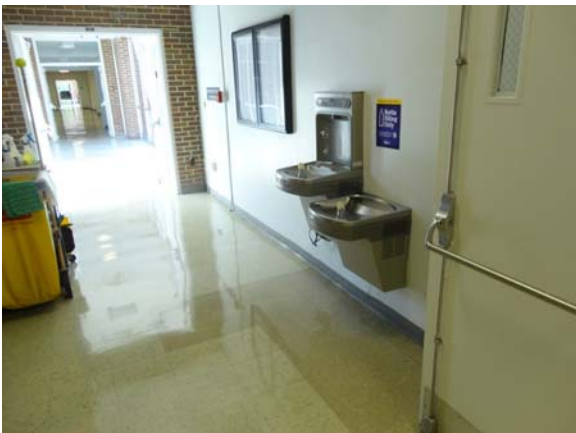
RIVE012a 5/13/2021
Older vinyl floor tile but newer dual-level water fountain
Second floor corridor

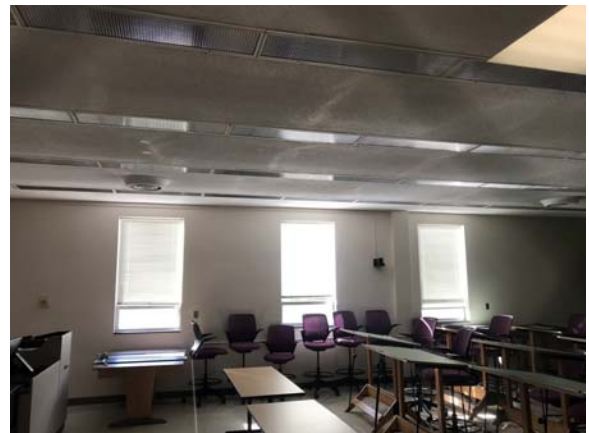
RIVE012e 5/13/2021
Original retrofitted T8 lighting fixtures
Room 262

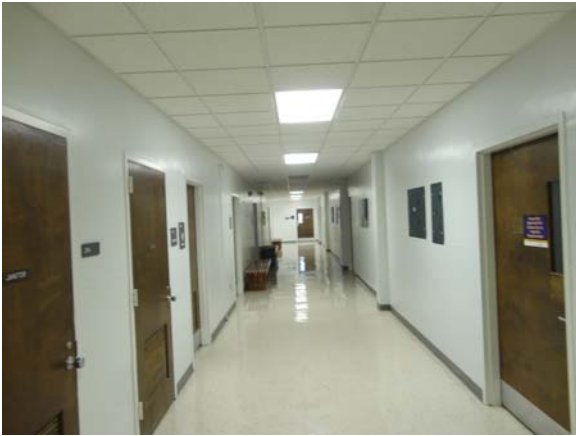
RIVE013a 5/13/2021
Older vinyl tile and suspected ACM above acoustical ceiling
Second floor, south corridor

Textured finishes in the corridor ceilings, as well as in the offices and classrooms, are suspected to contain asbestos. Many of these ceilings also have visible water or contact damage. It is also assumed that original textured ceilings are still present above the existing lay-in acoustical ceilings. These textured ceilings should be sampled and tested for the presence of asbestos. Assuming a positive test result, these ceilings should be properly abated prior to finish upgrades in these areas.

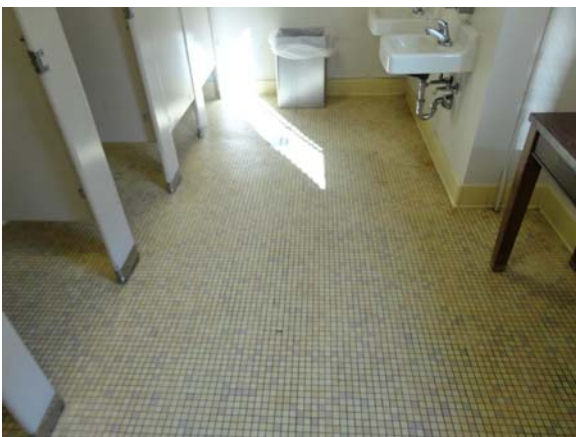
RIVE015a 5/13/2021
Older 1x1 ceramic floor tile
Second floor, south women's restroom

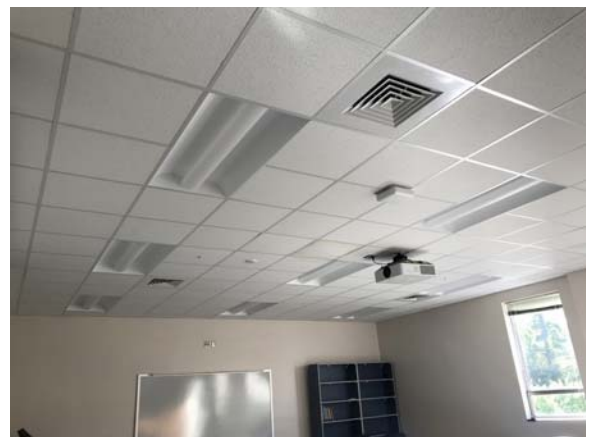
RIVE015e 5/13/2021
Recessed, lay-in LED lighting fixtures
Room 260

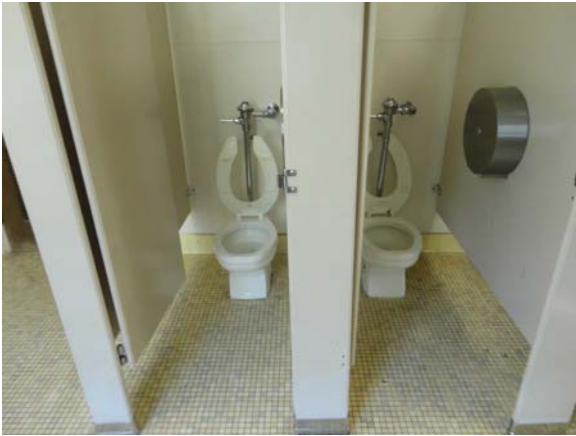
RIVE016a 5/13/2021
Older standard tankless water closets
Second floor, south women's restroom

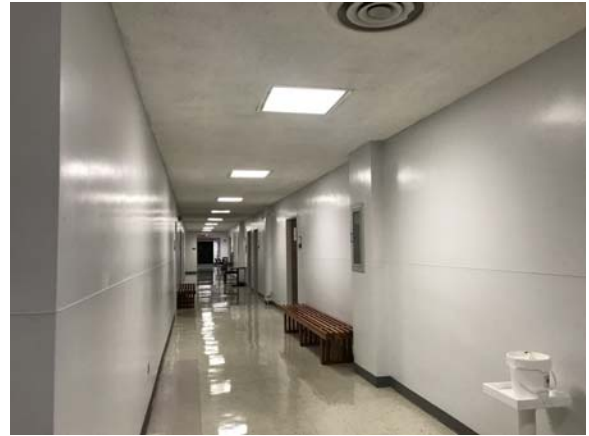
RIVE016e 5/13/2021
Retrofitted LED lighting fixtures
Second floor corridor

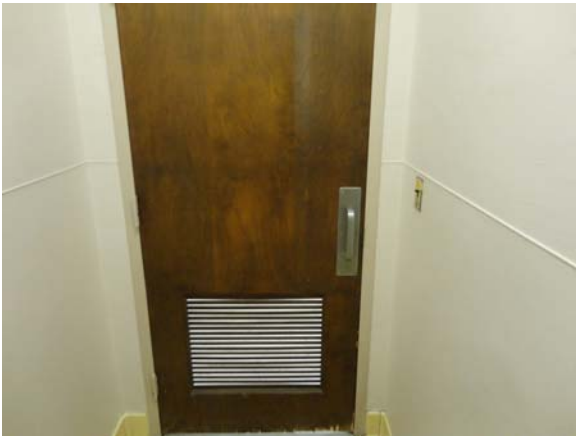
RIVE017a 5/13/2021
Narrow clearances in restroom vestibules
Second floor, restrooms

restroom space will reduce total fixture counts in the building. It is recommended that new fully accessible three-fixture, all-gender restrooms be installed at key locations on both levels to meet current accessibility requirements. Also, the water fountains vary in age and level of accessibility. There is one newer dual-level fountain, and the remaining fountains should be upgraded to similar accessible dual-level units set in wheelchair accessible corridor alcoves.

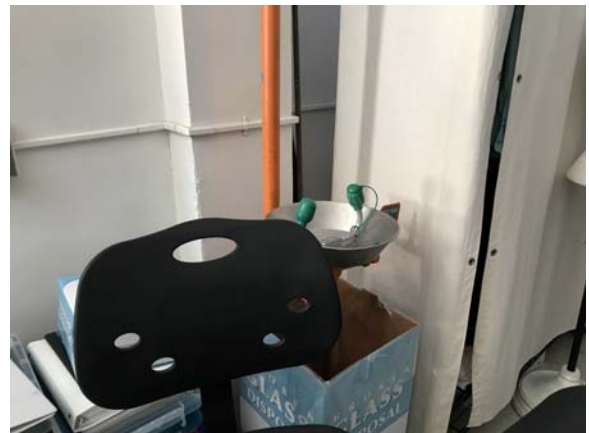
RIVE018e 5/13/2021
Emergency eyewash station
Room 258

Emergency eyewash and shower stations in the laboratory areas appear to be original. It is recommended that they be replaced due to lifecycle depletion.

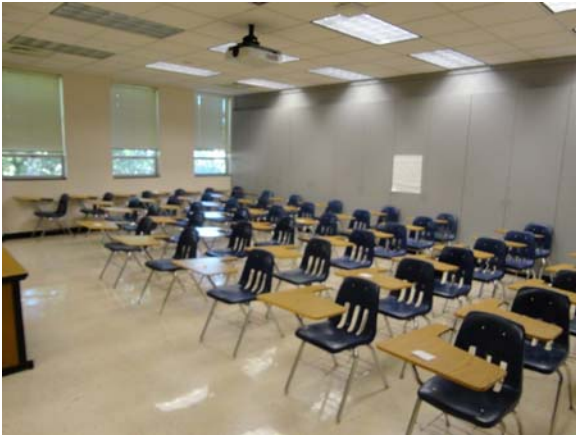
RIVE019a 5/13/2021
Older vinyl floor tile and older acoustical ceiling
Second floor, classroom

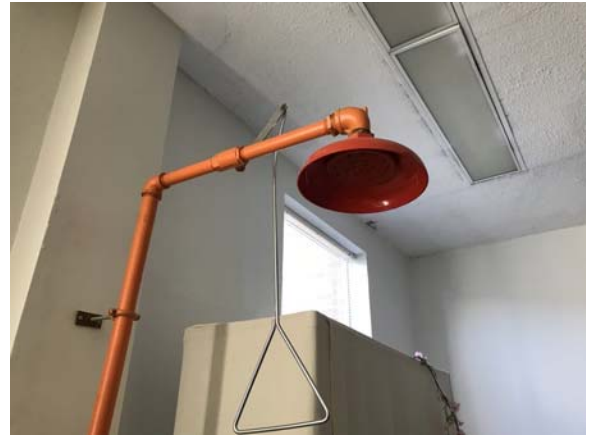
RIVE019e 5/13/2021
Emergency shower
Room 258

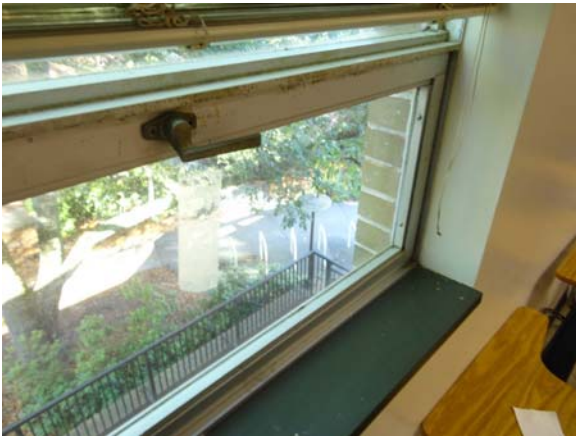
RIVE020a 5/13/2021
Original single-pane, metal-framed glazing
Second floor

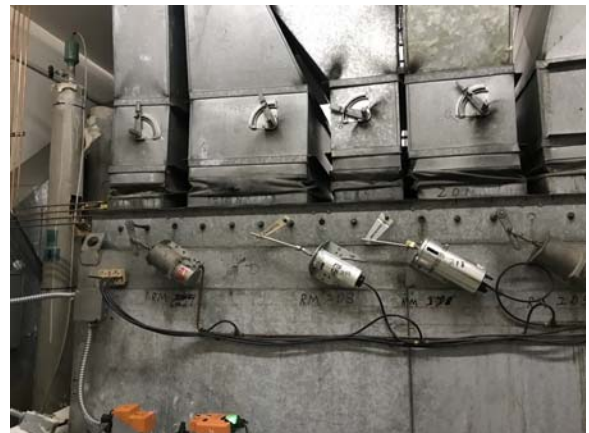
RIVE021e 5/13/2021
Air handling unit AHU-005
Room 214

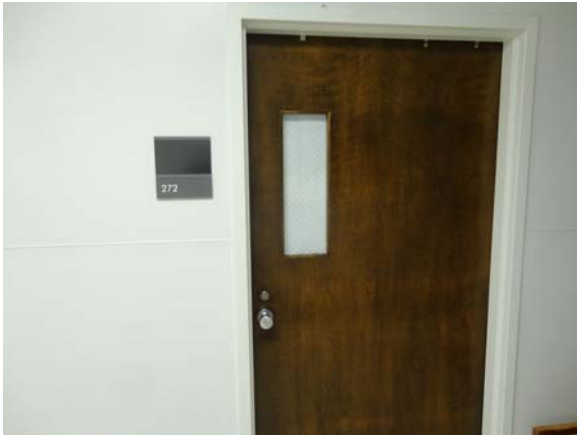
RIVE022a 5/13/2021
Original doors with knob hardware
Second floor corridor

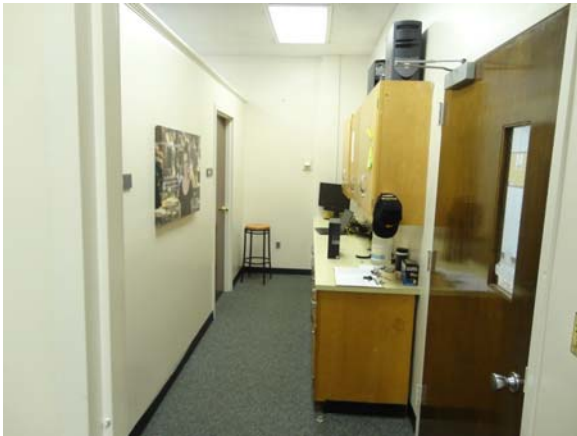
RIVE023a 5/13/2021
Original casework and break area sink
Second floor, south office suite

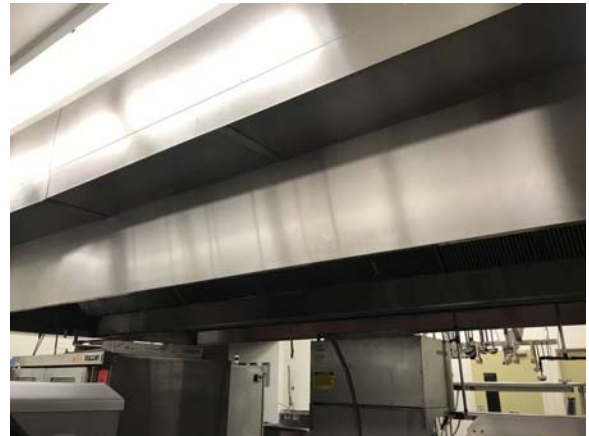
RIVE023e 5/13/2021
Commercial kitchen hood
Room 158

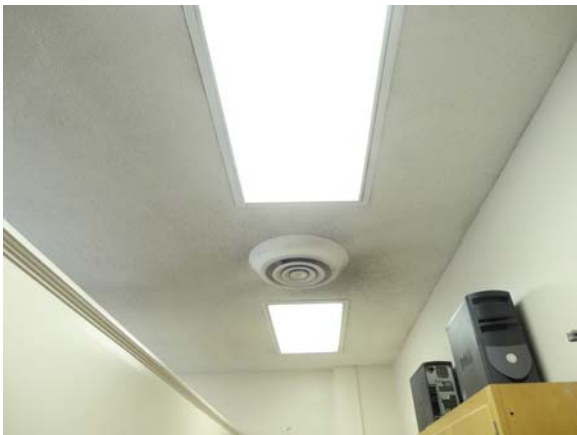
RIVE024a 5/13/2021
Original textured ceiling
Second floor, south office suite

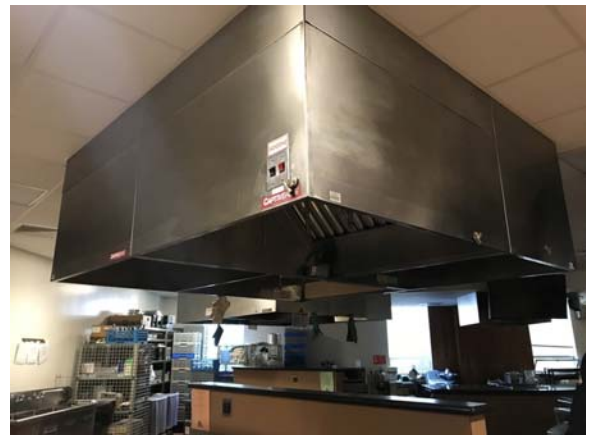
RIVE024e 5/13/2021
Commercial kitchen hood
Room 158

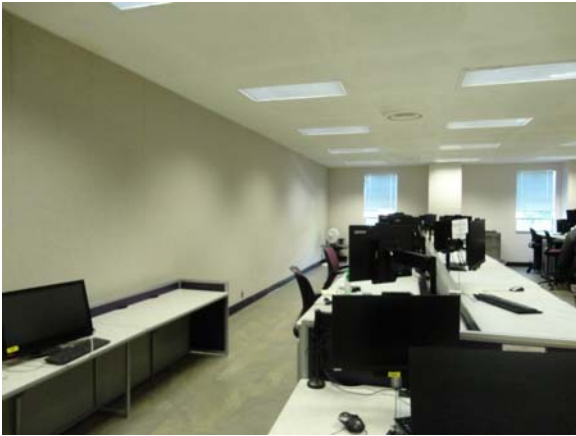
RIVE025a 5/13/2021
Newer LVT flooring but original textured ceiling
Second floor, south computer labs

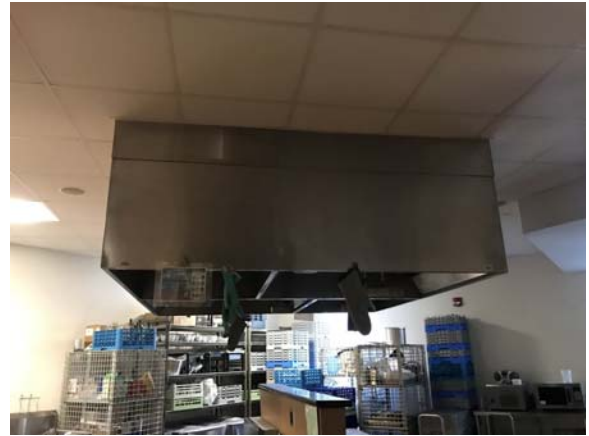
RIVE025e 5/13/2021
Commercial kitchen hood
Room 158

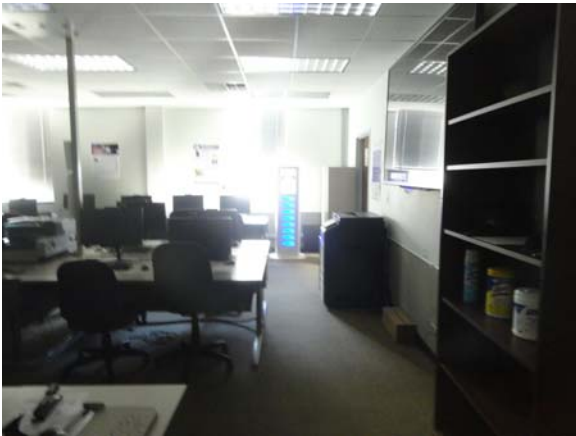
RIVE026a 5/13/2021
Older broadloom carpeting and 2x2 acoustical ceiling
Second floor, computer lab

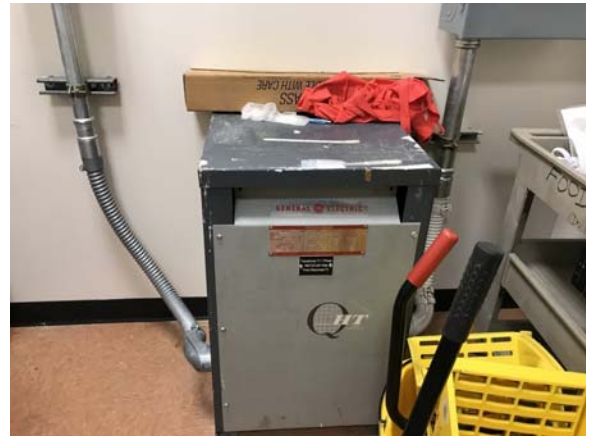
RIVE026e 5/13/2021
Secondary step-down transformer
Room 158

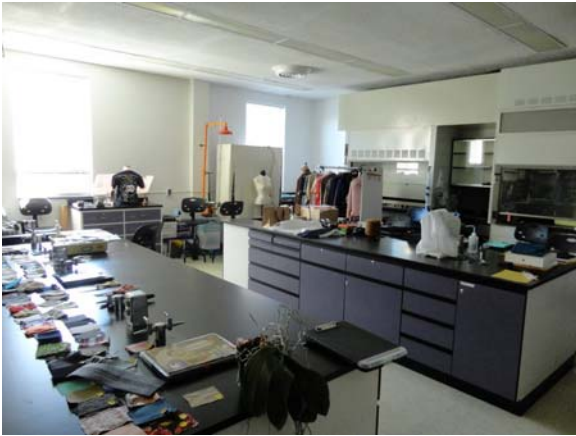
RIVE028a 5/13/2021
Newer casework
Second floor, textile lab

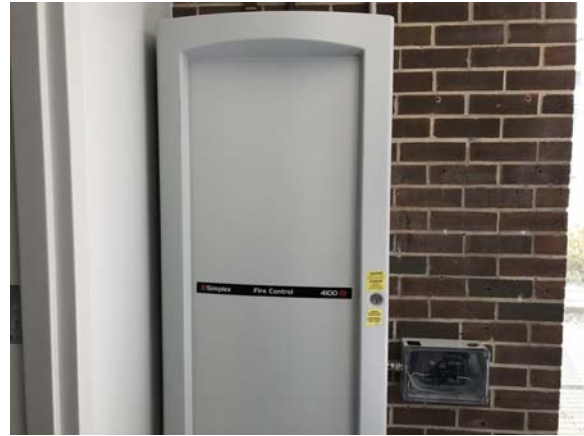
RIVE028e 5/13/2021
Fire alarm extension panel
First floor corridor

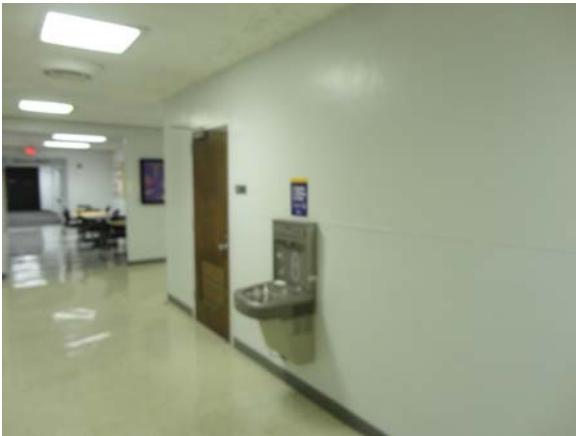
RIVE029a 5/13/2021
Newer single-level water fountain with bottle filler
Second floor corridor

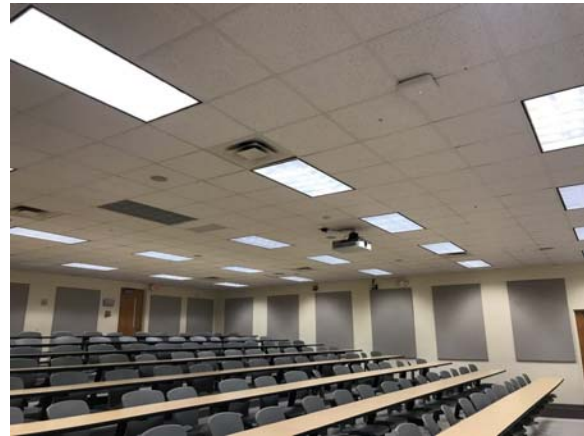
RIVE029e 5/13/2021
Open-cell grid T8 lighting fixtures
Room 102

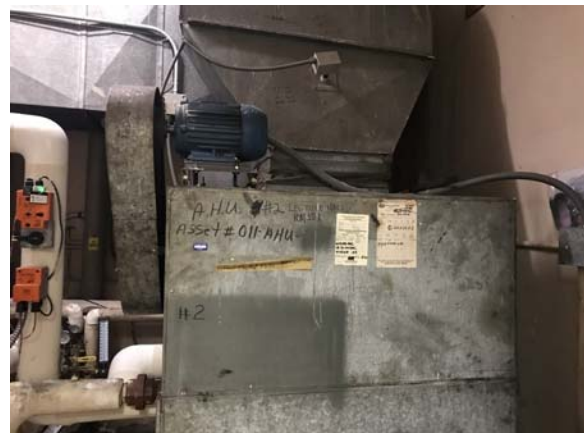
RIVE030e 5/13/2021
Air handling unit AHU-002
Room 113

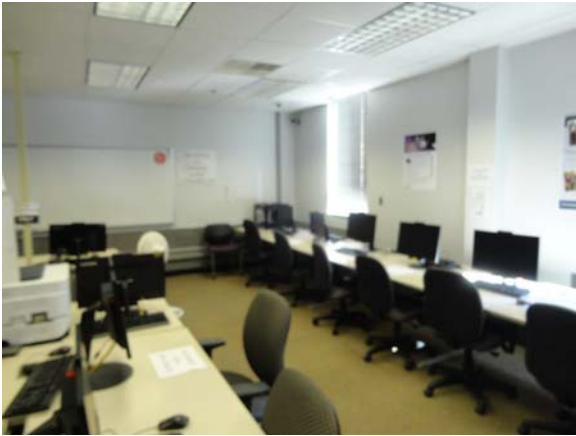
RIVE031a 5/13/2021
Older broadloom carpeting and acoustical ceiling
Second floor, computer lab

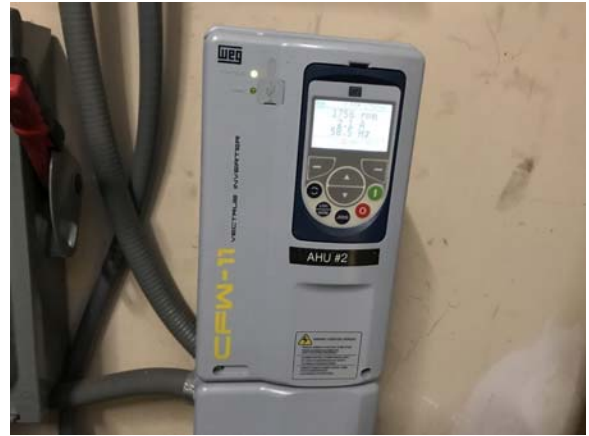
RIVE031e 5/13/2021
VFD for AHU-002
Room 113

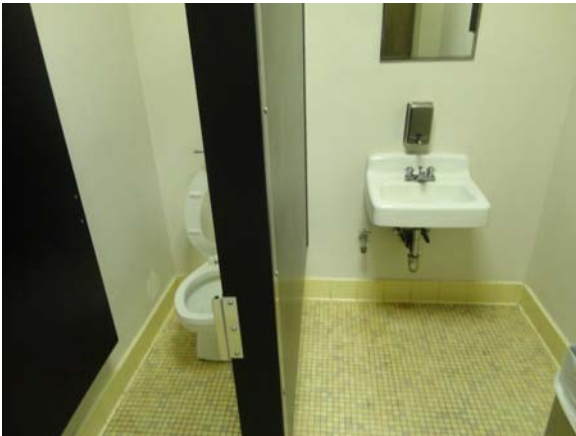
RIVE032a 5/13/2021
Older standard fixtures
Second floor, central men's restroom

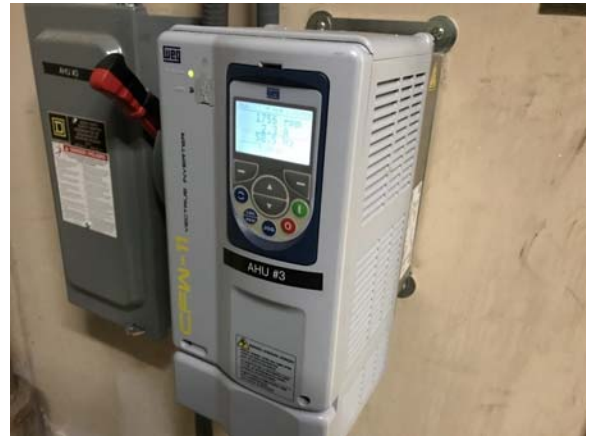
RIVE032e 5/13/2021
VFD for AHU-003
Room 113

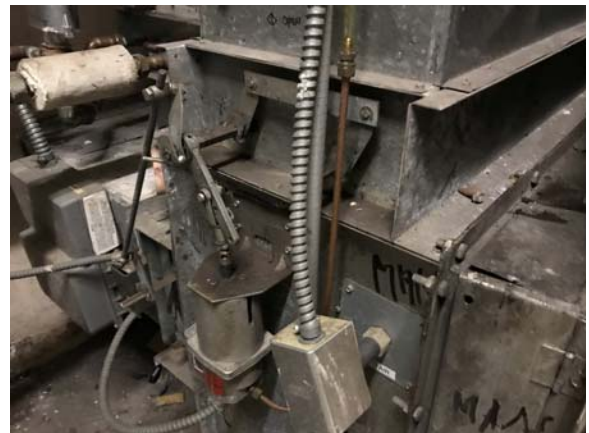
RIVE033e 5/13/2021
Air handling unit AHU-003
Room 113

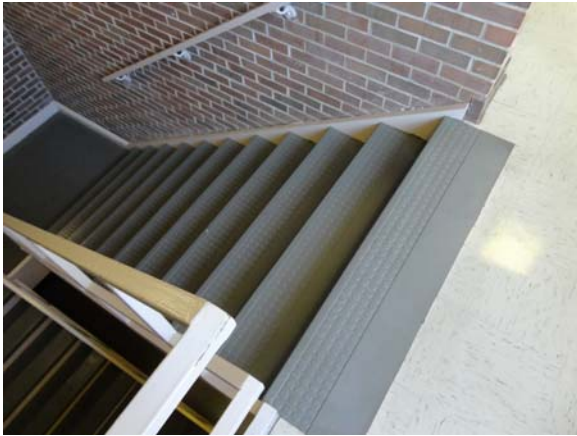
RIVE034a 5/13/2021
Rubber stair treads in average condition
Second floor, central stair tower

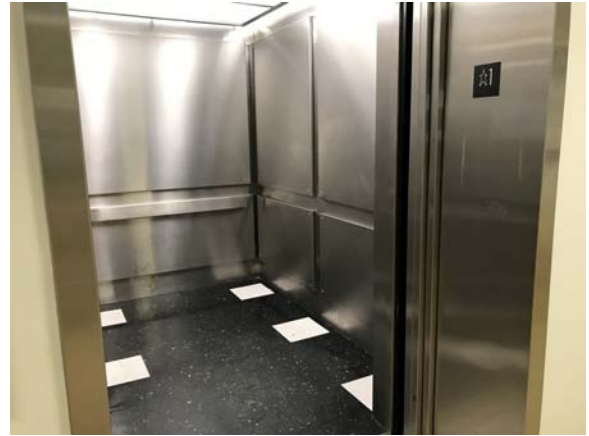
RIVE034e 5/13/2021
Elevator interior
Elevator

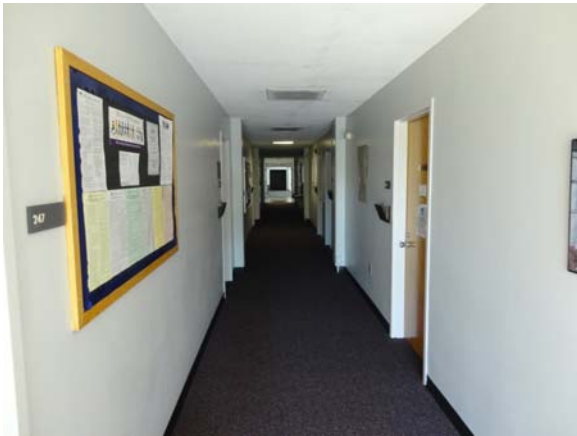
RIVE035a 5/13/2021
Older broadloom carpeting and textured ceiling
Second floor, north office corridor

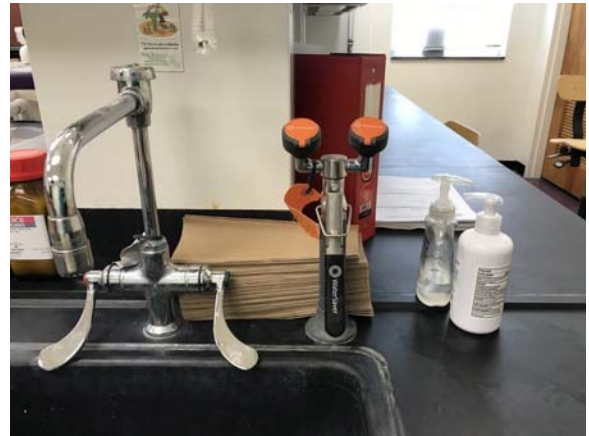
RIVE035e 5/13/2021
Emergency eyewash station
Room 110C

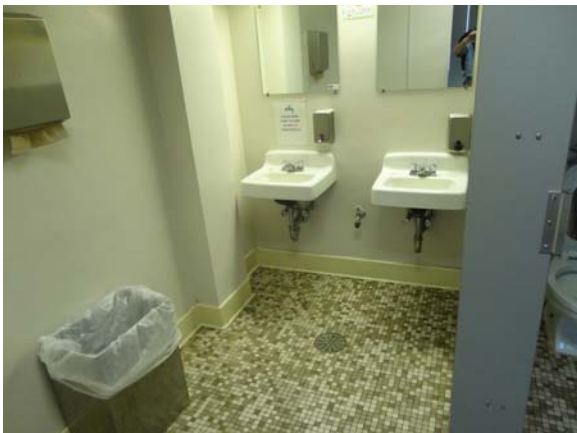
RIVE036a 5/13/2021
Older wall-hung lavatories
Second floor, central women's restroom

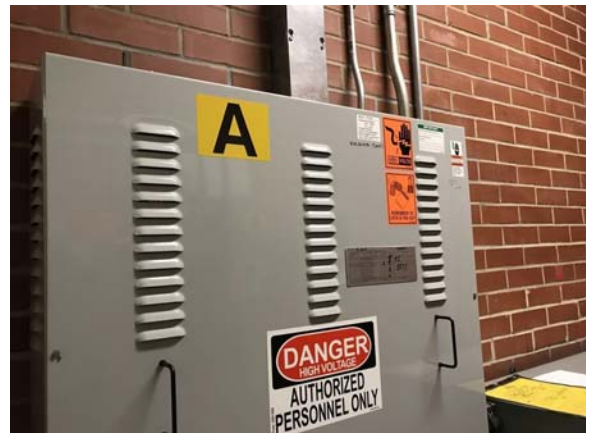
RIVE036e 5/13/2021
Elevator A controls
Room 111

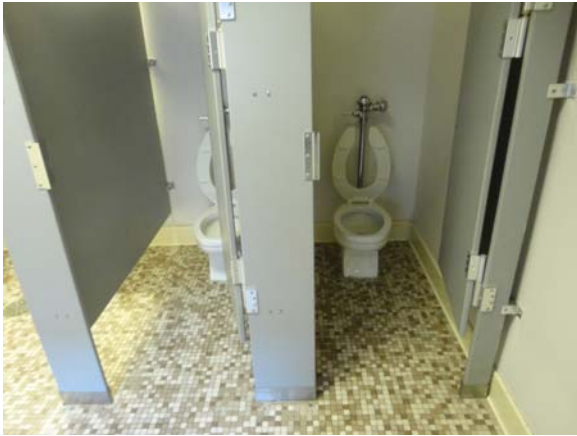
RIVE037a 5/13/2021
Older standard toilet stalls
Second floor, central women's restroom

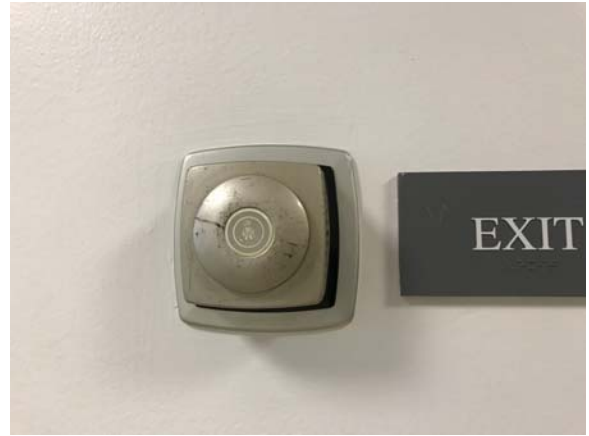
RIVE037e 5/13/2021
Pneumatic local thermostat
First floor corridor

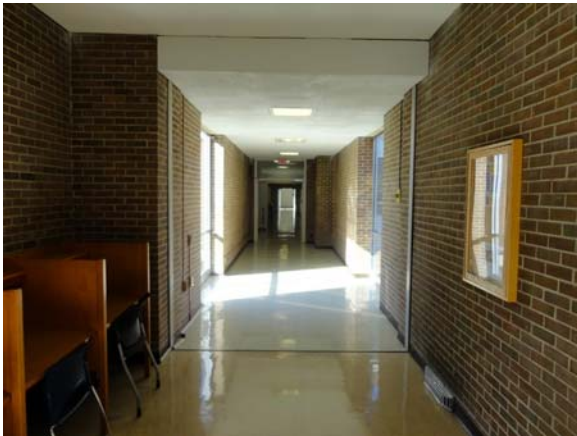
RIVE038a 5/13/2021
Some brick veneer walls along upper corridor
Second floor, north corridor

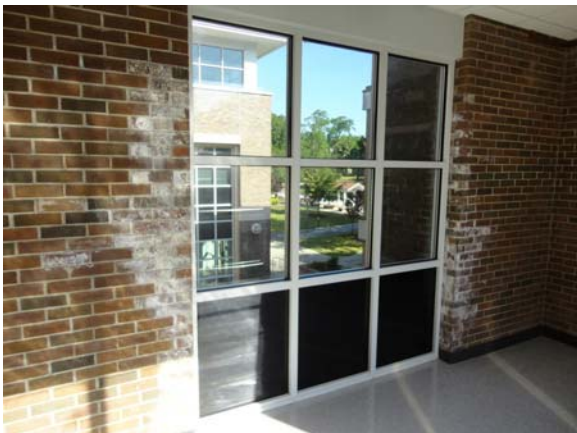
RIVE039a 5/13/2021
Some efflorescence around exterior glazing
Second floor, north corridor

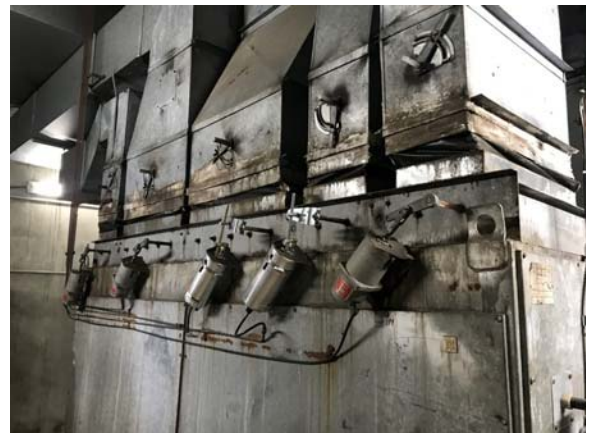
RIVE039e 5/13/2021
Zoned deck for air handling unit AHU-001
Room 02

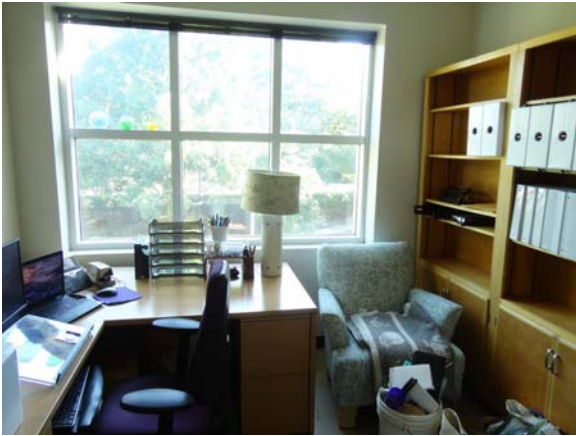
RIVE040a 5/13/2021
Newer exterior glazing in select areas
Second floor, office

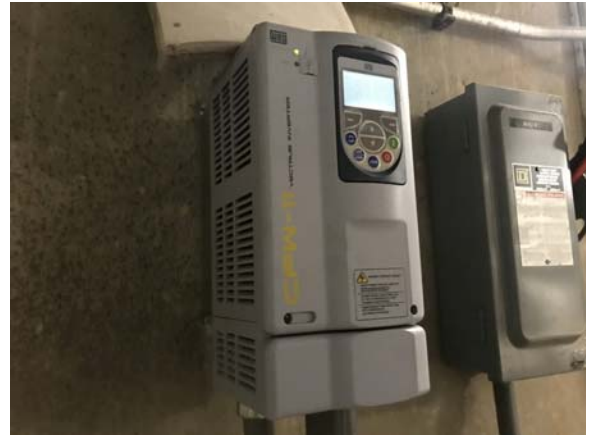
RIVE040e 5/13/2021
VFD for AHU-001
Room 02

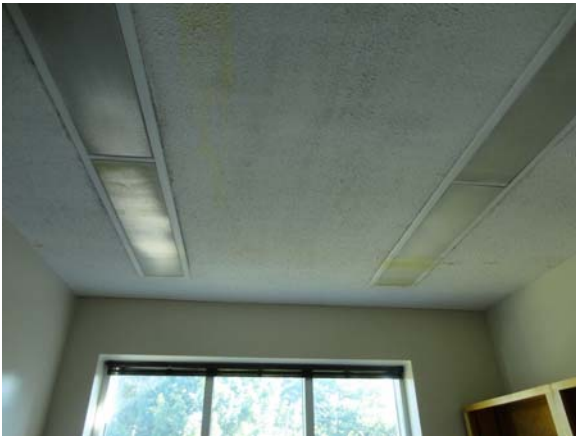
RIVE041a 5/13/2021
Stained textured ceiling
Second floor, office

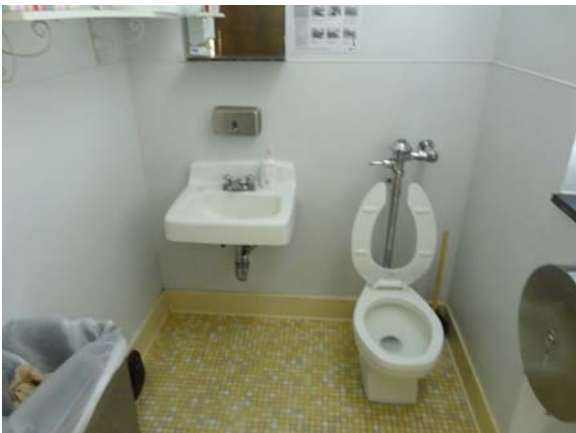
RIVE042a 5/13/2021
Older standard fixtures
First floor, south unisex restroom

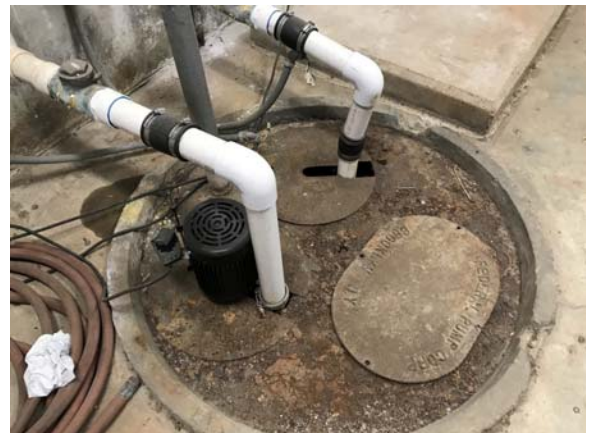
RIVE042e 5/13/2021
Sump pump
Room 03

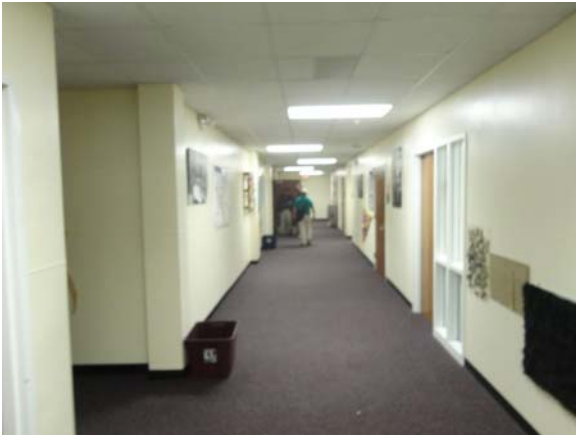
RIVE043a 5/13/2021
Broadloom carpeting and acoustical ceiling
First floor, south daycare area

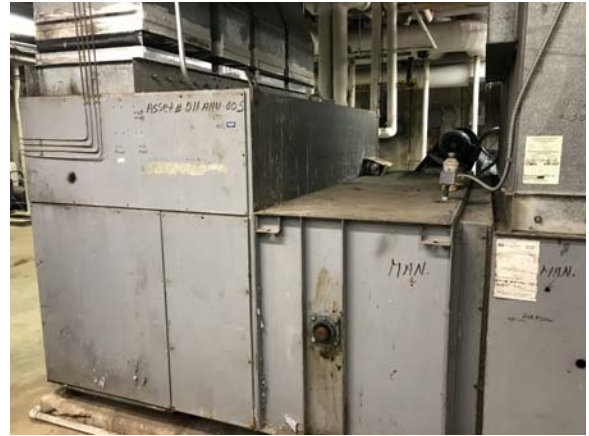
RIVE043e 5/13/2021
Air handling unit AHU-005
Room 03

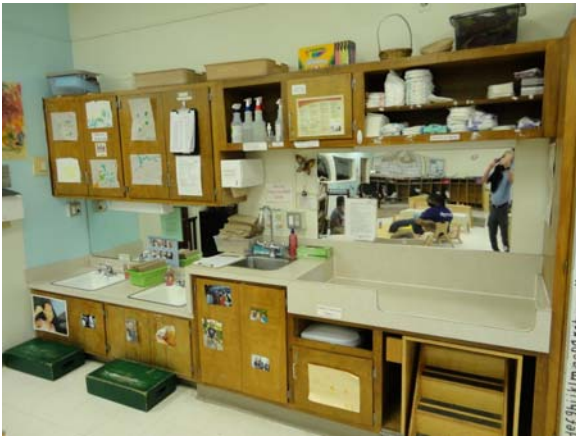
RIVE044a 5/13/2021
Older casework in toddler's dayroom
First floor, south daycare area

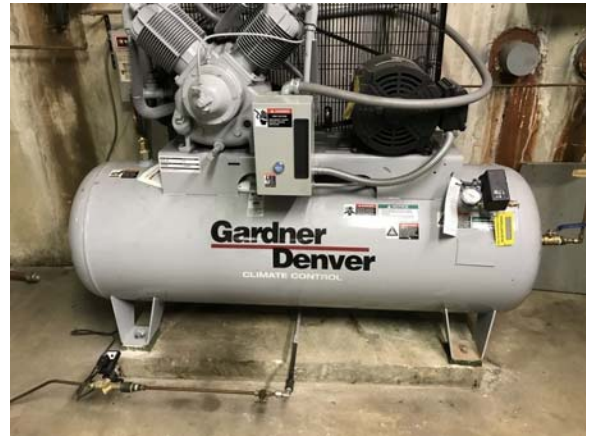
RIVE044e 5/13/2021
Controls air compressor
Room 03

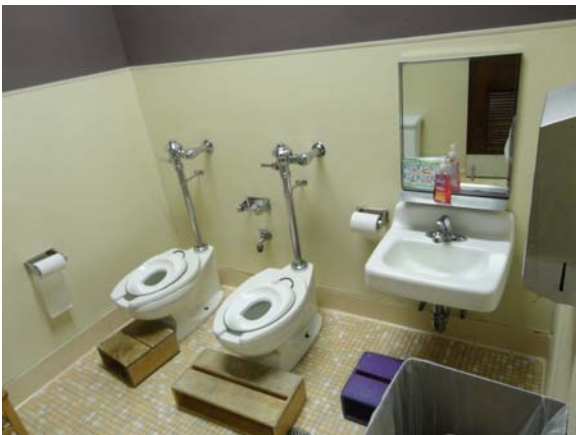
RIVE045a 5/13/2021
Two children's water closets and one wall-hung lavatory
First floor, south daycare area

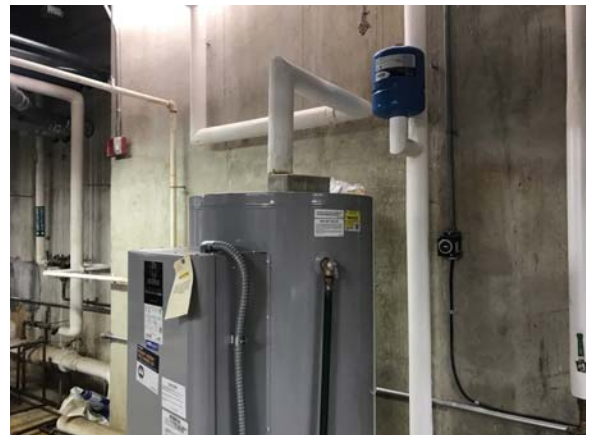
RIVE045e 5/13/2021
Residential electric water heater
Room 03

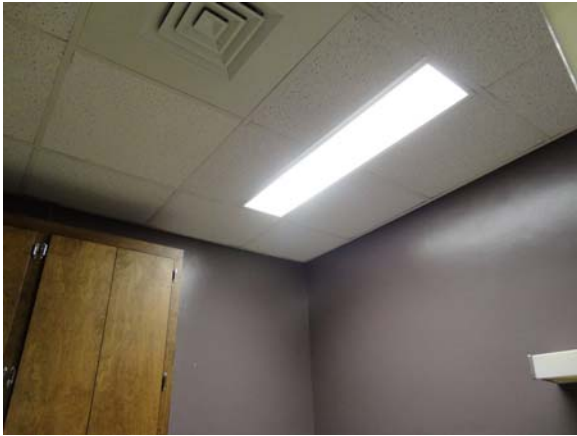
RIVE046a 5/13/2021
Acoustical ceiling
First floor, south daycare area

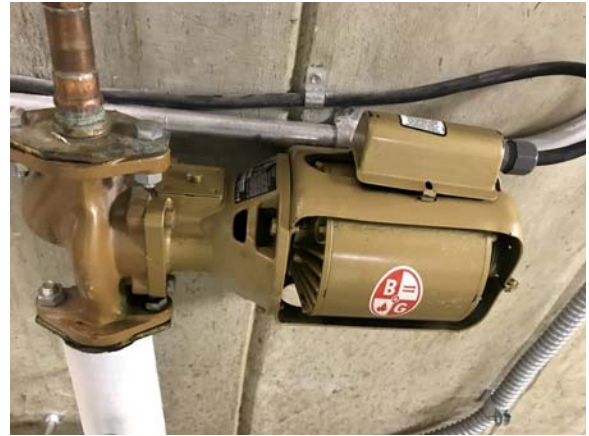
RIVE046e 5/13/2021
Domestic hot water circulation pump
Room 03

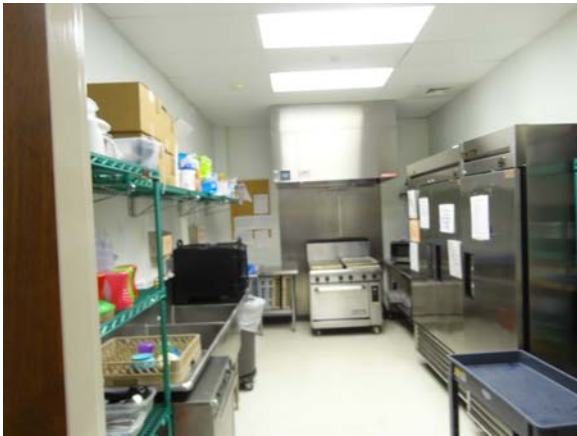
RIVE047a 5/13/2021
Typical finishes
First floor, south daycare kitchen

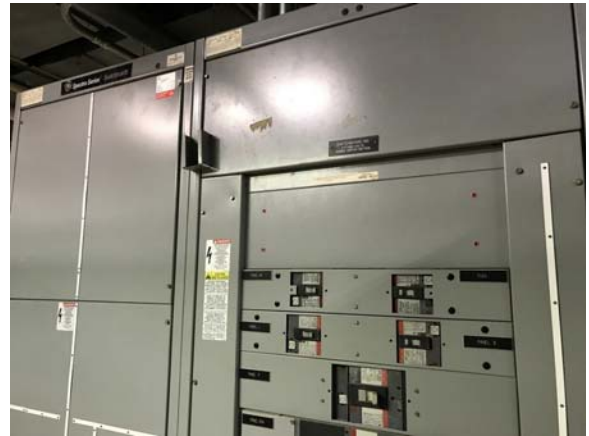
RIVE047e 5/13/2021
Main switchboard
Room 03

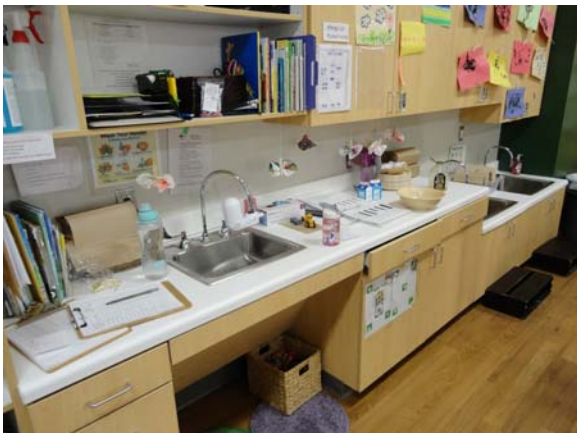
RIVE048a 5/13/2021
Newer casework
First floor, south daycare area

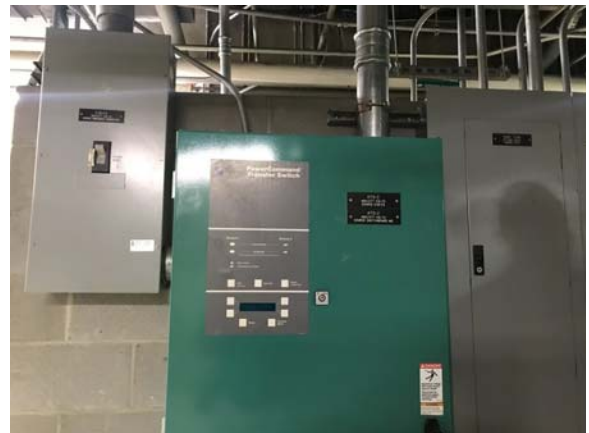
RIVE048e 5/13/2021
Automatic transfer switch
Room 03

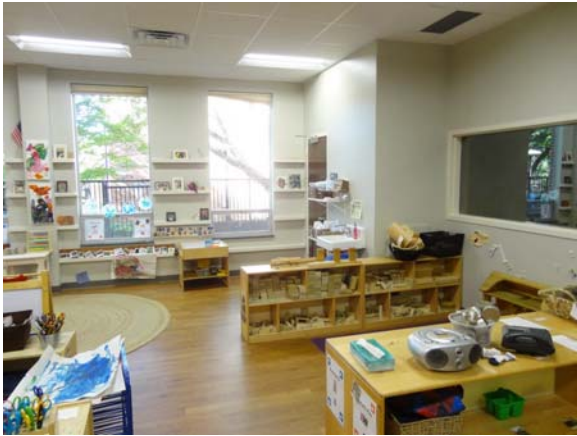
RIVE049a 5/13/2021
Newer sheet vinyl flooring
First floor, south daycare area

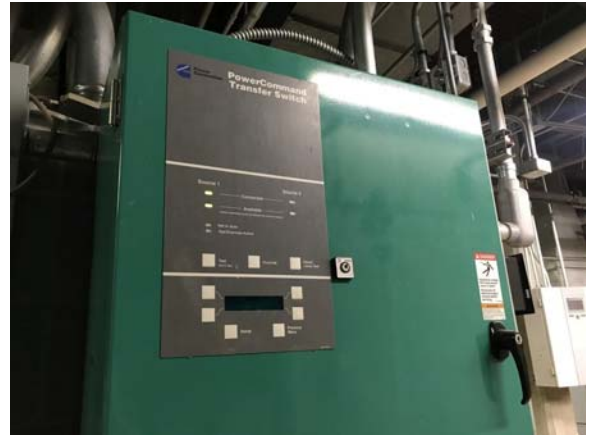
RIVE049e 5/13/2021
Automatic transfer switch
Room 03

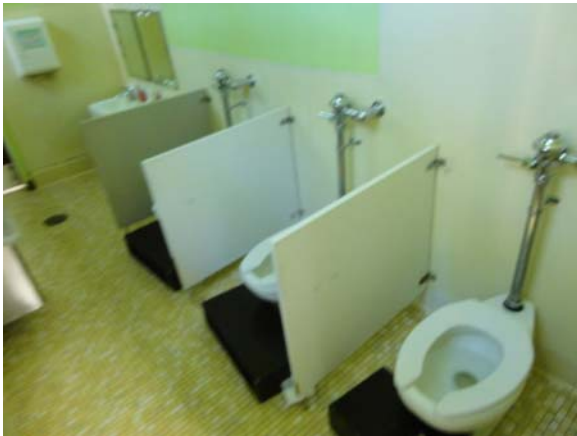
RIVE050a 5/13/2021
Three children's water closets and two wall-hung
lavatories
First floor, south daycare area

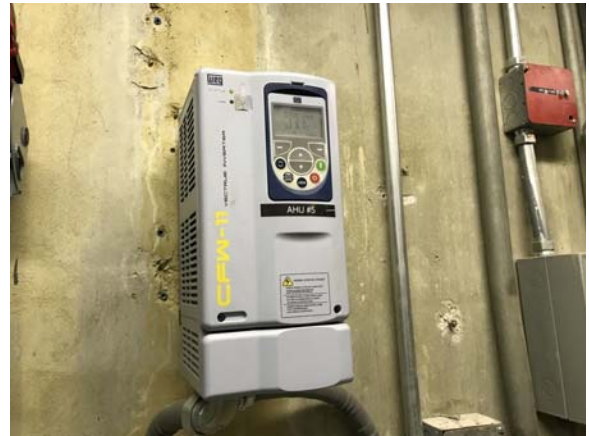
RIVE050e 5/13/2021
VFD for AHU-005
Room 03

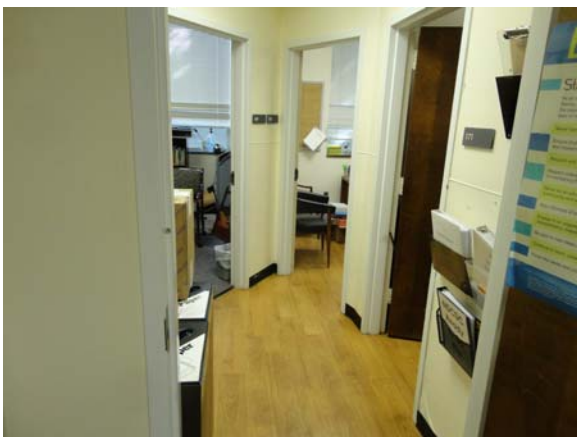
RIVE051a 5/13/2021
Newer sheet vinyl flooring in offices
First floor, south daycare area

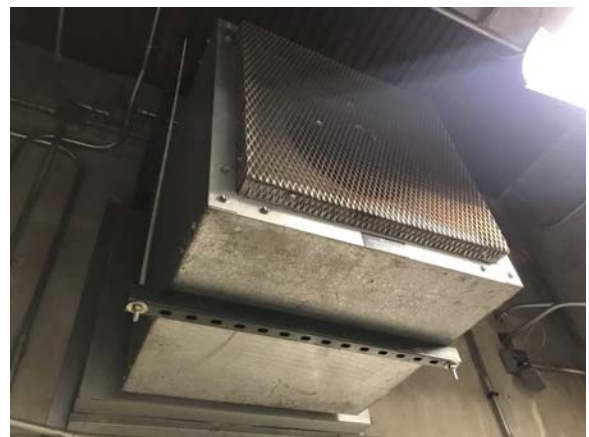
RIVE051e 5/13/2021
Propeller exhaust fan
Room 03
