EAST CAROLINA UNIVERSITY

Facility Condition Assessment

Rivers Building (010)

Inspected May 13, 2021

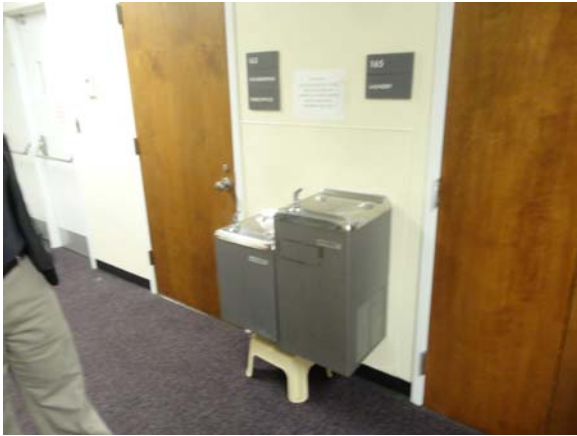
RIVE052a 5/13/2021
Older two-level water fountain
First floor, south daycare area

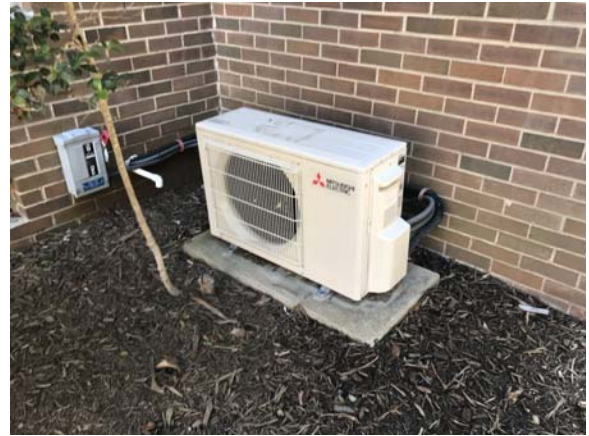
RIVE052e 5/13/2021
Ductless split condensing unit
Site

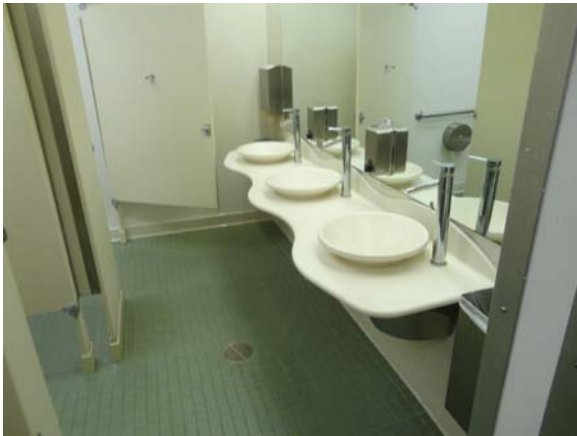
RIVE053a 5/13/2021
Three new accessible counter lavatories
First floor, central women's restroom

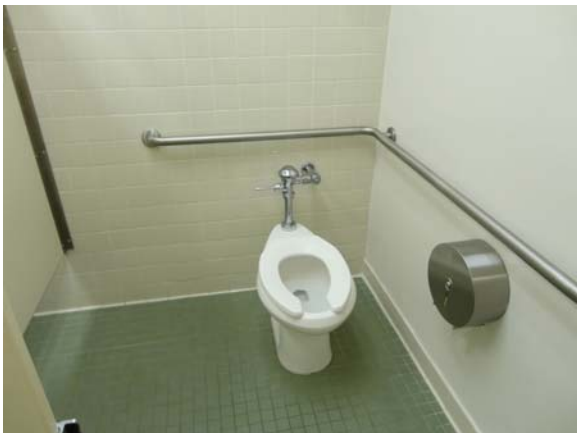
RIVE054a 5/13/2021
Accessible toilet stall
First floor, central women's restroom

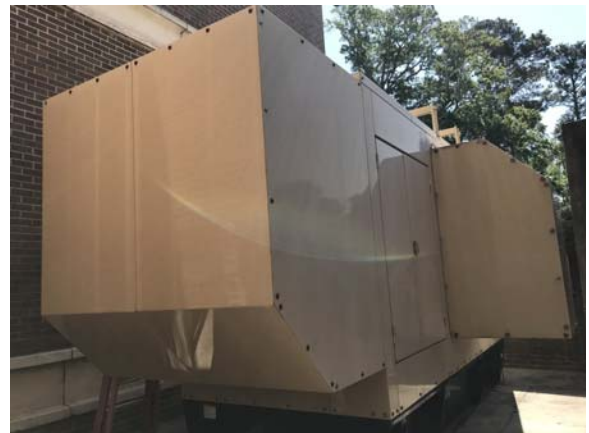
RIVE054e 5/13/2021
Emergency generator
Site

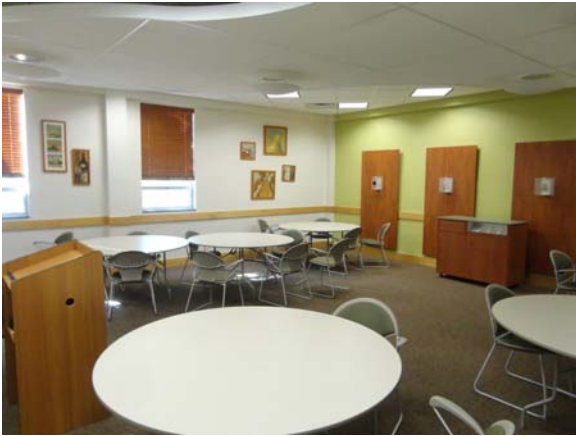
RIVE055a 5/13/2021
Newer broadloom carpeting and acoustical ceiling
First floor, east Culinary area

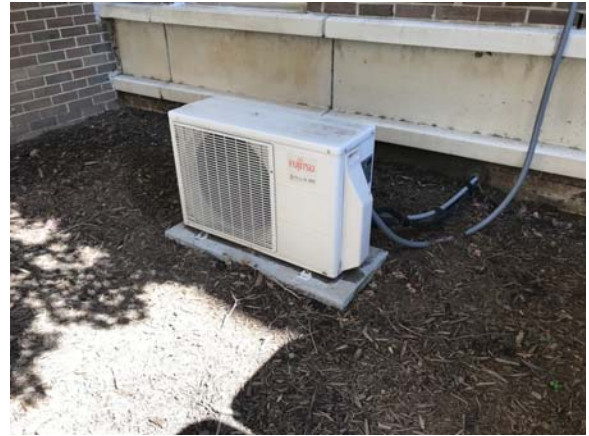
RIVE055e 5/13/2021
Ductless split condensing unit
Site

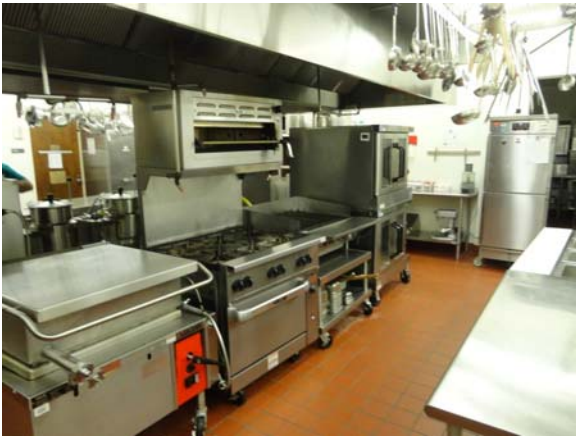
RIVE056a 5/13/2021
Cooking equipment
First floor, east Culinary area

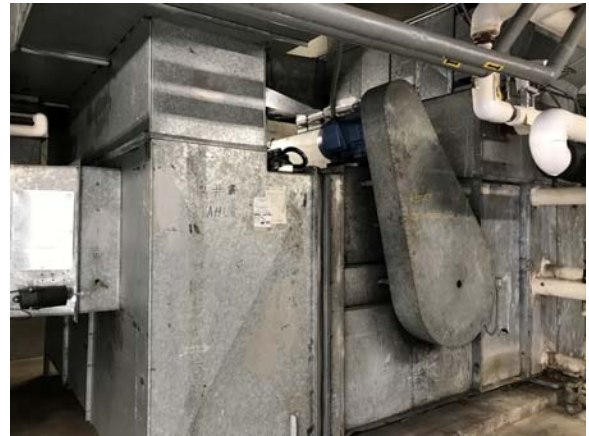
RIVE056e 5/13/2021
Air handling unit AHU-006
Room 04

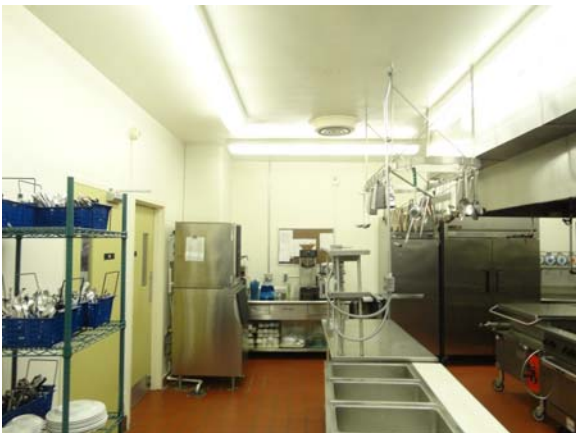
RIVE057a 5/13/2021
Quarry tile floor and painted ceiling
First floor, east Culinary area

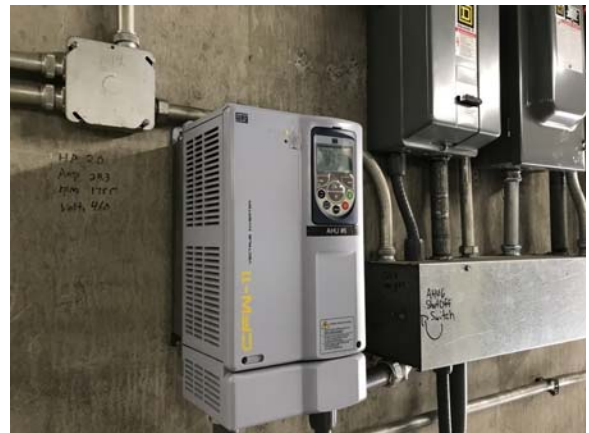
RIVE057e 5/13/2021
VFD for AHU-006
Room 04

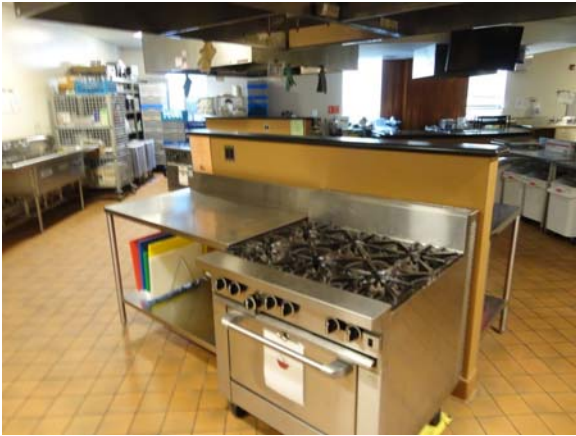
RIVE058a 5/13/2021
Quarry tile floor and staged cooking equipment
First floor, teaching kitchen

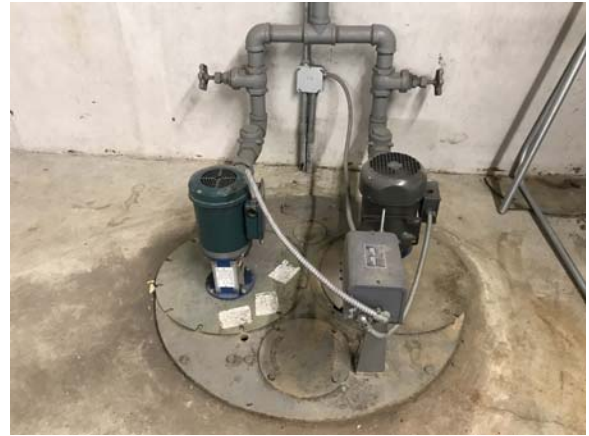
RIVE058e 5/13/2021
Sump pump
Room 04

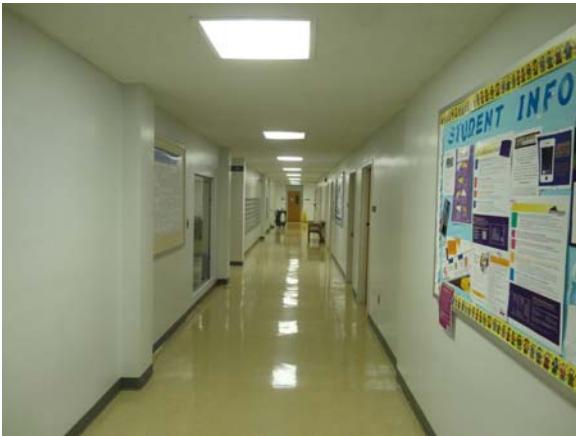
RIVE059a 5/13/2021
Older vinyl floor tile and original textured ceiling
First floor corridor

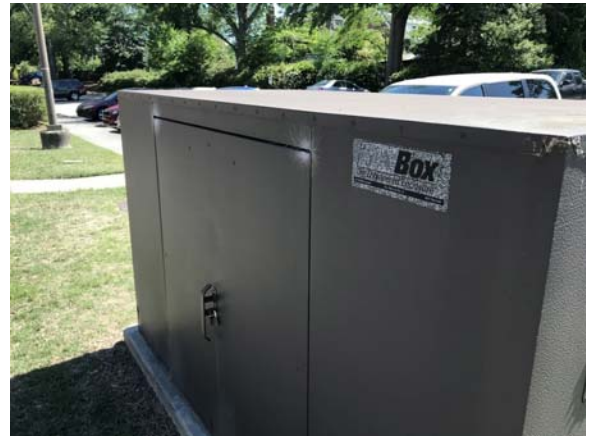
RIVE059e 5/13/2021
Location of water main backflow preventers
Site

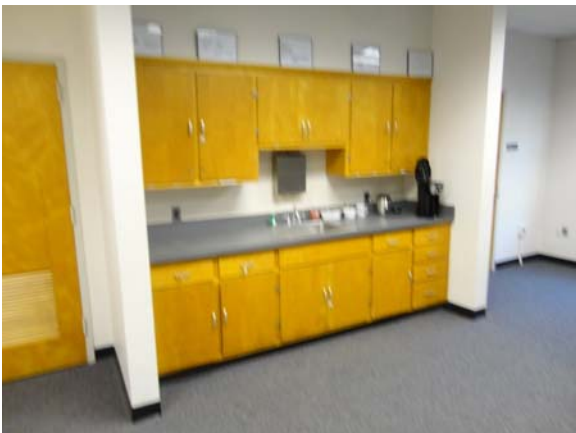
RIVE060a 5/13/2021
Older casework with sink
First floor, conference area

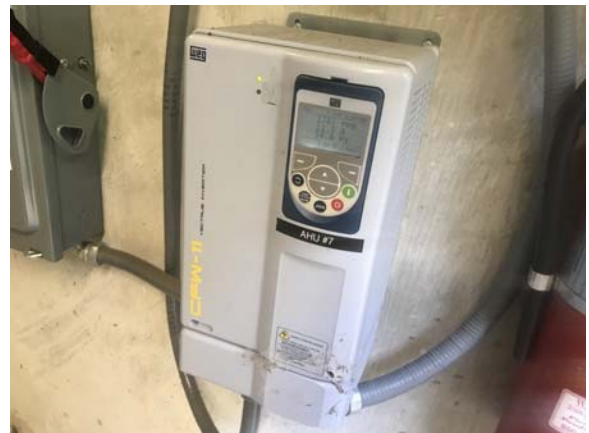
RIVE060e 5/13/2021
VFD for AHU-007
Room 05

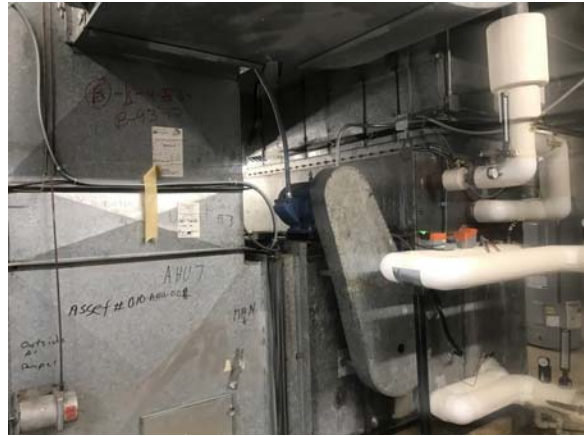
RIVE061e 5/13/2021
Air handling unit AHU-007
Room 05

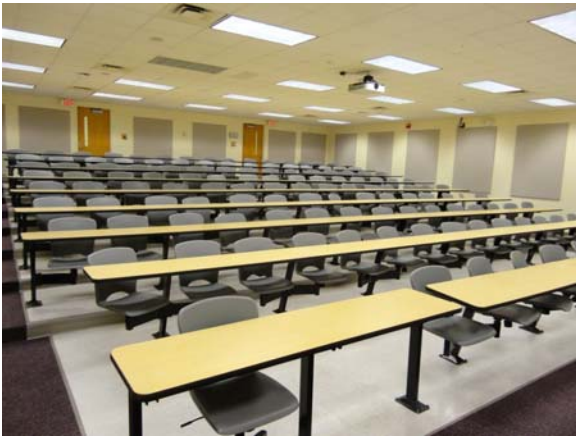
RIVE062a 5/13/2021
Fixed seating
First floor, north lecture room

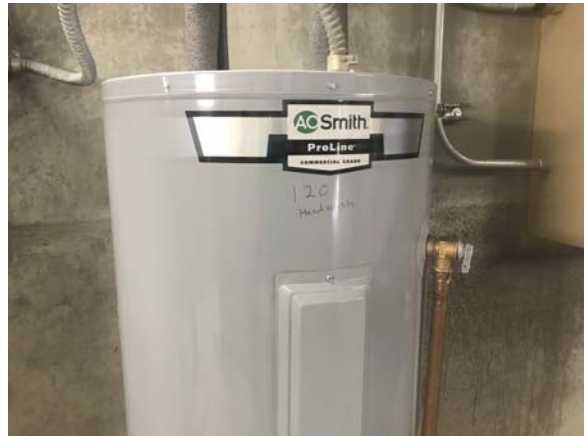
RIVE062e 5/13/2021
Residential electric water heater
Room 05

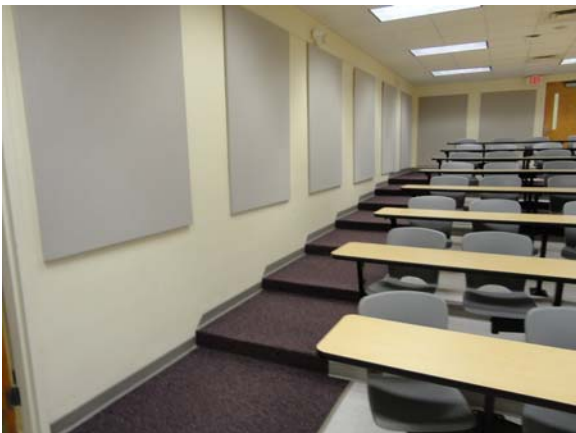
RIVE063a 5/13/2021
No side aisle handrails or assistive listening
First floor, north lecture room

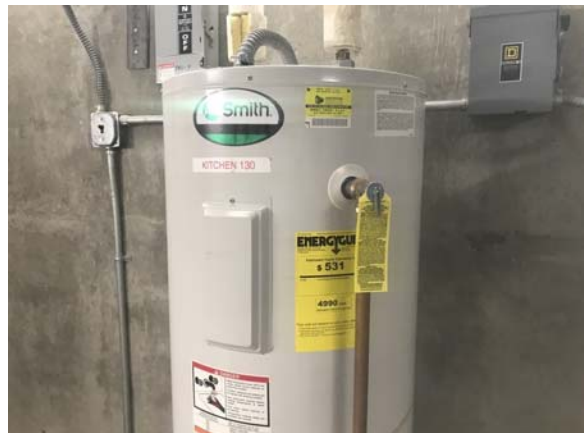
RIVE063e 5/13/2021
Residential electric water heater
Room 05

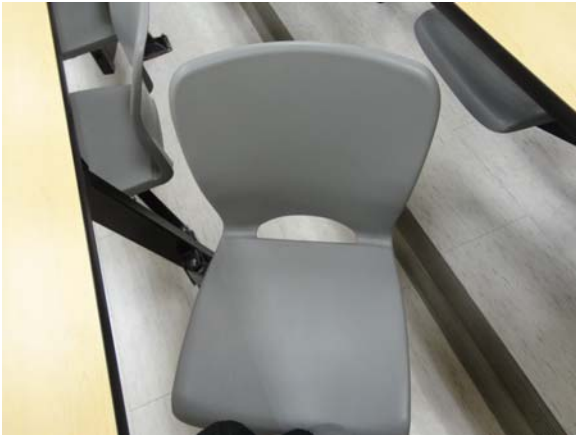
RIVE064a 5/13/2021
Molded plastic fixed seating
First floor, north lecture room

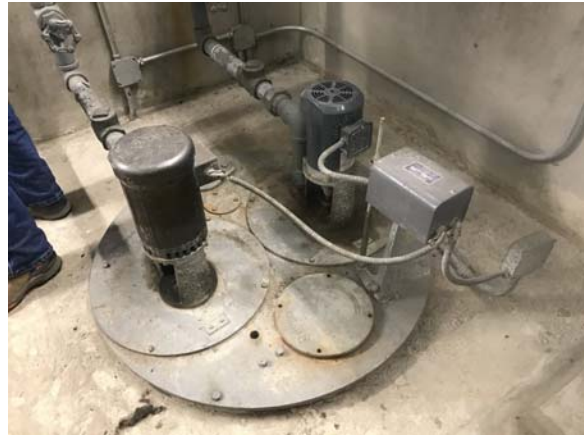
RIVE064e 5/13/2021
Sump pump
Room 05

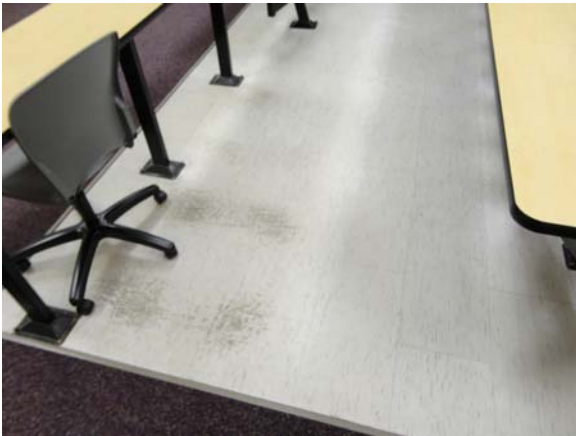
RIVE065a 5/13/2021
Worn vinyl flooring in seating aisles
First floor, north lecture room

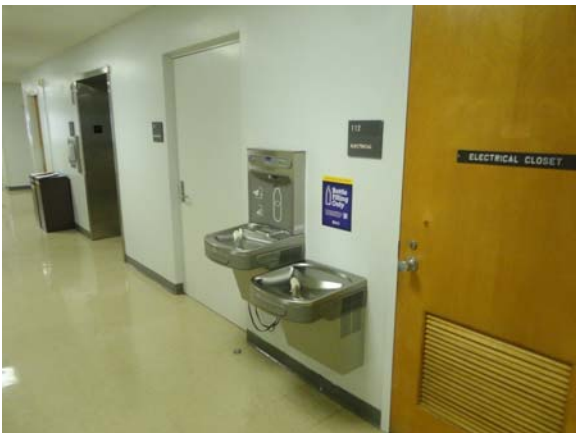
RIVE066a 5/13/2021
Newer dual-level water fountain
First floor, north corridor

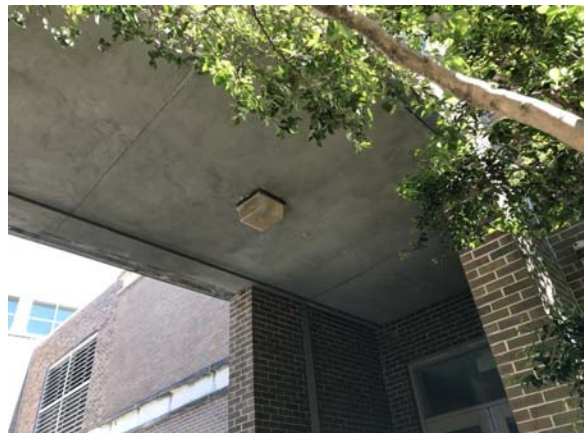
RIVE066e 5/13/2021
Ceiling-mounted HID lighting fixture
Exterior soffit

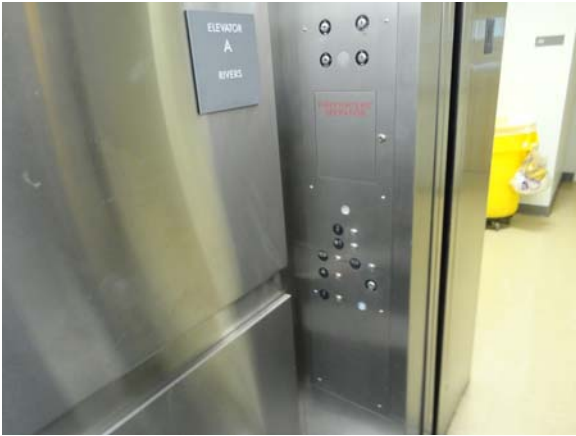
RIVE067a 5/13/2021
Accessible elevator control panel
Passenger elevator cab

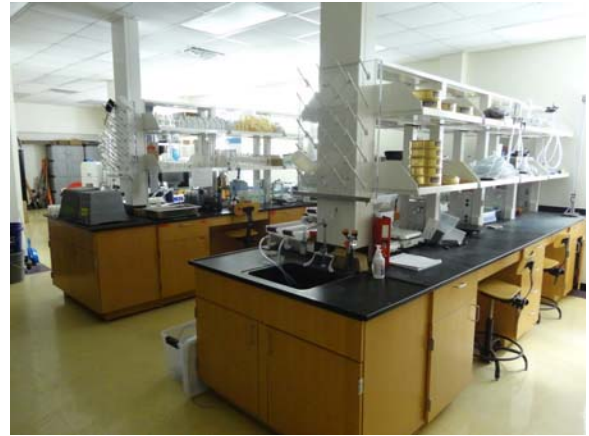
RIVE068a 5/13/2021
Standard wood lab cabinetry with vinyl floor tile
First floor, engineering lab

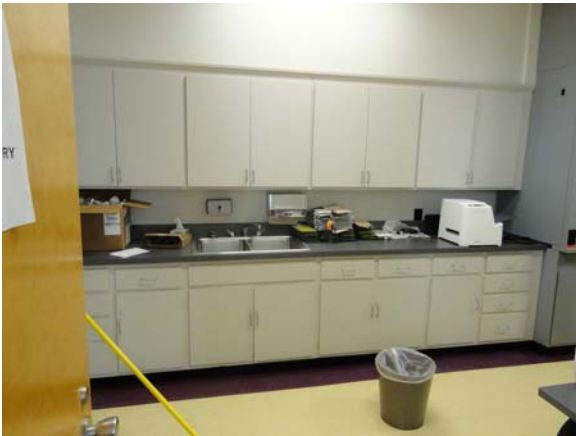
RIVE069a 5/13/2021
New casework and sink
First floor, office area

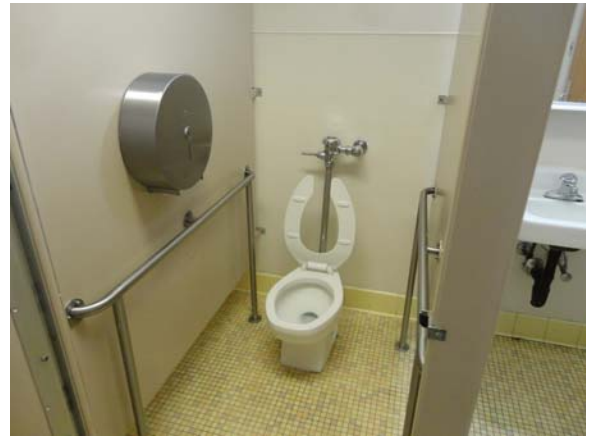
RIVE070a 5/13/2021
Partially accessible toilet stall
First floor, men's restroom

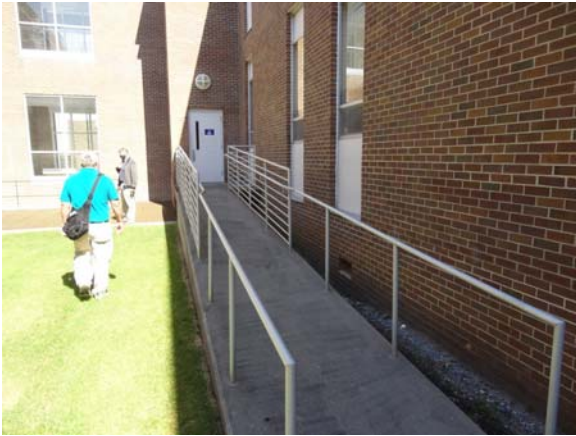
RIVE073a 5/13/2021
Ramp and railing to secondary egress
Courtyard

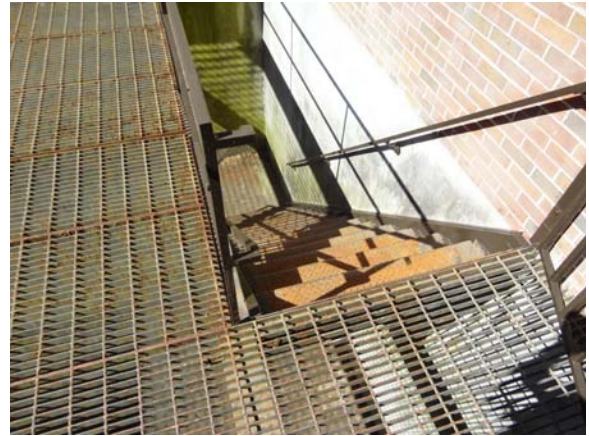
RIVE074a 5/13/2021
Rusted areaway access steps
Courtyard

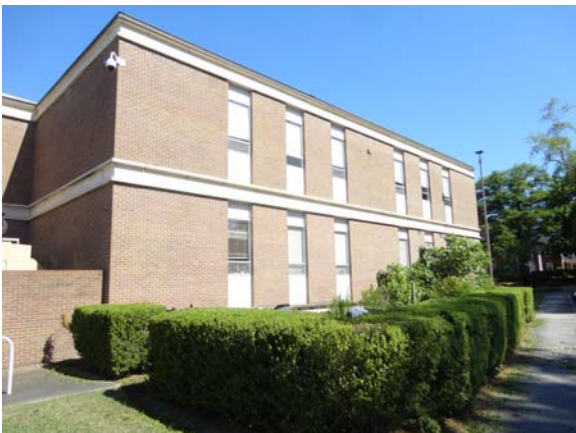
RIVE077a 5/13/2021
Brick, precast banding, and single-pane glazing
Northeast corner elevation

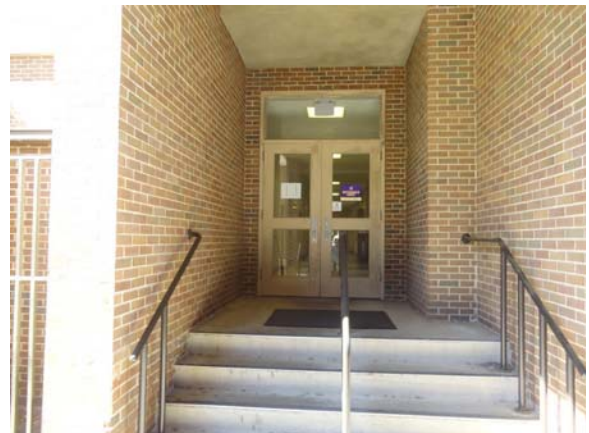
RIVE078a 5/13/2021
Typical metal and glass corridor egress doors
First floor, entry/egress

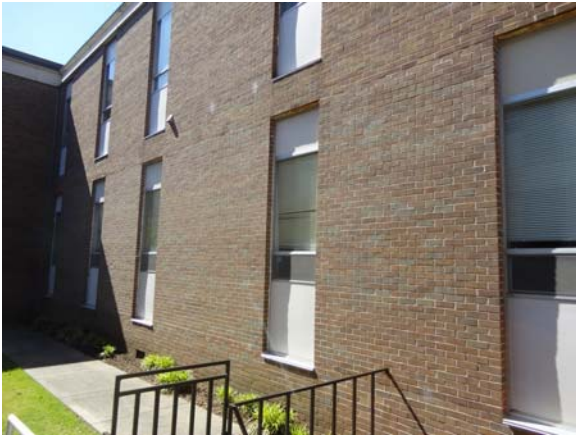
RIVE079a 5/13/2021
Single-pane glazing
Courtyard

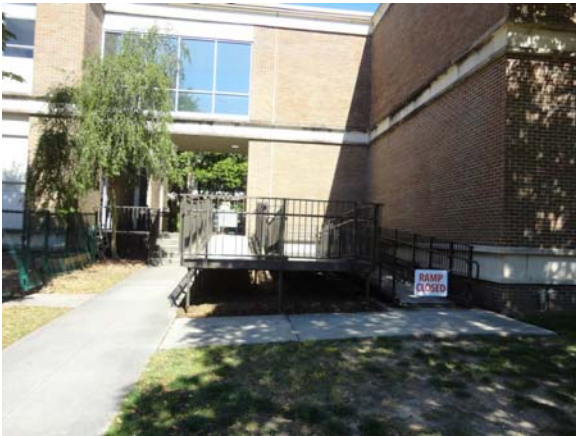
RIVE081a 5/13/2021
Rusted out pedestrian entry ramp
Southeast elevation

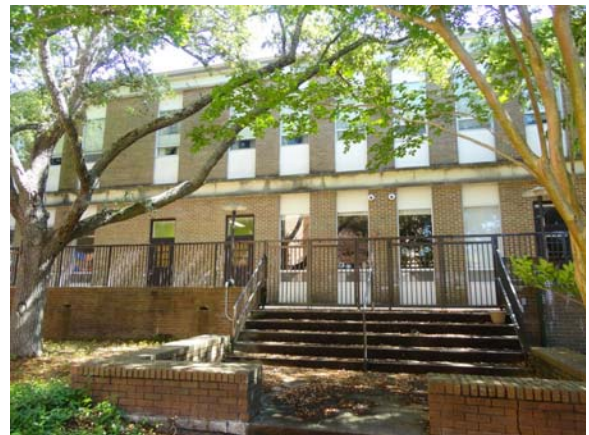
RIVE084a 5/13/2021
Brick, precast banding, and single-pane glazing
South elevation

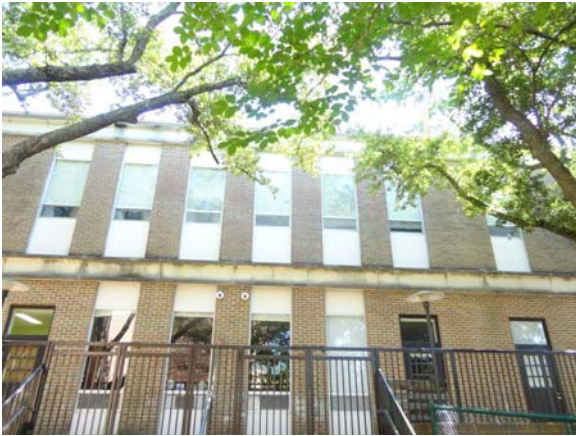
RIVE085a 5/13/2021
Staining visible on upper banding
South elevation

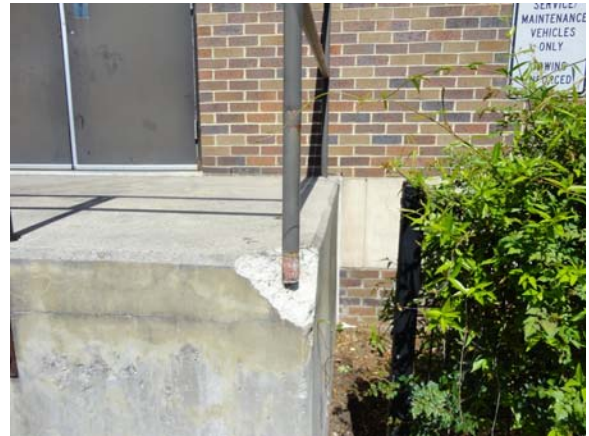
RIVE088a 5/13/2021
Damaged rail anchor at new service dock
Southeast elevation
