# EAST CAROLINA UNIVERSITY

Facility Condition Assessment

Slay Hall (076)

Inspected May 12, 2021

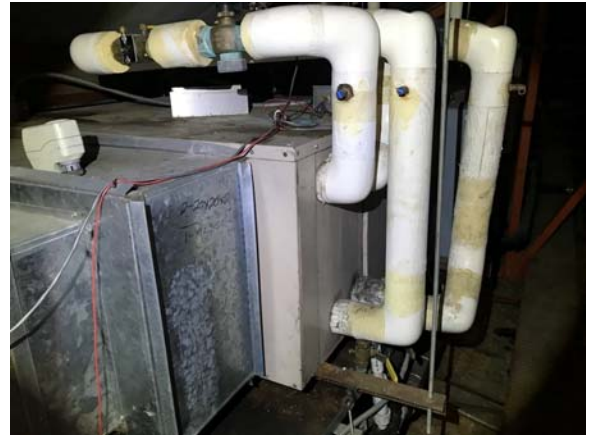
SLAY001e 5/12/2021  
Fan coil unit  
Attic

The main HVAC system provides heating and cooling via four-pipe console style and conventional style fan coil units utilizing heating hot water and chilled water. Two makeup air handling units in the attic serve the restrooms. Two fan coil units serve the main lobby and the lobby restrooms. Restroom exhaust is handled by rooftop centrifugal exhaust fans while the mechanical spaces have inline exhaust fans. The majority of these systems were installed in the mid-1990s during a renovation and should be considered for replacement due to lifecycle depletion.

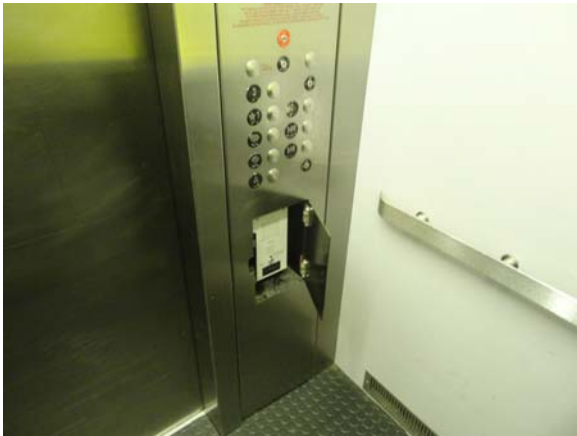
SLAY002a 5/12/2021  
Accessible communication unit in non-ADA phone box  
Passenger elevator cab

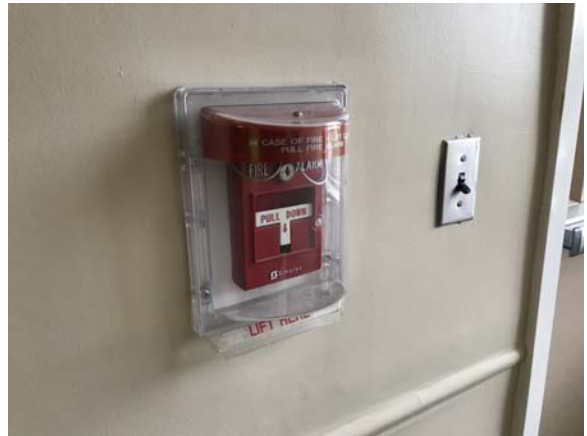
SLAY005e 5/12/2021  
Manual pull fire alarm device  
Third floor corridor

This facility contains a Simplex point addressable fire alarm and detection system with a main fire alarm panel, manual pull stations, smoke detectors, and horn and strobe alarm systems. The panel was installed in the mid-1990s and the devices were replaced around 2010. It is recommended that the panel and devices be considered for replacement within the next ten years due to technical obsolescence.

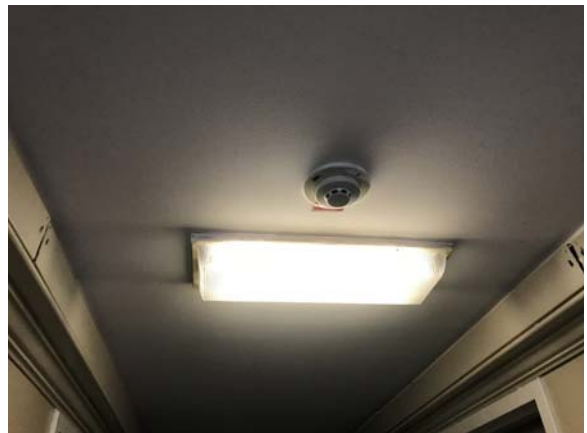
SLAY006e 5/12/2021  
T8 troffer lighting fixture  
Third floor corridor

The majority of the interior lighting was replaced in 1995 and consist of T8 troffers and recessed can CFL fixtures. Although the current lighting system appears to be in usable condition, it has fulfilled its financially viable life expectancy. Lighting technology is rapidly advancing and expectations for lamp durability, quality, intensity control, and efficiency are increasing with the advancement of LED lighting options. The lighting fixtures should be considered for upgrade to LED technology.

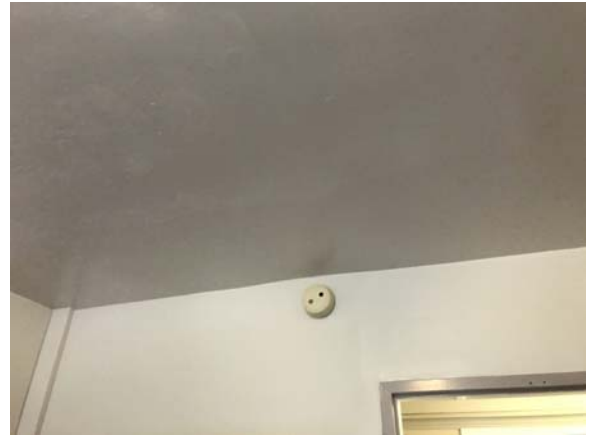
SLAY007e 5/12/2021  
Smoke detector  
Room 348

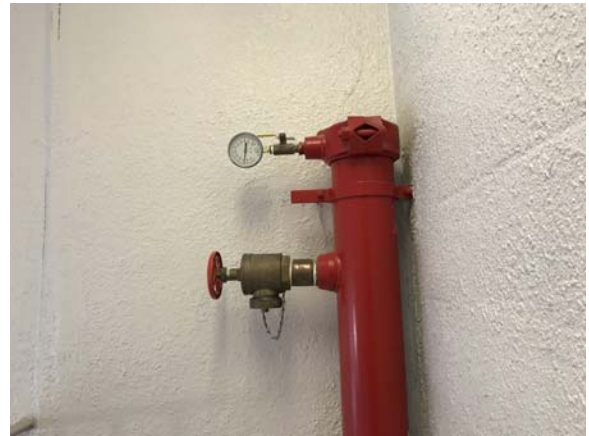
SLAY008e 5/12/2021  
Fire suppression stand pipe  
Stairwell

This facility is not protected via an automatic fire suppression system. Fire suppression is handled manually via strategically placed dry-type handheld fire extinguishers and standpipes. As a part of future renovation efforts, it is recommended an automatic wet-pipe fire suppression system be installed to protect the asset from a potential fire.

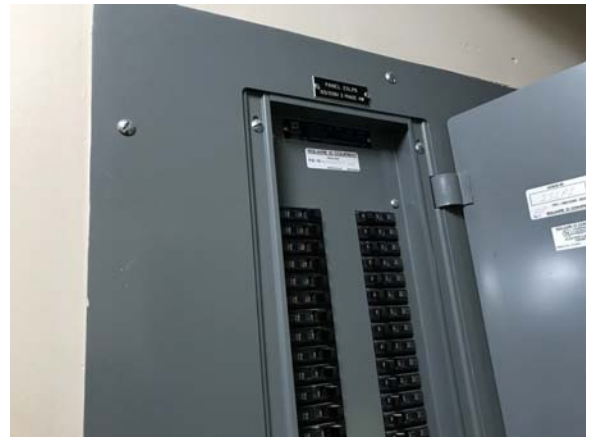
SLAY010e 5/12/2021  
Local panelboard  
Second floor corridor

Power is fed to this facility at 277/480 volts routed to an 800-amp main switchboard. Power is further reduced to 120/208 volts through secondary step-down transformers. Power is distributed at 120/208 and 277/480 volts via individual conductors in metallic conduit to secondary panelboards for use in local devices. The downline electrical system components include distribution feeders, conduits, local panelboards, load centers, safety switches, fused disconnects, receptacles, switches, and similar terminal elements. The incoming electrical service and distribution network were replaced in 1995 and are expected to remain viable for the next ten years. However, the switchboard should be evaluated for replacement due to lifecycle depletion.

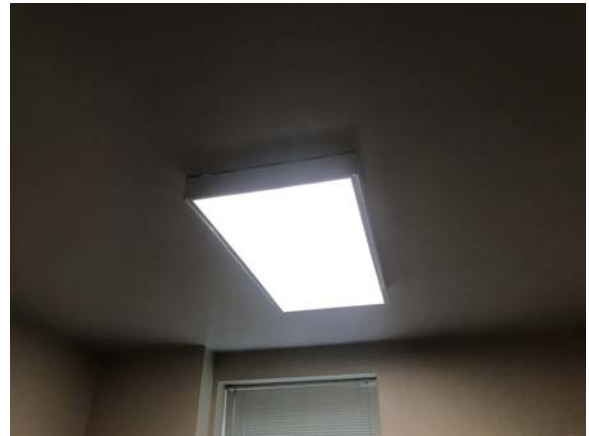
SLAY011e 5/12/2021  
T8 troffer lighting fixture  
Room 147

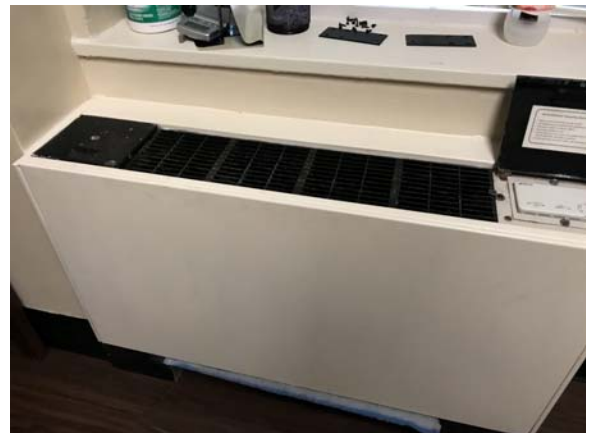
SLAY012e 5/12/2021  
Console fan coil unit  
Room 147

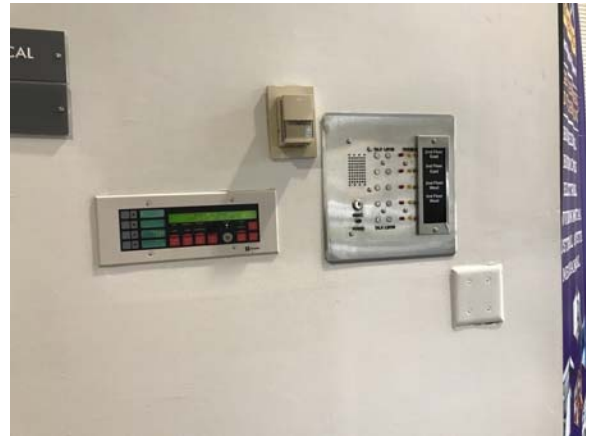
SLAY014e 5/12/2021  
Fire alarm annunciator panel  
Main lobby

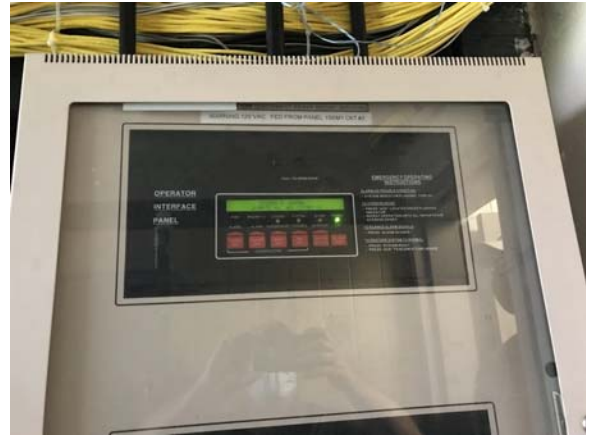
SLAY019e 5/12/2021  
Main fire alarm panel  
Room 137

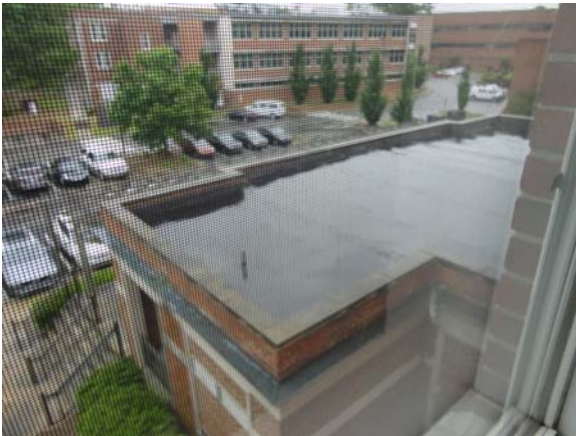
SLAY020a 5/12/2021  
View of older membrane roof  
Roof over entry lobby

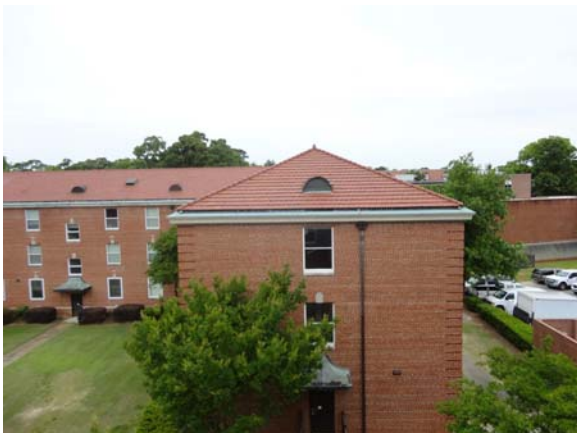
SLAY047a 5/12/2021  
Stress cracks at corner of brick and staining of cut stone  
Upper east elevation
