EAST CAROLINA UNIVERSITY

Facility Condition Assessment

Speight Building (012)

Inspected May 11, 2021

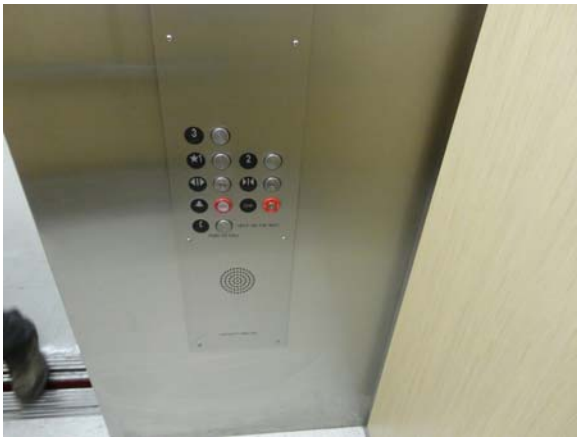
SPEI001a 5/11/2021
Accessible elevation control panel
Passenger elevator cab

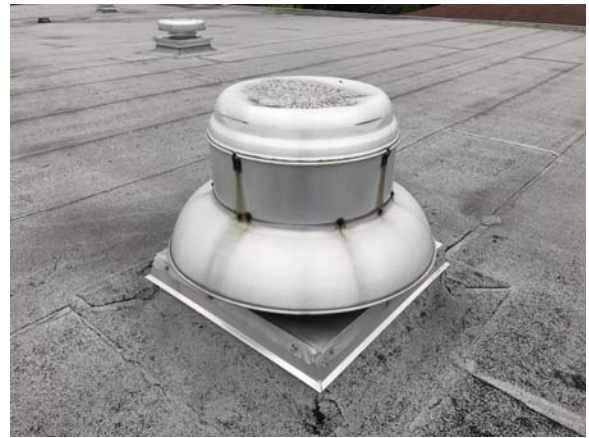
SPEI001e 5/11/2021
Centrifugal rooftop exhaust fan
Roof

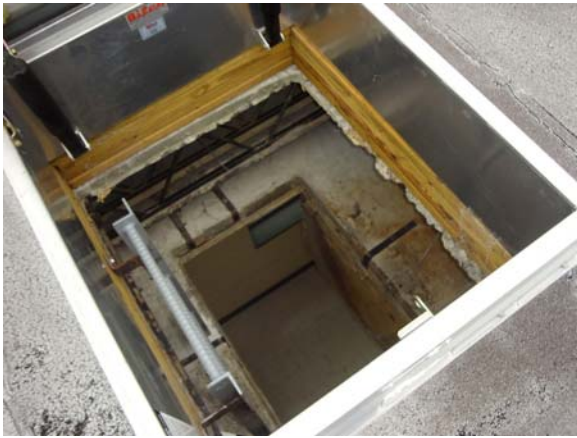
SPEI002a 5/11/2021
Poor lower hatch and no stair rail extension
Roof hatch

The multi-level flat roofs are aging and should be upgraded in the near few years. The roof hatch in the #3 stair tower has a newer top hatch but the lower hatch is poor and the ladder lacks any handrail extension features. Replace the lower hatch and install a railing extension unit to the top of the access ladder. Also, relocate the roof transition ladder that is located too close to the edge of the roof to help improve safety for service personnel.

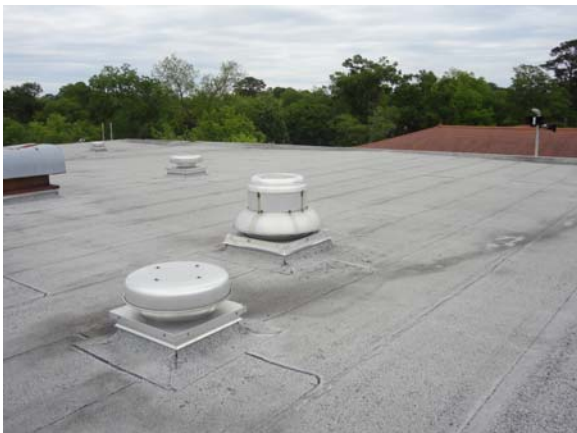
SPEI003a 5/11/2021
Upper built-up roof with cap sheet
Upper main roof

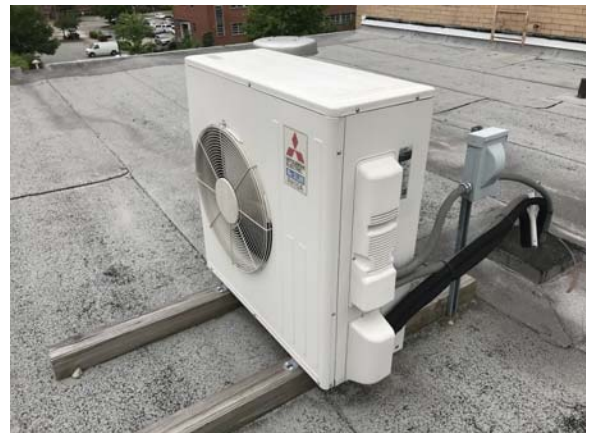
SPEI003e 5/11/2021
Ductless split condensing unit
Roof

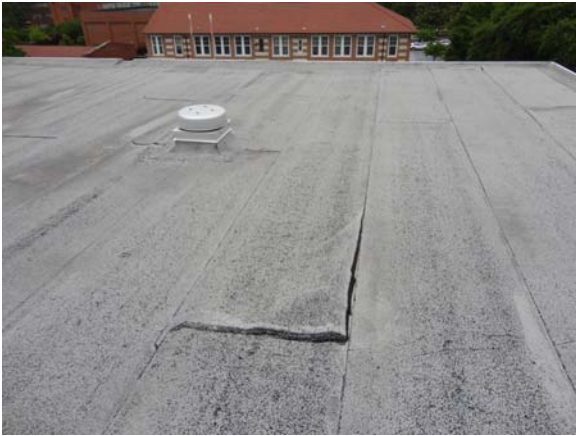
SPEI004a 5/11/2021
Blistered cap sheet
Upper main roof

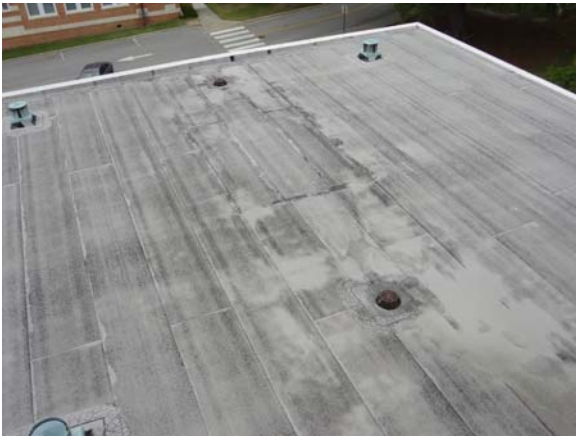
SPEI005a 5/11/2021
One of four lower built up roofs
Lower roof

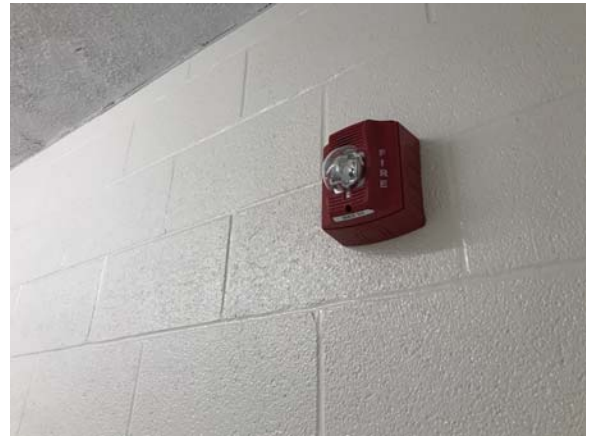
SPEI005e 5/11/2021
Horn with strobe fire alarm device
Third floor corridor

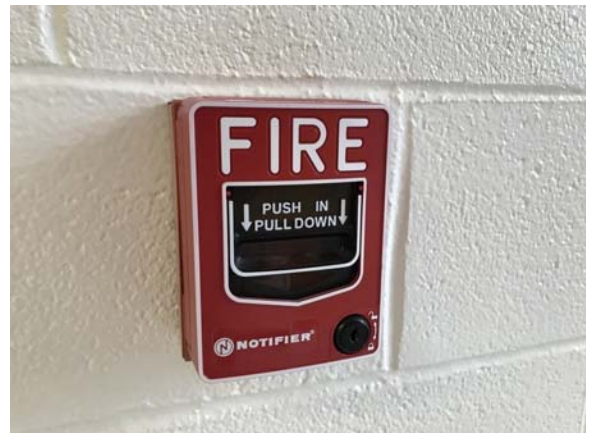
SPEI006e 5/11/2021
Manual pull fire alarm device
Third floor corridor

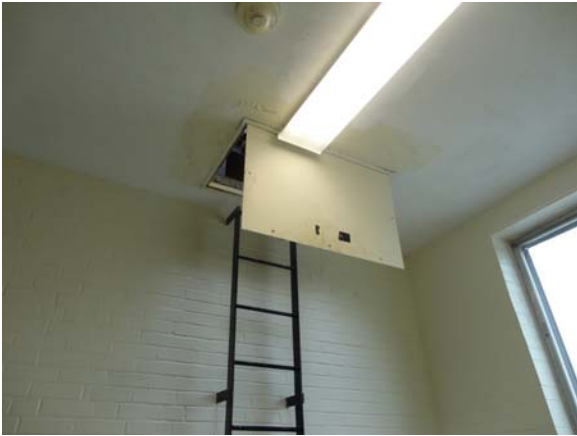
SPEI007a 5/11/2021
Aging original lower roof hatch
Third floor, stair tower

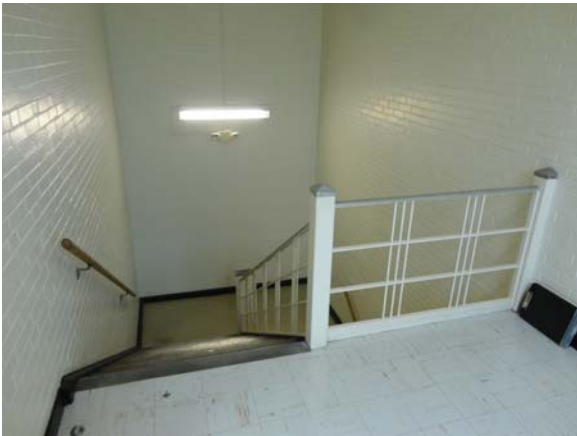
SPEI008a 5/11/2021
Nonaccessible inner and outer stair rails
Third floor, stair tower

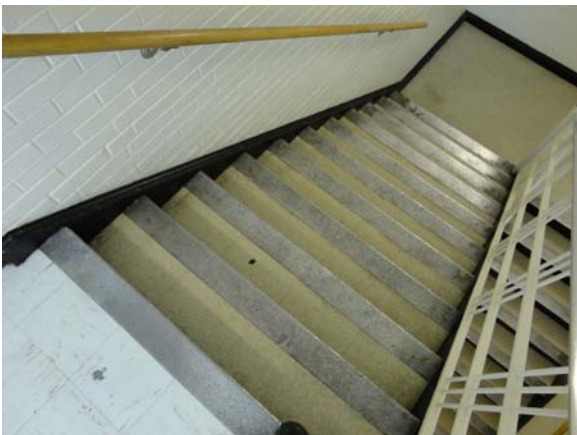
SPEI009a 5/11/2021
Worn stair treads
Third floor, stair tower

are addressed in the Health section. The acoustical ceilings vary in age, but overall they are in adequate condition at this time. Carpeting varies in age and is showing normal wear. Due its short lifecycle, all of the existing carpeting should be replaced in the near future. The ceramic floor and wall tile in the restrooms and janitor's closets is aging and should be upgraded when the restrooms are upgraded. The Accessibility section recommends that the stair treads in the four interior stair towers be upgraded with new rubber stair treads with color contrasting nosings.

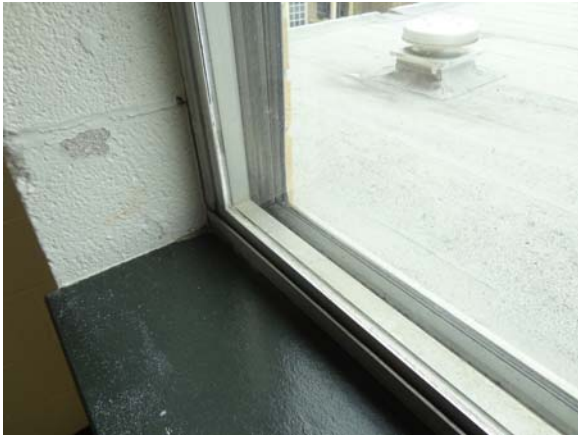
SPEI010a 5/11/2021
Windows with added outer storm window
Third floor

The primary and secondary doors have been upgraded to glass and metal assemblies and are in good overall condition. The hollow-metal service doors are older, but serviceable, and no upgrades are recommended at this time. While many of the window systems have been retrofitted with storm windows, the original windows continue to degrade and should be upgraded with new thermal-pane, metal-framed glazing on all elevations.

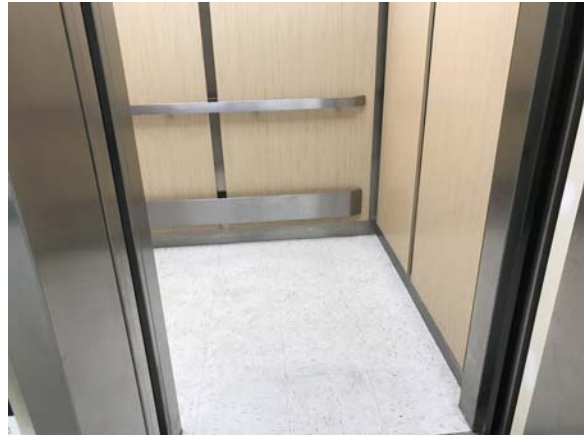
SPEI010e 5/11/2021
Elevator interior
Elevator

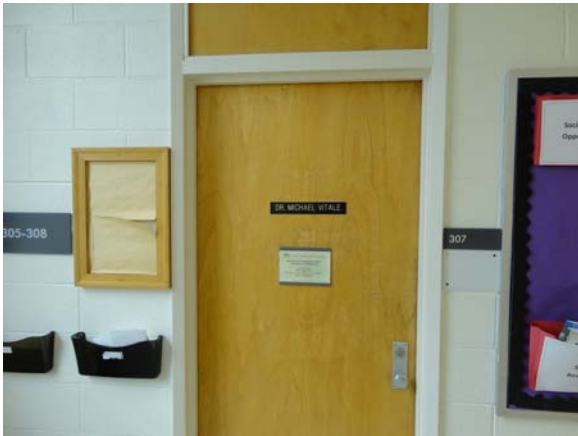
SPEI011a 5/11/2021
Nonrated corridor door with knob hardware
Third floor corridor

Many of the interior doors still lack lever hardware. These aging doors should be replaced and the new door assemblies should include lever hardware. However, if these doors are not upgraded in the near future then new accessible interior lever hardware sets should be installed on the existing doors on all floors. The room signage has been upgraded to wall-mounted high color contrast signage with Braille.

While the building appears to have adequate egress pathways, most of the interior doors are not fire rated and a building-wide corridor door upgrade is recommended to provide fire-rated corridor doors with lever hardware sets on all floors.

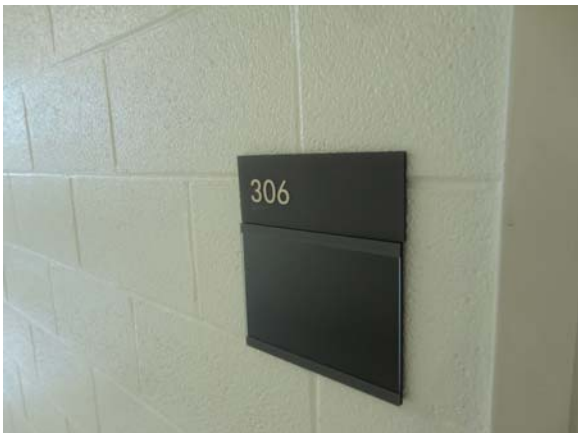
SPEI012a 5/11/2021
Accessible wall-mounted room signage
Third floor corridor

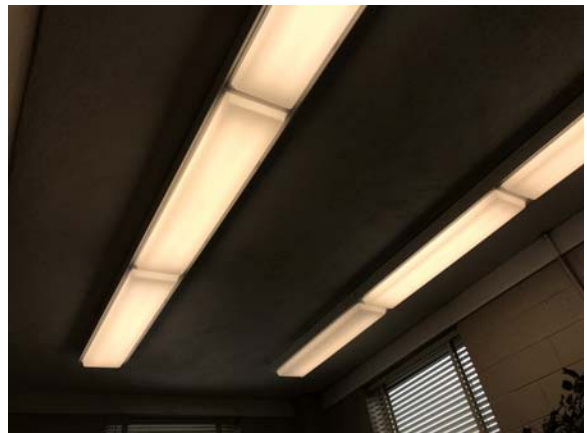
SPEI012e 5/11/2021
Retrofitted T8 lighting fixtures
Third floor, office space

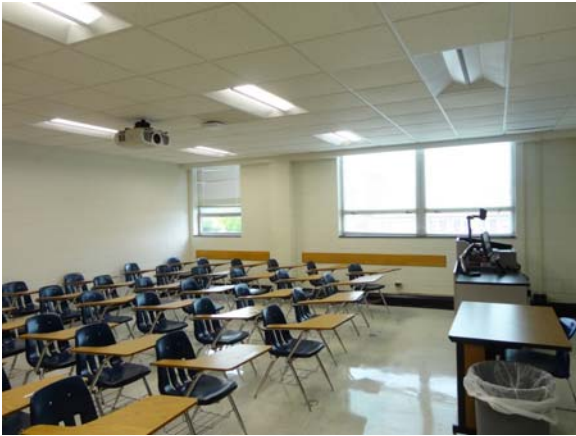
The interior finishes are in fair condition. Painted walls have older finishes and all of the walls should be repainted in the near future. Flooring is a mixture of carpeting and older vinyl that is assumed to contain asbestos. The painted textured ceilings are also believed to contain asbestos. These abatement issues

SPEI013a 5/11/2021
Original 9x9 vinyl flooring and newer acoustical ceiling
Third floor, classroom

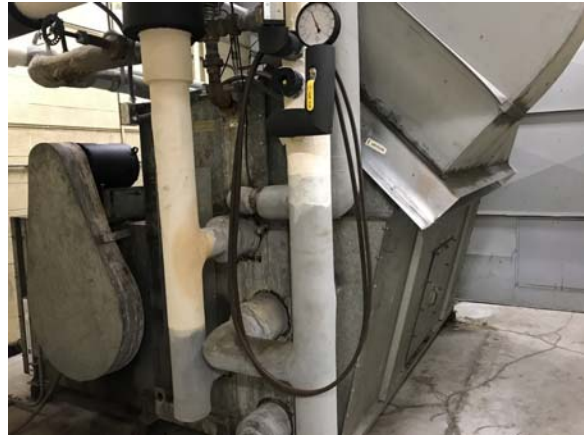
The main HVAC system provides heating and cooling via three constant air volume (CAV) air handling units, each with a zoned deck. The air handling units are visually timeworn as corrosion, air leaks, and insulation spalling were observed during the inspection. Exhaust for the restrooms is handled by two centrifugal exhaust fans, and a propeller exhaust fan serves the main mechanical room. The air handling units and exhaust fans have exceeded their respective statistical service lives and should be considered for removal and replacement with modern systems. Variable air volume (VAV) capable air handling units are recommended. Supplemental cooling for select spaces is handled by two ductless split systems. No issues were observed and they are expected to remain viable for the next ten years.

SPEI013e 5/11/2021
Air handling unit AHU-003
Room 252

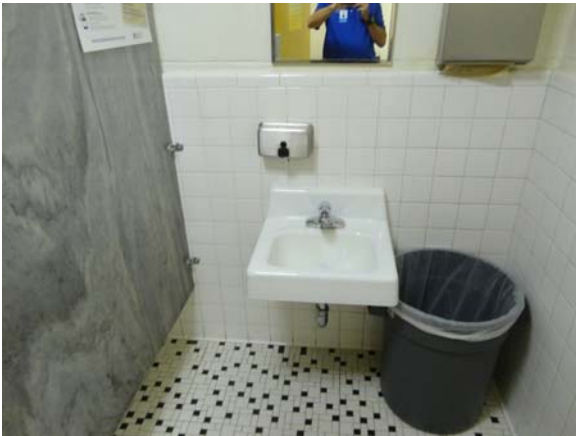
SPEI014a 5/11/2021
Older standard wall-hung lavatory
Third floor, all-gender restroom

Restrooms have older fixtures and none of these facilities are accessible despite the accessible restroom signage. It is recommended that both all-gender restrooms, as well as the men's and women's restrooms, be upgraded with new accessible fixtures, accessories, and finishes. All of the restrooms should be fitted with accessible power door assist units to further improve access. Also, upgrade all of the aging single-level water fountains with new fully accessible dual-level fountains set in wheelchair accessible corridor alcoves.

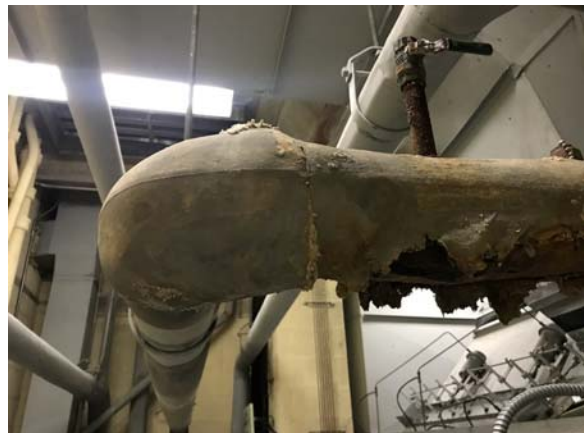
SPEI015e 5/11/2021
Suspect asbestos insulation
Room 252

Asbestos insulation was observed on mechanical piping during the inspection. Prior to any future renovation efforts, it is recommended that it be properly removed and disposed of according to local, state, and federal regulations.

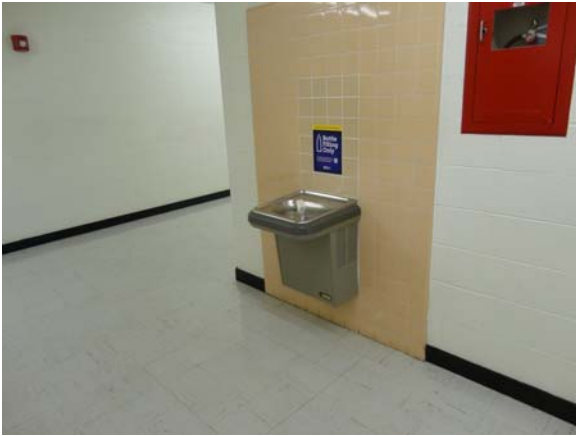
SPEI016a 5/11/2021
Newer, partially accessible, single-level water fountain
Third floor corridor

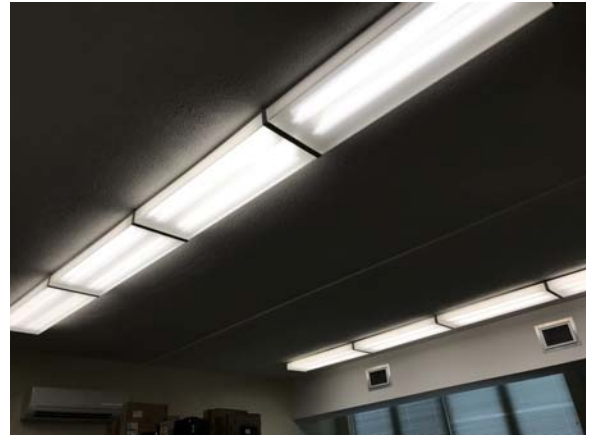
SPEI016e 5/11/2021
Retrofitted LED lighting fixtures
Room 228

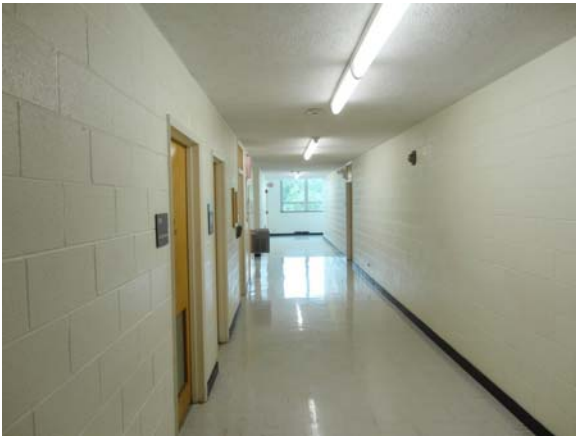
SPEI017a 5/11/2021
Original 9x9 vinyl flooring and original textured ceiling
Third floor corridor

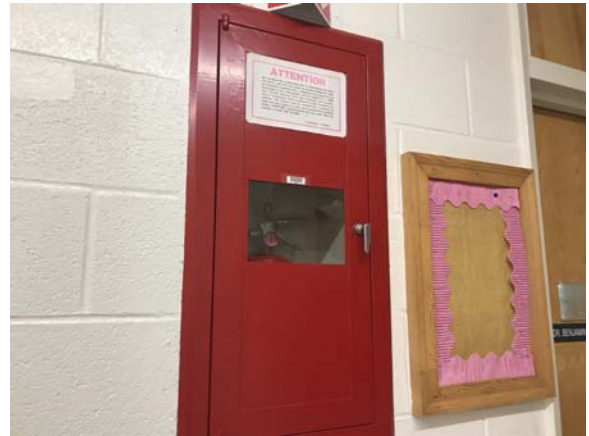
This facility is not protected by an automatic fire suppression system. Fire suppression is handled manually via strategically placed dry-type handheld fire extinguishers and standpipes. As a part of future renovation efforts, it is recommended that an automatic wet-pipe fire suppression system be installed.

SPEI017e 5/11/2021
Fire extinguisher and suppression stand pipe
Second floor corridor

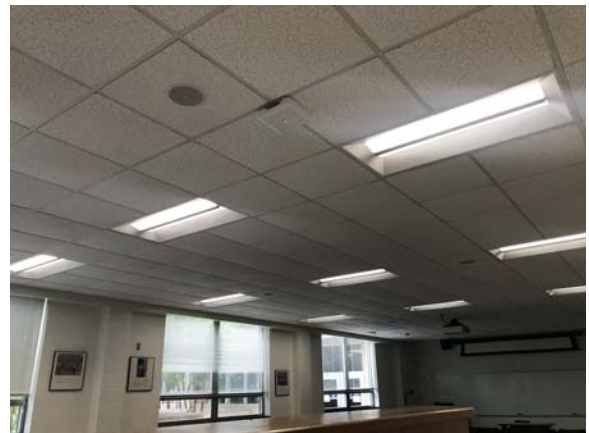
SPEI018e 5/11/2021
Recessed LED lighting fixtures
Room 129

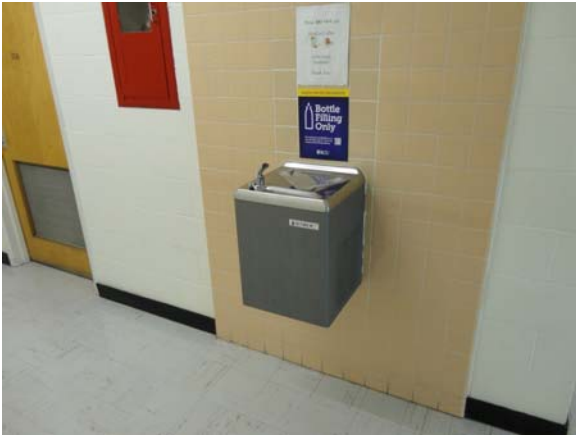
SPEI019a 5/11/2021
Older nonaccessible single-level water fountain
Third floor corridor

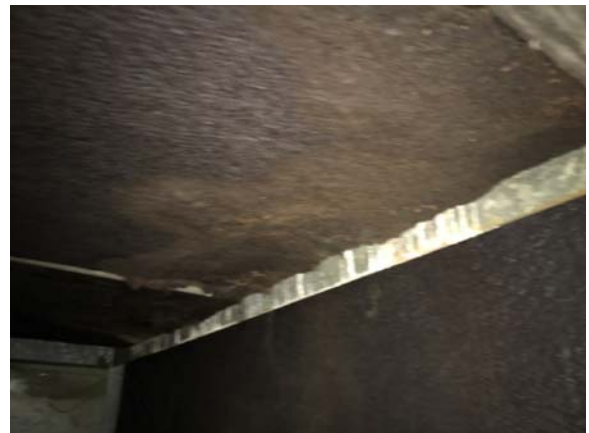
SPEI021e 5/11/2021
Insulation spalling inside AHU-002
Room 160

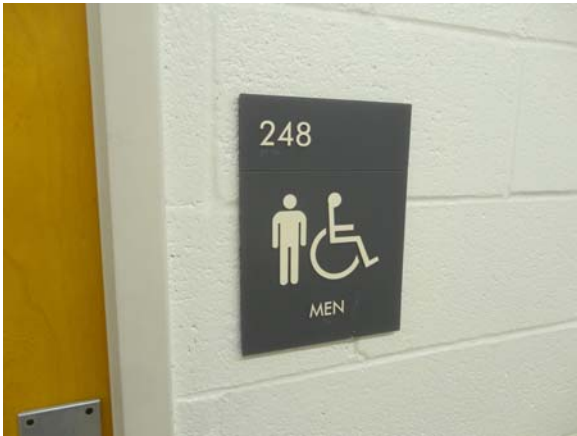
SPEI023a 5/11/2021
Nonaccessible restroom with ADA signage
Second floor, men's restroom

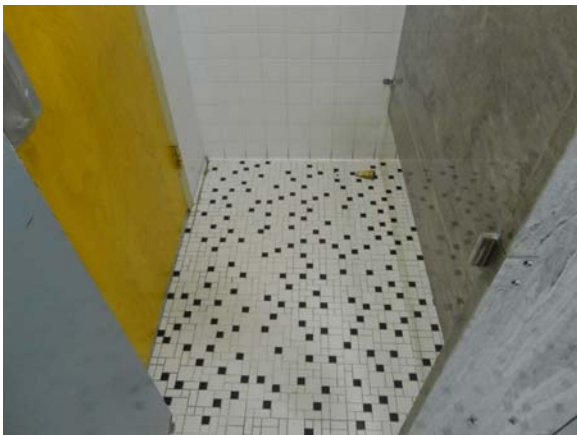
SPEI024a 5/11/2021
Narrow access at restroom entry
Second floor, men's restroom

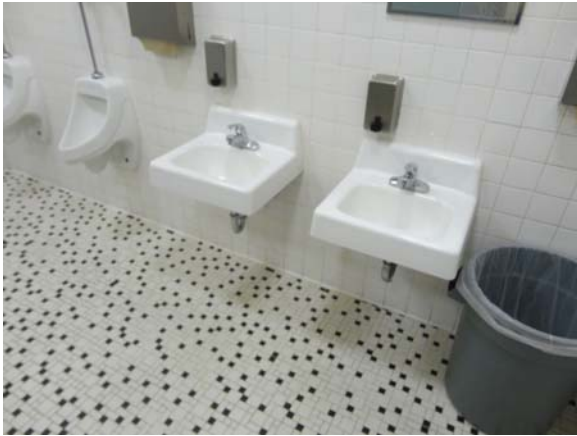
SPEI025a 5/11/2021
Partially accessible lavatories
Second floor, men's restroom

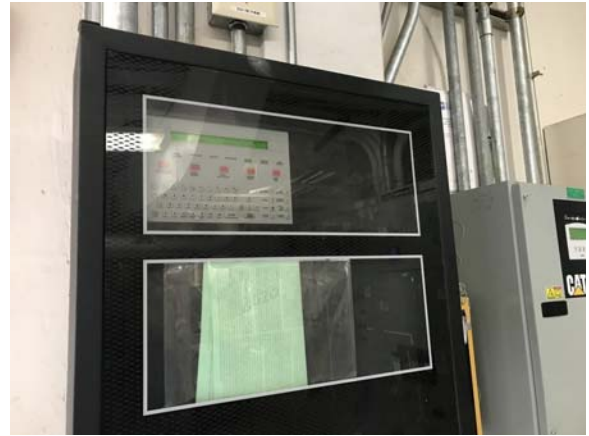
SPEI025e 5/11/2021
Main fire alarm panel
Room 165

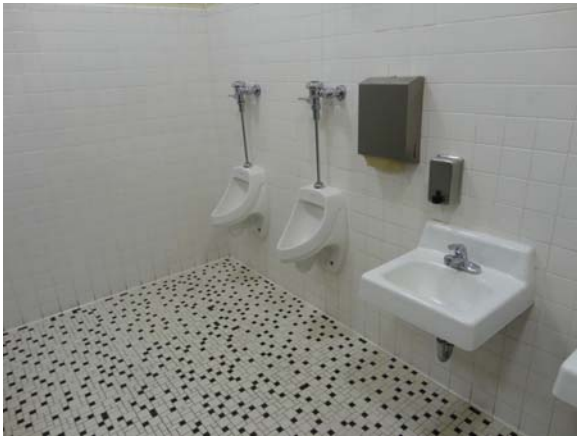
SPEI026a 5/11/2021
Partially accessible urinals
Second floor, men's restroom

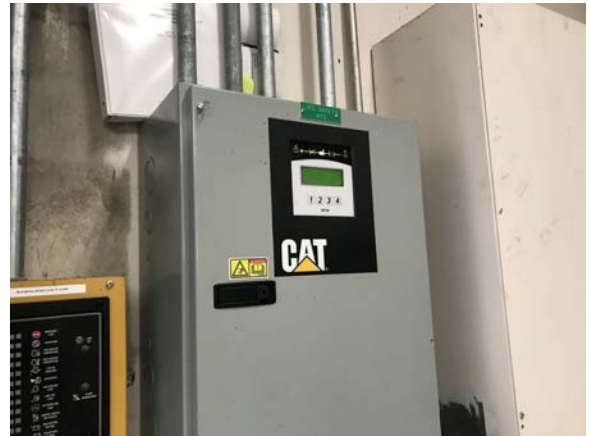
SPEI026e 5/11/2021
Automatic transfer switch
Room 165

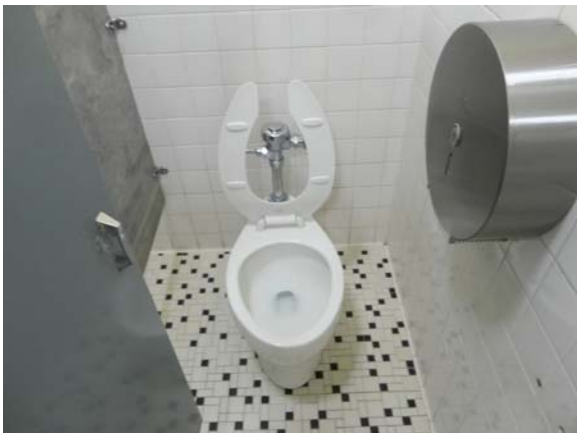
SPEI027a 5/11/2021
Standard narrow toilet stall
Second floor, men's restroom

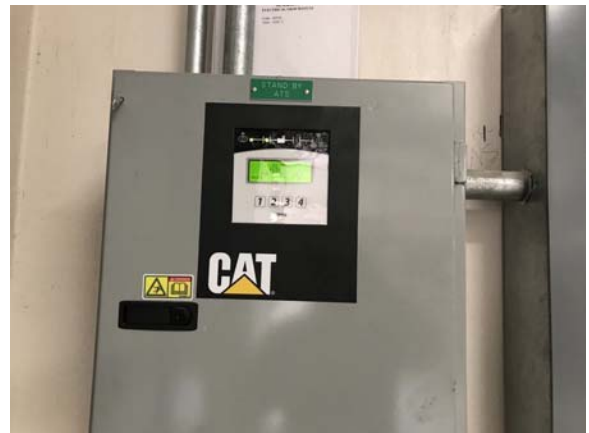
SPEI027e 5/11/2021
Automatic transfer switch
Room 165

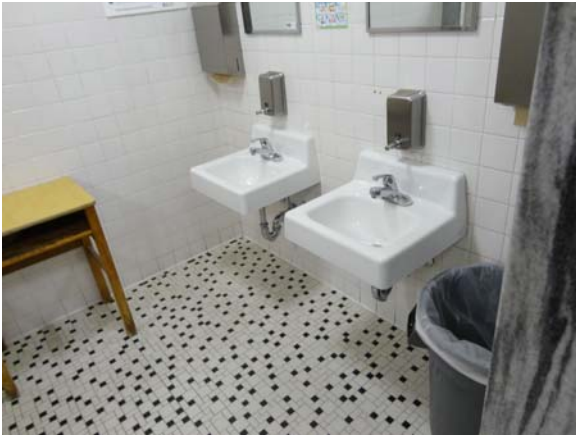
SPEI028a 5/11/2021
Partially accessible lavatories
Second floor, women's restroom

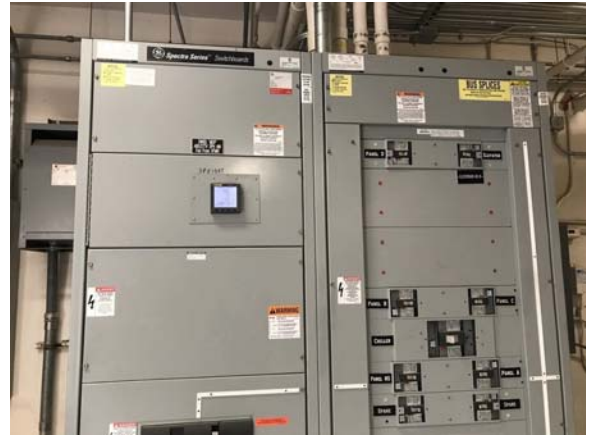
SPEI028e 5/11/2021
Main switchboard
Room 165

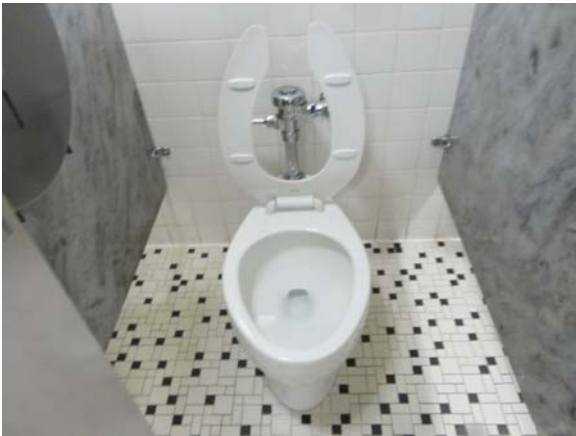
SPEI029a 5/11/2021
Standard narrow toilet stall
Second floor, women's restroom

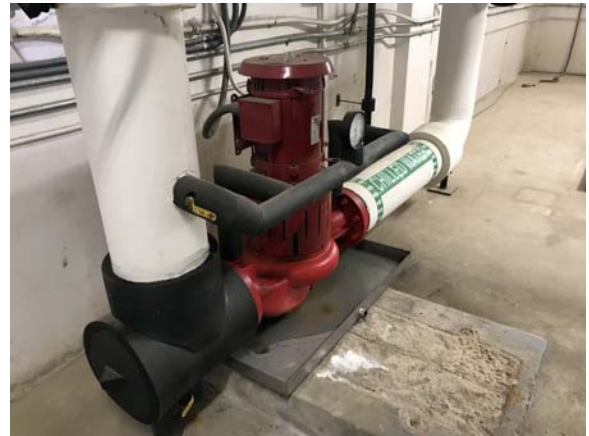
SPEI029e 5/11/2021
Chilled water pump
Room 165

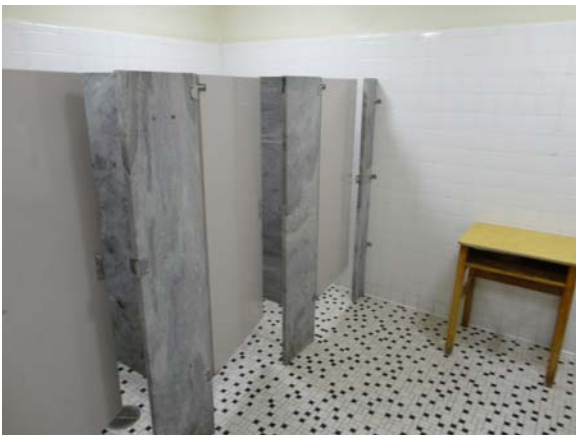
SPEI030a 5/11/2021
Ceramic floor tile and wainscot
Second floor, women's restroom

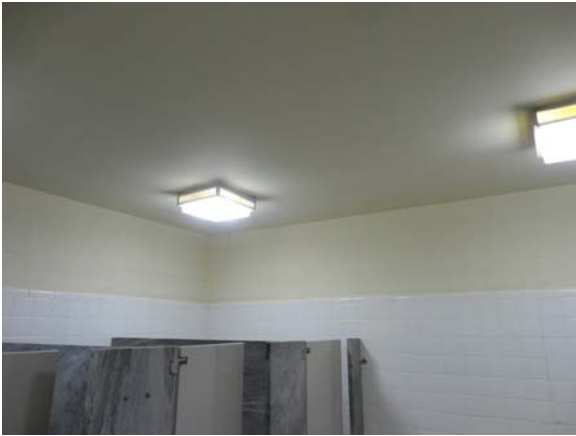
SPEI031a 5/11/2021
Painted ceiling
Second floor, women's restroom

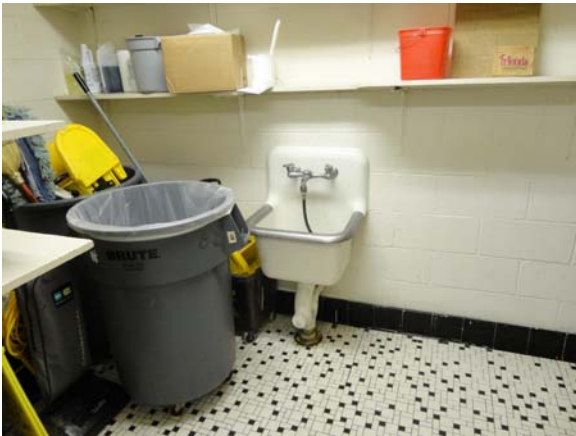
SPEI032a 5/11/2021
Original wall-mounted service sink
Second floor, janitor's closet

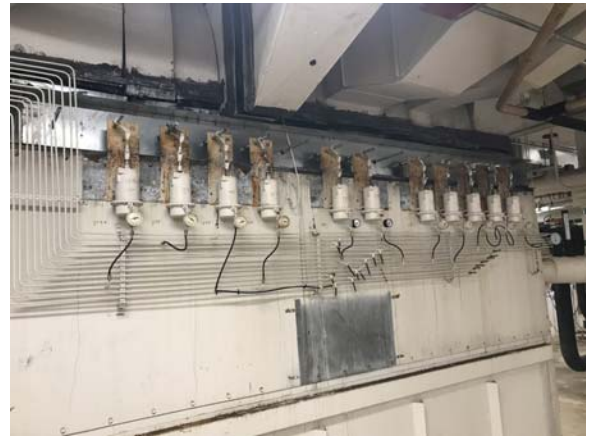
SPEI032e 5/11/2021
Zoned deck on AHU-001
Room 165

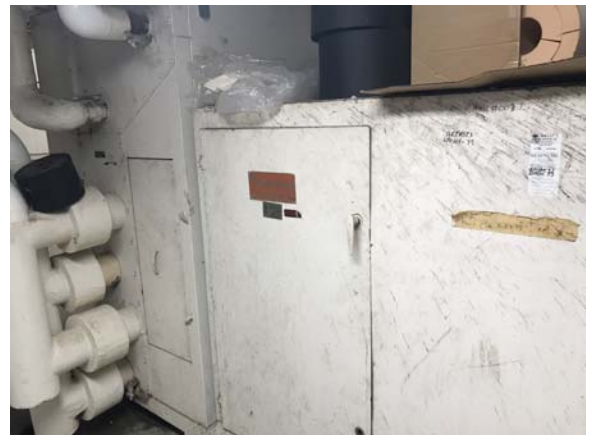
SPEI033e 5/11/2021
Air handling unit AHU-001
Room 165

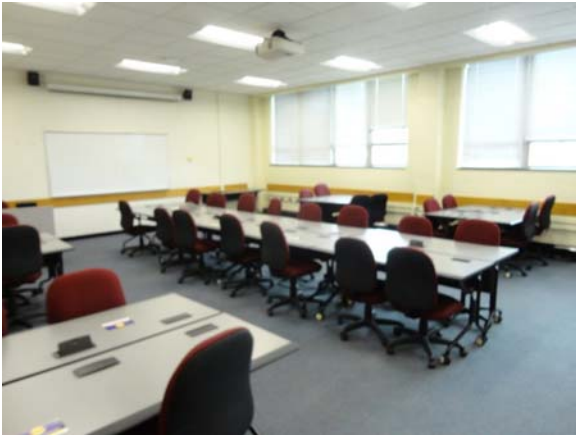
SPEI034a 5/11/2021
Older broadloom carpeting and newer acoustical ceiling
Second floor, smart classroom

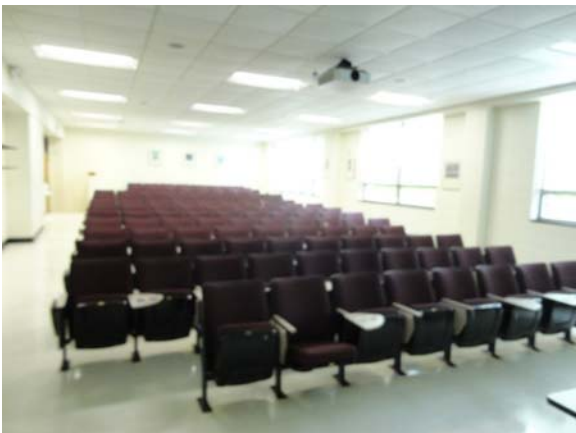
SPEI036a 5/11/2021
No side aisle rails and no indication of assistive listening
First floor, lecture room 129

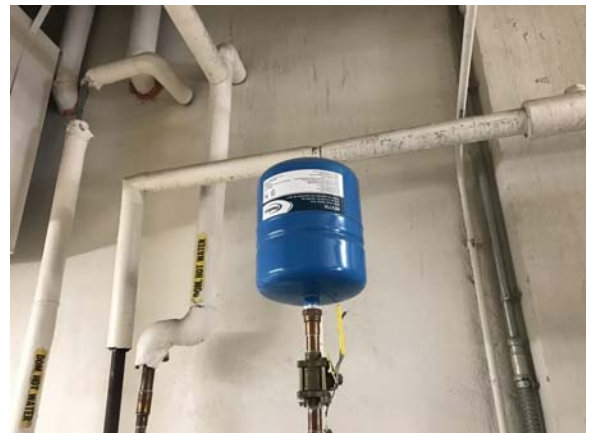
SPEI036e 5/11/2021
Expansion tank
Room 165

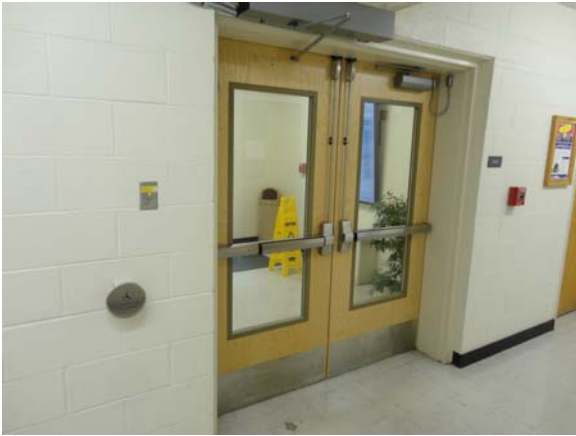
SPEI037a 5/11/2021
Upgraded stair access doors with power door assist
First floor, stair tower

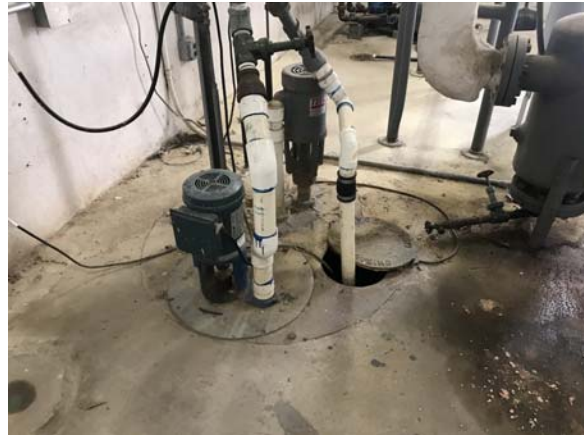
SPEI037e 5/11/2021
Sump pump
Room 165

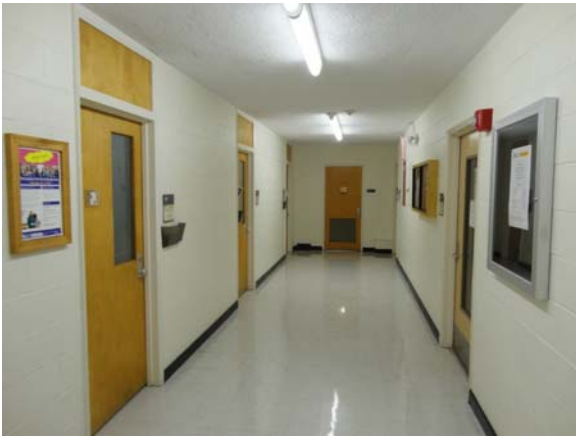
SPEI038a 5/11/2021
Original 9x9 vinyl flooring and original textured ceiling
First floor corridor

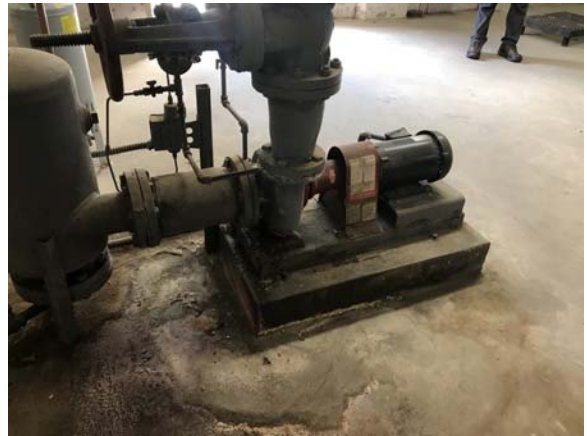
SPEI038e 5/11/2021
Heating hot water pump
Room 165

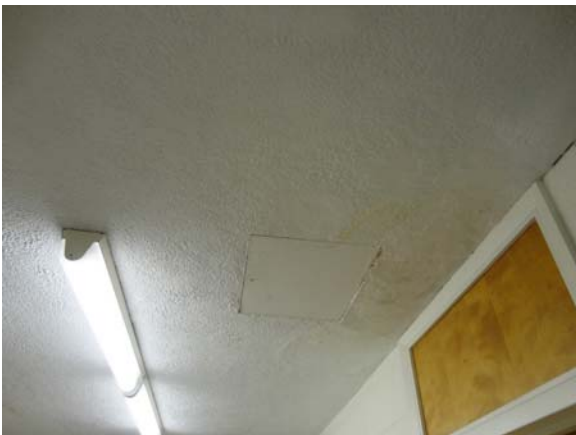
SPEI039a 5/11/2021
Original textured ceiling
First floor corridor

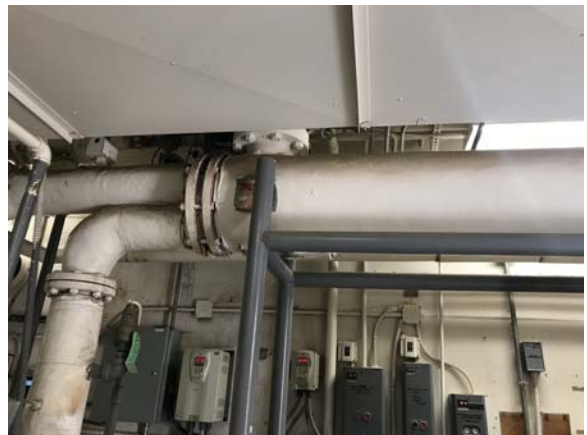
SPEI039e 5/11/2021
Heating hot water shell-and-tube heat exchanger
Room 165

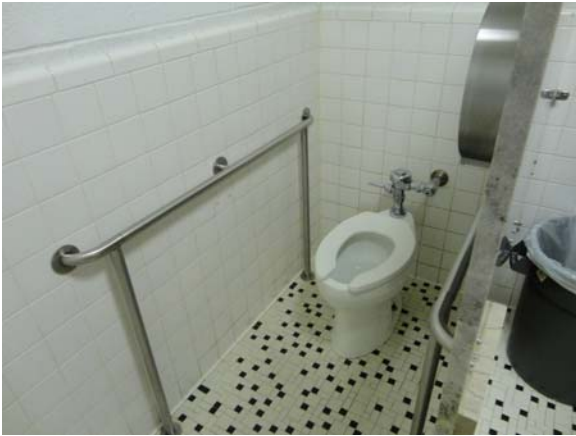
SPEI040a 5/11/2021
Partially accessible toilet stall
First floor, all-gender restroom

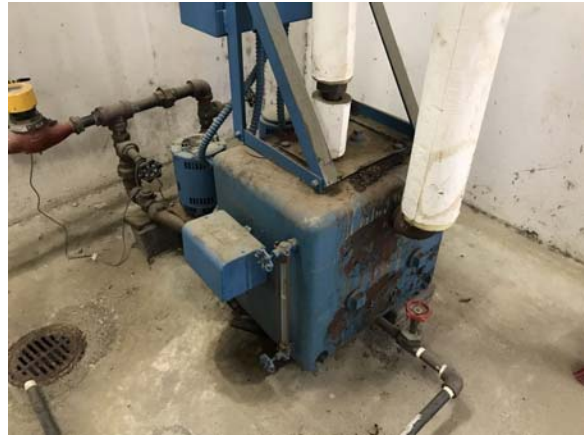
SPEI040e 5/11/2021
Condensate receiver
Room 165

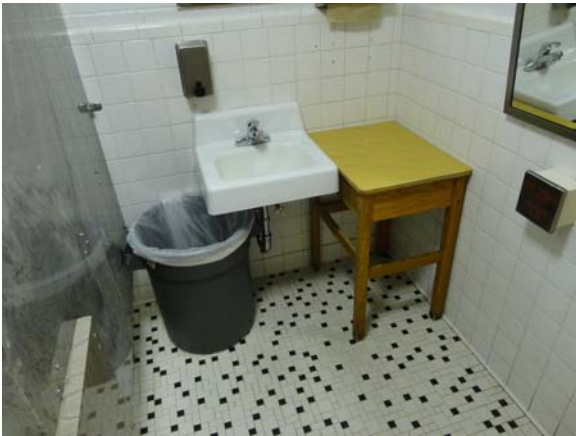
SPEI041a 5/11/2021
Partially accessible wall-hung lavatory and power door assist
First floor, all-gender restroom

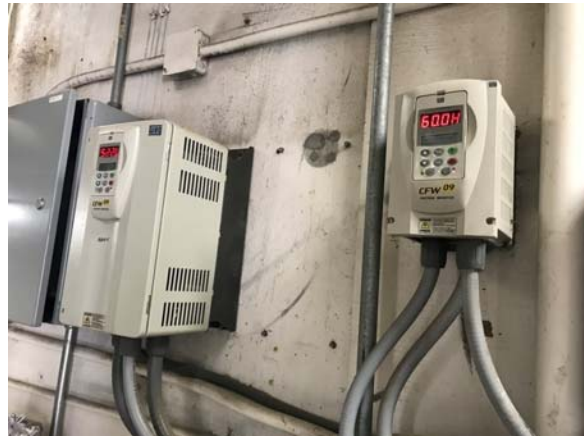
SPEI041e 5/11/2021
VFDs for AHU-001 and heating hot water pump
Room 165

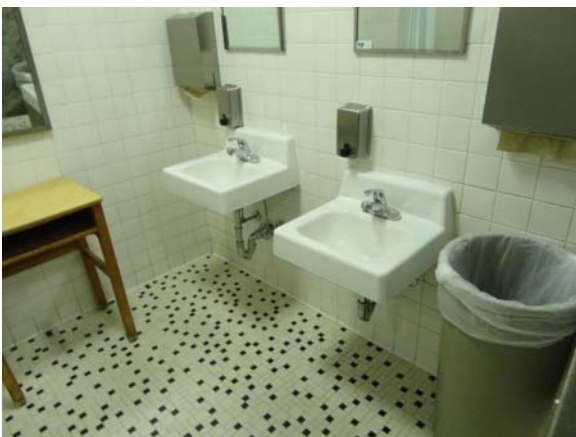
SPEI042a 5/11/2021
Two older wall-hung lavatories
First floor, restroom

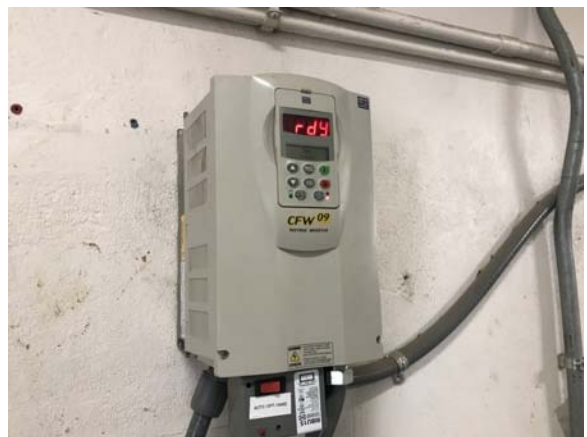
SPEI042e 5/11/2021
VFD for chilled water pump
Room 165

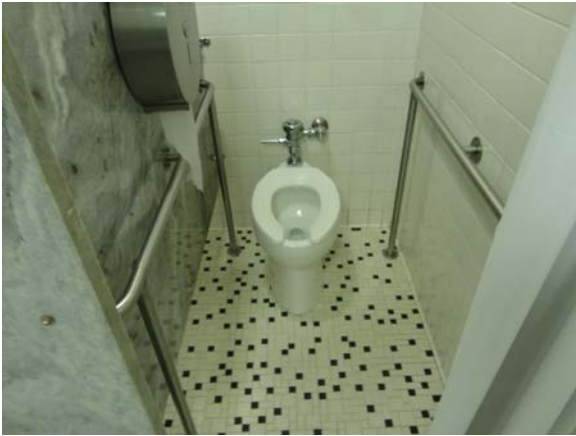
SPEI043a 5/11/2021
Partially accessible toilet stall
First floor, restroom

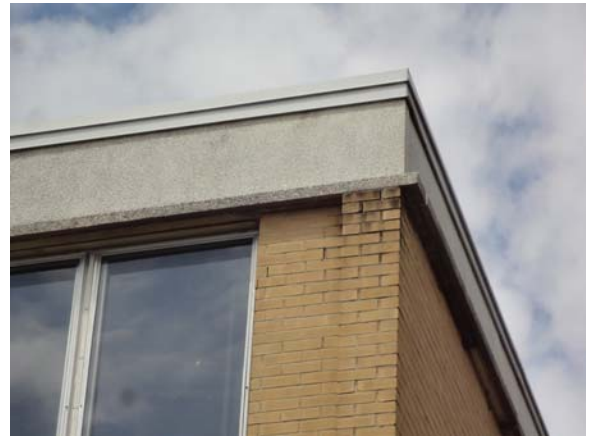
SPEI053a 5/11/2021
Brick facades and glazing
Southeast corner elevation

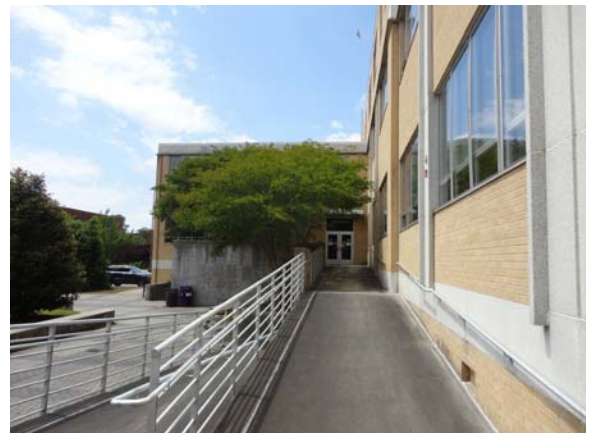
SPEI055a 5/11/2021
Updated ramped entry
Southeast elevation

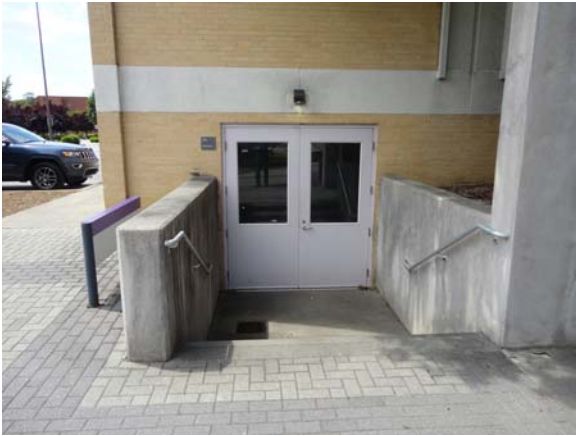
SPEI056a 5/11/2021
Updated ramp with flanking handrails
Southeast elevation

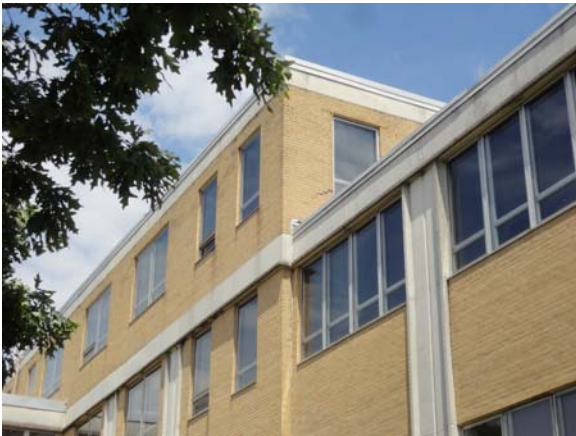
SPEI058a 5/11/2021
Brick facades and glazing
Southwest corner elevation
