EAST CAROLINA UNIVERSITY

Facility Condition Assessment
Umstead Residence Hall (075)
Asset UMST

Inspected May 12, 2021

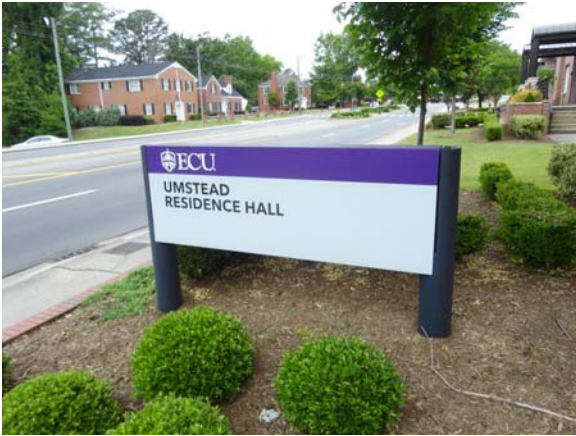
UMST001a 5/12/2021
Building site signage
South site

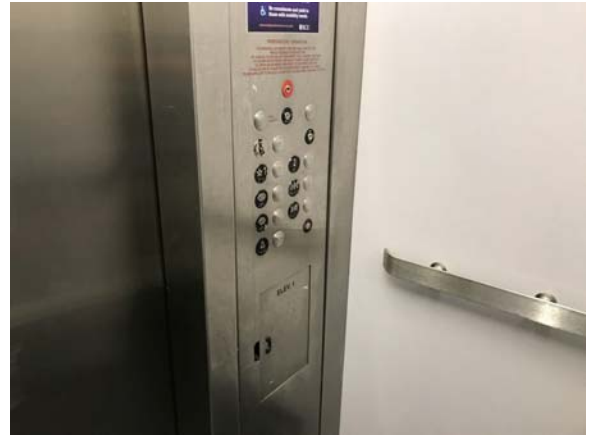
UMST001e 5/12/2021
Cab interior
Elevator

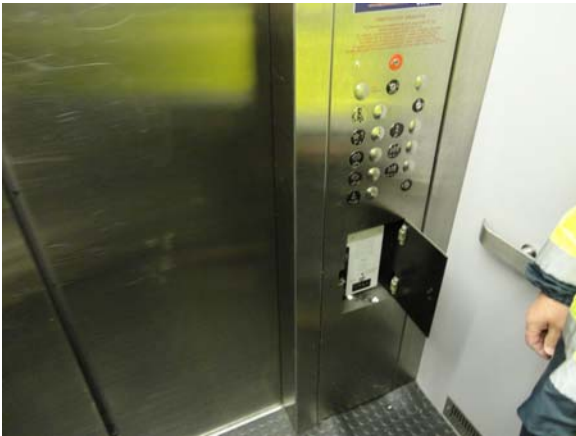
UMST002a 5/12/2021
Accessible two-way communication in non-ADA phone
box
Passenger elevator cab

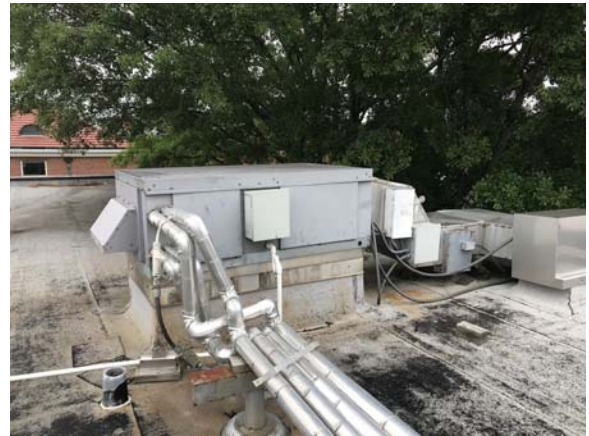
UMST002e 5/12/2021
Rooftop makeup air handling unit
Roof

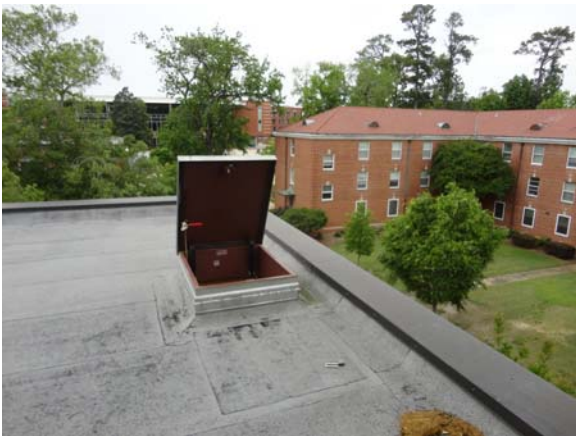
UMST003a 5/12/2021
One of three roof hatches located at edge of roof
Roof

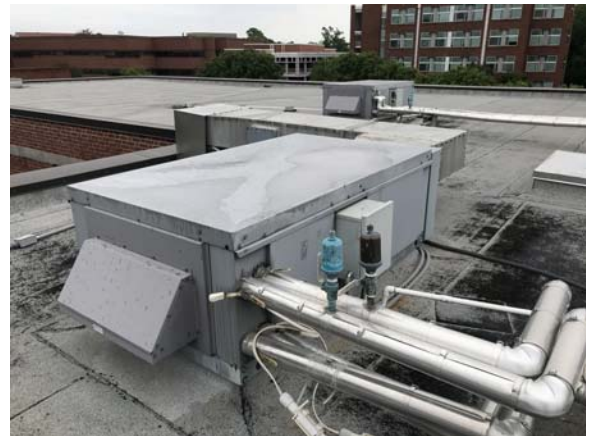
UMST003e 5/12/2021
Rooftop makeup air handling unit
Roof

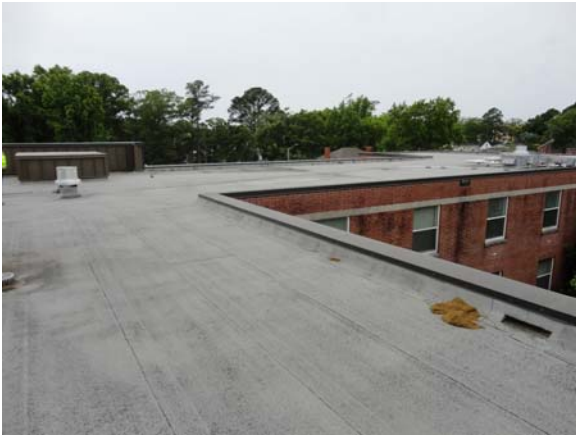
The main upper built-up roof was installed in 2005 and will reach the end of its normal life span within the next five to six years. Replace this roof in kind when required. The lower south lobby roof is newer and should be considered for replacement at the end of the next ten years. The three upper roof hatches are aging and located at the edge of the roof. Also, the roof hatch ladder access is inadequate and rooftop mechanical equipment is located near the roof perimeter. Upgrade the roof hatches and ladders at each location and install safety guardrails at the roof hatches and rooftop mechanical

UMST004a 5/12/2021
Built-up roof with cap sheet and low parapet cap flashing
Main flat roof

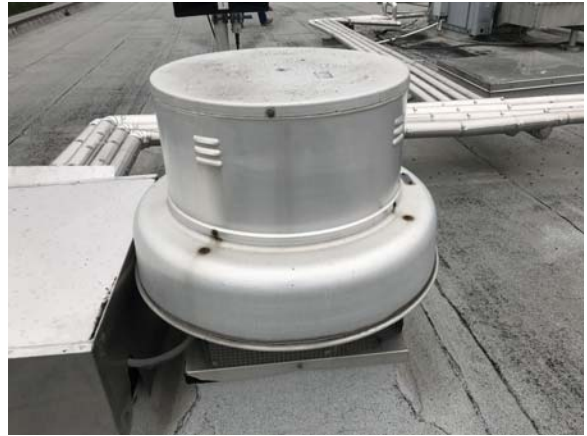
UMST004e 5/12/2021
Centrifugal rooftop exhaust fan
Roof

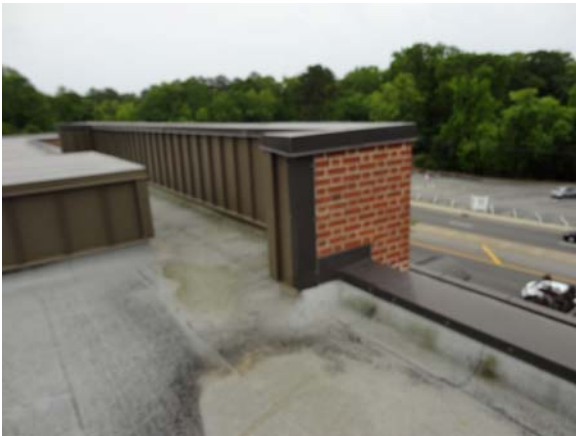
UMST005a 5/12/2021
Raised parapet cap at front elevation
Upper center of south elevation

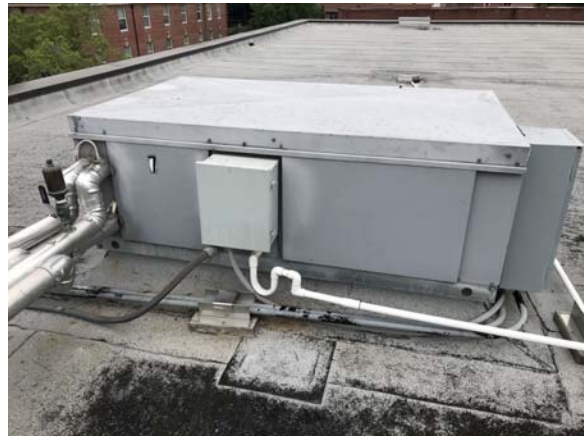
UMST005e 5/12/2021
Rooftop makeup air handling unit
Roof

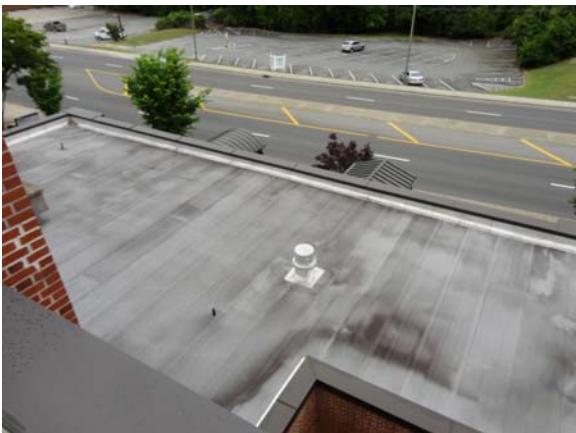
UMST006a 5/12/2021
Lower built-up roof with cap sheet
Lobby roof

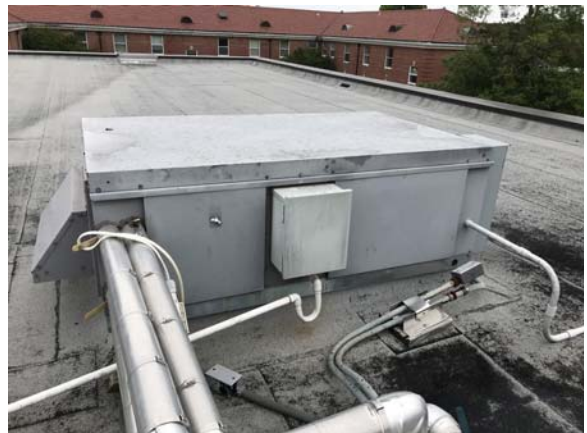
UMST006e 5/12/2021
Rooftop makeup air handling unit
Roof

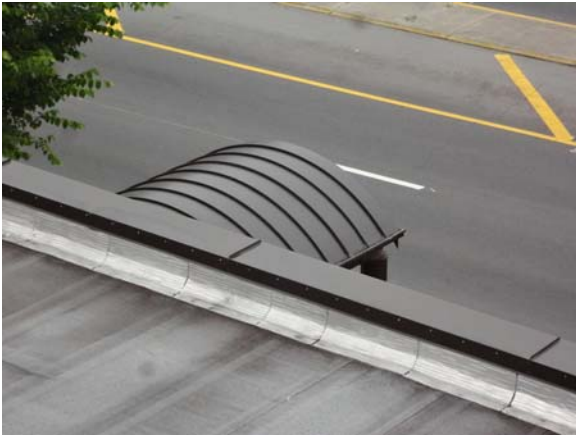
equipment. The standing-seam metal canopy roofs at the two south entry doors are still in good condition and no upgrades are warranted.

UMST007a 5/12/2021
One of two standing-seam barrel arch entry canopies
South main entry

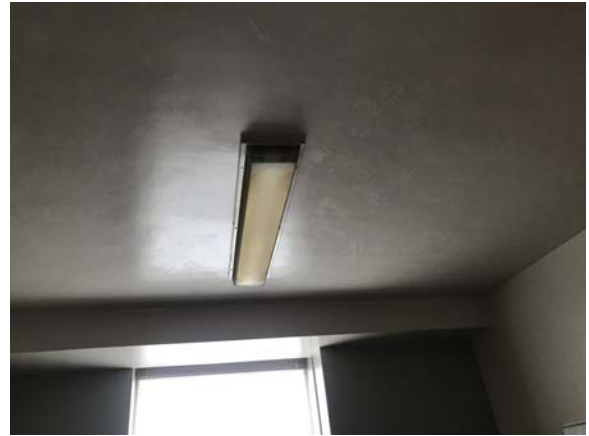
The majority of the interior lighting was replaced in 1995 and consists of T8 troffers and recessed can CFL fixtures. Although the current lighting system appears to be in usable condition, it has fulfilled its financially viable life expectancy. Lighting technology is rapidly advancing and expectations for lamp durability, quality, intensity control, and efficiency are increasing with the advancement of LED lighting options. The lighting fixtures should be considered for upgrade to LED technology.

UMST007e 5/12/2021
T8 troffer lighting fixture
Room 302

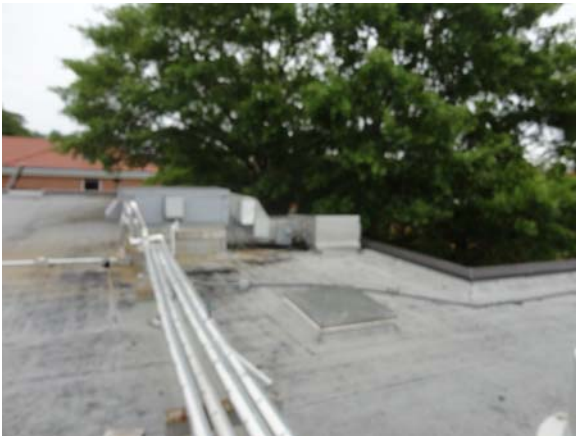
UMST008a 5/12/2021
Tree overhang over portion of main roof
Main roof

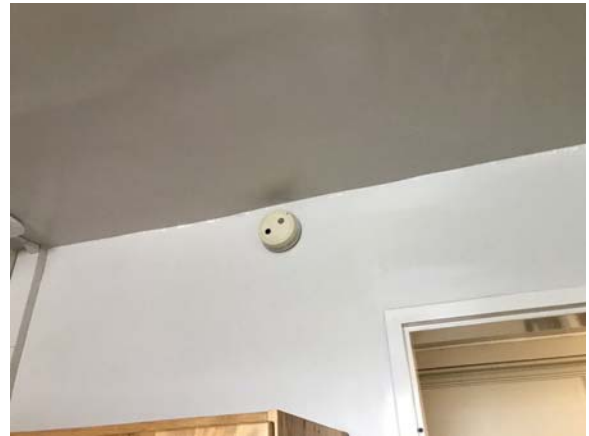
UMST008e 5/12/2021
Covered fire suppression sprinkling device
Room 302

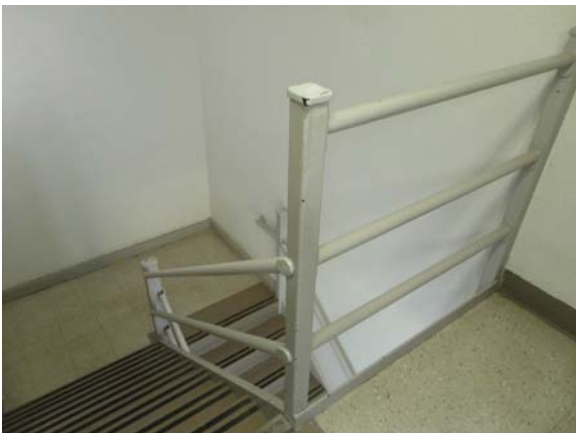
Access to the building is provided by wheelchair ramps on the north and south. However, the five stair towers lack accessible railing designs and both the inner and outer handrails should be replaced with new accessible railings on each stair run. Also, replace the worn rubber stair treads on each stair run.

UMST009a 5/12/2021
Wide picket spacing on inner switchback railing
Third floor, stair tower

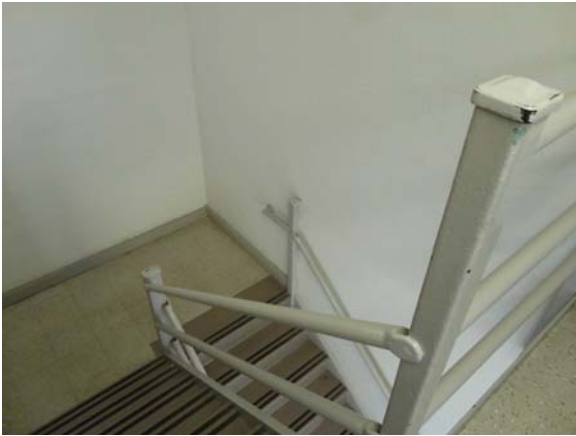
UMST010a 5/12/2021
Accessible inner handrails
Third floor, stair tower

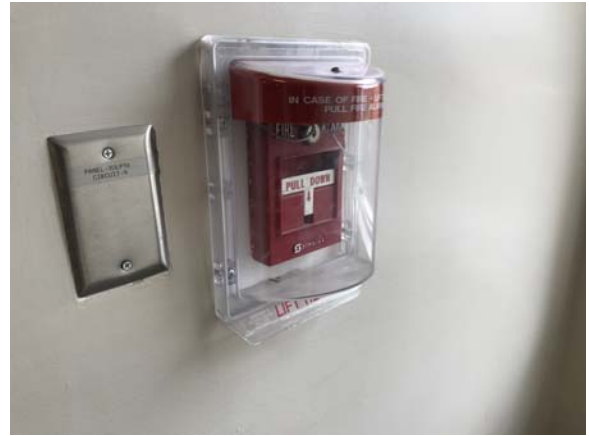
UMST010e 5/12/2021
Manual pull fire alarm device
Third floor corridor

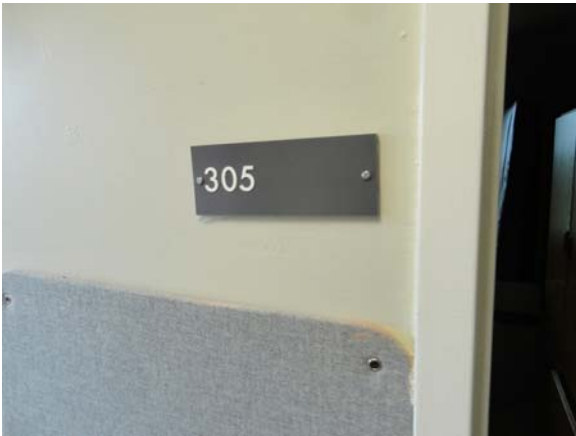
UMST011a 5/12/2021
Accessible wall-mounted room signage with Braille
Third floor corridor

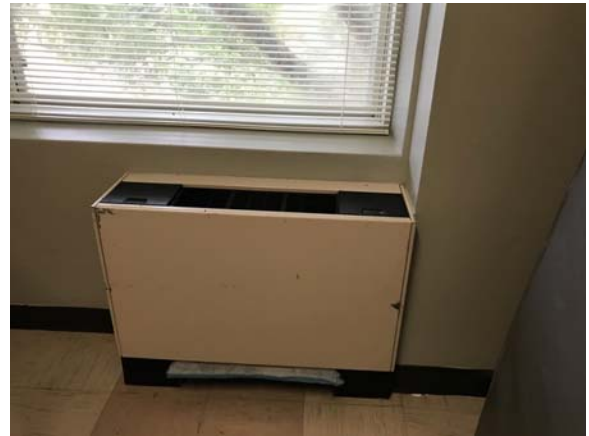
UMST011e 5/12/2021
Console fan coil unit
Room 305

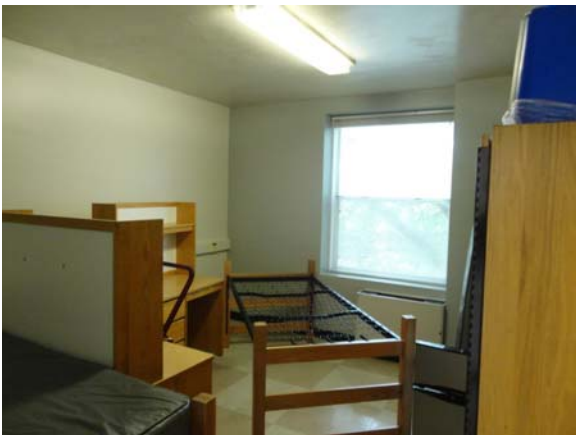
UMST012a 5/12/2021
Older VCT and painted walls and ceiling
Third floor, dorm room

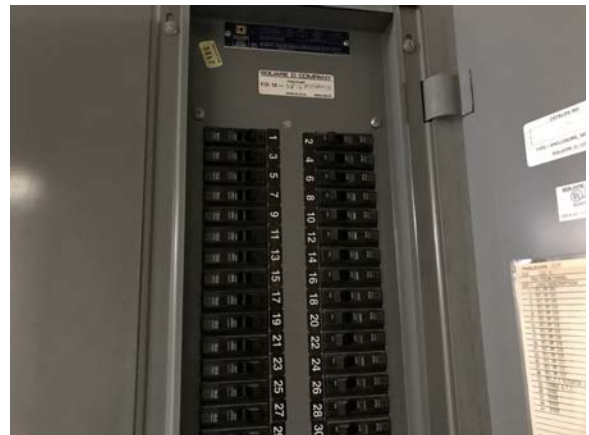
UMST012e 5/12/2021
Local panelboard
Second floor corridor

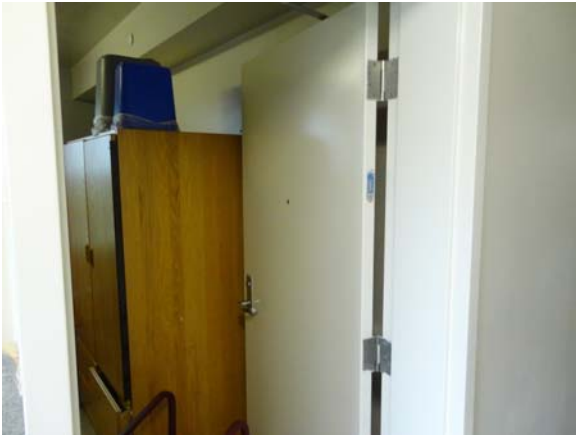
UMST013a 5/12/2021
Newer fire-rated corridor door with lever hardware
Third floor corridor

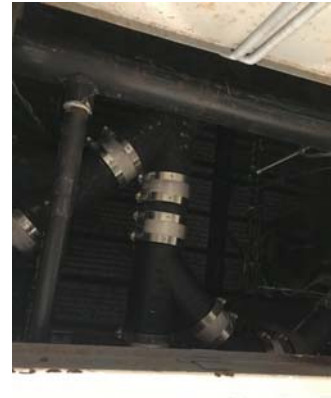
UMST013e 5/12/2021
Cast-iron drain piping with hubless connections
Trash room

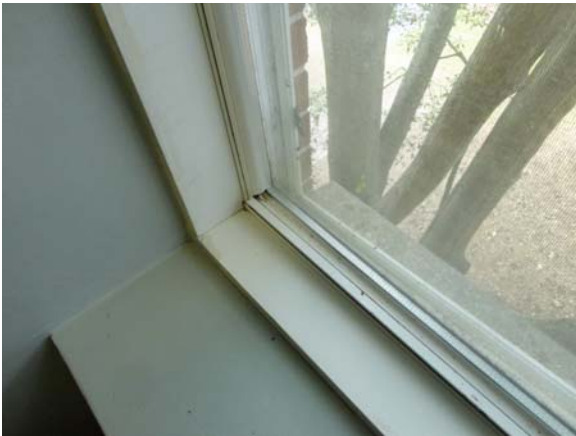
UMST014a 5/12/2021
Older thermal-pane, metal-framed glazing
Third floor

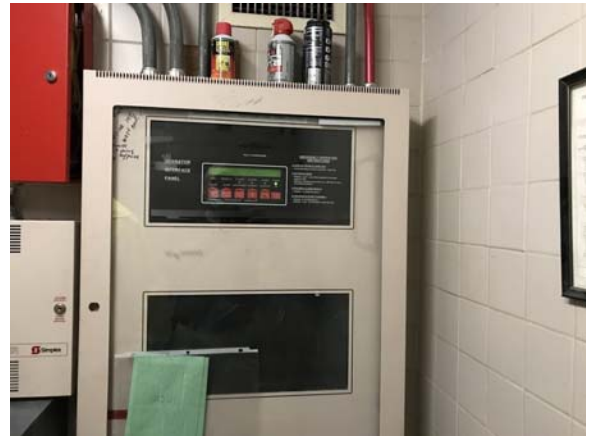
This facility contains a Simplex point addressable fire alarm and detection system that contains a main fire alarm panel, manual pull stations, smoke detectors, and horn and strobe alarm systems. The panel was installed in the mid-1990s with the devices replaced within the last ten years. It is recommended that the panel and devices be considered for replacement within the next ten years due to technical obsolescence.

UMST014e 5/12/2021
Main fire alarm panel
Room 108

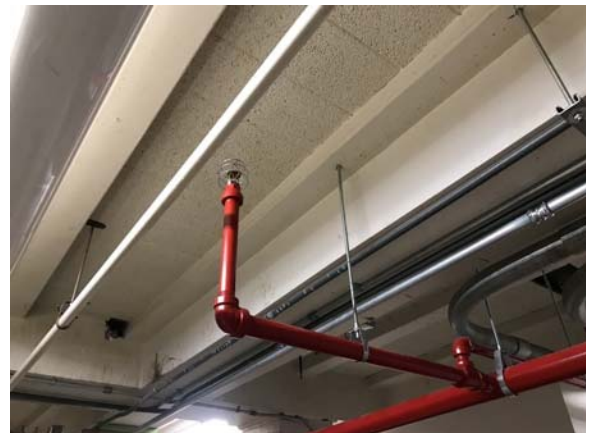
UMST015e 5/12/2021
Fire suppression sprinkling device
Room 006

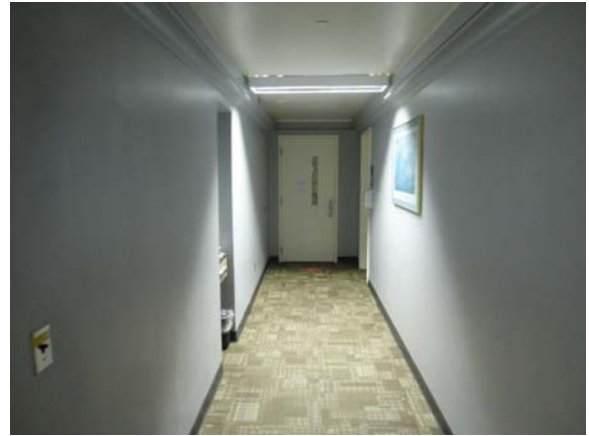
UMST043a 5/12/2021
Newer carpeting and painted walls and ceiling
First floor, Dean of Student Affairs office

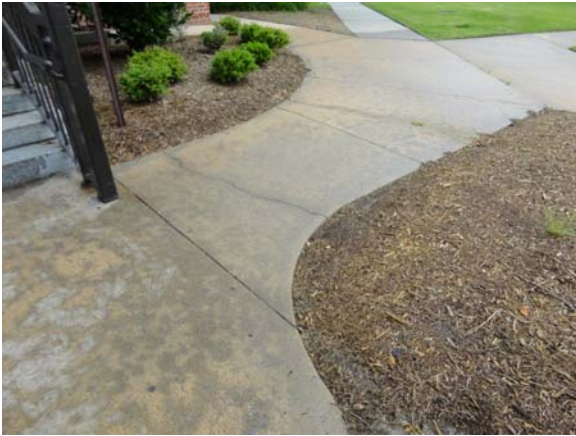
UMST048a 5/12/2021
Some differential settlement on concrete sidewalks
Southeast corner of site

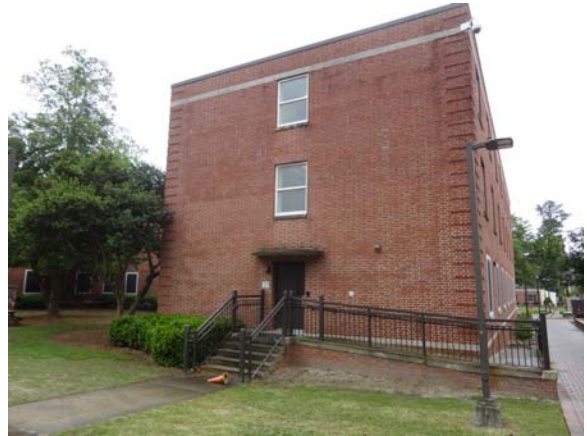
UMST057a 5/12/2021
Ramped access to secondary entry/egress point
Northwest wing

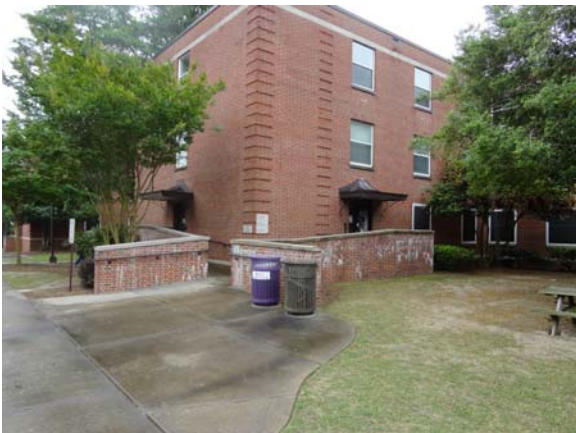
UMST058a 5/12/2021
Brick exterior and glazing
Northwest corner elevation

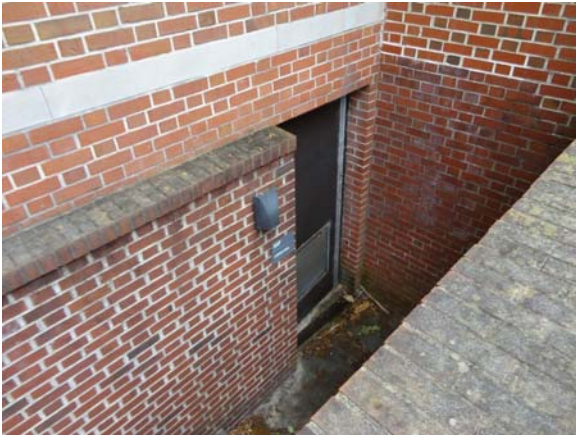
UMST060a 5/12/2021
Detail of heavy efflorescence
Central north wing

The low masonry walls at the north central entry/egress ramp have heavy efflorescence and should be cleaned and repointed to help control water infiltration.
