EAST CAROLINA UNIVERSITY

Facility Condition Assessment

Whichard Building (031)

Inspected May 10, 2021

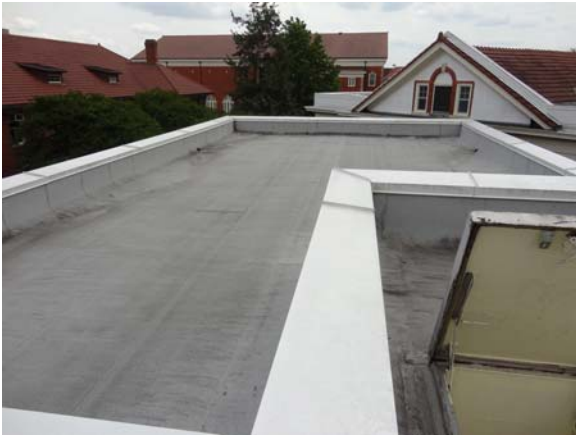
The flat, single-ply membrane roofing system on the Annex and east wing were replaced with new built-up roofs around 2015. These roofs still appear to be in good condition. However, the roof hatch for the annex roof is deteriorated and lacks any safety guards for the access ladder. Upgrade this roof access for service personnel. The pitched, clay tile roofing system on the main building appears to be adequate and no roofing upgrades appear to be needed for the next ten years. The three smaller copper clad door canopies on the secondary and service doors have some weathering but should be adequate for the near future.

WHIC001a 5/10/2021
Newer built-up roof and cap sheet
Annex roof

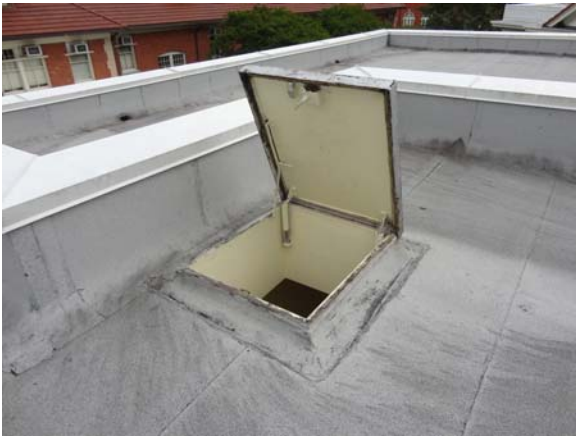
WHIC002a 5/10/2021
Deteriorated roof hatch
Annex roof

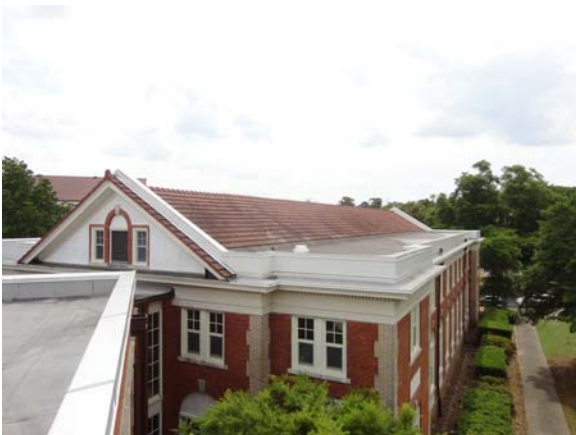
WHIC003a 5/10/2021
Older pitched clay tile roof and newer flat side roof
Main roof

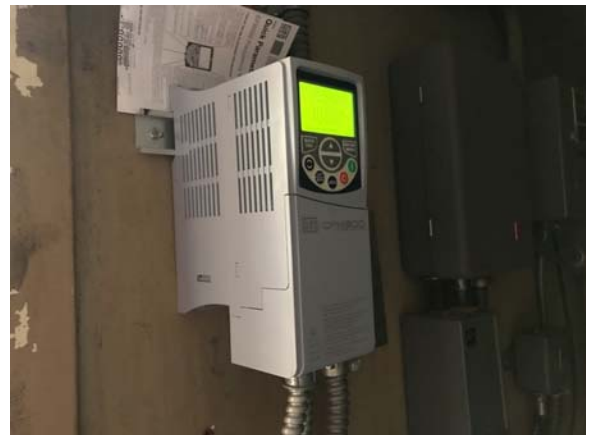
WHIC003e 5/10/2021
VFD for AHU-002
Room 227

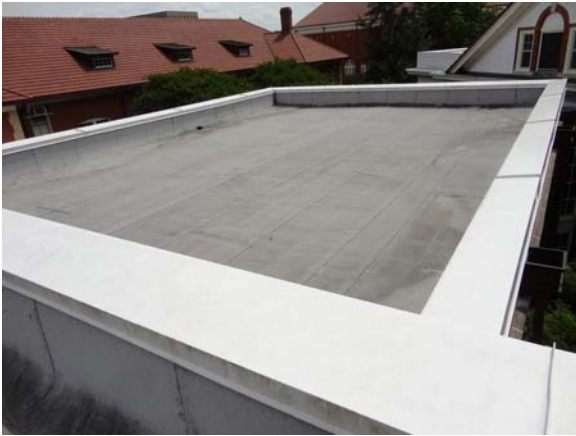
WHIC004a 5/10/2021
Metal cap flashing detail on low parapet wall
Annex roof perimeter

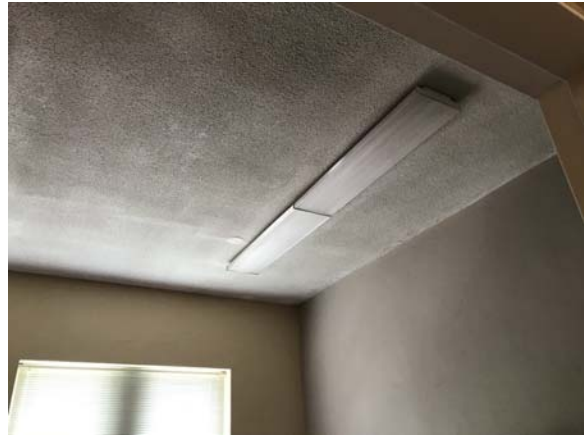
WHIC004e 5/10/2021
Retrofitted T8 troffer lighting fixture
Stairwell

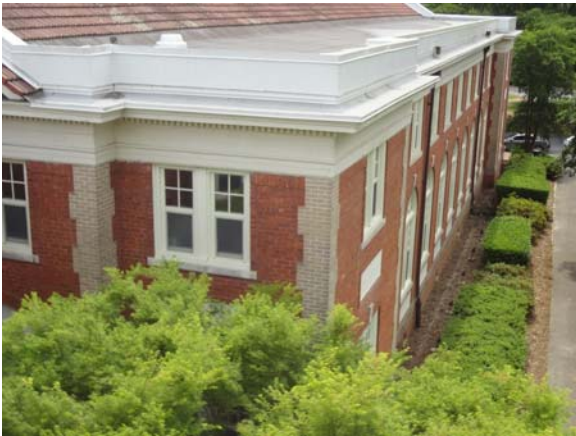
The brick is in overall good condition, but there are some localized signs of water infiltration in the form of efflorescence along the front arcade and several areas of plaster damage on the interior perimeter walls. The brick should be repointed in these areas. The painted wood cornice, dental work, and exterior trim have weathered paint and should be repainted in the near future.

WHIC005a 5/10/2021
Upper wood cornice work and wood trim have peeling
paint
Upper exterior of main building

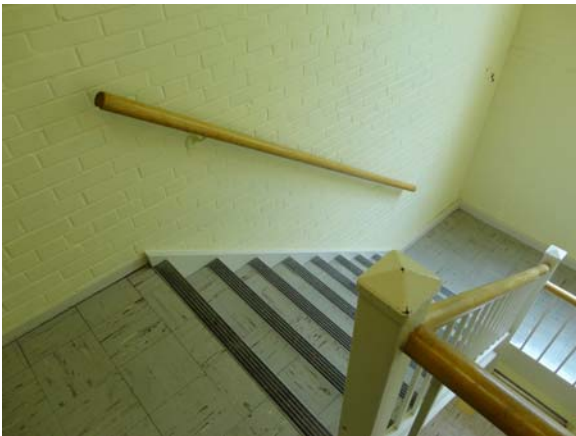
The north and south interior stair towers lack accessible inner and outer railing designs and each stair run should be fitted with new flanking railings and new compliant guardrails. Stair treads should also be fitted with new rubber stair treads once the existing nine-inch vinyl floor tile has been removed. The exterior breezeway stair tower also is not accessible and is recommended for replacement in the Fire/Life Safety section. The new stair should have accessible railing designs and paneled risers.

WHIC006a 5/10/2021
9x9 vinyl floor tile and nonaccessible handrails
Second floor, annex stair tower

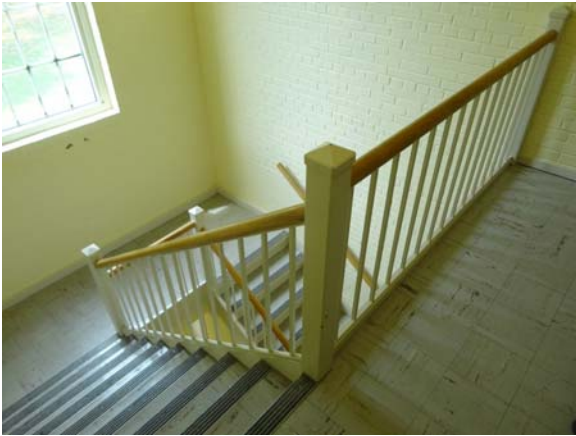
WHIC007a 5/10/2021
Low guardrail and inadequate switchback rail
Second floor, annex stair tower

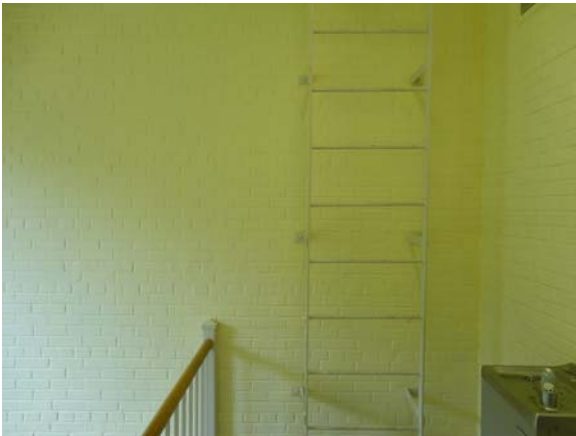
WHIC008a 5/10/2021
No fall protection for ladder at top of stair tower
Second floor, annex stair tower

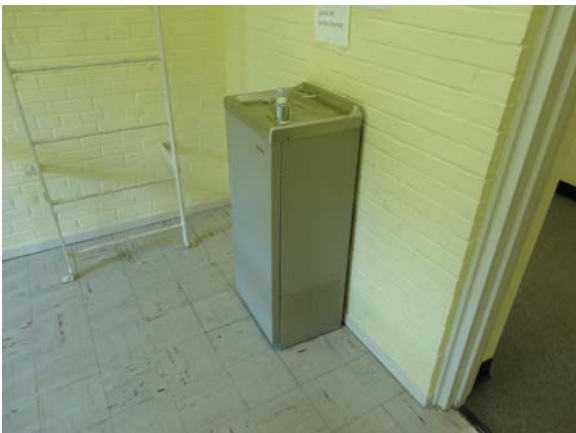
WHIC009a 5/10/2021
Poorly located, nonaccessible, aging water fountain
Second floor, stair tower

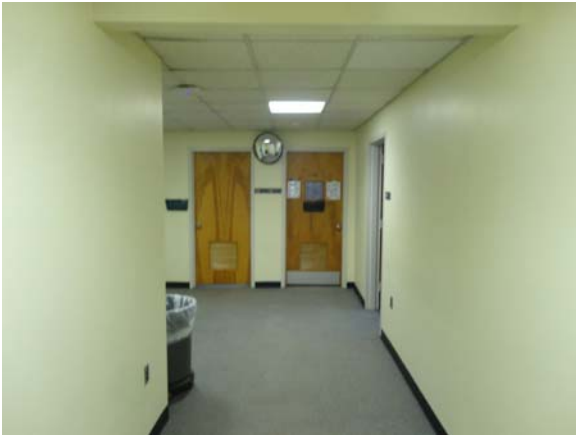
Carpeting throughout the building is older and showing wear. Install new carpet tile building wide. It is assumed that the present carpeting is installed over older nine-inch vinyl flooring and this older flooring is addressed in the Health section, as is the older nine-inch vinyl flooring in the interior stair towers. New rubber stair treads are recommended once the stairs are prepped. Ceramic floor tile and wainscot in the four restrooms are older and timeworn. It is recommended that new tile finishes be installed in each of these restrooms as part of recommended renovations.

WHIC010a 5/10/2021
Older carpeting and acoustical ceiling
Second floor, annex corridor

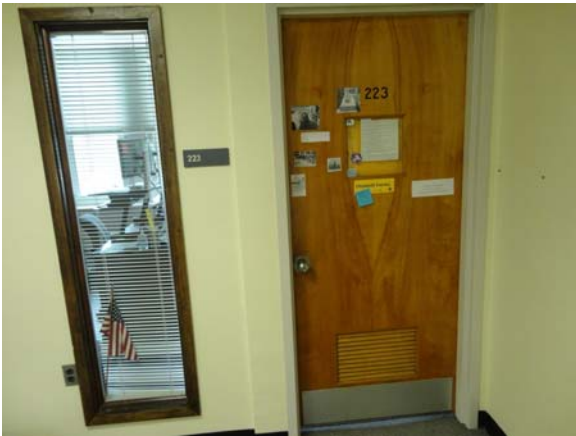
While the building appears to have adequate egress pathways, the corridor doors are not fire rated and should be upgraded in all areas on all floors. Also, the breezeway metal stair is weathered and has open risers. It is recommended that this aging stair be replaced with a new secondary egress stair at the same location. The new stair should have accessible handrails and metal panel risers.

WHIC011a 5/10/2021
Nonrated corridor door with knob hardware
Second floor, annex corridor

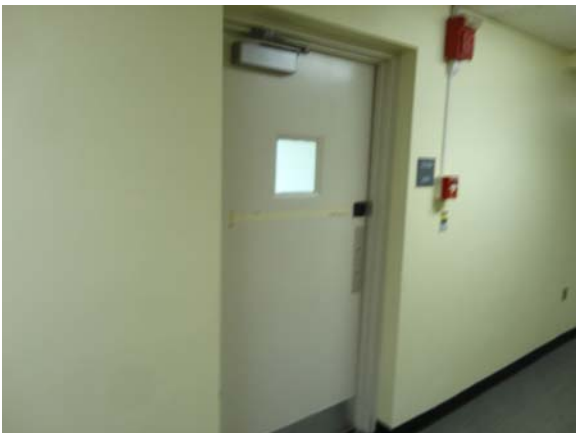
WHIC012a 5/10/2021
No positive latching hardware on stair tower door
Second floor, stair tower

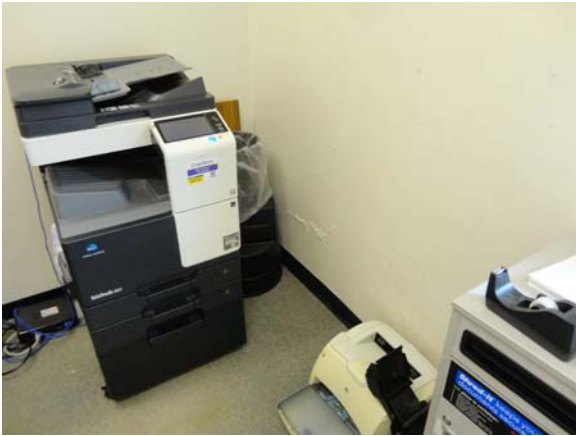
WHIC013a 5/10/2021
Signs of possible localized water infiltration
Second floor, perimeter wall

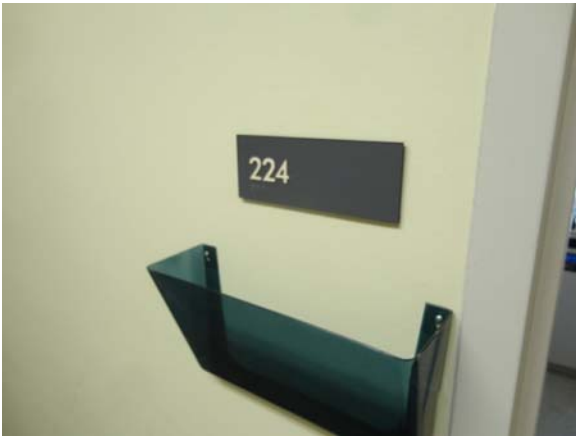
WHIC014a 5/10/2021
Upgraded accessible room signage
Second floor corridor

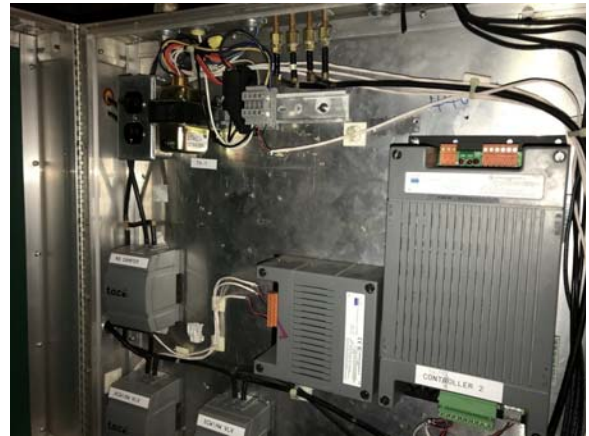
The HVAC distribution network is a zoned CAV design and was renovated in the 1950s. The distribution network consists of insulated metallic conduit, insulated mechanical piping, valves, diffusers, and similar elements. The HVAC controls are a direct digital and pneumatic hybrid and were reported to have been updated in the 1980s. It is recommended that the HVAC distribution network and controls be removed and replaced with and a modern, energy-efficient VAV system with full DDC. The air compressor for the pneumatic controls is due for replacement and can be removed from future budgeting when DDC is installed.

WHIC014e 5/10/2021
Pneumatic HVAC controls
Room 214D

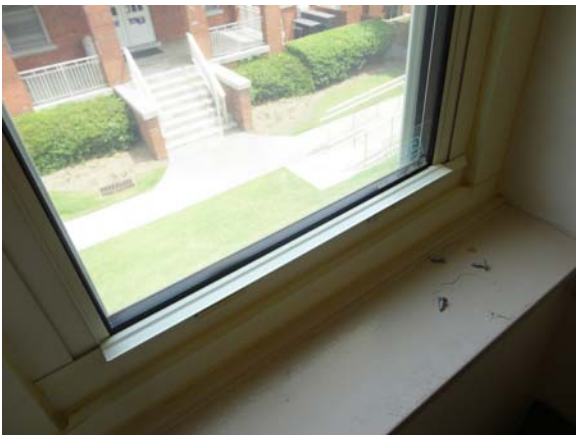
WHIC015a 5/10/2021
Updated exterior glazing
Second floor, annex

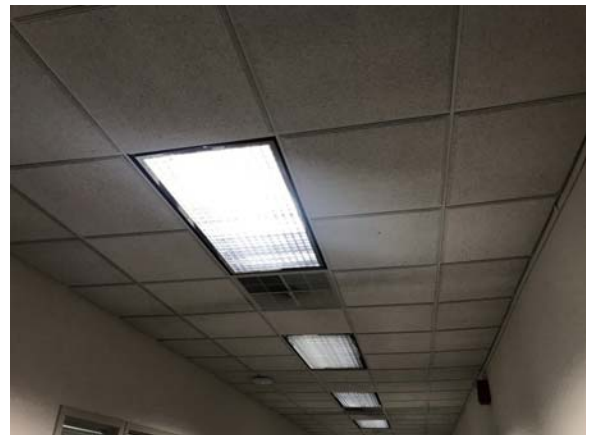
WHIC015e 5/10/2021
Retrofitted recessed T8 lighting fixtures
First floor corridor

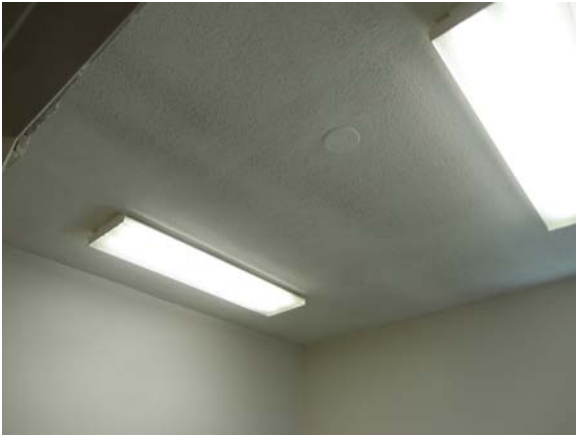
The ceiling finishes on both floors are a mixture of acoustical lay-in tile and older textured ceilings. The textured ceilings are assumed to contain asbestos and should be sampled and tested. Also, it is believed that there are textured ceilings above the lay-in acoustical ceilings. The textured ceilings are addressed in the Health section. The acoustical ceilings are showing some age and should be considered for replacement within the next ten years or in conjunction with ceiling finish abatement. The painted smooth ceiling in the central atrium has a good appearance and should be repainted within the next five years.

WHIC016a 5/10/2021
Textured ceilings
Second floor, annex office

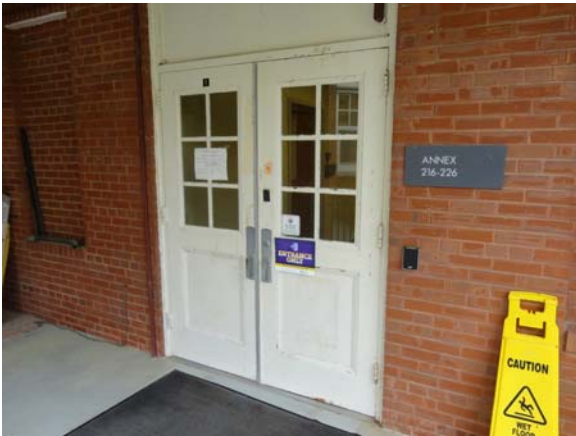
WHIC017a 5/10/2021
Older entry doors with security swipe
Second floor, annex south elevation

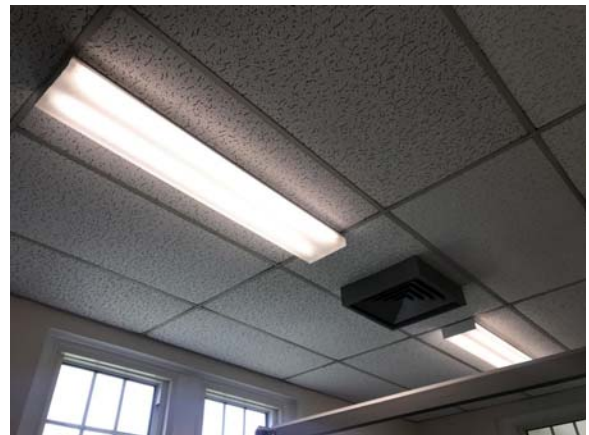
WHIC018e 5/10/2021
Retrofitted T8 troffer lighting fixture
Room 106K

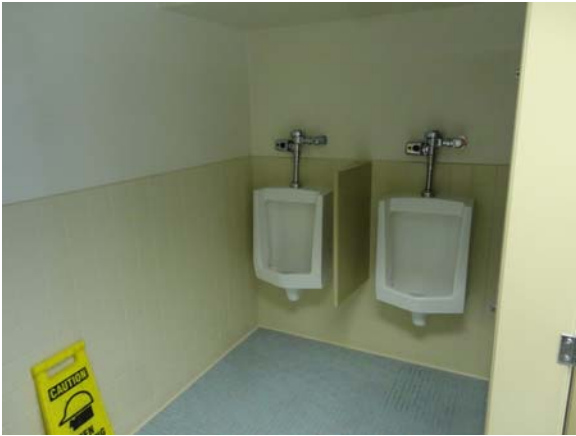
WHIC019a 5/10/2021
Newer wall-hung urinals
Second floor, men's restroom

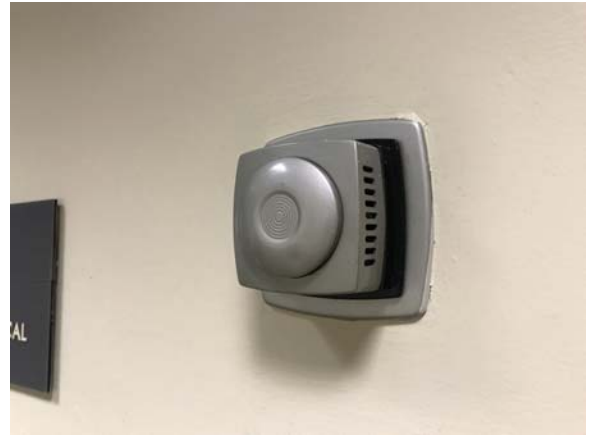
WHIC019e 5/10/2021
Local pneumatic thermostat
First floor corridor

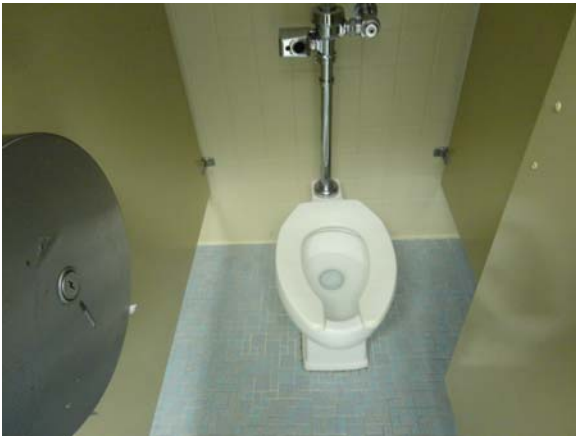
The restrooms have aging fixtures and finishes and only the first floor restrooms are even partially accessible. Expanding the restroom layouts to the new larger circulation clearances would likely reduce the fixture counts and expanding the footprint of the restrooms would be difficult where they are located. It is recommended that new, accessible, all-gender, three-fixture restrooms be installed on each floor to meet accessibility standards. Also, the water fountains are aging and not fully accessible. Replace the fountains on both floors with fully accessible, dual-level units set in wheelchair accessible corridor alcoves.

WHIC020a 5/10/2021
Older standard tankless water closet
Second floor, men's restroom

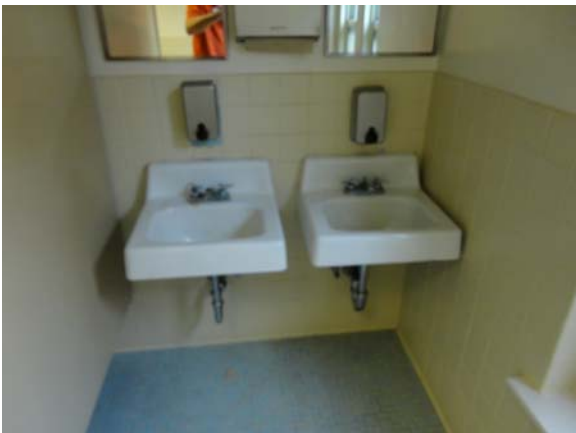
WHIC021a 5/10/2021
Older wall-hung lavatories
Second floor, men's restroom

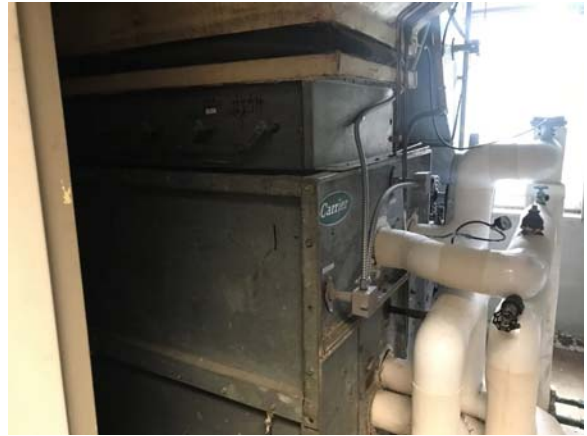
The main HVAC system provides heating and cooling via six constant air volume (CAV) air handling units with zoned decks. Exhaust for the mechanical room is handled by a centrifugal exhaust fan. The air handling units and exhaust fan have exceeded their respective statistical service lives and should be

WHIC022e 5/10/2021
Air handling unit AHU-001
Room 108

considered for removal and replacement with modern systems. Variable air volume (VAV) capable air handling units are recommended.

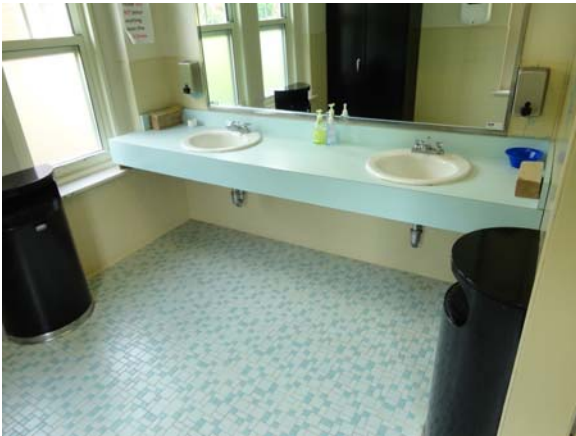
WHIC023a 5/10/2021
Older counter lavatories
Second floor, women's restroom

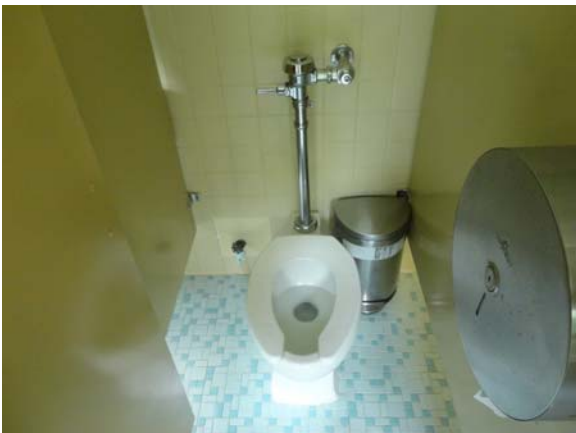
WHIC024a 5/10/2021
Older standard tankless water closet
Second floor, women's restroom

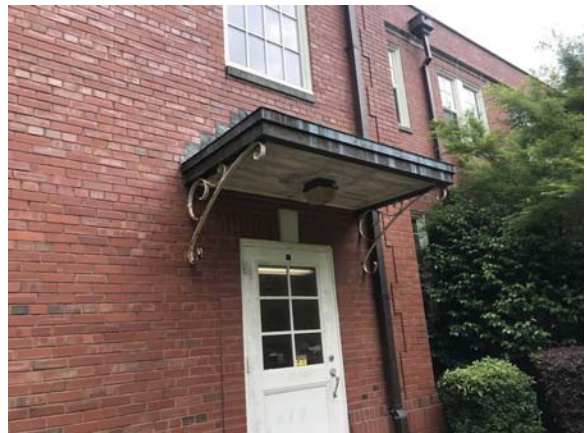
WHIC024e 5/10/2021
Ceiling-mounted HID lighting fixture
Exterior soffit

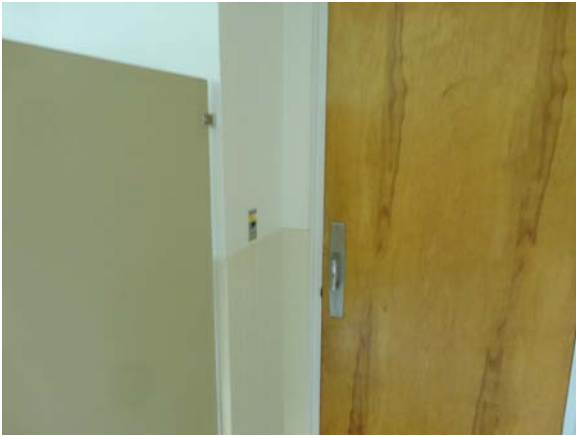
WHIC025a 5/10/2021
Narrow door clearances and restroom entry door
Second floor, women's restroom

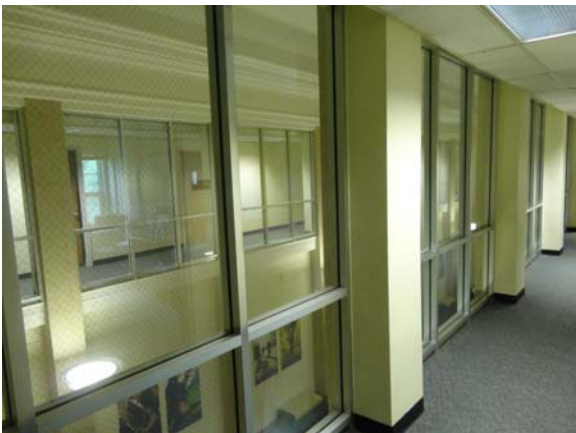
WHIC027a 5/10/2021
Wire glass glazing in central atrium
Second floor, original building

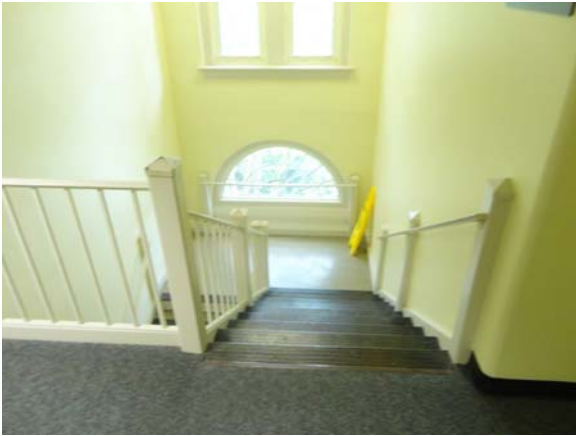
WHIC028a 5/10/2021
Nonaccessible railing detail on stair tower
Second floor, original stair tower

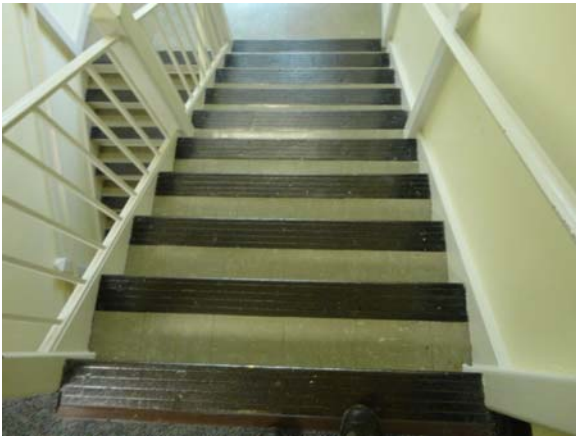
WHIC029a 5/10/2021
9x9 vinyl flooring on stair treads
Second floor, original stair tower

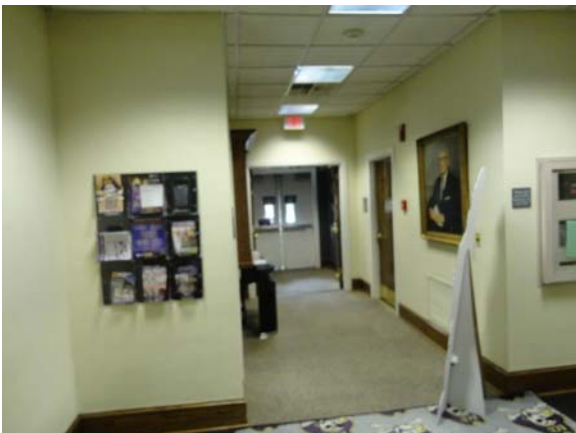
WHIC030a 5/10/2021
Carpeting and acoustical ceiling in vestibule
First floor, original building

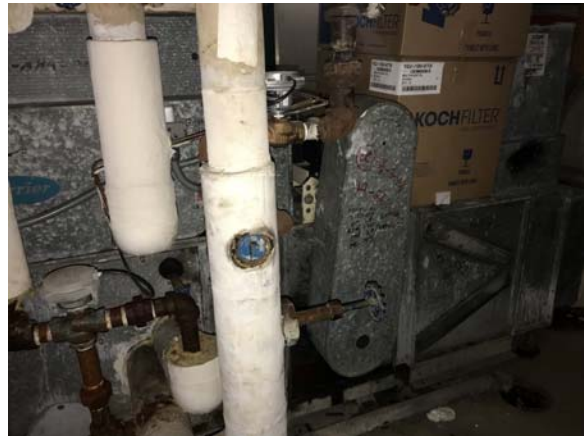
WHIC035e 5/10/2021
Air handling unit AHU-006
Room 117D

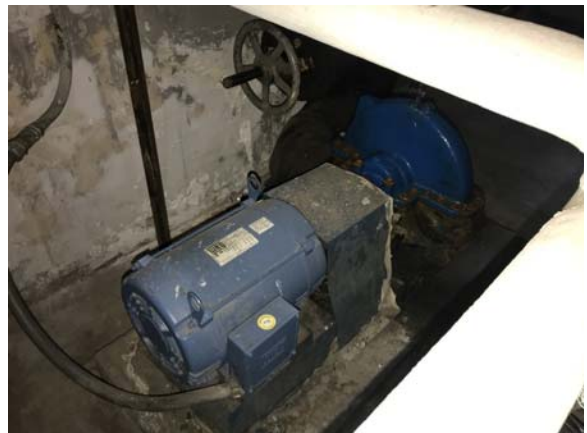
WHIC036e 5/10/2021
Chilled water pump
Room 117D

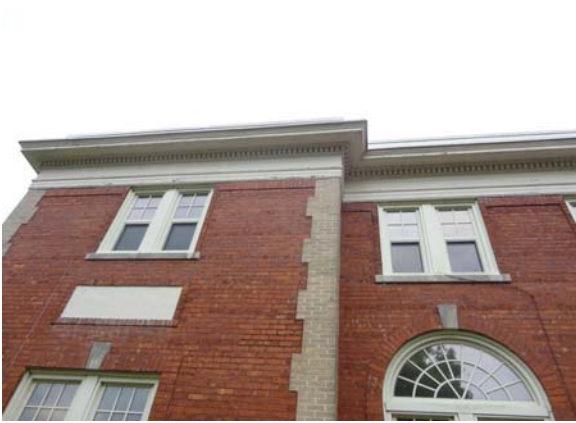
WHIC057a 5/10/2021
Weathered upper wood cornice
Upper west elevation of original building

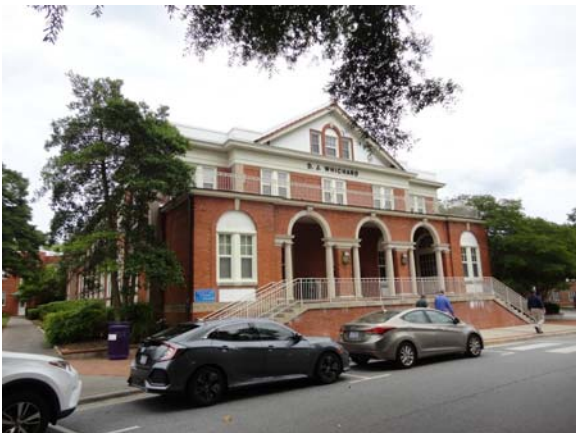
WHIC059a 5/10/2021
Brick facade and glazing
South elevation of original building

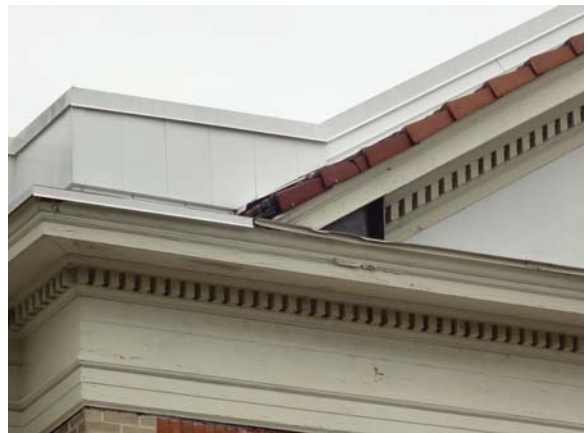
WHIC060a 5/10/2021
Weathering on upper cornice
Upper south elevation of original building

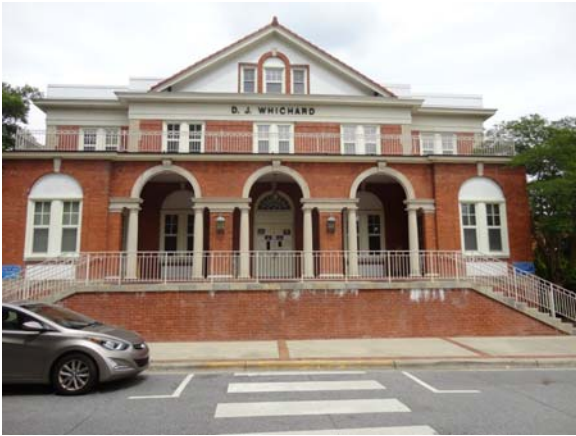
WHIC061a 5/10/2021
Signs of efflorescence on entry steps
South elevation of original building

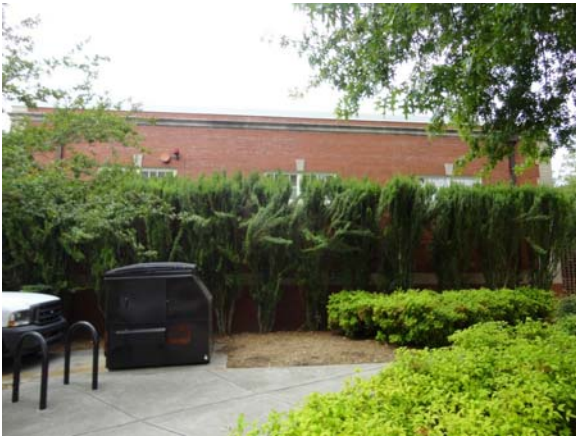
WHIC063a 5/10/2021
Brick facade
East elevation of east wing

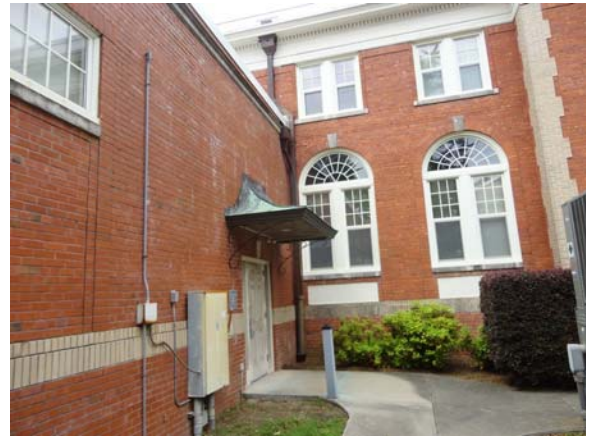
WHIC064a 5/10/2021
Entry doors and copper clad canopy
North elevation of east wing

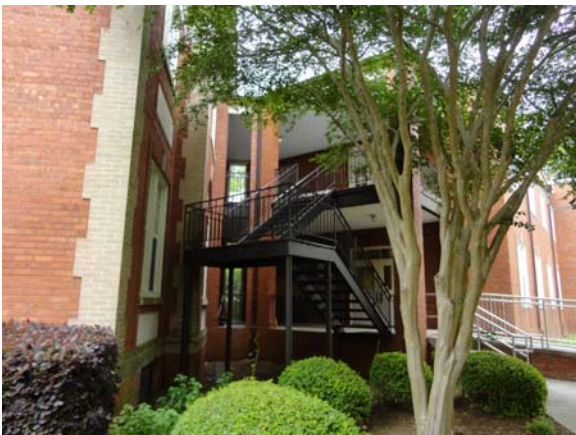
WHIC065a 5/10/2021
Aging exterior metal egress stair with open risers
Northeast breezeway

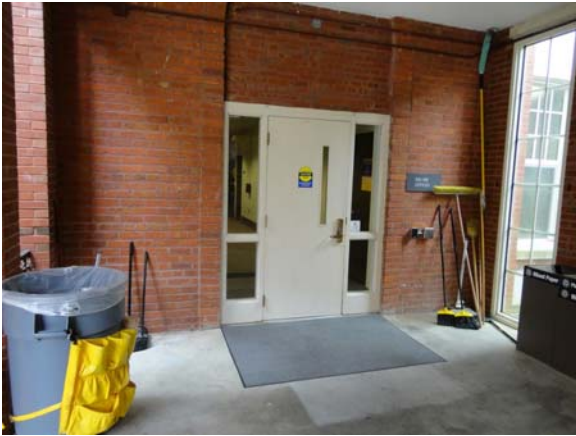
WHIC067a 5/10/2021
Newer hollow-metal door with sidelights and power assist
First floor, north entry to original building

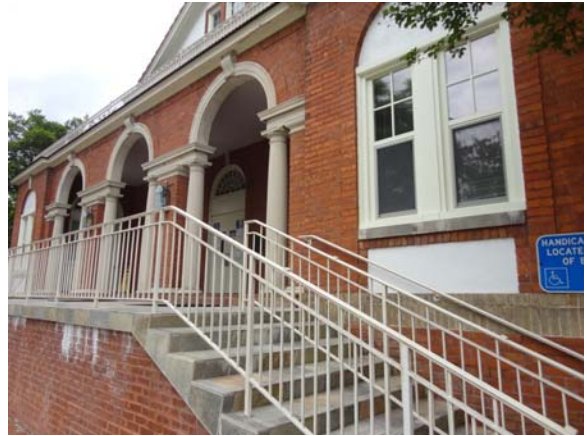
WHIC068a 5/10/2021
Accessible handrails on main south entry steps
South elevation of original building

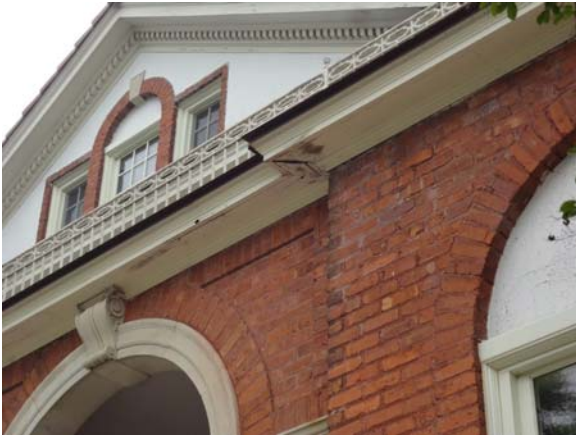
WHIC069a 5/10/2021
Localized dry rot on soffit
South elevation
