EAST CAROLINA UNIVERSITY

Facility Condition Assessment

Belk Building

Inspected January 11, 2023

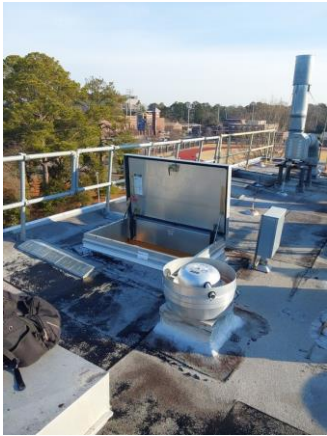
013001a 1/11/2023
Roof hatch with fall protection
Roof

The roof hatch and the skylights are missing fall protection on either side. It is recommended that fall protection be added to improve worker safety and limit liability. The roof lacks a sufficient parapet wall to prevent workers from falling. Installation of roof davits for tie-offs is recommended.

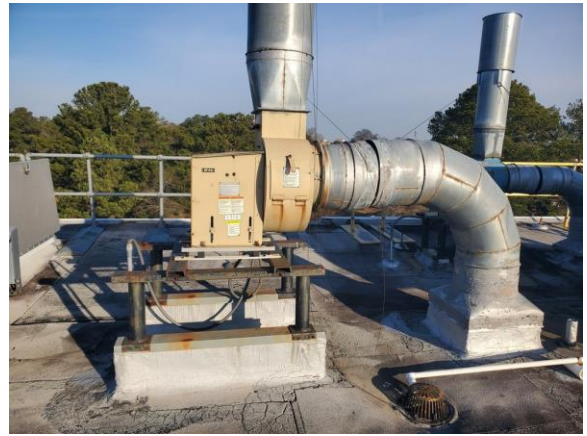
013001e 1/11/2023
Utility set fan EF-3-2 for fume hood
Roof

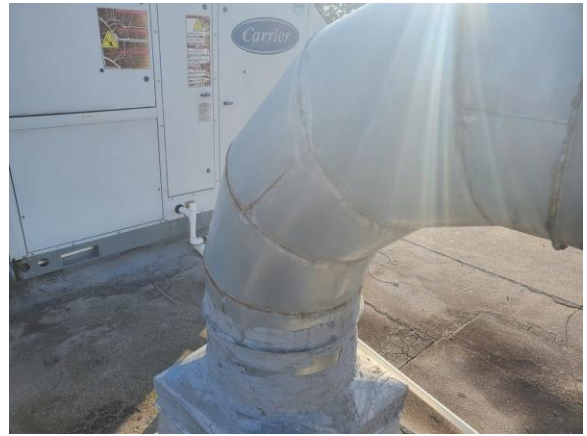
013002e 1/11/2023
Slight corrosion on steel ductwork
Roof

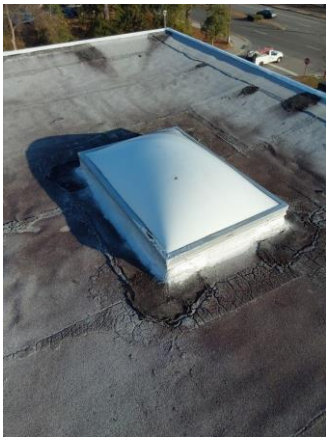
013005a 1/11/2023
Fiberglass skylight
Roof over stair 2

The roof is comprised of flat, single level modified bitumen. The roof drains via an internal roof drain system. There is equipment on the roof as well as skylights. It is recommended that the roof be replaced as the existing stress conditions will lead to failure if left unattended. Replace the stressed roofing and flashing with similar applications. The fiberglass skylights will also need replacement within ten years.

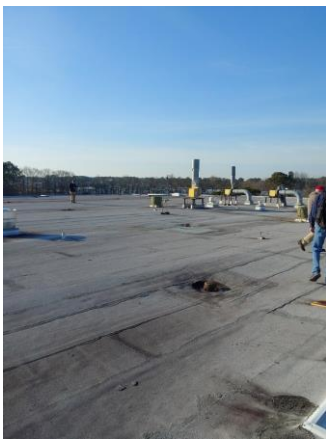
013006a 1/11/2023
Overall roof photo
Roof

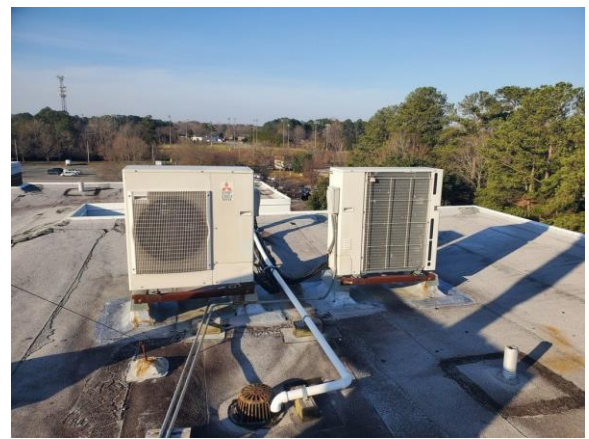
013006e 1/11/2023
Ductless split system air-cooled condensers
Roof

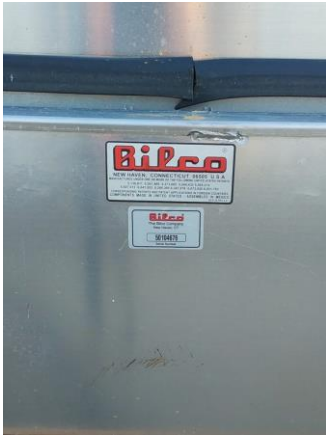
013007a 1/11/2023
Roof hatch nameplate
Roof

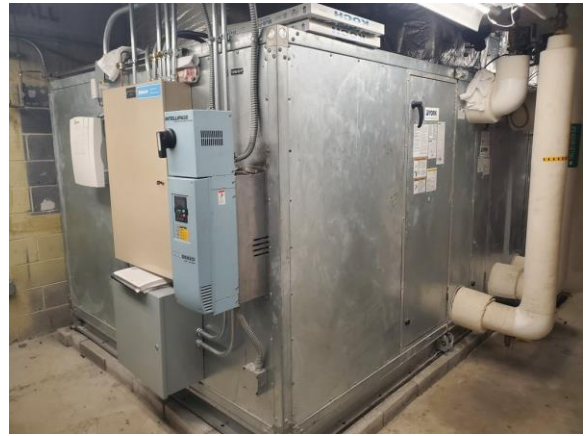
013007e 1/11/2023
Air handler AHU-3-1
Room 3303

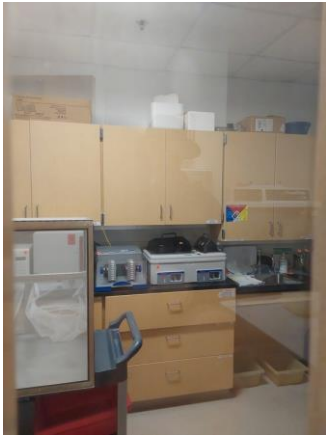
013008a 1/11/2023
Biohazard lab with lab casework
Room 3304

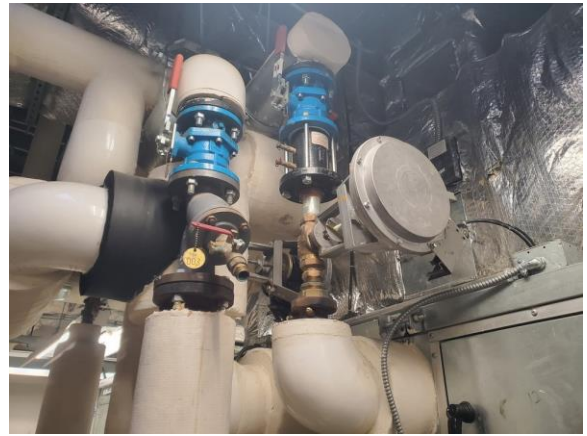
013008e 1/11/2023
Various distribution equipment
Room 3303

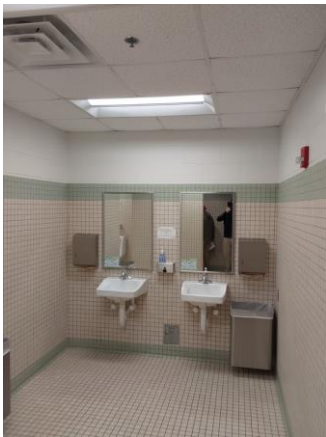
013009a 1/11/2023
Restroom lavatories
Room 3601

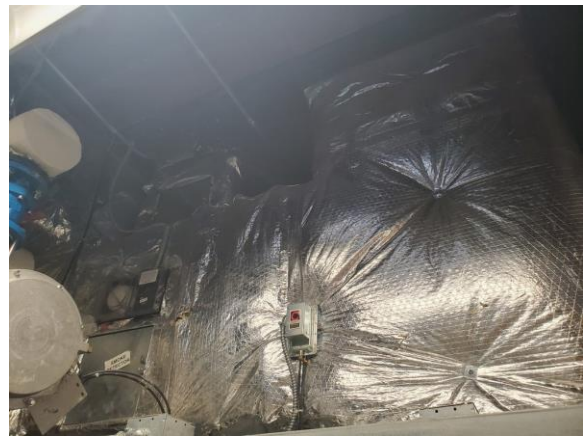
013009e 1/11/2023
Insulated, metal ductwork with detection
Room 3303

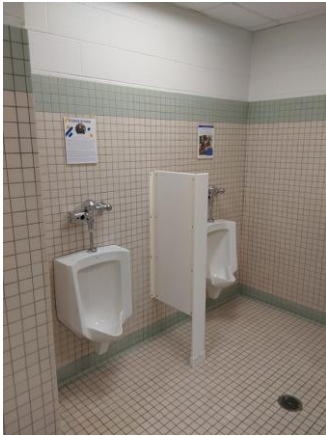
013010a 1/11/2023
Men's urinals
Room 3601

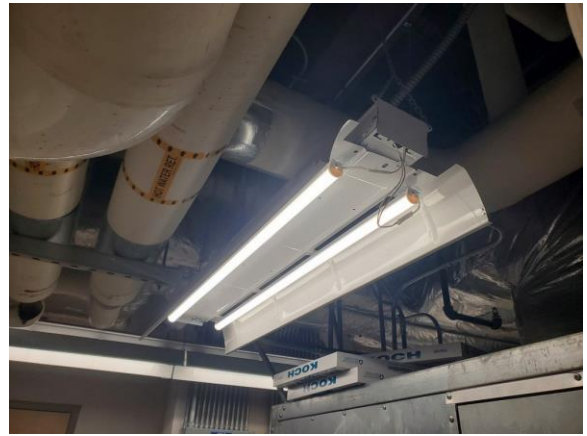
013010e 1/11/2023
Pendant style lighting with LED retrofit kit
Room 3303

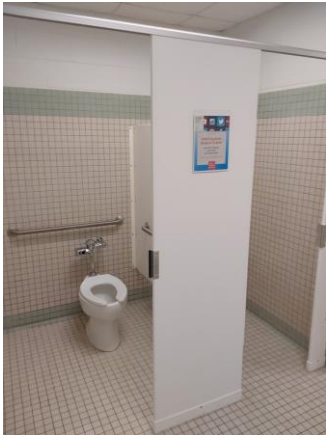
013011a 1/11/2023
Nonaccessible water closet
Room 3601

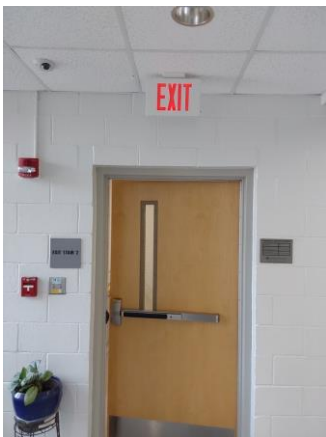
013012a 1/11/2023
Typical exit stair door with signage
Stair 2

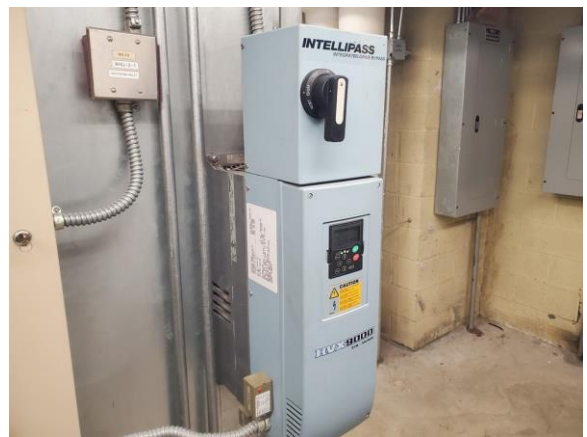
013012e 1/11/2023
Variable speed drive for AHU-3-1 supply fan
Room 3303

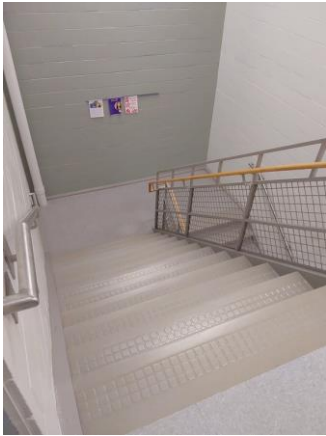
013013a 1/11/2023
Stairs with compliant handrails and guardrail
Stair 2

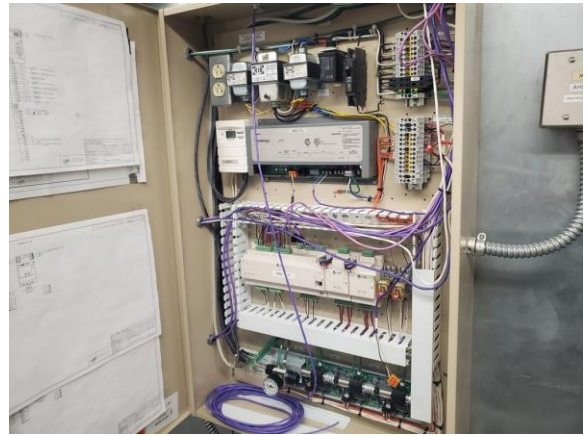
013013e 1/11/2023
DDC control panel CP-3-1 with updates
Room 3303

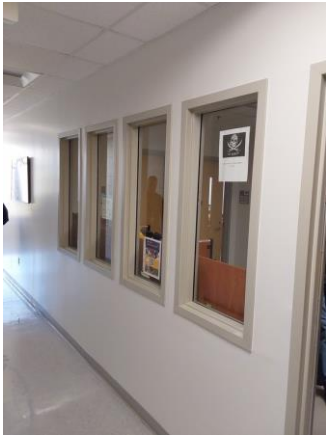
013014a 1/11/2023
Interior tempered glass along corridor
Room 3006

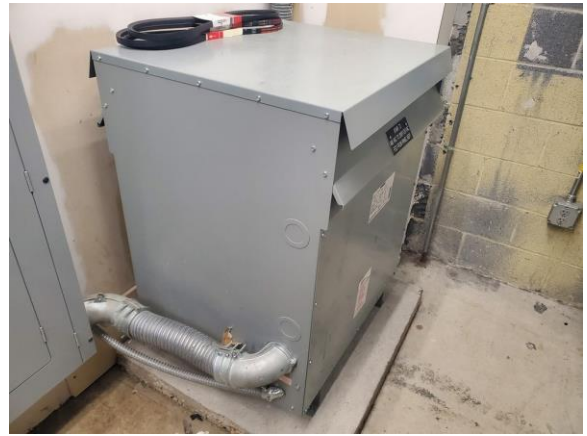
013014e 1/11/2023
Siemens dry type transformer
Room 3303

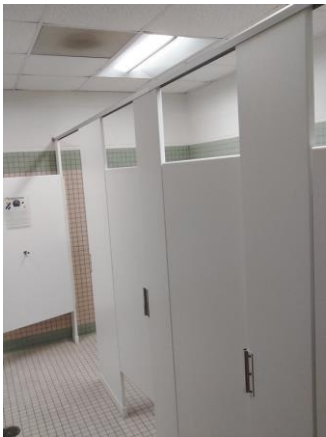
013015a 1/11/2023
Partitions in women's restroom
Room 3602

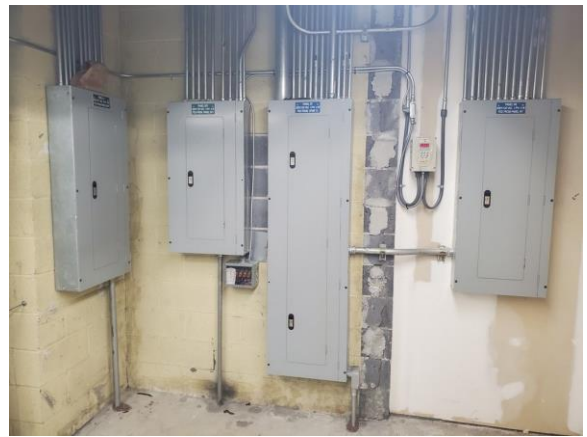
013015e 1/11/2023
Siemens secondary electric panelboards
Room 3303

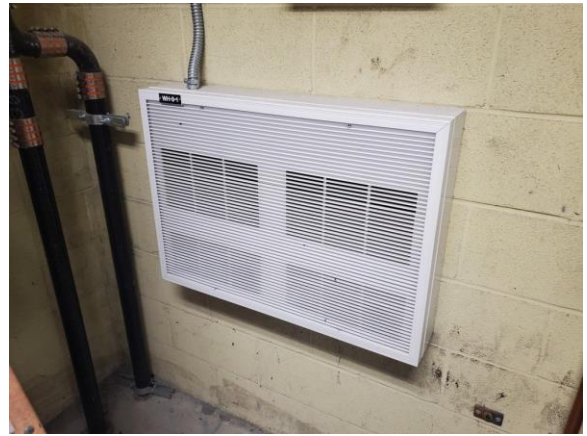
013016e 1/11/2023
Electric unit heater WH-3-1
Room 3303

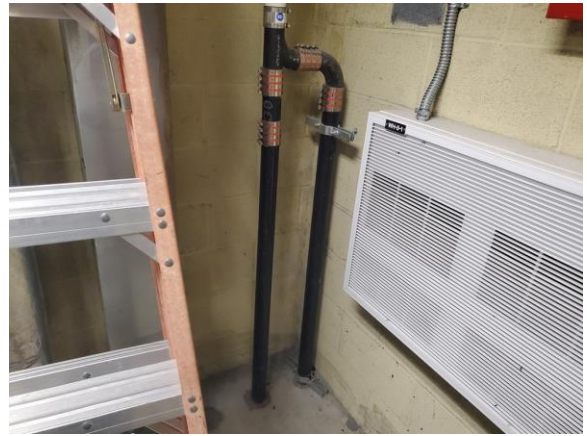
013017e 1/11/2023
ABS waste piping
Room 3303

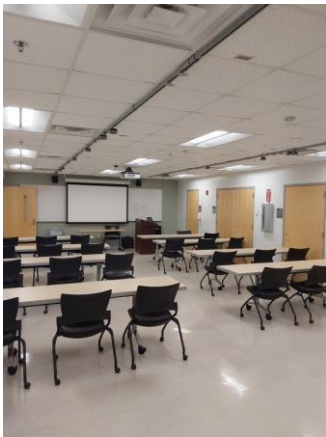
013018a 1/11/2023
Classroom with finishes shown
Room 3506

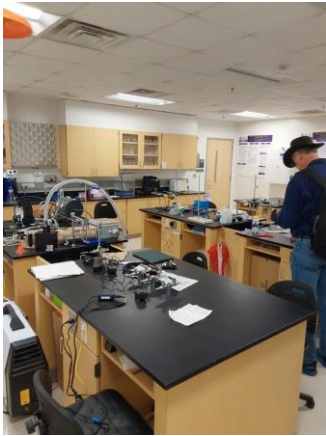
013019a 1/11/2023
Typical lab with welded seam vinyl floor
Room 3501

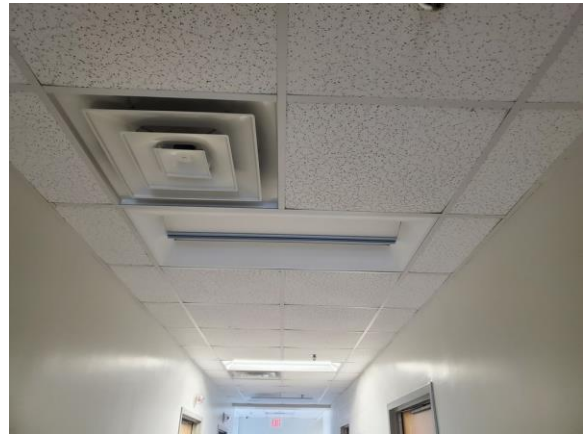
013019e 1/11/2023
2x4 recessed lighting with LED retrofit
Corridor 3004

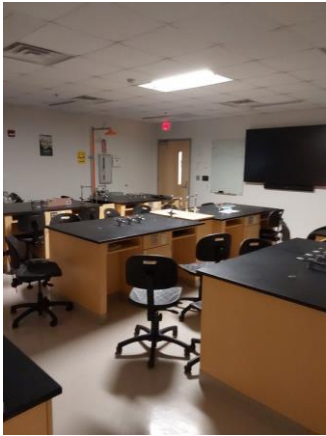
013020a 1/11/2023
Typical lab casework islands
Room 3502

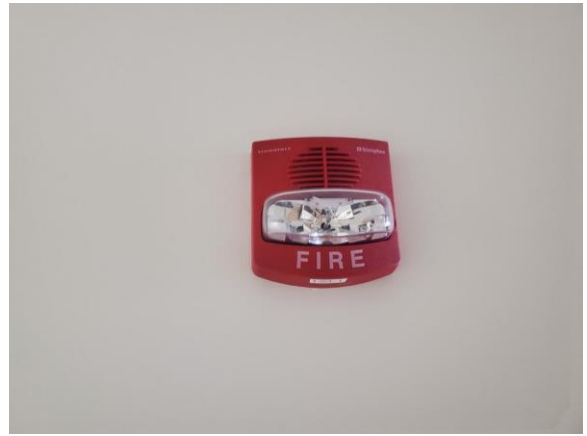
013020e 1/11/2023
Fire alarm system notifier
Corridor 3004

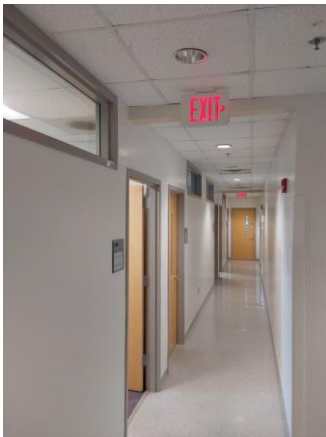
013021a 1/11/2023
Corridor with finishes and signage shown
Room 3009

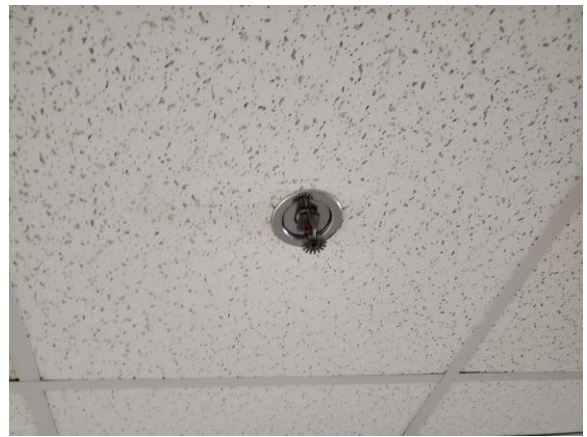
013021e 1/11/2023
Fire suppression system sprinkler head
Corridor 3004

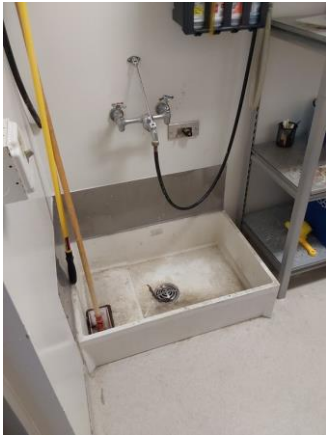
013022a 1/11/2023
Custodial mop sink
Room 3307

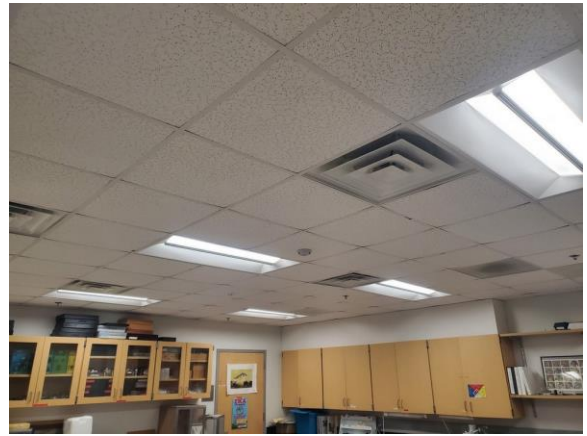
013022e 1/11/2023
Lab/classroom lighting with occupancy
Room 3504

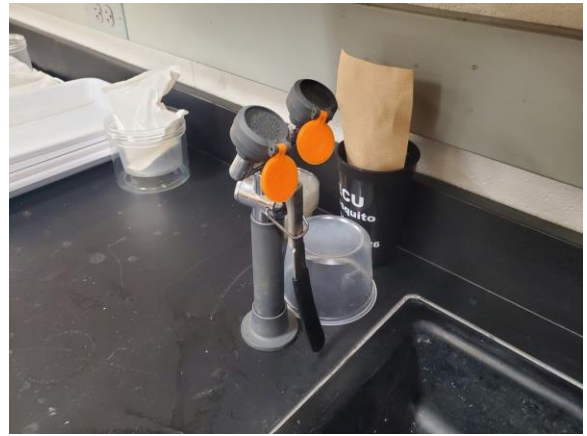
013023e 1/11/2023
Eyewash/drench hose
Room 3504

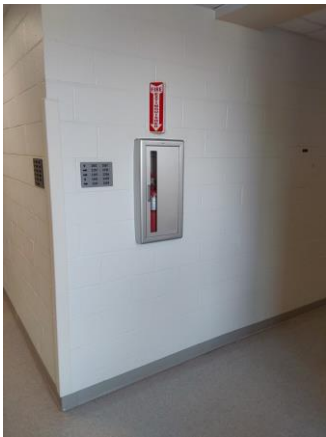
013024a 1/11/2023
Typical fire extinguisher cabinet
Room 3004

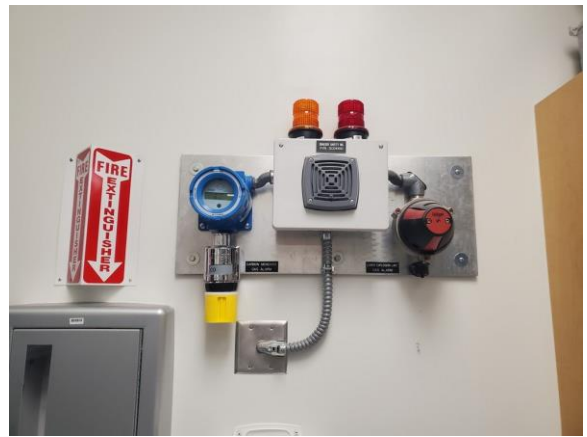
013024e 1/11/2023
Carbon monoxide monitoring system
Room 3504

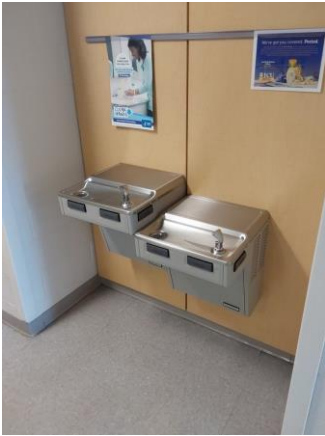
013025a 1/11/2023
Typical dual height water fountain
Room 3006

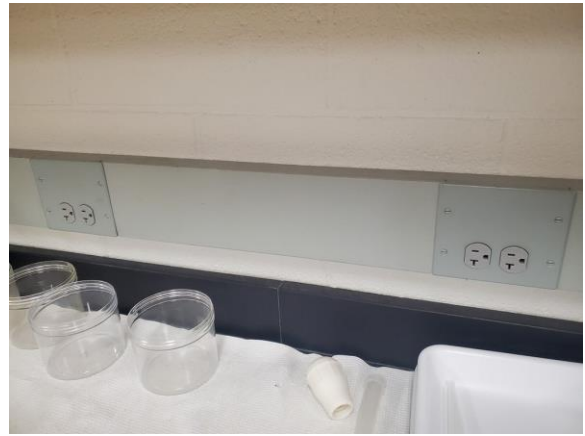
013025e 1/11/2023
Typical electrical outlets
Room 3504

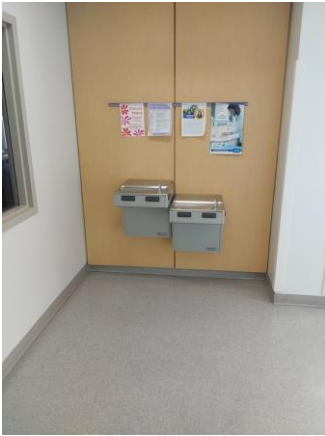
013026a 1/11/2023
Typical water fountain and wall finish
Room 3003

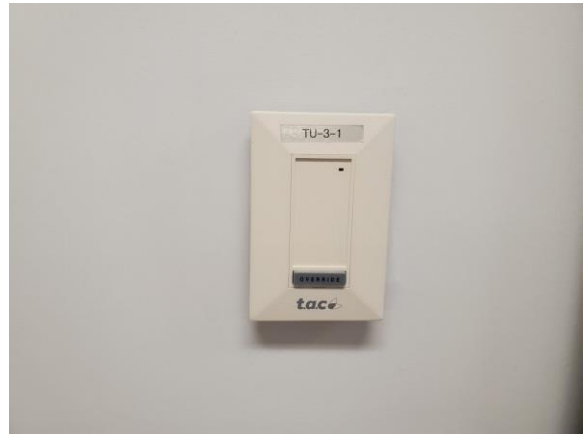
013026e 1/11/2023
Original thermostat for VAV terminal unit
Room 3504

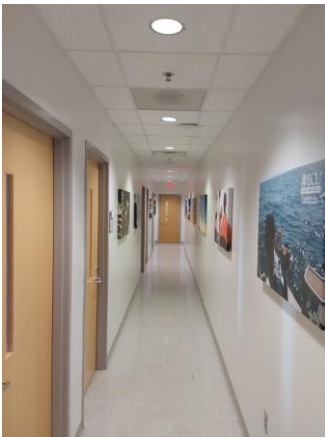
013027a 1/11/2023
Corridor with finishes shown
Room 2014

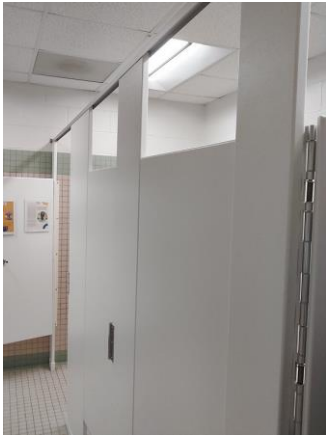
013028a 1/11/2023
Women's restroom partitions
Room 2702

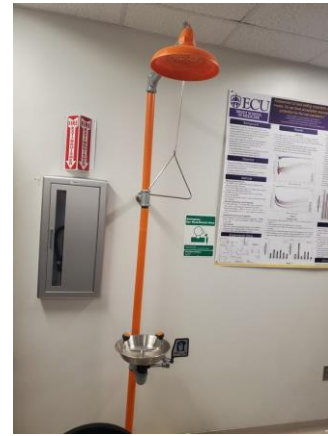
013028e 1/11/2023
Combination safety shower/eyewash station
Room 3501

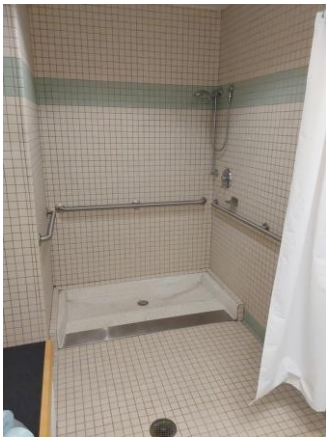
013029a 1/11/2023
Women's restroom roll-in shower
Room 2702

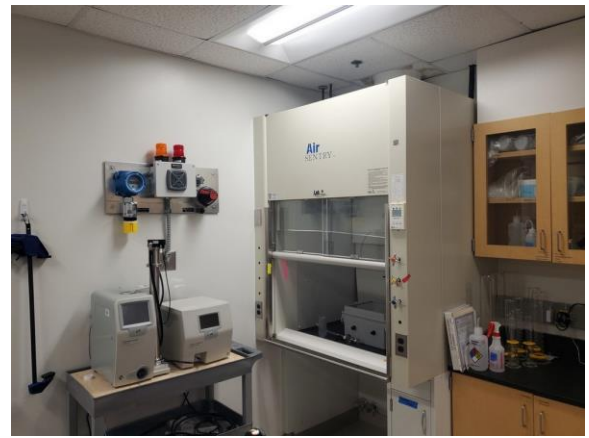
013029e 1/11/2023
Fume hood
Room 3501

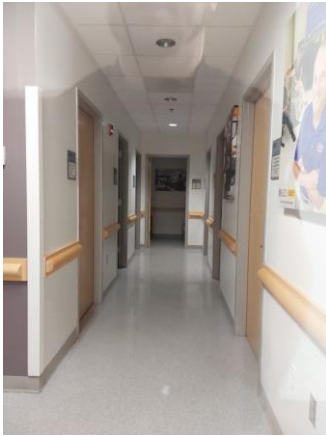
013031a 1/11/2023
Corridor with finishes shown
Room 2018

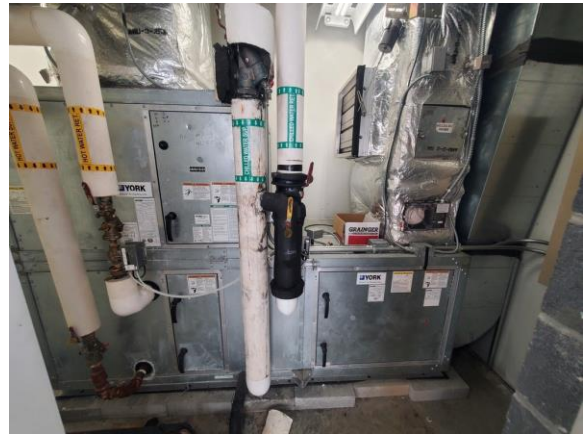
013031e 1/11/2023
Air handler AHU-3-2 for computer lab
Room 3101

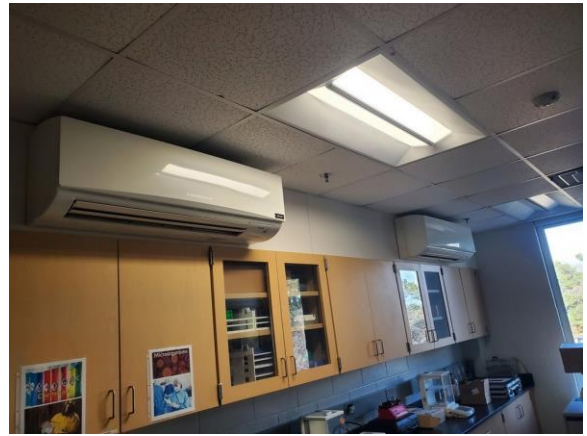
013032e 1/11/2023
Ductless split system blower assemblies
Room 3301

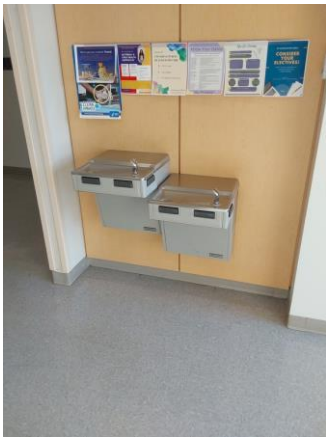
013033a 1/11/2023
Dual-height water fountain
Room 2001

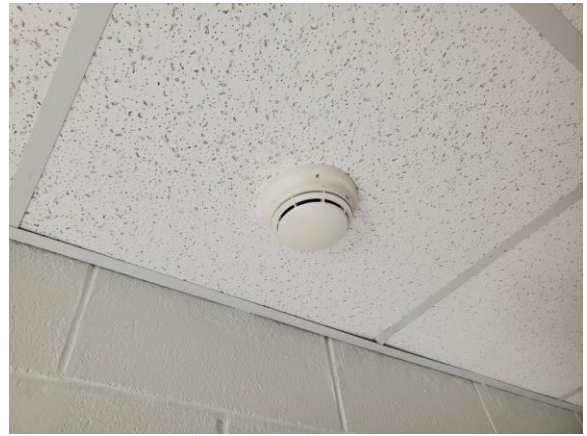
013034e 1/11/2023
Fire alarm system detector
Second floor corridor

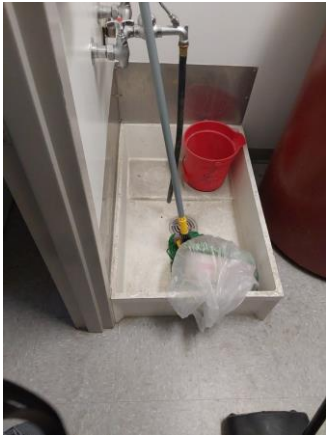
013035a 1/11/2023
Mop sink
Room 2311

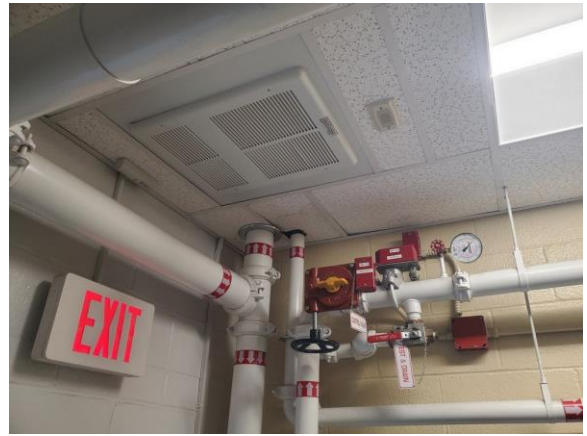
013035e 1/11/2023
Fire riser, tamper switches, flow switches
Stair S-2

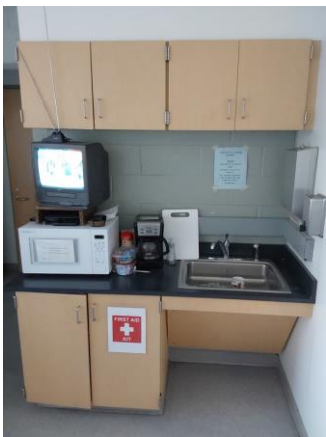
013036a 1/11/2023
Casework with accessible sink
Room 2310

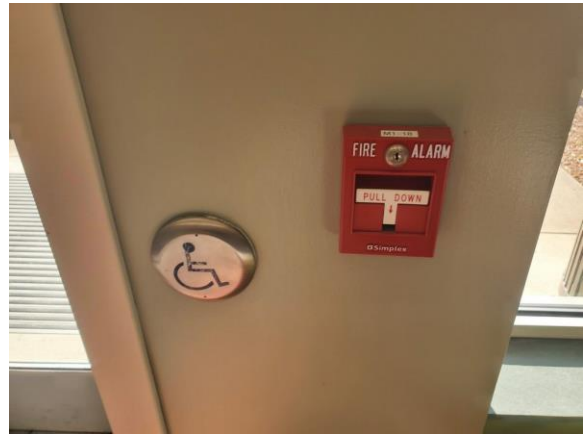
013037e 1/11/2023
Fire alarm system pull station
Vestibule 1002

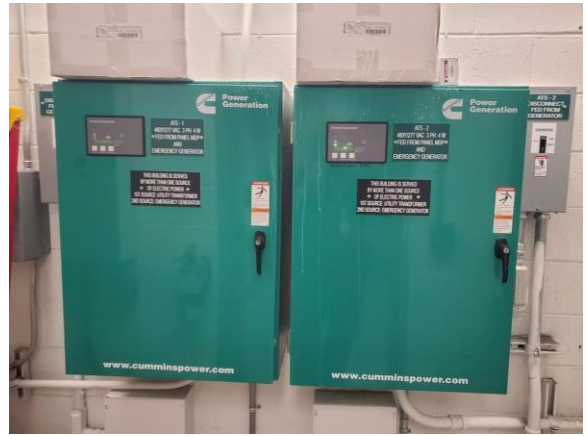
013038e 1/11/2023
Two automatic transfer switches
Room 1303

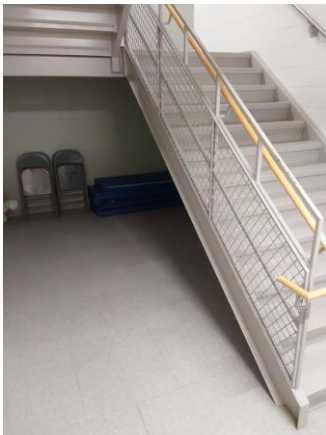
013059a 1/11/2023
Stair tower with missing cane rail
Stair 1

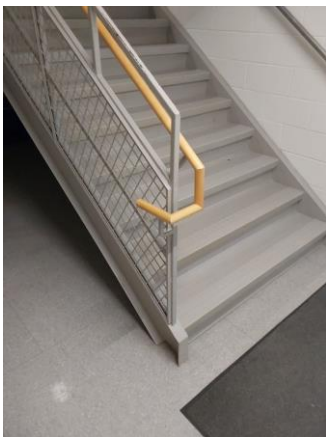
013060a 1/11/2023
Stair tower with missing handrail extension
Stair 1

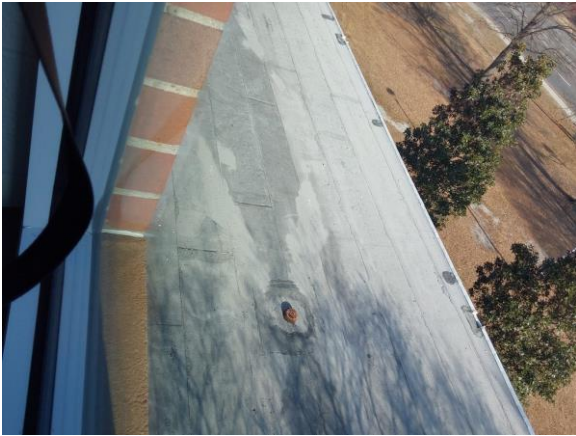
013061a 1/11/2023
Modified bitumen build-out roof
Roof

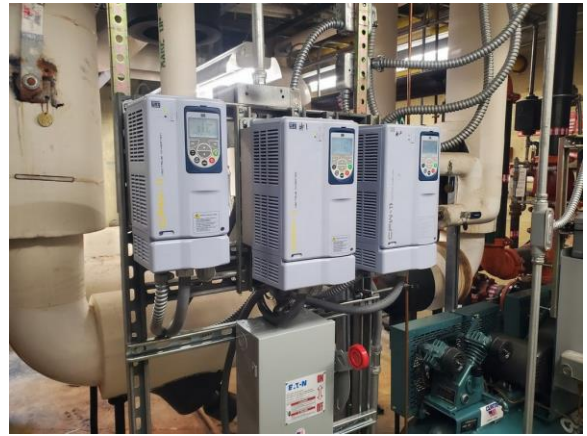
013061e 1/11/2023
Chilled water pump VFDs
Room 1307

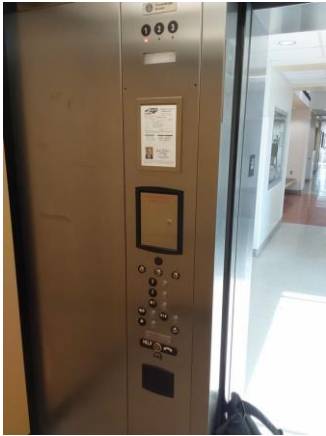
013062a 1/11/2023
Compliant elevator control board
Elevator

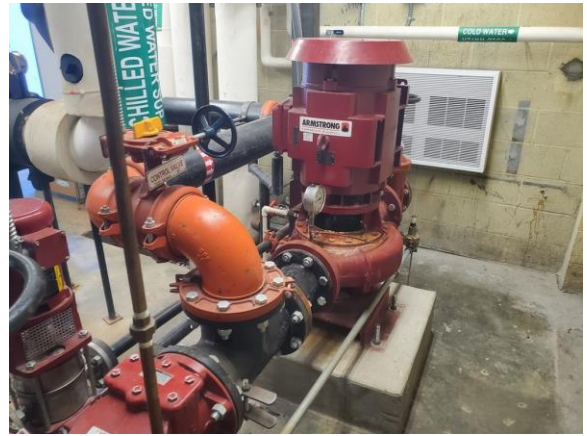
013062e 1/11/2023
Main fire pump
Room 1307

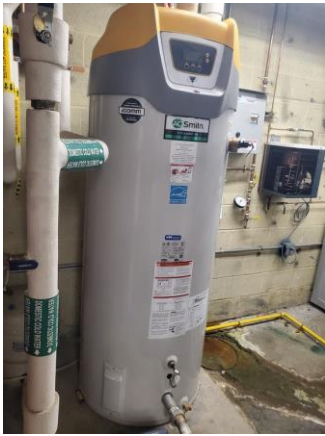
013065e 1/11/2023
Natural gas fired domestic water heater
Room 1307

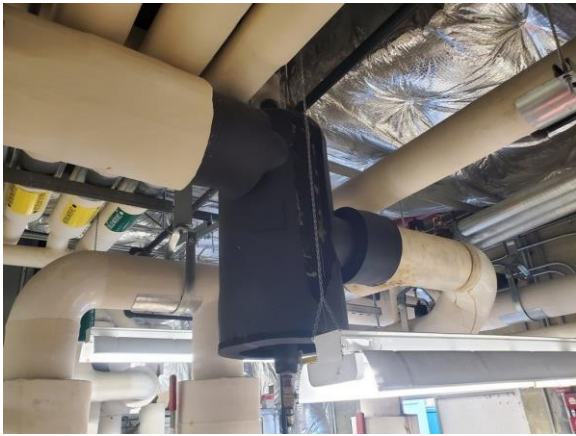
013067e 1/11/2023
Chilled water system air separator
Room 1307

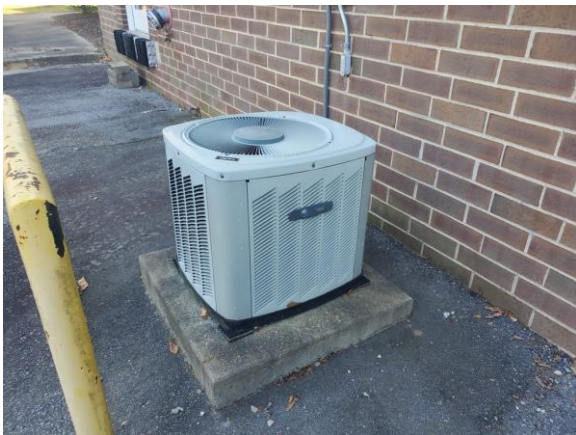
013069e 1/11/2023
Air-cooled condenser CU-1-1
Site

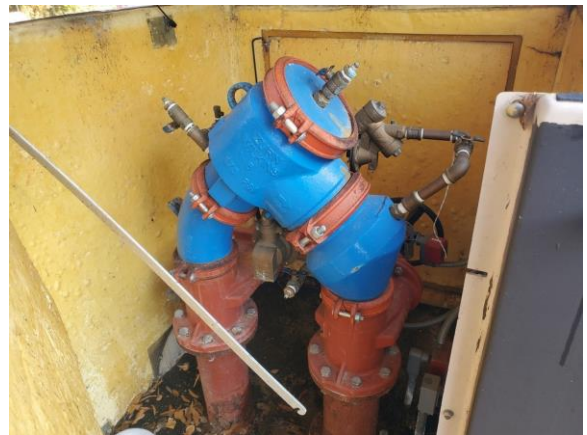
013070e 1/11/2023
Six-inch fire water backflow device
Site

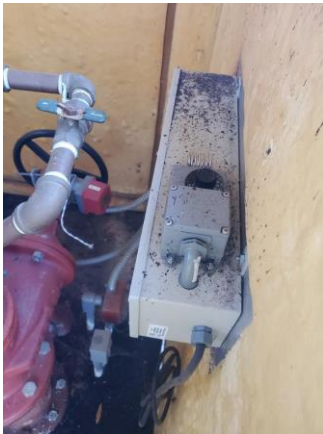
013071e 1/11/2023
Electric heater for fire backflow
Exterior

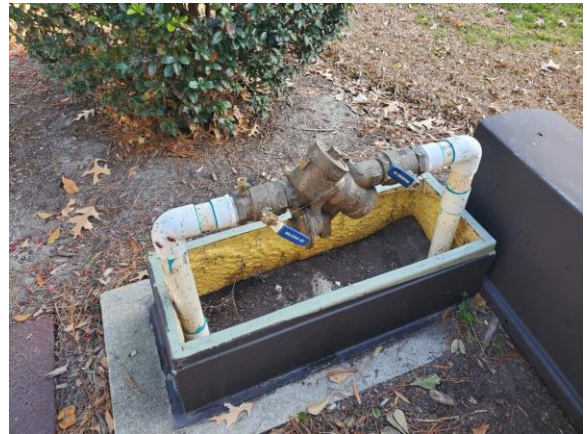
013072e 1/11/2023
Irrigation water backflow
Site

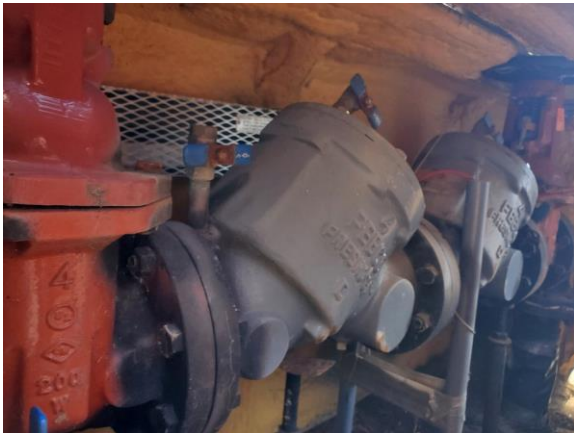
013073e 1/11/2023
Four-inch potable water backflow device
Exterior

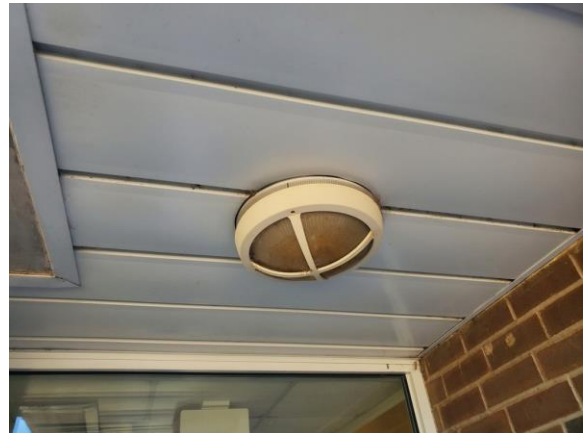
013074e 1/11/2023
Circa 2008 surface mounted HID lighting
Exterior

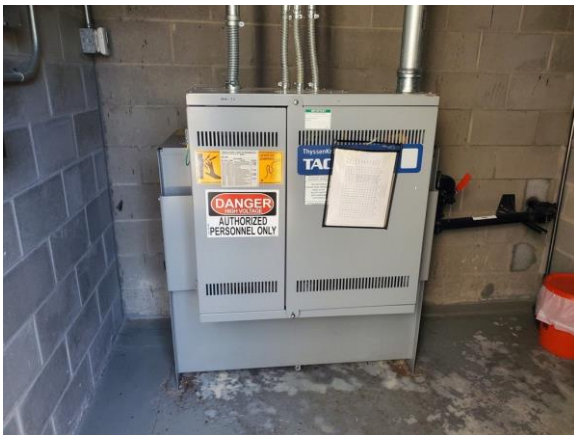
013075e 1/11/2023
Hydraulic elevator machine
Room 1701

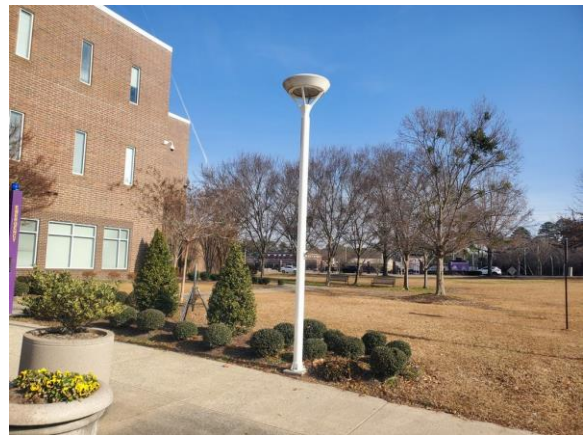
013076e 1/11/2023
Pole-mounted exterior lighting with LED lamp
Site
