# EAST CAROLINA UNIVERSITY

Facility Condition Assessment

Flanagan Building

Inspected January 9, 2023

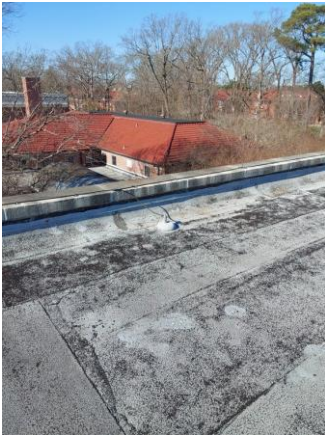
002001a 1/9/2023  
Low parapet wall with lightning protection  
Roof

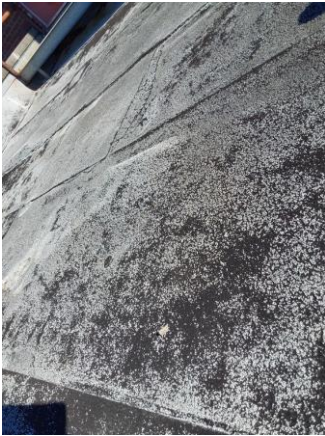
The modified bitumen roof on the older portion of the building shows a loss of aggregate as well as blistering on multiple areas. This roof should be replaced in the next year and the newer modified bitumen roof should be replaced in five years. The north terracotta tile portion of the roof is in good condition and should outlast the scope of this report. The gutter system for the modified bitumen portion of the roof is also due to be replaced within ten years. The lightning systems on the roofs should outlast the scope of this report.

002002a 1/9/2023  
Modified bitumen roof with blistering  
Roof

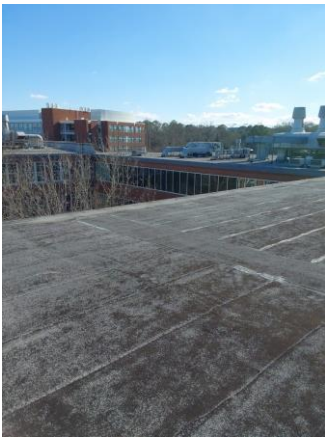
Both roof hatches do not have adequate fall protection on all sides. It is recommended that fall protection be added to comply with OSHA standards. Additionally, it is recommended that davits be installed for worker tie offs due to the lack of parapet walls on all flat roofs.

002003a 1/9/2023  
Roof edge with no parapet  
Roof

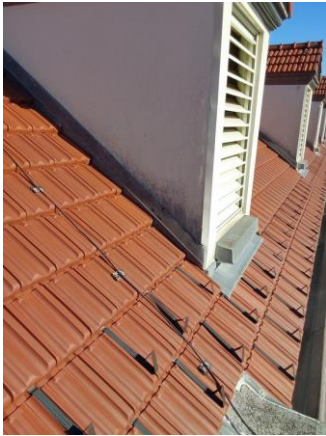
002004a 1/9/2023  
Grime on EIFS siding of dormers  
Roof

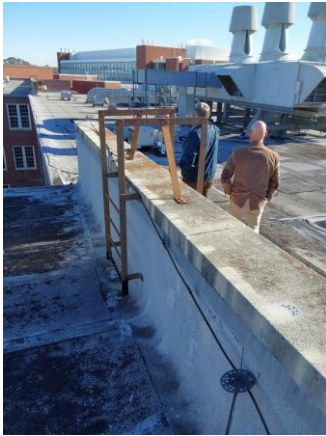
002005a 1/9/2023  
Transfer ladder of parapet  
Roof

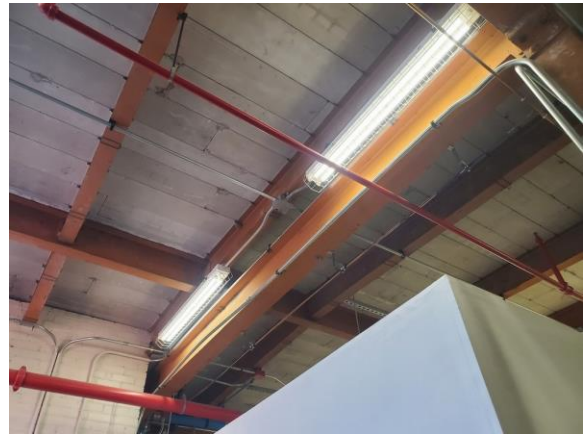
002005e 1/9/2023  
Surface-mounted lighting  
Room 450

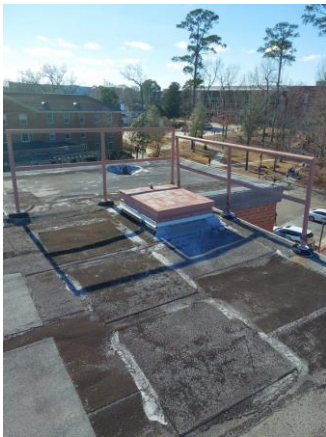
002006a 1/9/2023  
Roof hatch with worn fall protection  
Roof

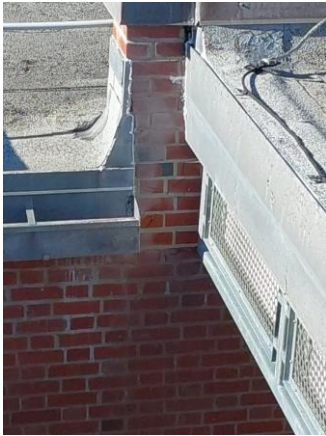
The brick shows signs of cracking near the roof gutters on the southern wing. The brick joints on the walls of the tile roof are also showing signs of deterioration. Replacement of damaged bricks and repointing is recommended to restore the exterior brick. Additionally, multiple areas on the brick, stone, and concrete panels show signs of efflorescence and other deposits. It is recommended that these surfaces be given a light chemical treatment and power washed to restore their appearance.

002007a 1/9/2023  
Cracked brick above gutter  
Roof

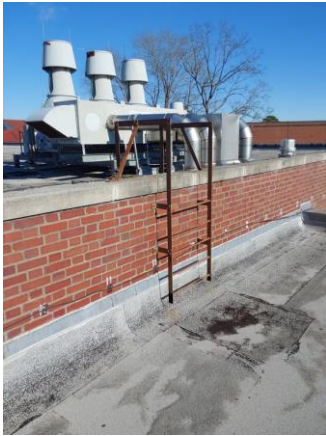
002008a 1/9/2023  
Parapet transfer ladder  
Roof

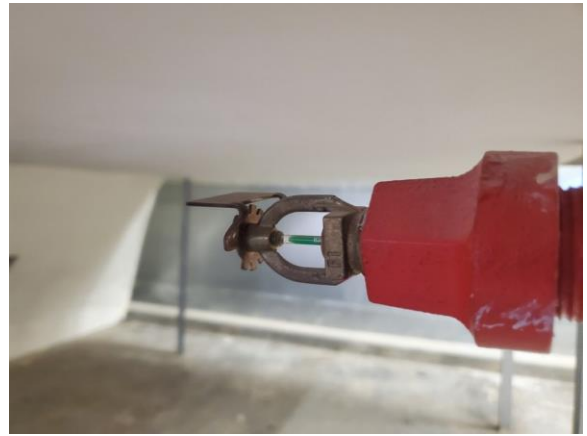
002008e 1/9/2023  
Sprinkler head  
Room 450

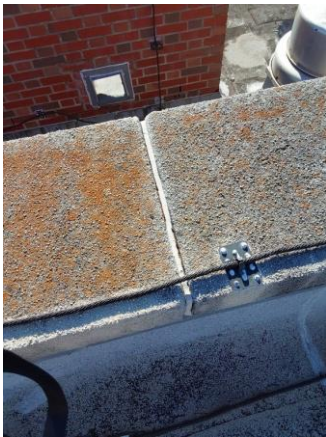
002009a 1/9/2023  
Worn sealant on parapet joints  
Roof

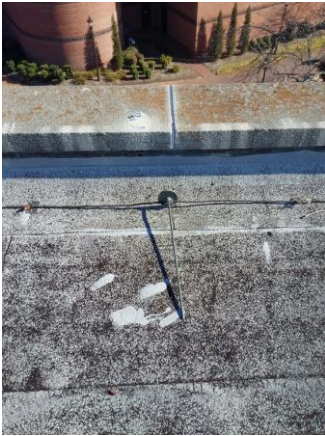
002010a 1/9/2023  
Lighting protection system detached from roof  
Roof

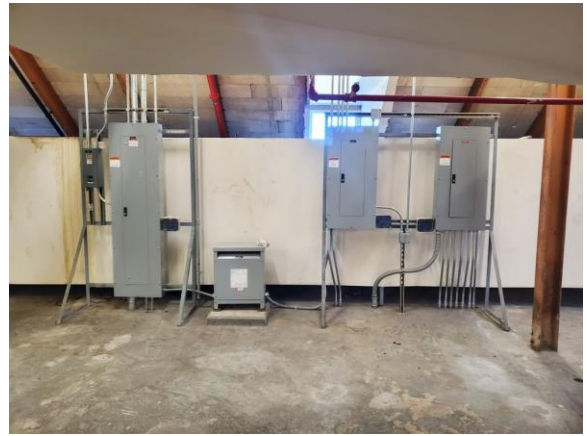
002010e 1/9/2023  
Various secondary electrical  
Room 450

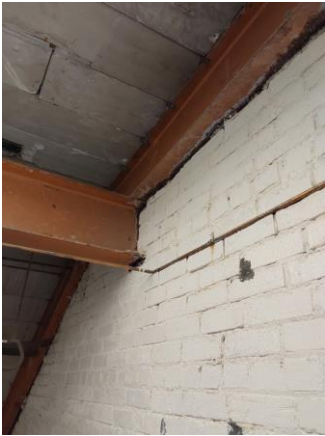
002011a 1/9/2023  
Corrosion of structural steel members  
Roof attic

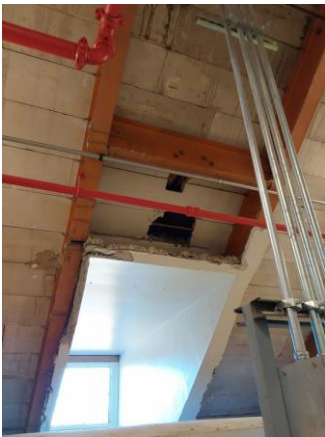
002012a 1/9/2023  
Hole in substructure of terracotta roof  
Roof attic

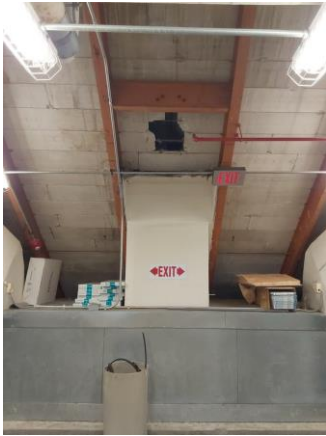
002013a 1/9/2023  
Exit signage and roof attic  
Roof attic

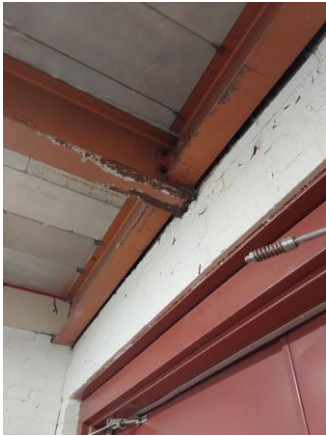
002014a 1/9/2023  
Corrosion of structural steel members  
Roof attic

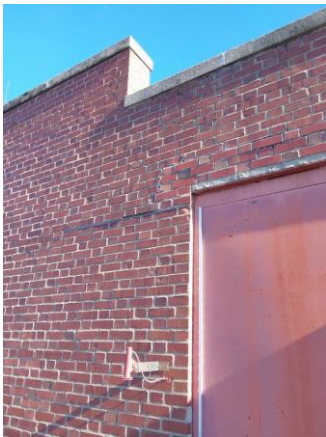
002015a 1/9/2023  
Exterior brick damage on west end of attic  
Roof

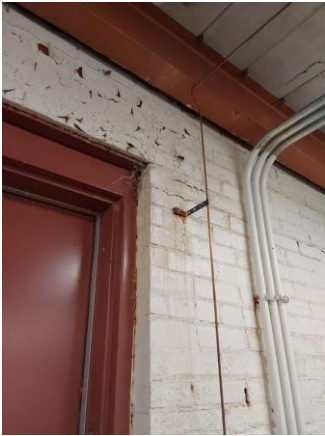
002016a 1/9/2023  
Signs of water infiltration from exterior  
Roof attic

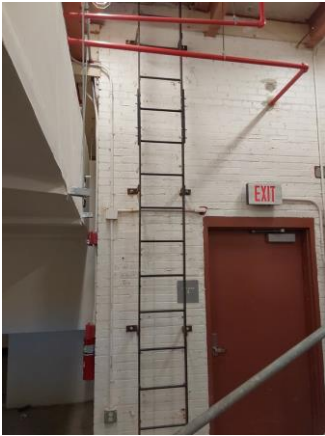
002017a 1/9/2023  
Roof ladder to flat portion of tile roof  
Roof attic

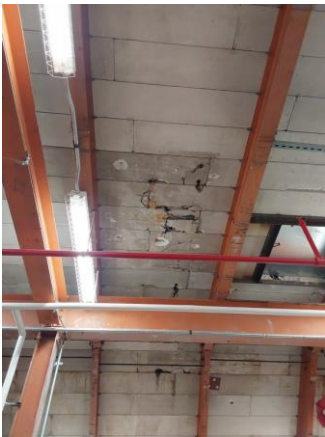
002018a 1/9/2023  
Signs of water damage  
Roof attic

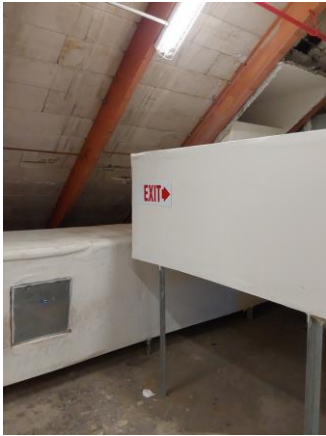
002019a 1/9/2023  
Exit signage and roof attic  
Roof attic

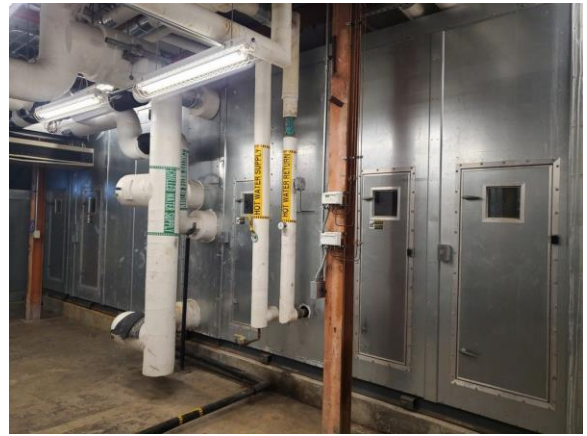
002019e 1/9/2023  
Heating and chilled water pipe for AHU-2 coils  
Room 450

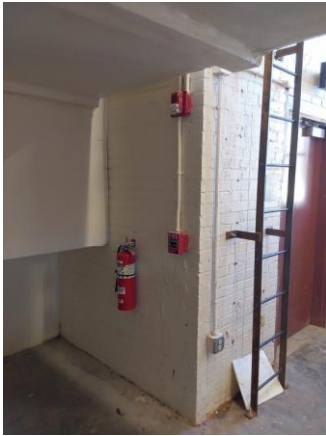
002020a 1/9/2023  
Roof ladder and extinguisher  
Roof attic

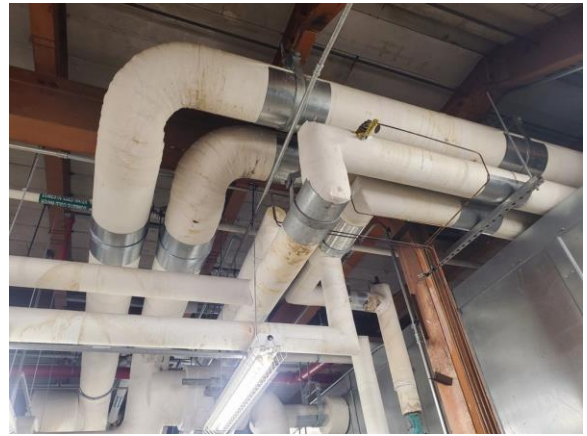
002020e 1/9/2023  
Various system piping  
Room 450

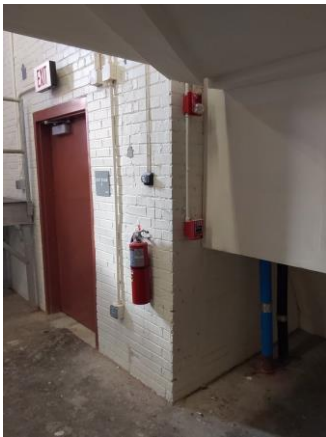
002021a 1/9/2023  
Extinguisher with fire pull and alarm  
Roof attic

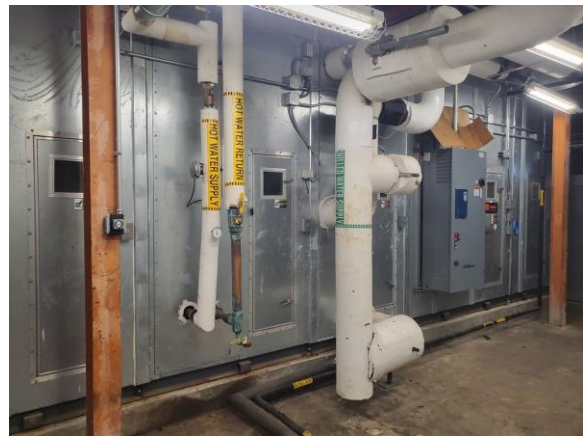
002021e 1/9/2023  
Air handler AHU-1  
Room 450

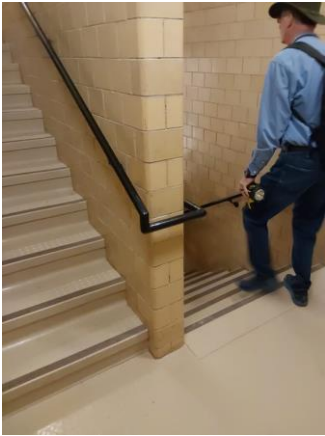
002022a 1/9/2023  
Stair tower handrails  
Stair 3

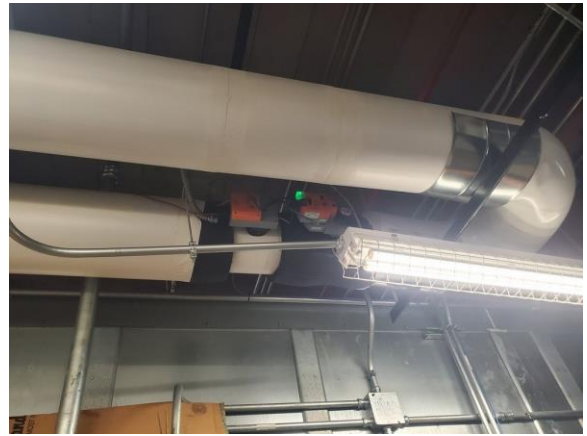
002022e 1/9/2023  
Updated control system actuators  
Room 450

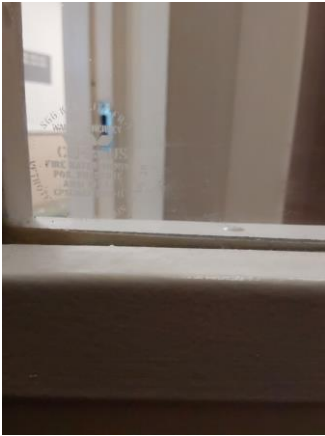
002023a 1/9/2023  
Stair tower fire glass rating  
Stair 3

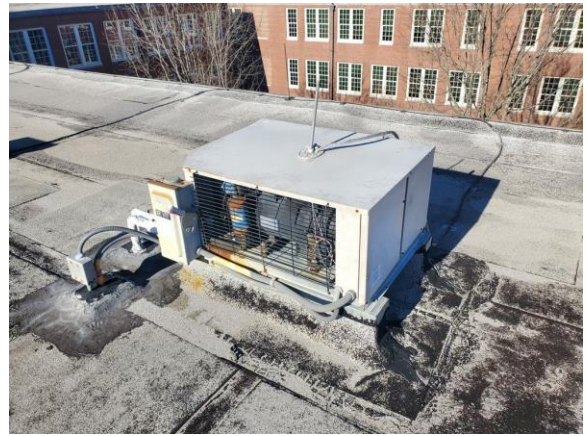
002023e 1/9/2023  
Cold room refrigeration unit  
Roof

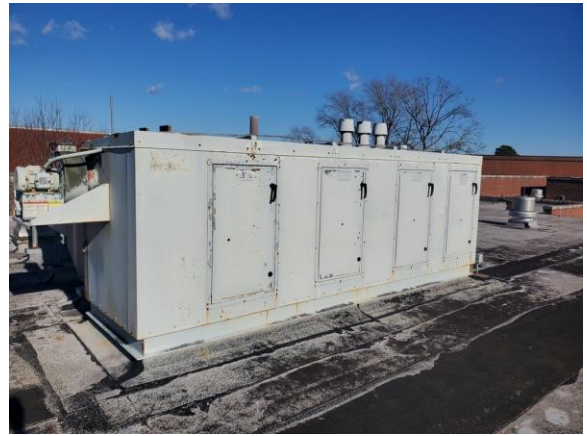
002025e 1/9/2023  
Air handler DDU-1 for room 3212  
Roof

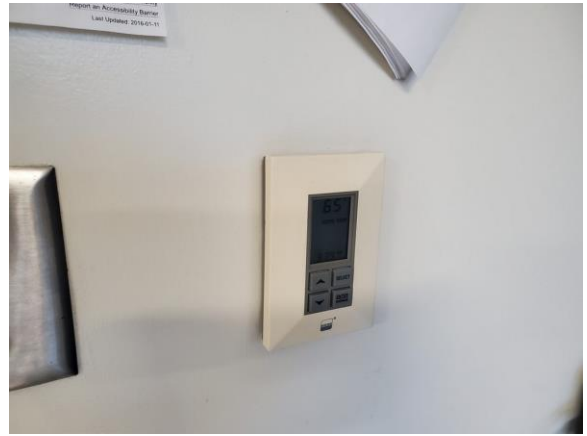
002032e 1/9/2023  
Thermostat to be replaced in 2023  
Room 337

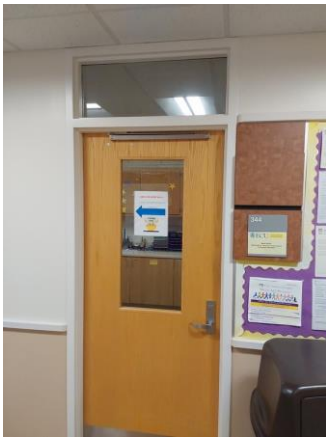
002033a 1/9/2023  
Nonrated safety tempered glass on doors  
Room 340

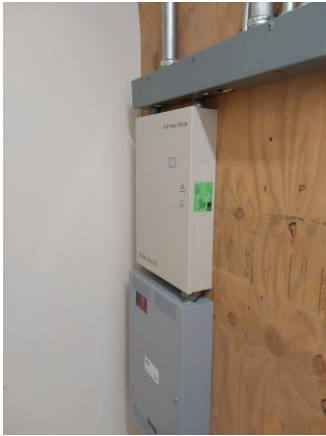
002044a 1/9/2023  
Door access control box  
Room 370

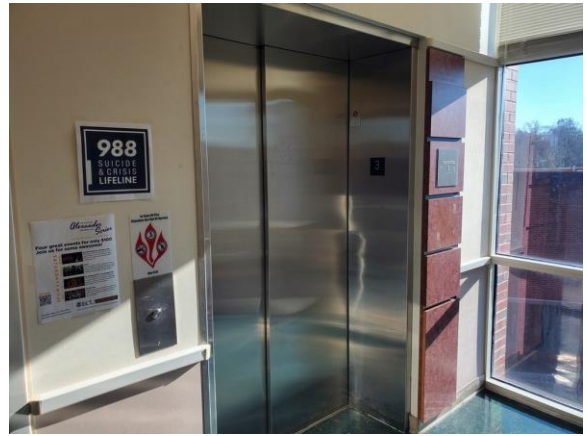
002044e 1/9/2023  
Elevator B passenger car doors  
Lobby 394

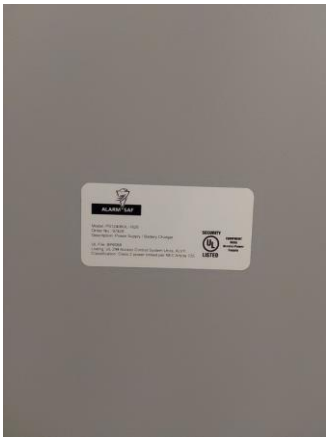
002045a 1/9/2023  
Door access control box nameplate  
Room 370

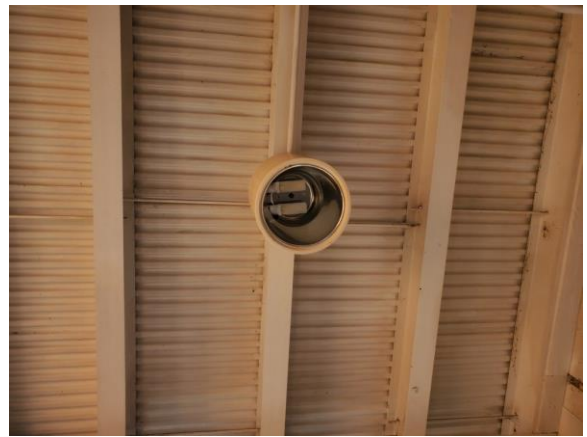
002045e 1/9/2023  
Surface mounted exterior lighting  
Balcony 3201

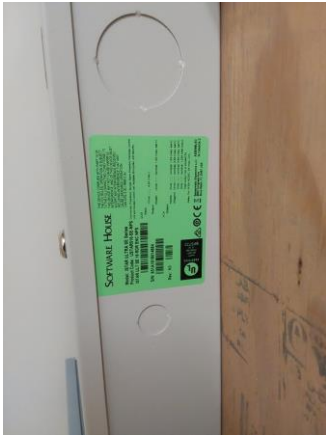
002046a 1/9/2023  
Door access box third floor  
Room 370

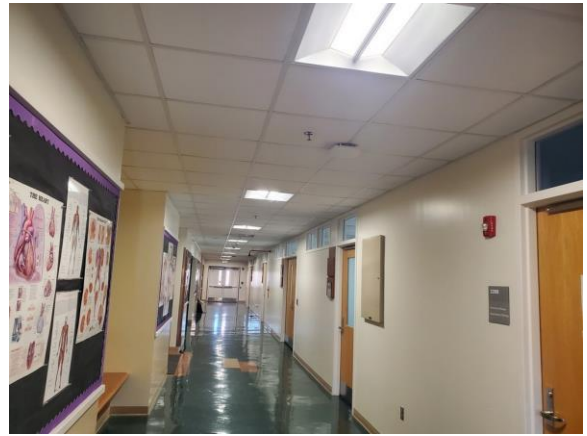
002046e 1/9/2023  
Overview of corridor systems in 2008 addition  
Corridor 3202

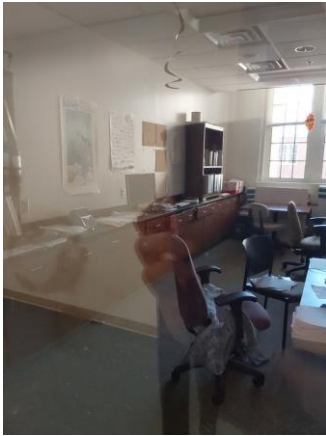
002047a 1/9/2023  
Laminate casework with solid surface top  
Room 376

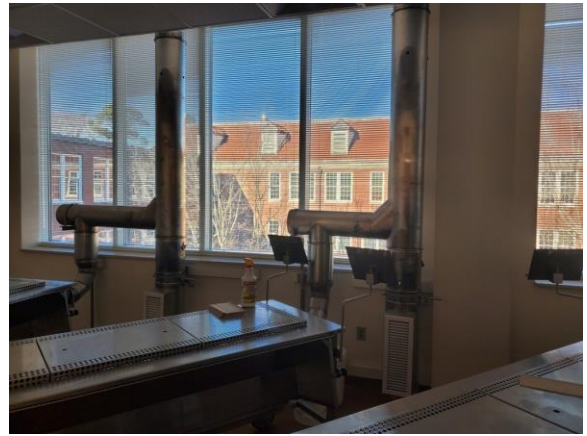
002047e 1/9/2023  
Ductwork from AHU DDU-1  
Room 3212

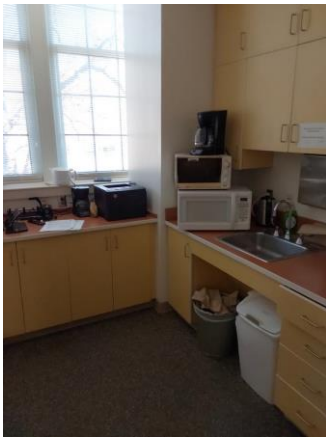
002048a 1/9/2023  
Laminate casework counter with sink  
Room 381

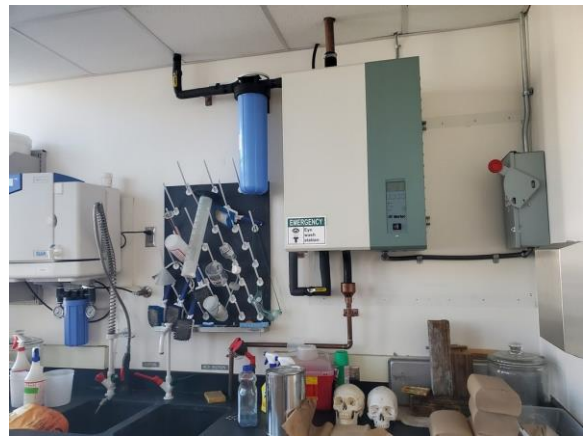
002048e 1/9/2023  
Electric humidification device  
Room 3212

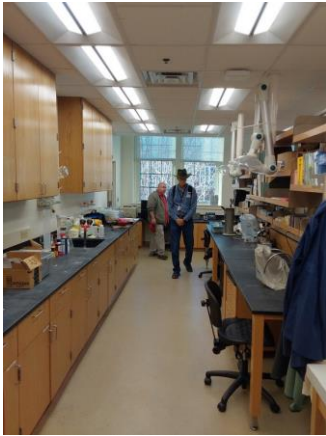
002049a 1/9/2023  
Solid surface lab counter and laminate cabinets  
Room 382

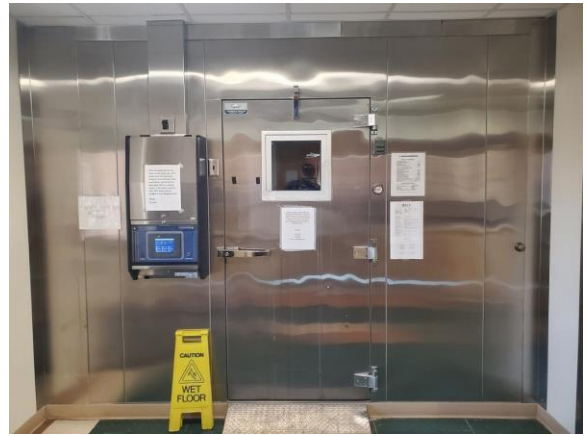
002049e 1/9/2023  
Walk-in freezer  
Room 3224

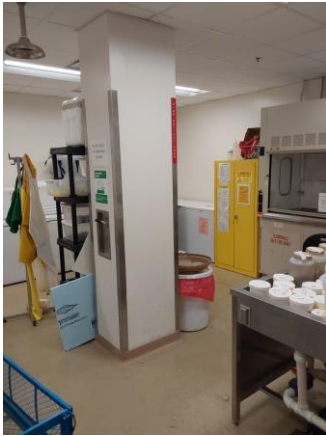
002050a 1/9/2023  
Lab storage with epoxy flooring and ACT ceiling  
Room 384

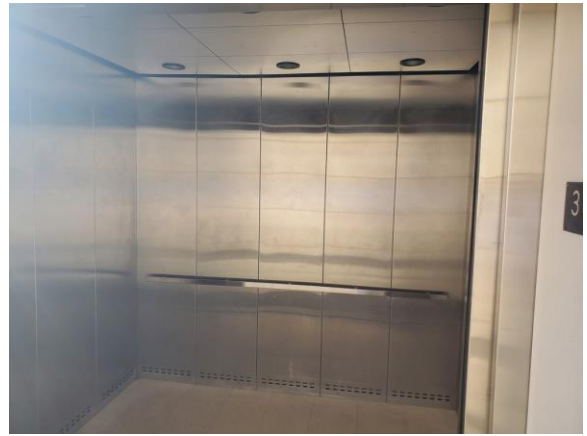
002050e 1/9/2023  
Interior of Freight Elevator A  
Balcony 302

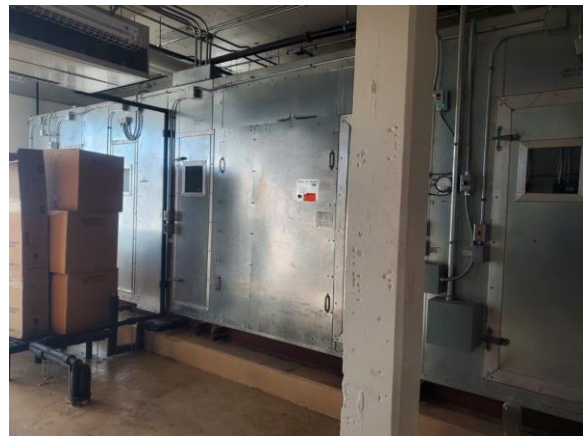
002051e 1/9/2023  
Air handler AHU-3  
Room 2205

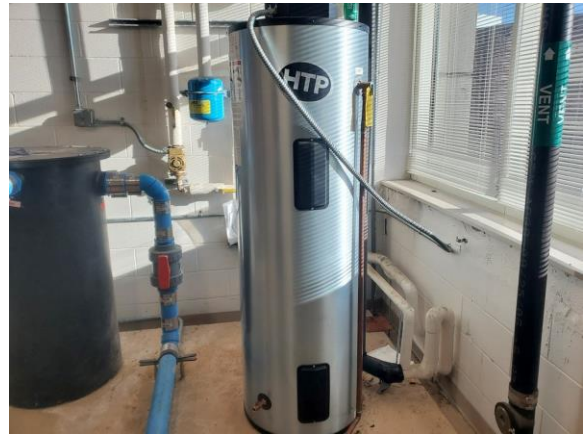
002052e 1/9/2023  
Electric water heater  
Room 2205

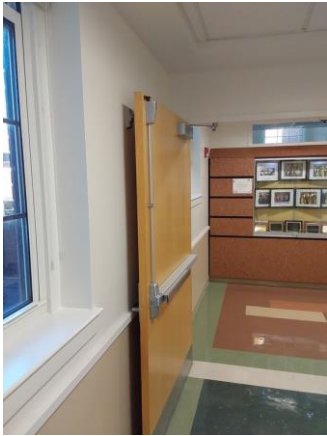
002053a 1/9/2023  
Corridor doors with panic hardware  
Room 340

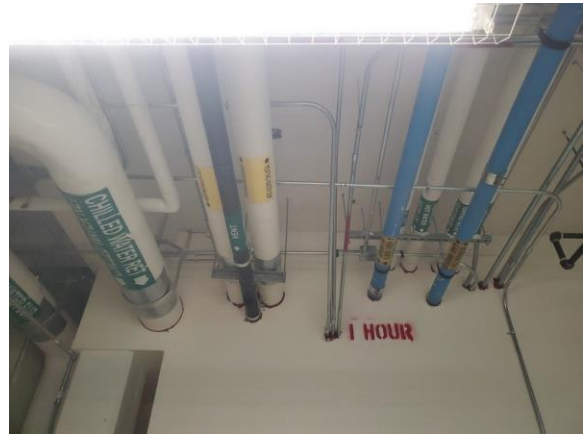
002053e 1/9/2023  
Various piping systems  
Room 2205

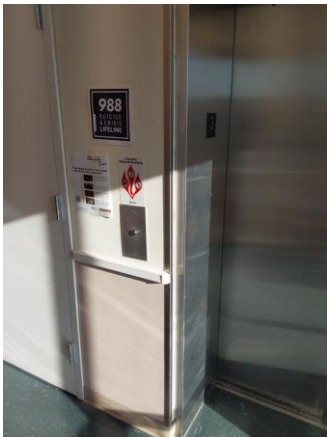
002054a 1/9/2023  
Elevator operating button  
Elevator B

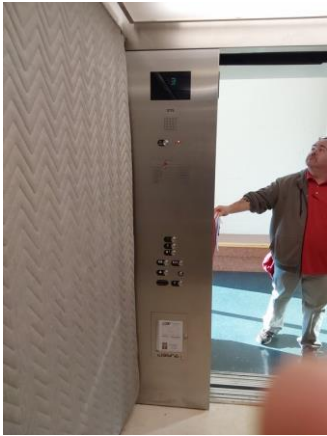
002055a 1/9/2023  
Elevator control panel  
Elevator B

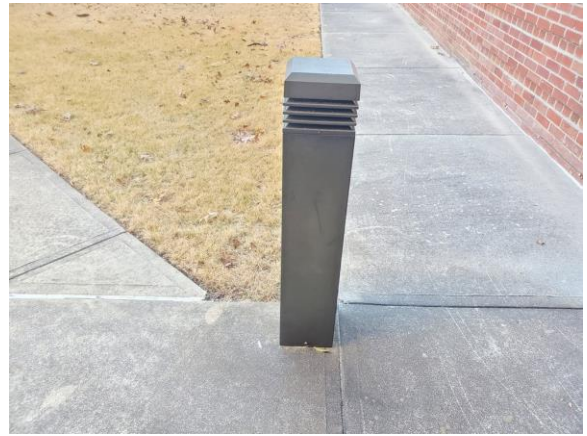
002055e 1/9/2023  
Bollard type lighting  
Courtyard/rock garden

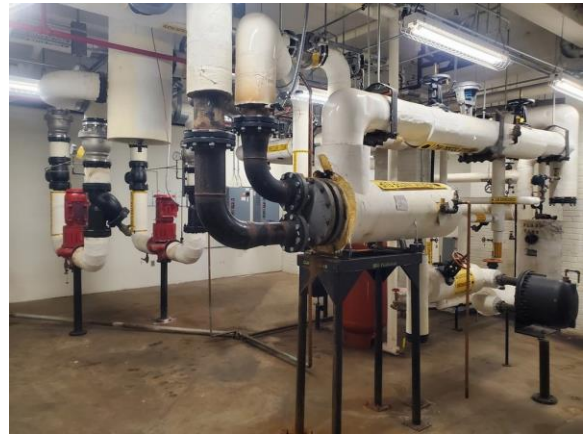
002056e 1/9/2023  
Overview of mechanical room  
Room 153

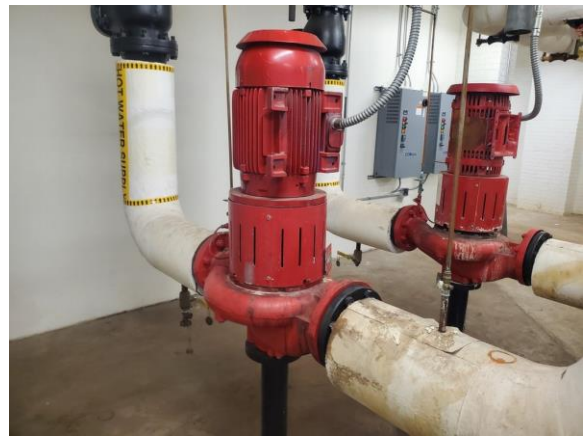
002057e 1/9/2023  
Heating water pumps HWP-1 and 2  
Room 153

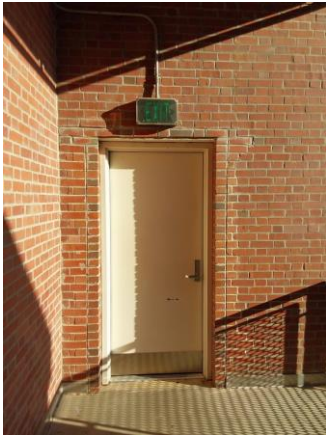
002058a 1/9/2023  
Missing panic hardware  
Stair 2, 3201

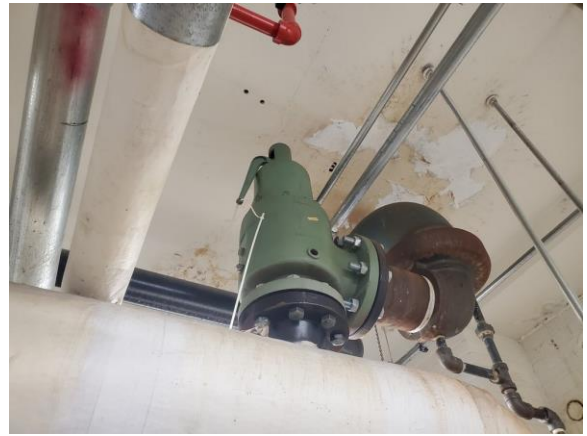
002059e 1/9/2023  
Steam safety relief  
Room 153

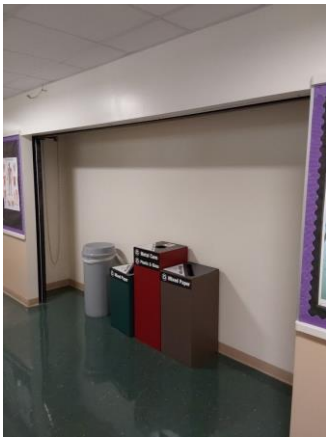
002060a 1/9/2023  
Roll-up fire door  
Room 3202

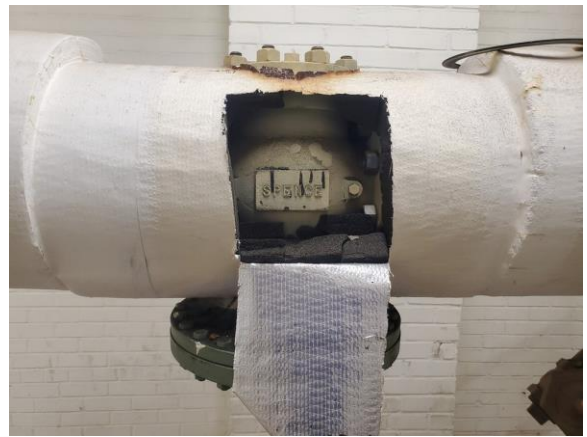
002060e 1/9/2023  
Steam pressure reducing station  
Room 153

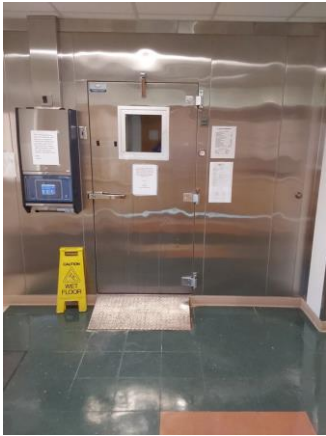
002061a 1/9/2023  
Freezer with adjacent finishes  
Room 3202

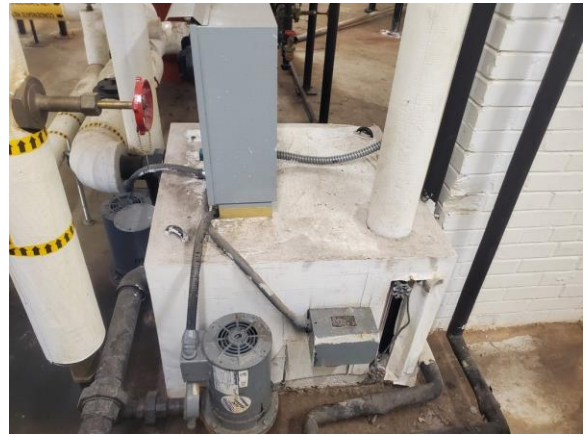
002061e 1/9/2023  
Duplex condensate return system CU-1  
Room 153

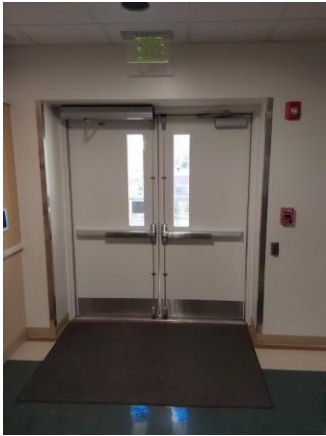
002062a 1/9/2023  
Panic hardware with power door opener  
Room 3202

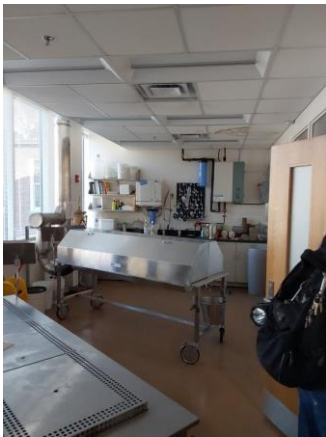
002063a 1/9/2023  
Lab with epoxy flooring and damaged ceiling  
Room 3212

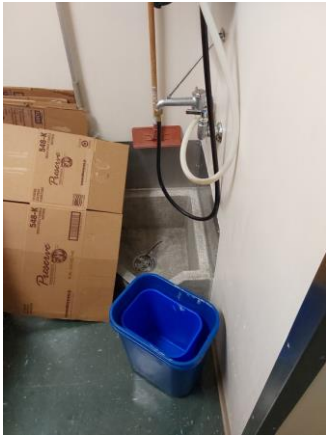
002064a 1/9/2023  
Typical mop sink  
Room 330

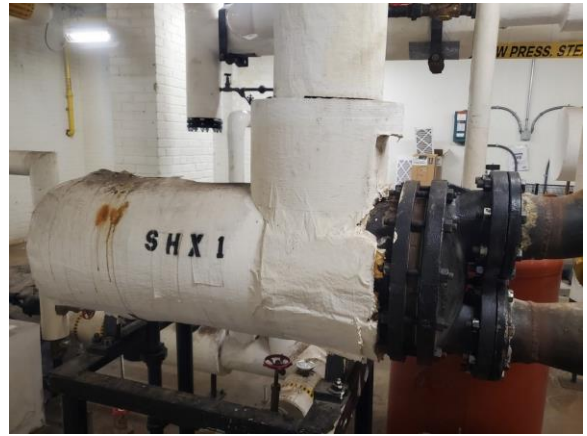
002064e 1/9/2023  
Heating water shell-and-tube heat exchanger  
Room 153

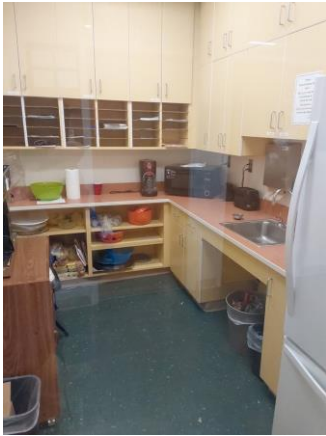
002065a 1/9/2023  
Double wall laminate casework and countertop  
Room 326

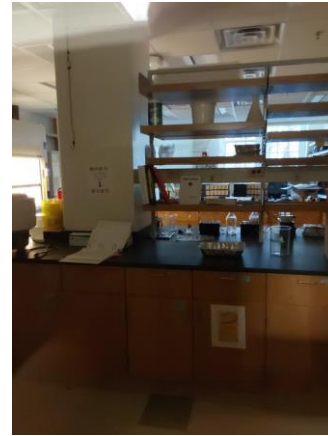
002088a 1/9/2023  
Solid surface lab countertop islands  
Room 178

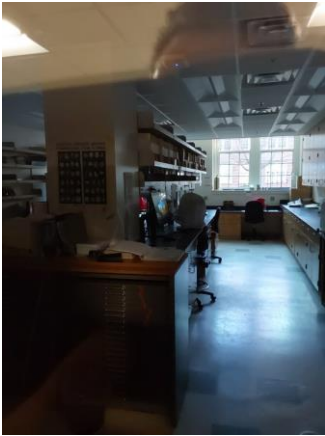
002089a 1/9/2023  
Solid surface lab wall countertop with case work  
Room 184

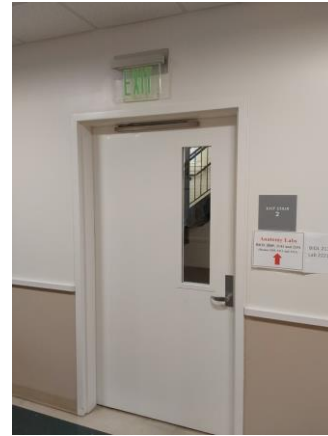
002091a 1/9/2023  
Exit door in need of panic hardware  
Stair 2

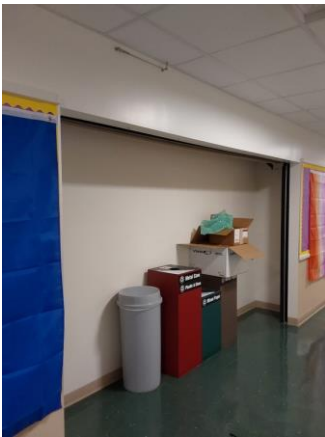
002092a 1/9/2023  
Roll-up overhead door  
Room 1202

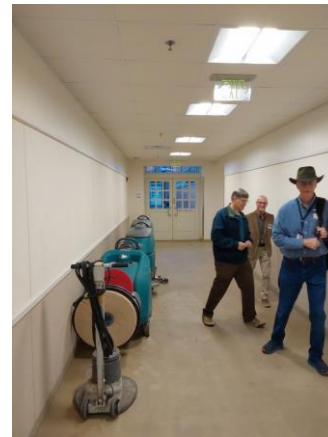
002093a 1/9/2023  
Epoxy floor with acoustic wall covering  
Room 1202

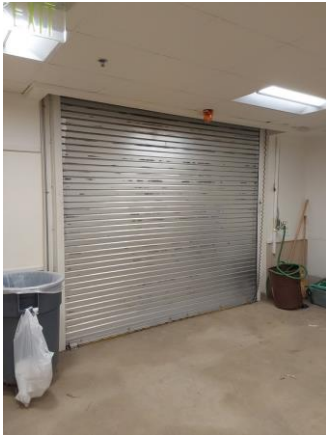
002094a 1/9/2023  
Loading dock overhead door  
Room 107

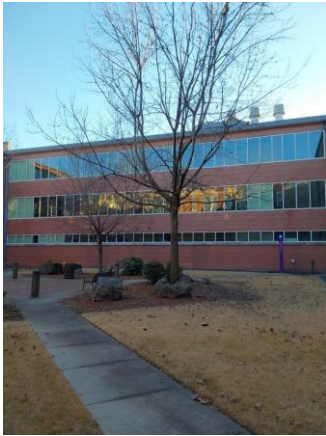
002096a 1/9/2023  
Exterior brick and ribbon glazing  
Inside South wing

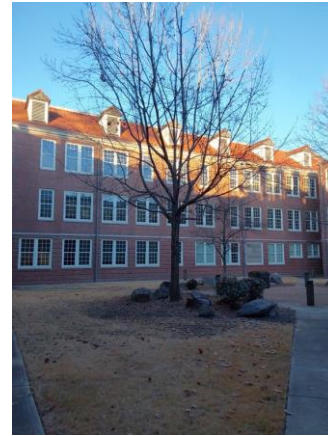
002097a 1/9/2023  
Exterior brick and windows with lower  
Inside north wing

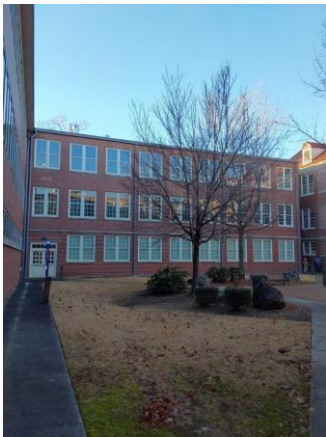
002098a 1/9/2023  
Exterior brick and windows with exterior door  
Inside west wing

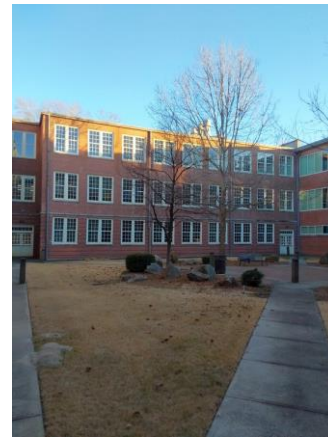
002099a 1/9/2023  
Exterior brick and gutters  
Inside east wing

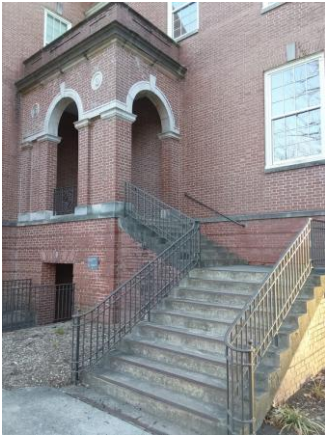
002100a 1/9/2023  
Noncompliant stair rail  
Northwest elevation

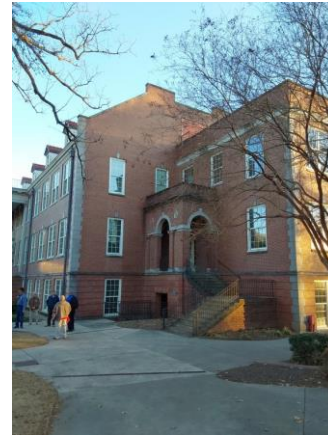
002101a 1/9/2023  
Exterior brick and glazing  
Northwest elevation

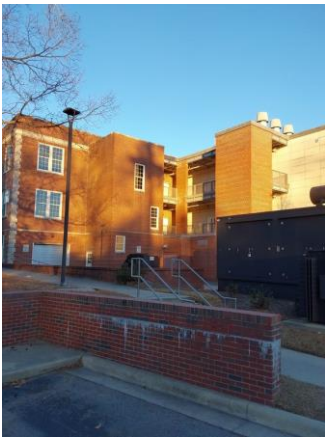
002104a 1/9/2023  
Exterior balconies and brick efflorescence  
Southwest elevation

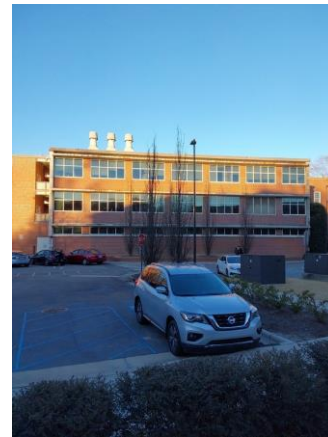
002105a 1/9/2023  
Exterior brick and storefront glazing  
South elevation

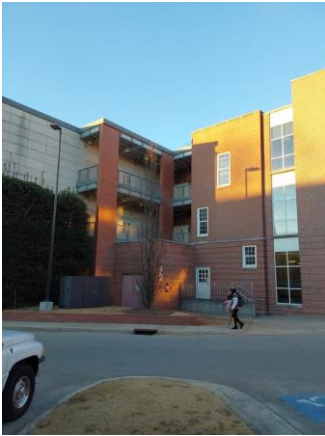
002106a 1/9/2023  
Exterior brick and concrete panel  
Southeast elevation

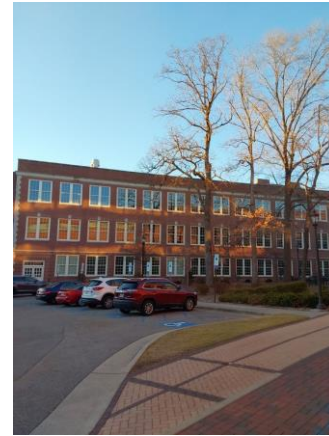
002107a 1/9/2023  
Exterior brick, windows, and ADA entry  
East elevation

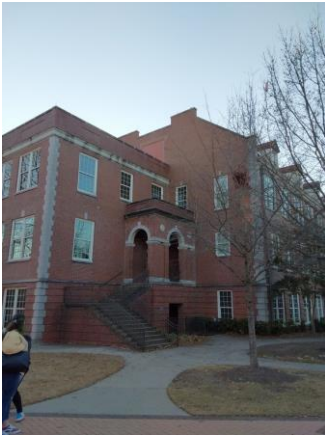
002108a 1/9/2023  
Exterior brick and stone entry  
Northeast elevation

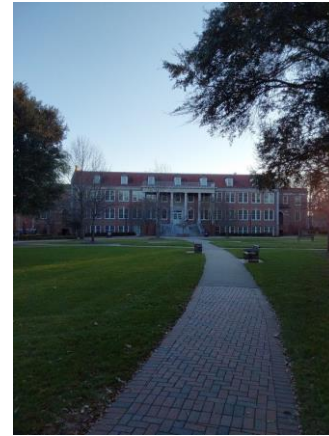
002109a 1/9/2023  
Front approach to main entry  
North elevation

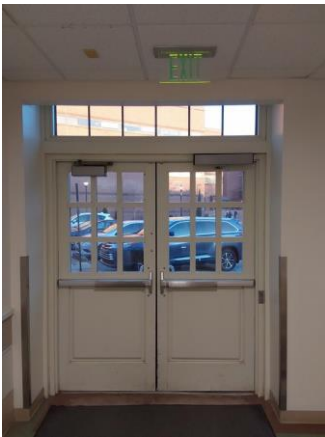
002110a 1/9/2023  
Exit doors with power door operator  
East elevation
