# EAST CAROLINA UNIVERSITY

Facility Condition Assessment

Fletcher Music Center

Inspected January 10, 2023

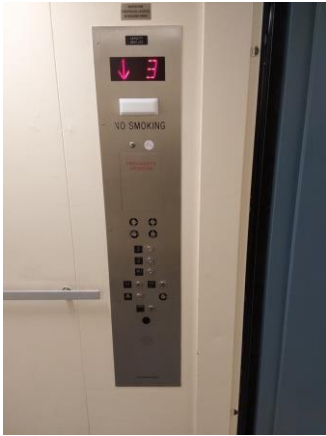
009001a 1/10/2023  
Freight elevator panel  
Room OA399

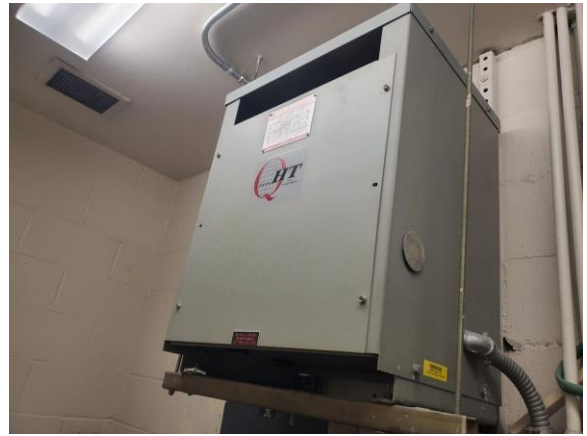
009001e 1/10/2023  
Original dry-type transformer  
Room A380

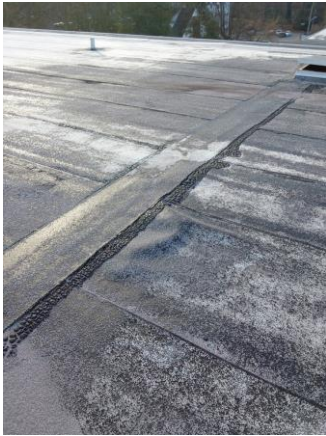
009002a 1/10/2023  
Roof blistering  
Roof

The flat roof structure is covered with a modified bitumen system. Additionally, there are architectural accent shed roofs with flat terracotta tile at the south and west elevations and elevated portions of the older roof with insulated concrete panels. The existing stress conditions around the seams and at the perimeter flashing of the modified bitumen roofs will lead to failure if left unattended. It is recommended that the modified bitumen roofing system on the older portions of the building be replaced with a similar application including the flashing. The newer modified bitumen portion will need replacement in six to eight years. A roof hatch on the older portion of the modified bitumen roof also needs to be replaced.

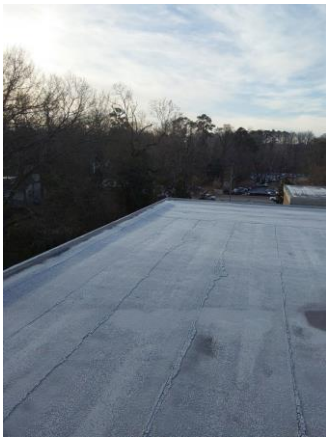
009003a 1/10/2023  
Lack of fall protection on roof perimeter  
Roof

The lack of parapet walls on the older portions of the roof requires the installation of dispersed roof tie-off davits to ensure the safety of workers. Additionally, install compliant guardrails around all of the roof hatches. The roof ladder leading to the stage roof is unprotected by a safety cage. Installation of a safety cage is recommended to ensure worker safety.

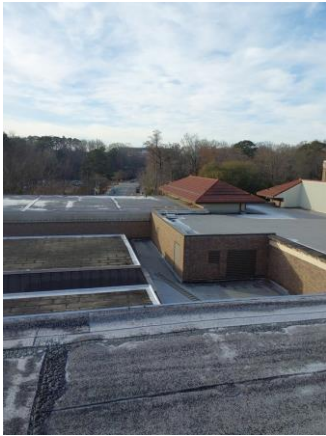
009004a 1/10/2023  
Overall view of roofs  
Roof

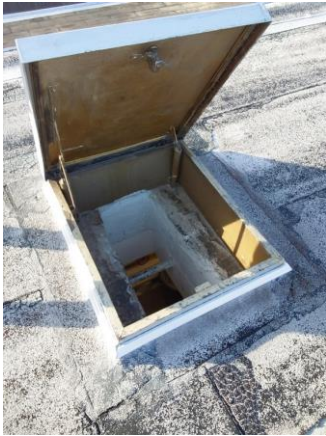
009005a 1/10/2023  
Roof hatch with very small access  
Roof

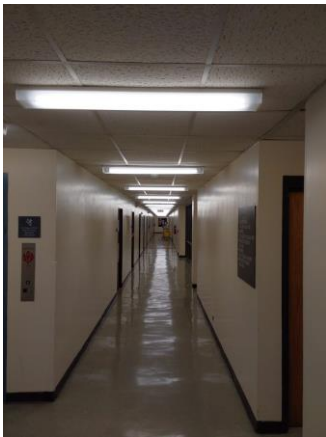
009006a 1/10/2023  
Typical corridor with 9x9 ACT ceiling  
South corridor

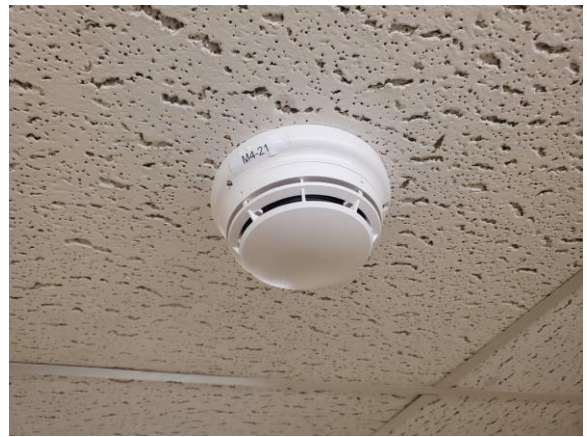
009006e 1/10/2023  
Updated smoke/heat detector  
Third floor corridor

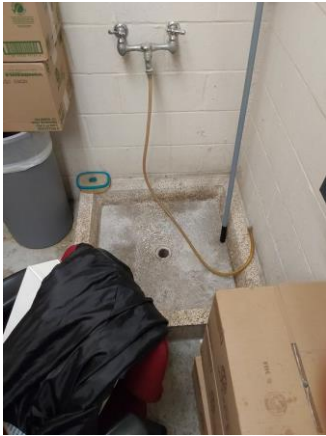
009007a 1/10/2023  
Typical mop sink  
Room OA380

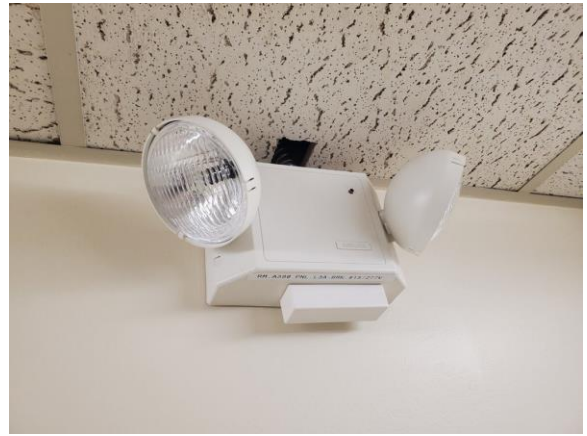
009007e 1/10/2023  
Updated emergency light fixture  
Third floor corridor

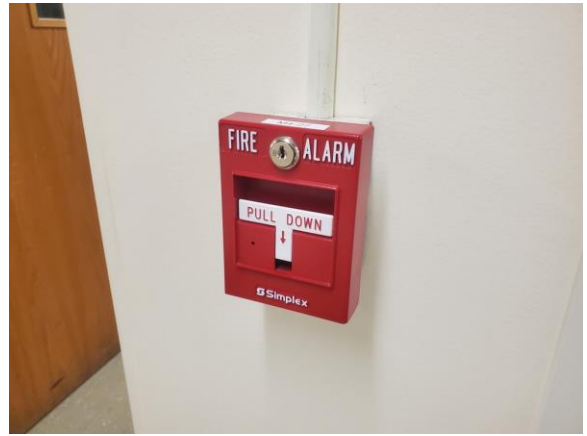
009008e 1/10/2023  
Updated manual fire alarm pull station  
Third floor corridor

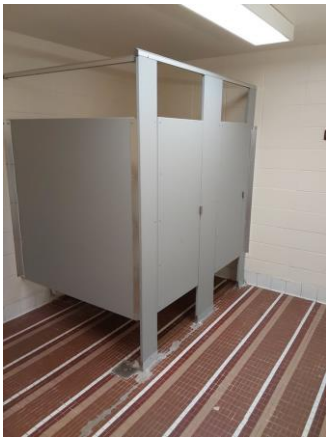
009009a 1/10/2023  
Toilet partitions  
Room OA381

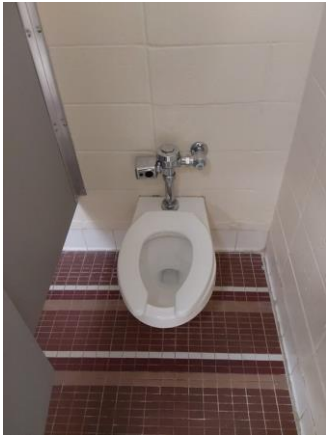
009010a 1/10/2023  
Typical water closet  
Room OA381

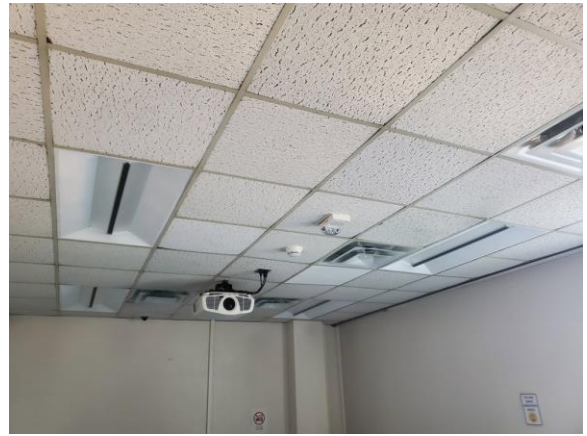
009010e 1/10/2023  
Overview of classroom and office lighting  
Room A300

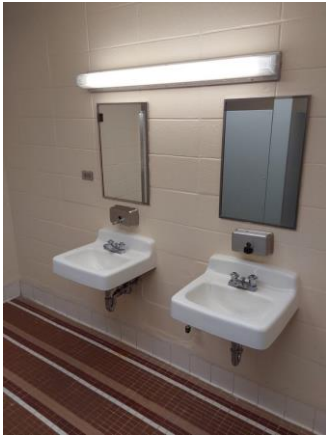
009011a 1/10/2023  
Noncompliant wall-hung lavatories  
Room OA381

The men's and women's restrooms on the second and third floors are partially ADA compliant, and the new set of restrooms on the first floor outside the recital hall is fully ADA compliant. The overall level of restroom accessibility is fair, but short of full compliance with modern accessibility legislation. The restrooms in the north wing of the building require a complete remodel of existing stalls and fixtures. Installation of power door operators is also recommended, along with ADA-compliant signage.

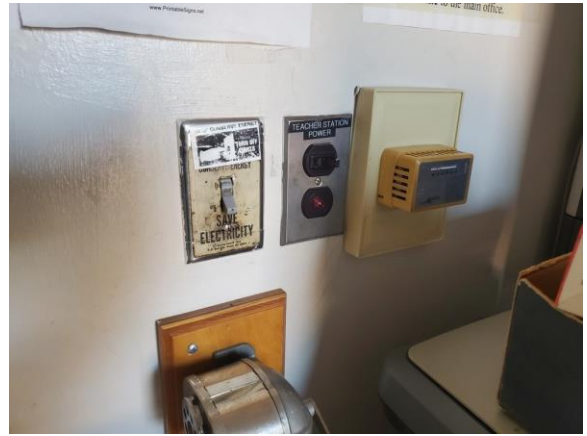
009011e 1/10/2023  
Original light switch, outlet, and aged thermostat  
Room A300

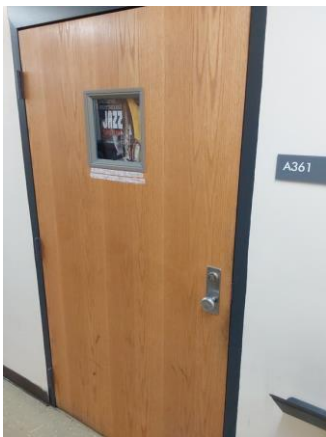
009012a 1/10/2023  
Typical office door with knob hardware  
Room OA361

There are a number of single-level drinking fountains on each floor that are a barrier to accessibility. All single-level drinking fountains should be replaced with dual-level, refrigerated units. Many of the interior doors have older knob hardware which is a barrier to accessibility. It is recommended that all knob hardware be replaced with lever actuated hardware.

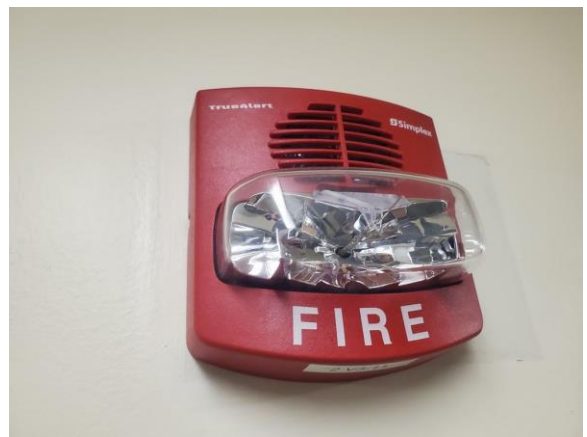
009012e 1/10/2023  
Updated fire alarm notifier  
Third floor corridor

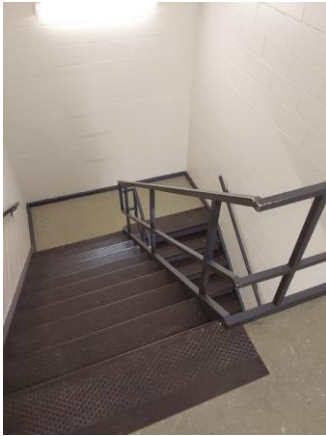
009013a 1/10/2023  
Stair tower railing with noncompliant guardrail  
Southeast stair tower

The stairs have older rubber treads and painted metal railing and the tread finishes on the fire stairs are old and do not have the proper gripping ability for safety. Current accessibility legislation requires that stairs have graspable handrails on both sides, that the rails have a specific end geometry, and that the handrails continue horizontally at the landings. In addition, guardrails must prevent the passage of a four-inch diameter sphere (six inches in the triangle formed by the lower rail and tread/riser angle). The stair railing systems should be replaced and treads upgraded. Additionally, the stage stairs and the loading area stairs do not have proper handrails on either side. It is recommended that compliant handrails and guardrails be installed in these areas.

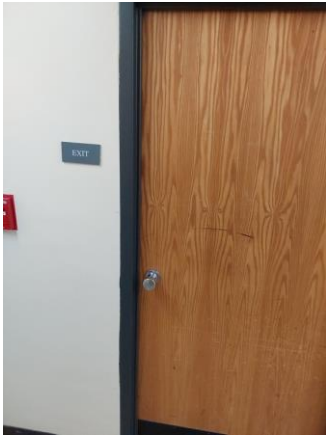
009014a 1/10/2023  
Stair tower with noncompliant exit door  
Southeast stair tower

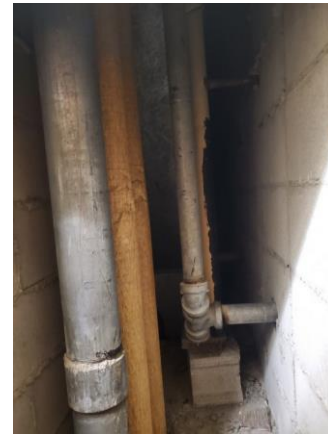
009014e 1/10/2023  
Original supply and waste piping systems  
Third floor pipe chase

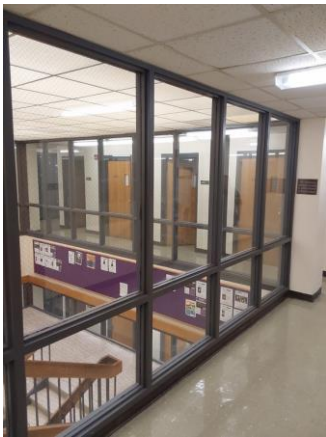
009015a 1/10/2023  
Safety glass adjacent to corridor  
Central stair

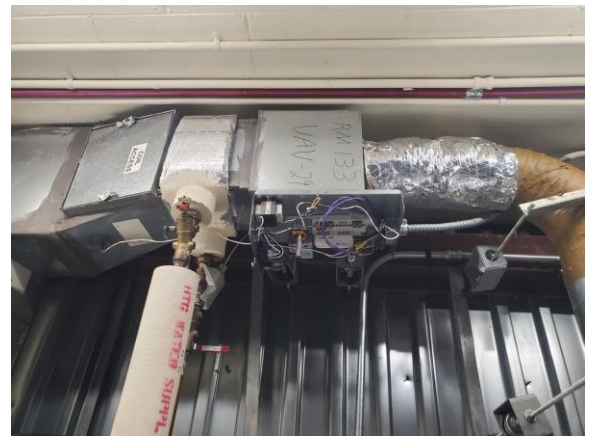
009015e 1/10/2023  
VAV terminal assembly  
Mechanical B135

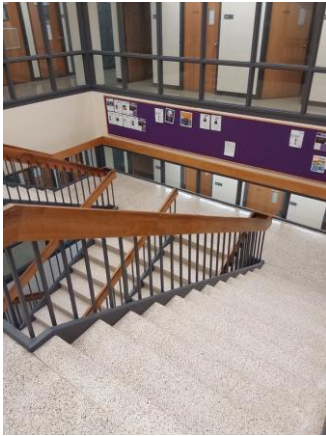
009016a 1/10/2023  
Noncompliant stair railing with missing handrail  
Central stair

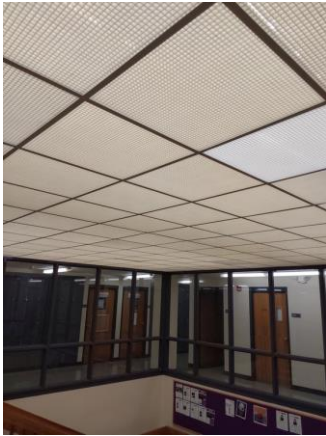
009017a 1/10/2023  
Honeycomb light diffusers above central stair  
Central stair

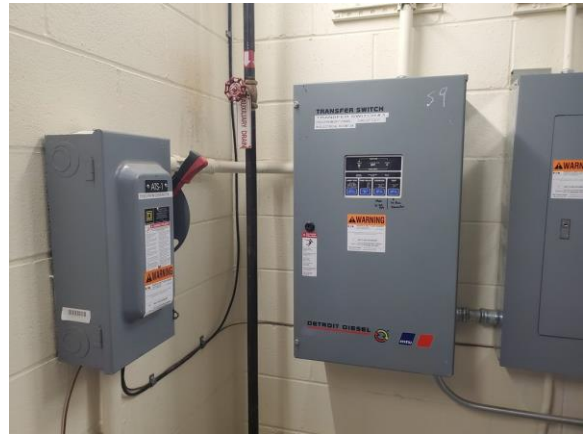
009017e 1/10/2023  
Automatic transfer switch 1  
Mechanical B135

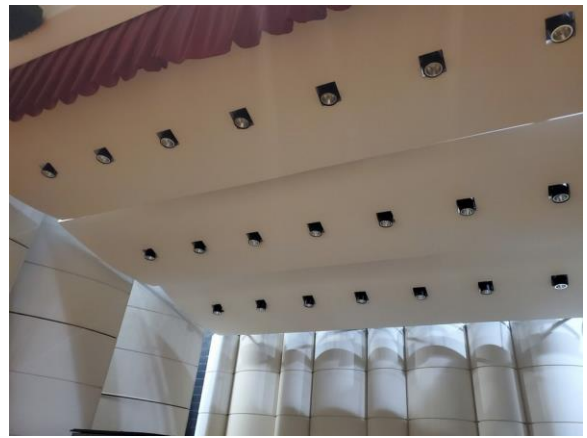
009038e 1/10/2023  
Overview of stage lighting  
Stage 107A

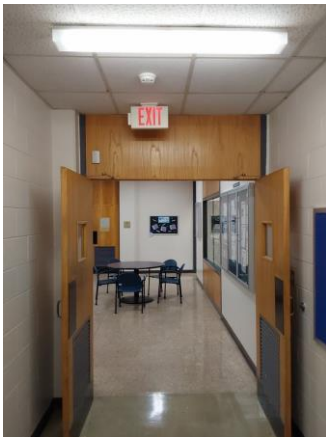
009039a 1/10/2023  
Noncompliant exit doors with safety glass  
Room 101

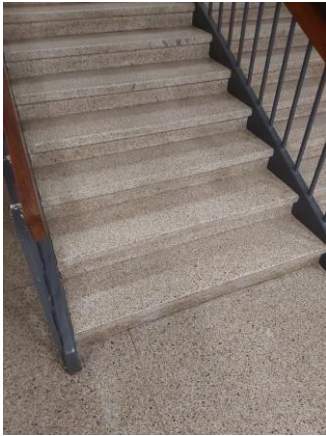
009040a 1/10/2023  
Central stair without tread finish  
Room 101

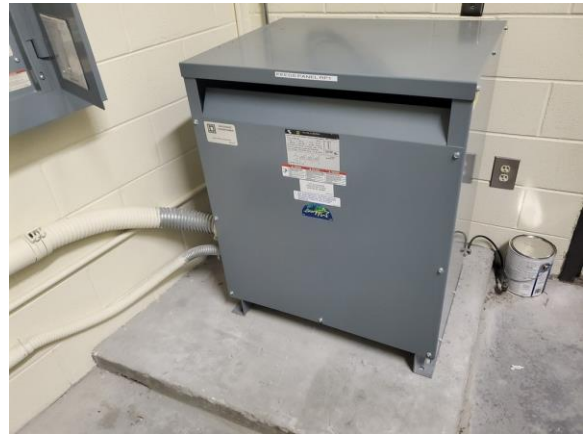
009040e 1/10/2023  
Circa 2006 dry type transformer  
Electric B134

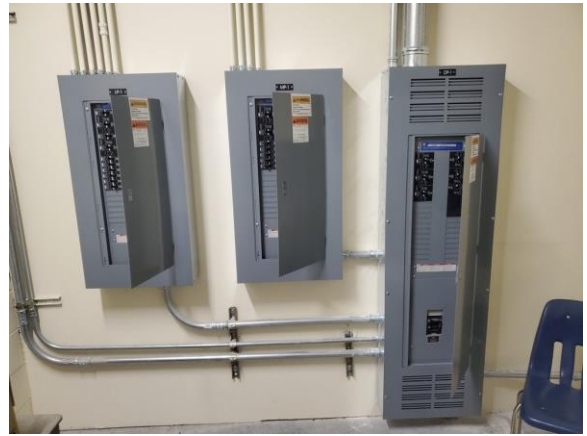
009041e 1/10/2023  
Circa 2006 electrical panelboards  
Electric B134

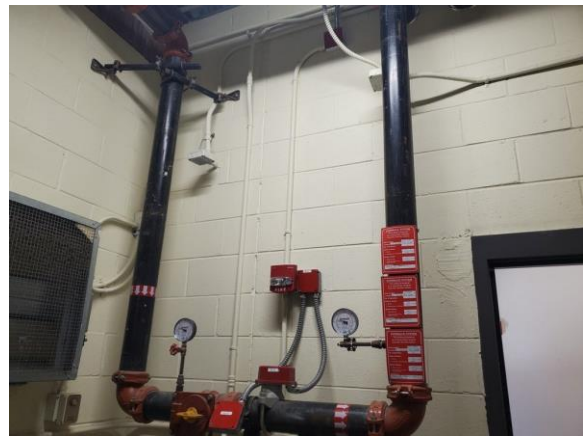
009042e 1/10/2023  
Fire suppression system riser for 2006 addition  
Fire Pump room B132

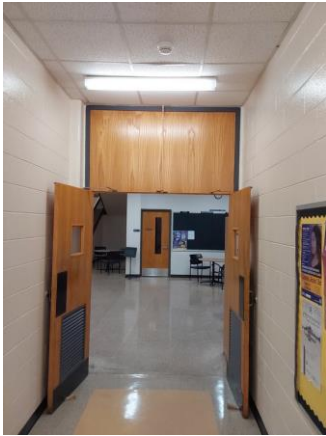
009043a 1/10/2023  
Corridor exit doors without safety glass  
Room 101

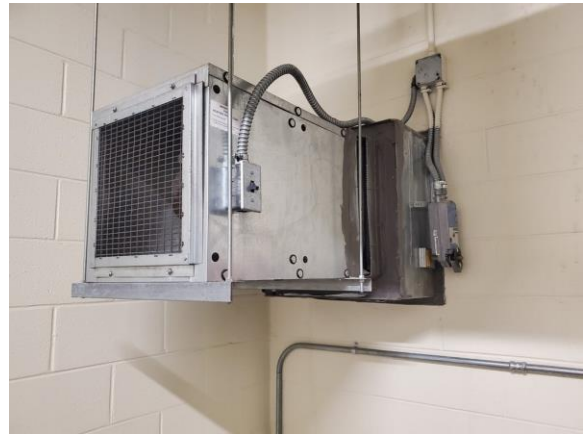
009043e 1/10/2023  
Through-wall exhaust fan  
Fire Pump room B132

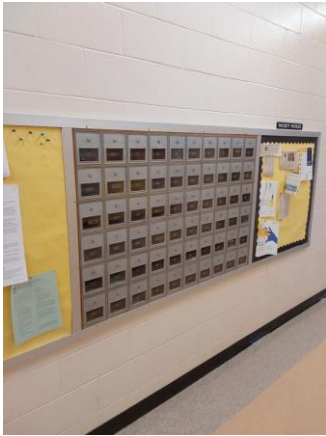
009044a 1/10/2023  
Pass through mailboxes on corridor wall  
Room OA118

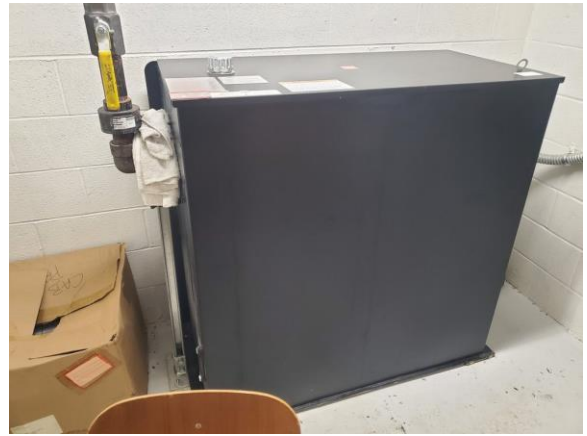
009044e 1/10/2023  
Hydraulic elevator machine  
Elevator A126

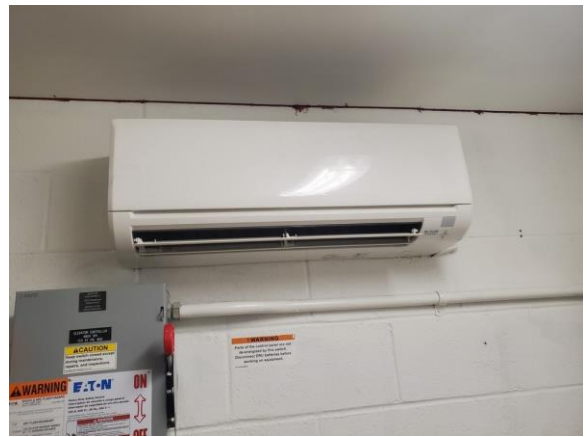
009045e 1/10/2023  
Split system blower assembly  
Elevator A126

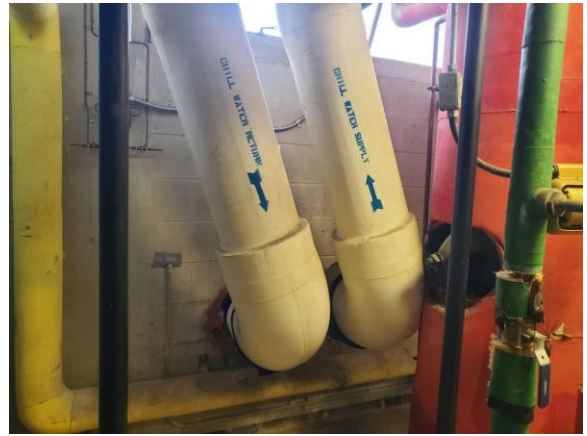
009046e 1/10/2023  
Main chilled water from utility system  
Mechanical 124

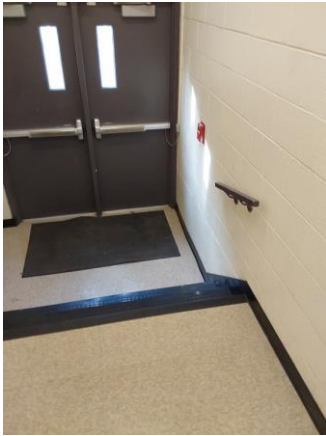
009047a 1/10/2023  
Noncompliant stair railing  
Room 114

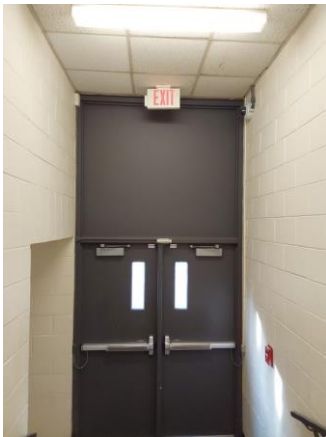
009048a 1/10/2023  
Exit door showing panic hardware  
Room 114

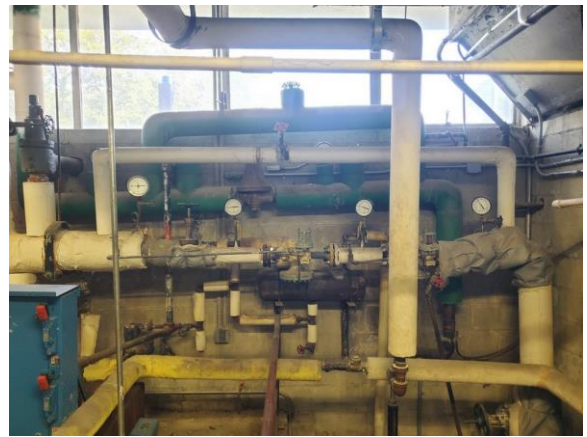
009048e 1/10/2023  
Steam pressure reducing station and relief valve  
Mechanical 124

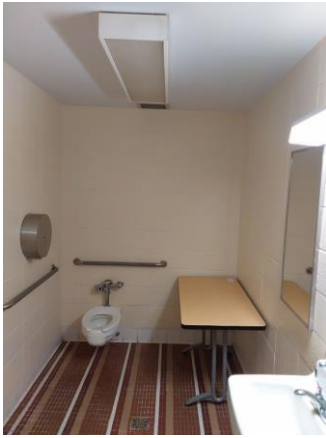
009049a 1/10/2023  
Typical single-user restroom  
Room OC116A

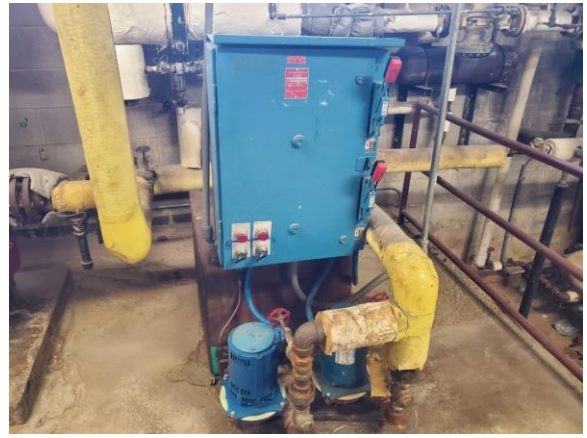
009049e 1/10/2023  
Duplex condensate return system  
Mechanical 124

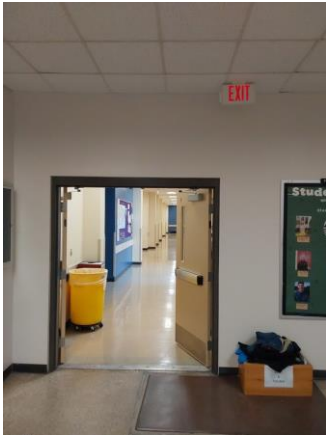
009050a 1/10/2023  
Fire exit door with inset panic hardware  
Room 101

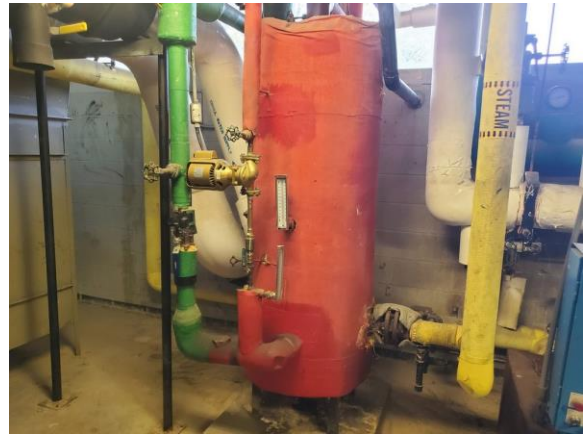
009050e 1/10/2023  
Aged steam to water domestic water heater and pump  
Mechanical 124

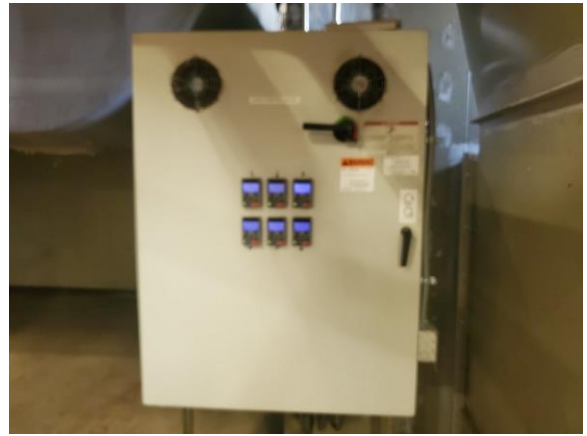
009052e 1/10/2023  
VFDs for AHU-2 fan wall system  
Mechanical 124

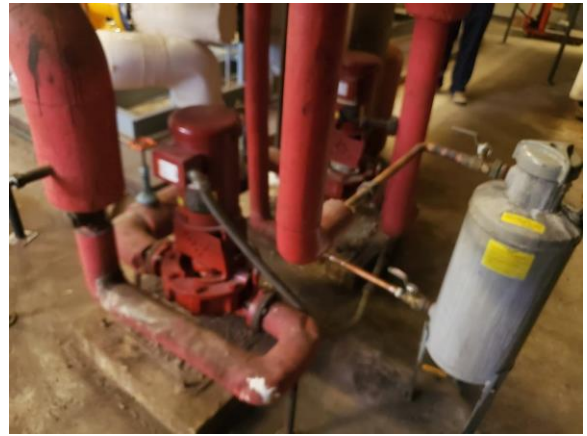
009053e 1/10/2023  
Heating water supply pumps  
Mechanical 124

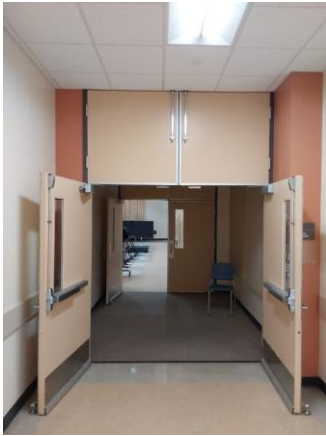
009055a 1/10/2023  
Double egress doors with panic hardware  
Room OB110

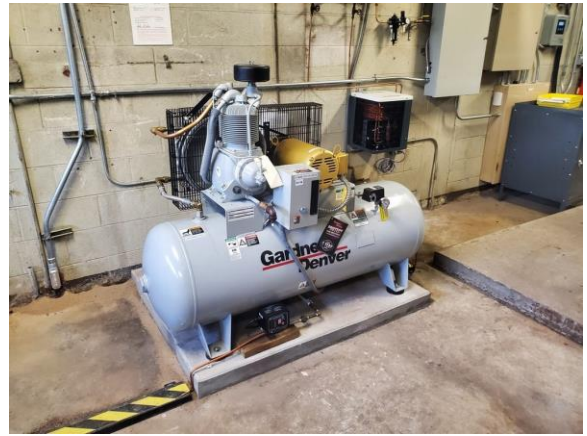
009055e 1/10/2023  
Reciprocating air compressor and dryer for control system  
Mechanical 124

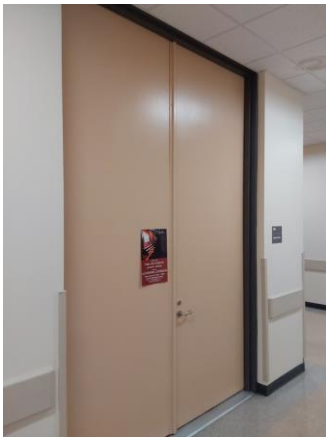
009056a 1/10/2023  
Full height doors  
Room OB115

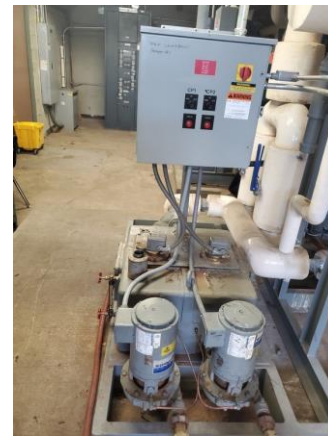
009056e 1/10/2023  
Duplex condensate return system  
Mechanical 124

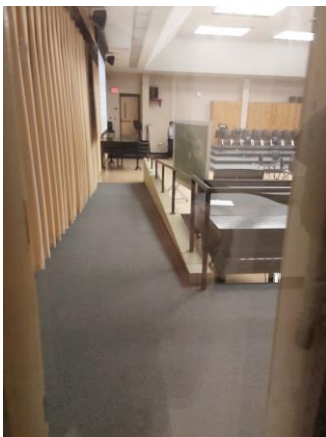
009057a 1/10/2023  
Wheelchair ramp in music classroom  
Room OB136

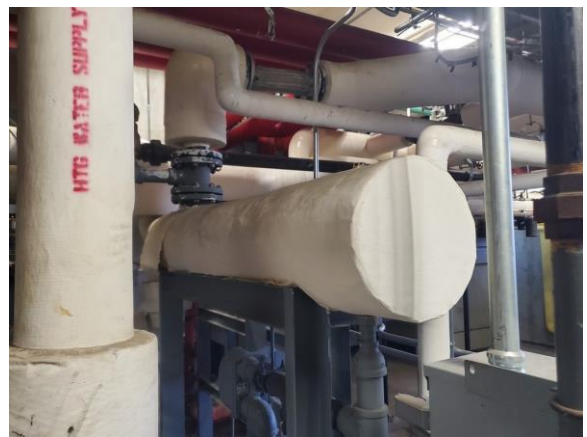
009057e 1/10/2023  
Heating water shell-and-tube heat exchanger  
Mechanical 124

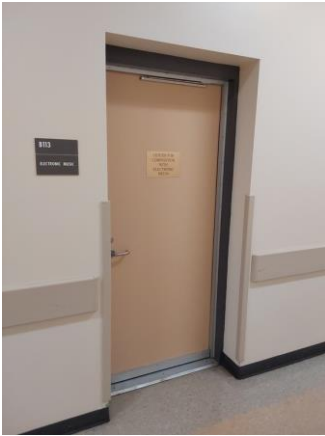
009058a 1/10/2023  
Music room with sealed threshold and frame  
Room OB113

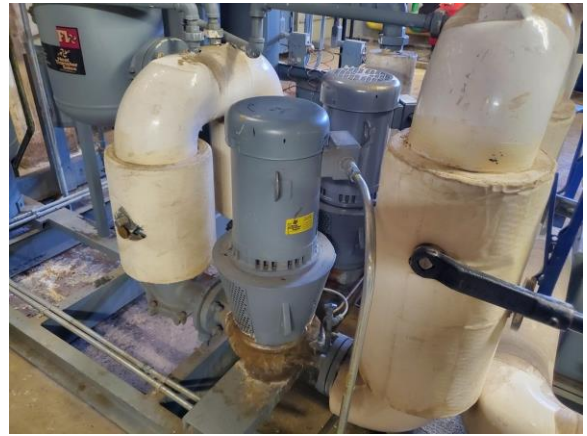
009058e 1/10/2023  
Heating water supply pumps  
Mechanical 124

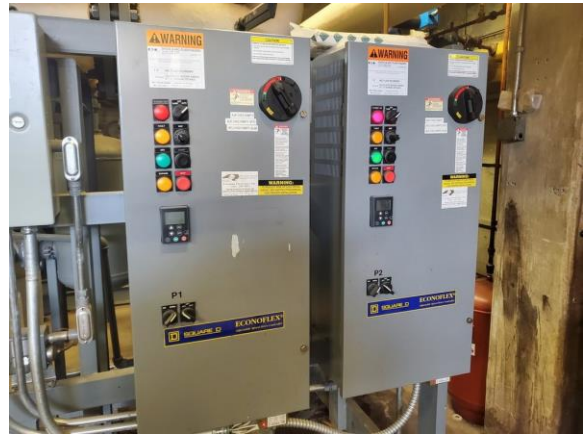
009059e 1/10/2023  
HW pump variable speed drives  
Mechanical 124

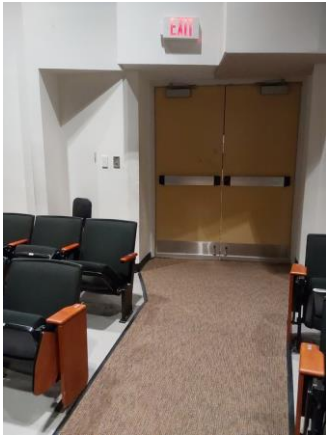
009083a 1/10/2023  
ADA-compliant seat in back of auditorium  
Room OC107

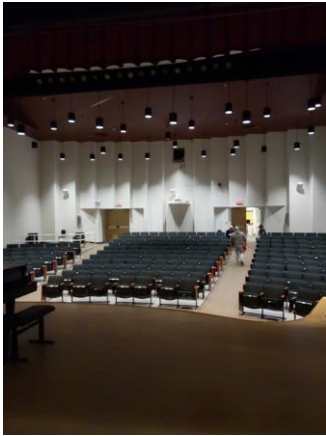
009085a 1/10/2023  
ADA-compliant seat in front of auditorium  
Room OC107

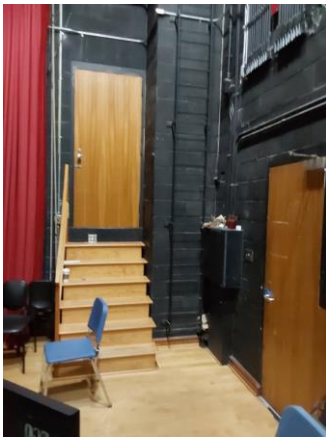
009087a 1/10/2023  
Backstage stairs  
Room OC107

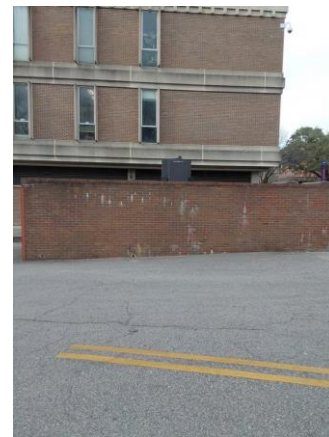
009100a 1/10/2023  
Exterior brick, stone, and glazing  
East elevation

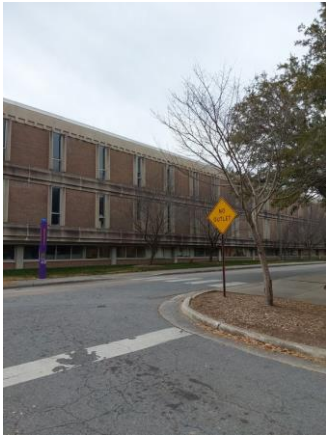
009101a 1/10/2023  
Efflorescence on brick  
East elevation

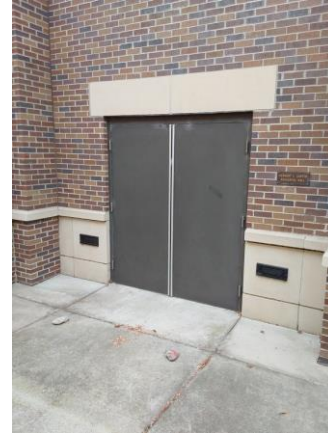
009108a 1/10/2023  
Hollow-metal door the safety glass  
West elevation

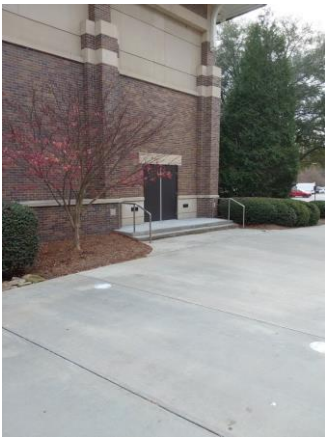
009111a 1/10/2023  
Addition west elevation  
West elevation

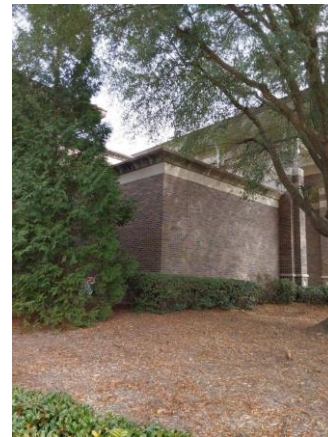
009112a 1/10/2023  
Hollow-metal door west elevation  
West elevation

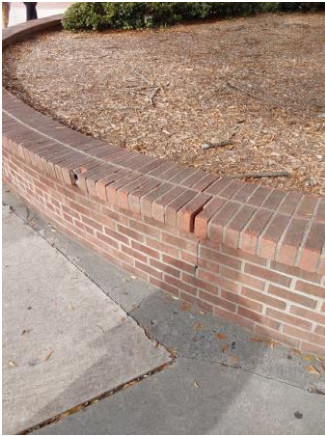
009113a 1/10/2023  
Northwest corner brick and eave  
Southwest elevation

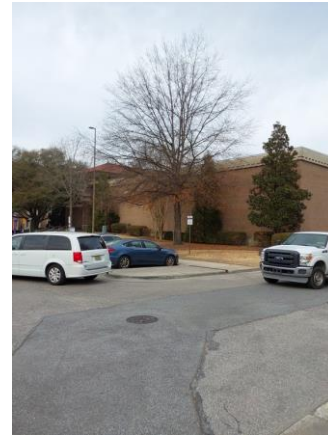
009116a 1/10/2023  
Dirty elevation awning  
South elevation

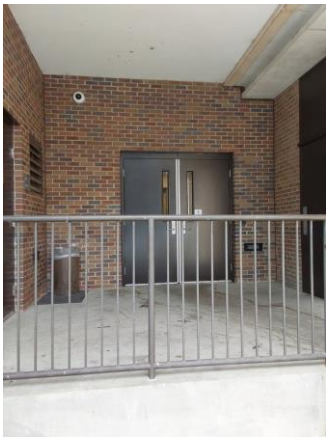
009123a 1/10/2023  
Hollow-metal doors at loading dock  
East elevation

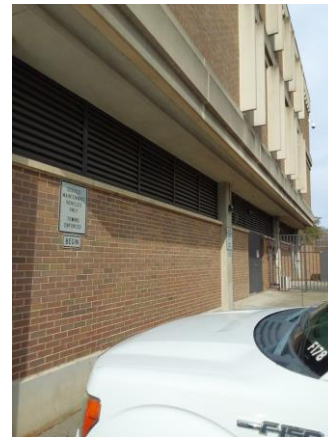
009124a 1/10/2023  
Exterior hollow-metal doors  
East elevation
