EAST CAROLINA UNIVERSITY

Facility Condition Assessment

Joyner East

Inspected January 12, 2023

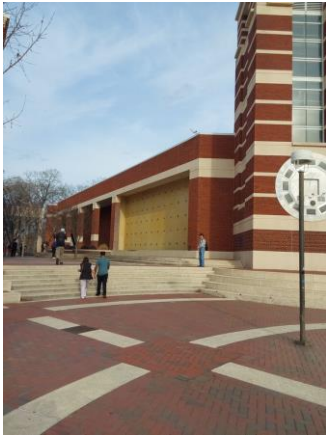
001A001a 1/12/2023
Water wall and brick pavers
West elevation

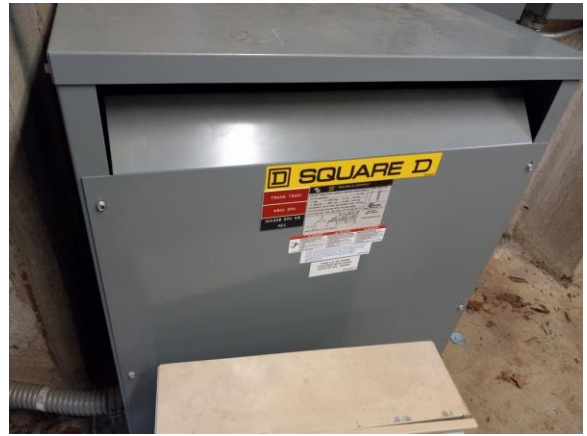
001A001e 1/12/2023
150-kVA dry-type transformer TDAS1
Room B01

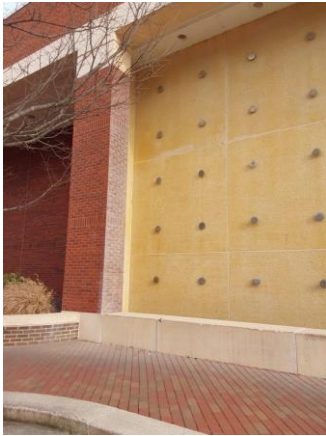
001A002a 1/12/2023
Water stains on wall
West elevation

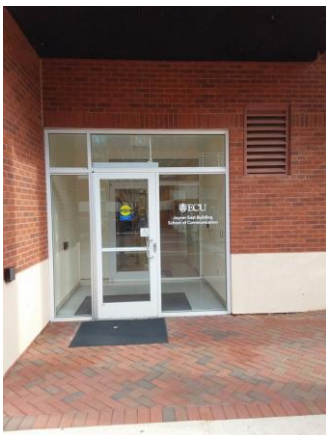
001A003a 1/12/2023
Exterior door power operator
West elevation

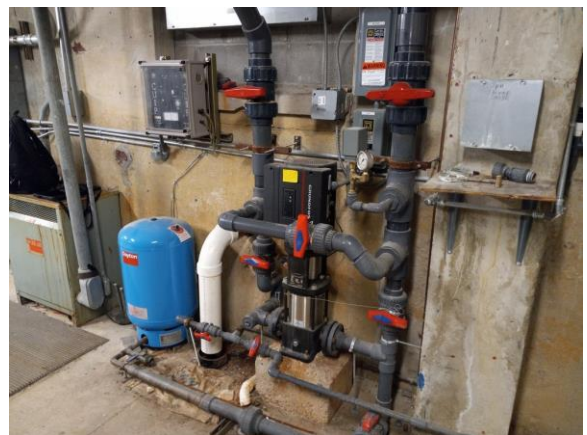
001A003e 1/12/2023
Water wall feature pump skid
Room B01

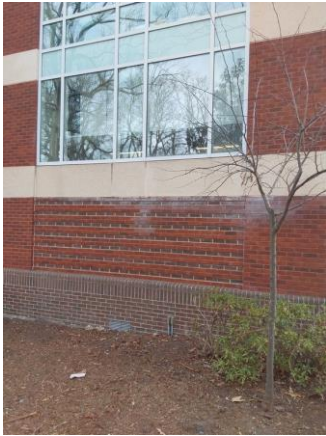
A portion of the brick joints show signs of wear and are recommended for near-term repointing with the remainder of the building being due for repointing within ten years. The white metal siding on the interior overlook walls of the basement roof will be due for joint restoration within ten years. Both the brick and metal siding have visible deposits. The brick will require a light chemical treatment and power washing to remove efflorescence and the siding will require power washing to remove grime.

001A004a 1/12/2023
Brick efflorescence
North elevation

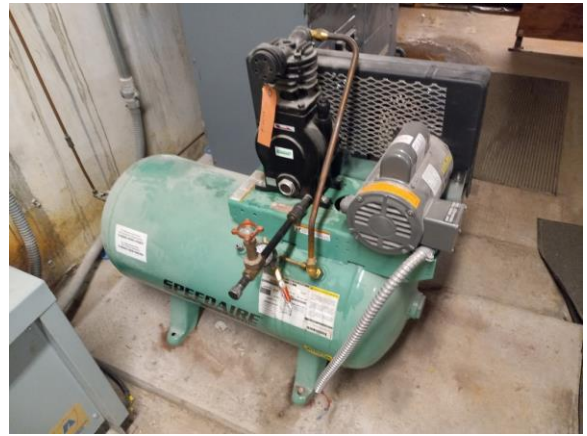
001A005e 1/12/2023
Air compressor
Room B01

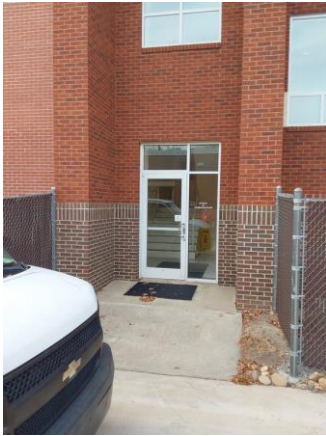
001A007a 1/12/2023
Exterior powder-coated aluminum door
East elevation

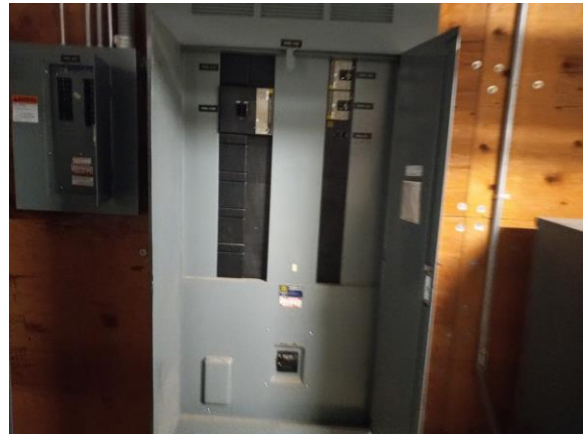
001A007e 1/12/2023
600-amp panelboard LPB5
Room B01

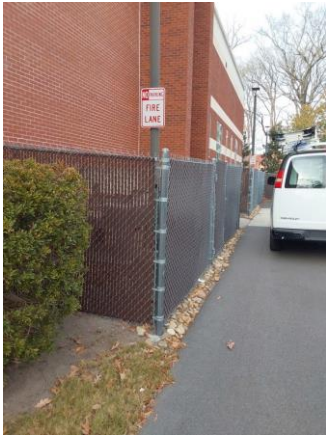
001A008a 1/12/2023
Exterior chain link fence
East elevation

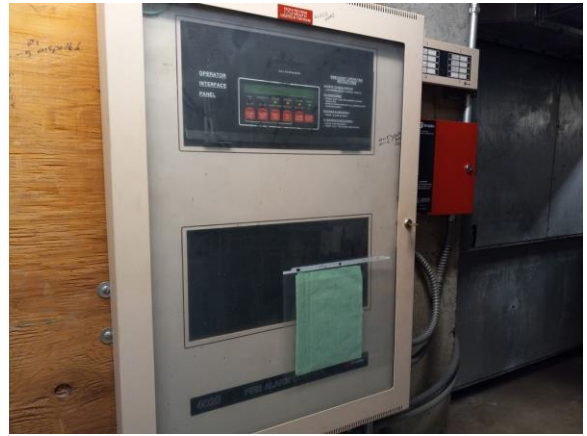
some systematic renewal of select notifiers and smoke detectors occurred in 2020. While the system is serviceable, the main FACP and 1997 vintage devices are recommended for renewal due to age.

001A008e 1/12/2023
Fire alarm control panel
Room B01

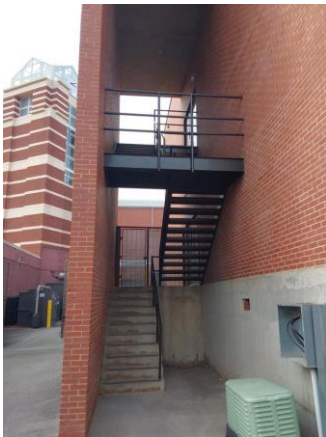
001A009a 1/12/2023
Exterior fire stair without handrail
South elevation

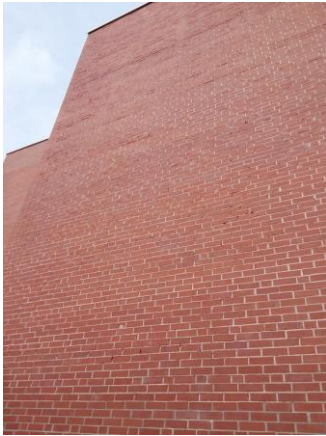
001A010a 1/12/2023
Brick deterioration on south facing wall
South elevation

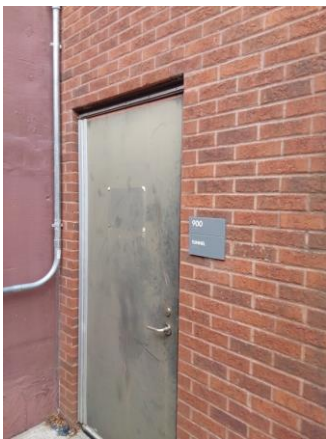
001A012a 1/12/2023
Exterior tunnel door
South elevation

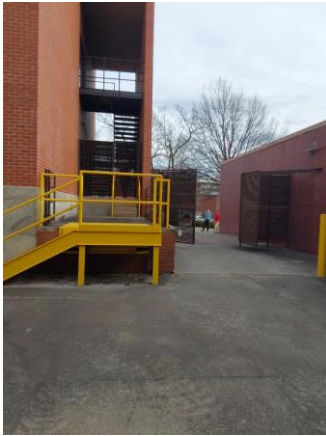
001A013a 1/12/2023
Exterior gates and stair
South elevation

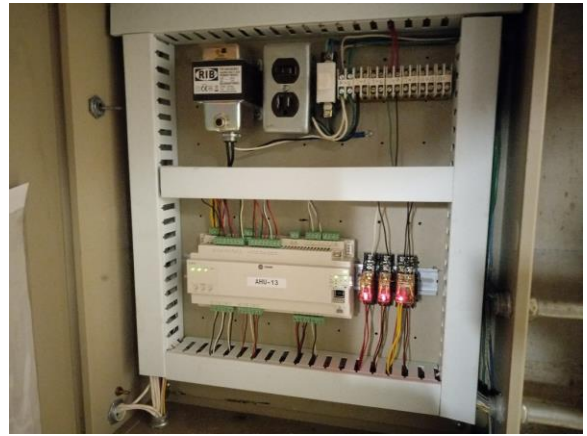
001A013e 1/12/2023
Modernized controls
Room B01

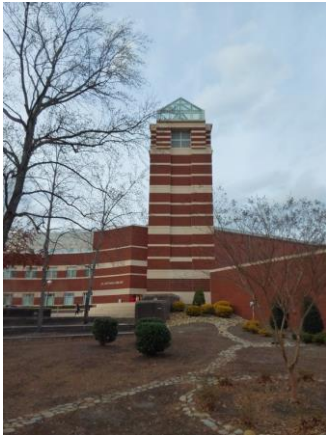
001A014a 1/12/2023
Clock tower with glazing and brick
Southeast elevation

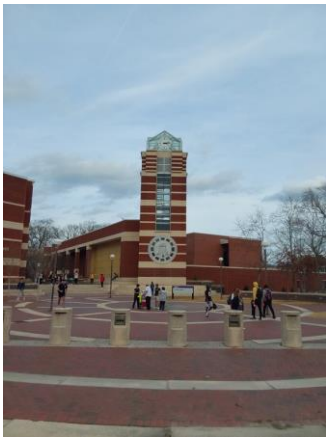
001A015a 1/12/2023
Clock tower glazing and brick
Southwest elevation

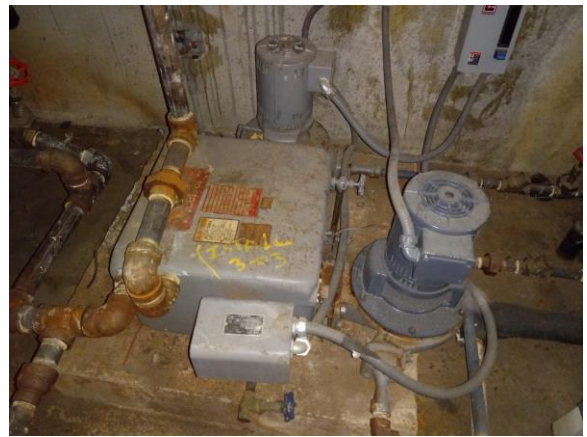
001A015e 1/12/2023
Duplex condensate return unit
Room B01

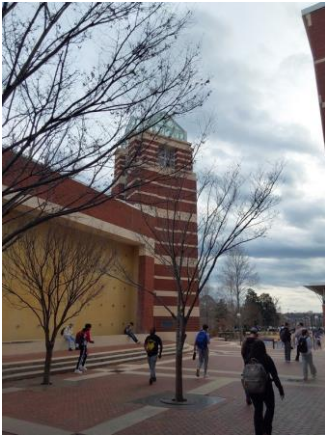
001A016a 1/12/2023
Clock tower glazing and brick
Northwest elevation

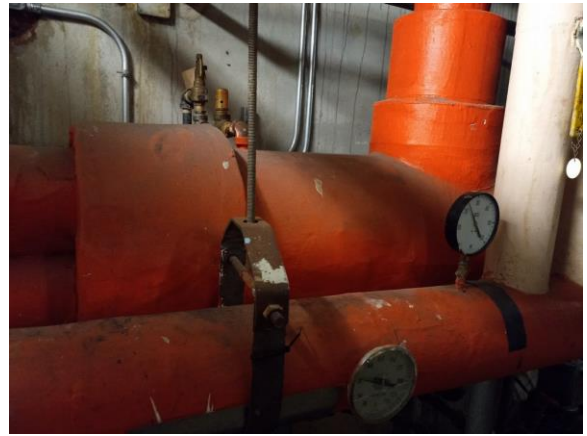
001A016e 1/12/2023
Shell and tube heat exchanger
Room B01

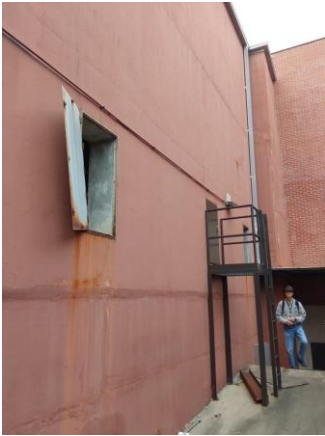
001A017a 1/12/2023
Replace water wall doors
West wall

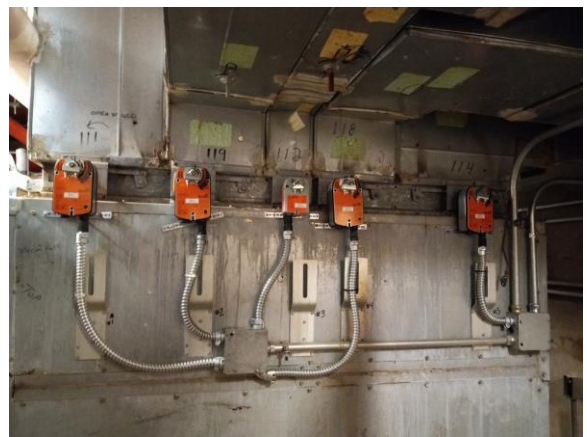
001A018e 1/12/2023
Updated controls on air handler AHU-16
Room B01

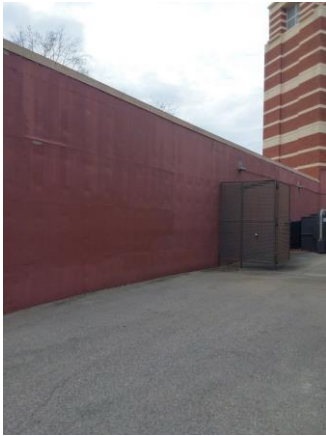
001A019a 1/12/2023
Back of south mechanical wall
South wall

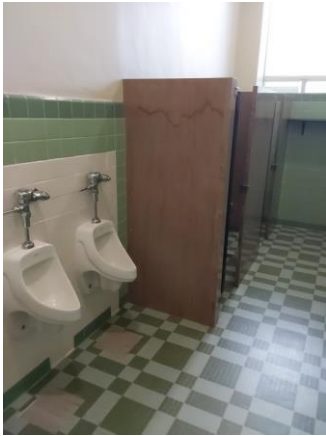
001A065a 1/12/2023
Men's restroom double doors too close
Room 108a

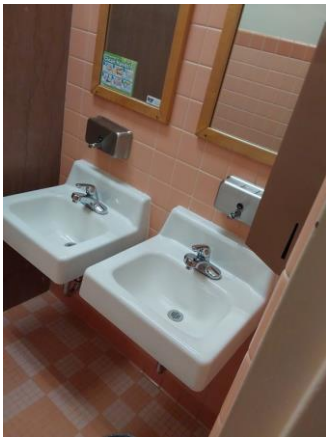
001A070a 1/12/2023
Wall-hung lavatories
Room 108B

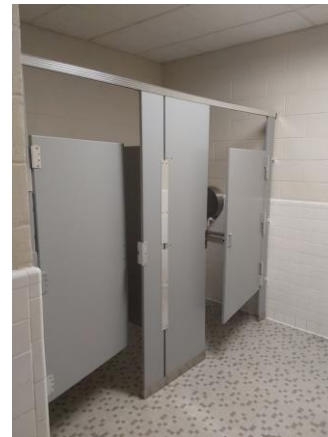
001A071a 1/12/2023
Plastic partitions
Room 109B

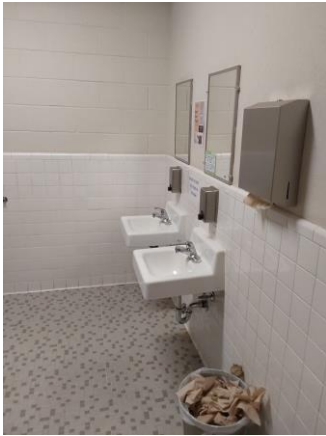
001A072a 1/12/2023
Wall-hung lavatories
Room 109B

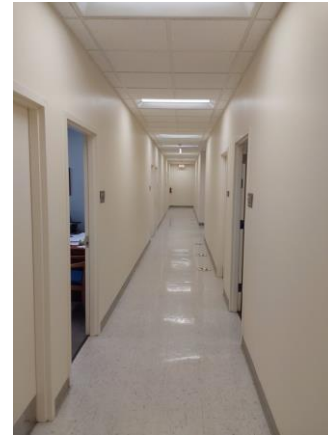
001A073a 1/12/2023
Lever hardware
First floor south corridor

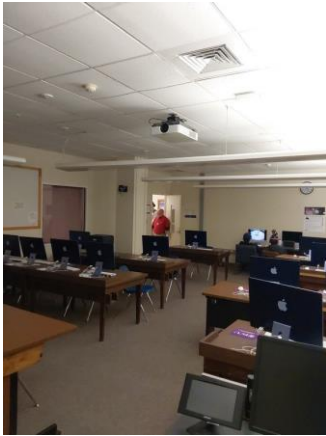
001A074a 1/12/2023
Computer lab finishes
Room 118
