EAST CAROLINA UNIVERSITY

Facility Condition Assessment

McGinnis Auditorium

Inspected January 10, 2023

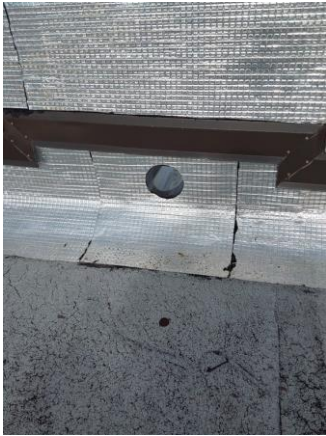
033001a 1/10/2023
Overflow scupper of stage roof
Stage roof

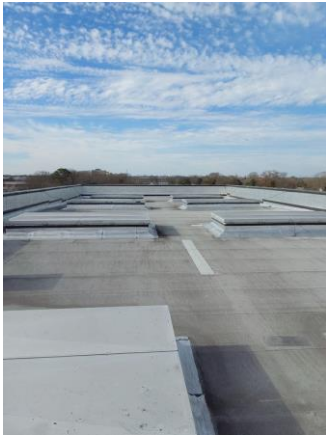
033002a 1/10/2023
Roof photo showing smoke vents
Stage roof

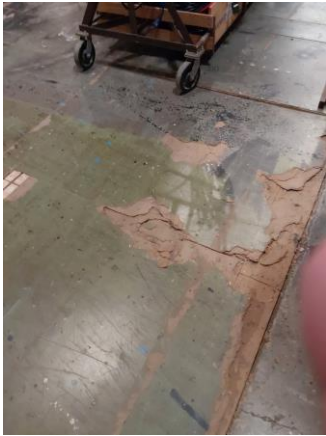
033004a 1/10/2023
Deteriorating stage floor
Room 209

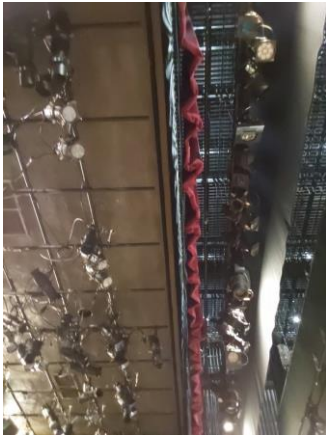
033005a 1/10/2023
Stage fire curtain
Room 209

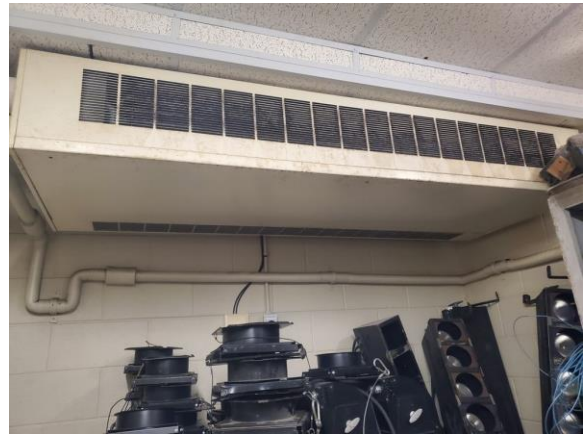
033005e 1/10/2023
Fan coil F-3
Dimmer room 214

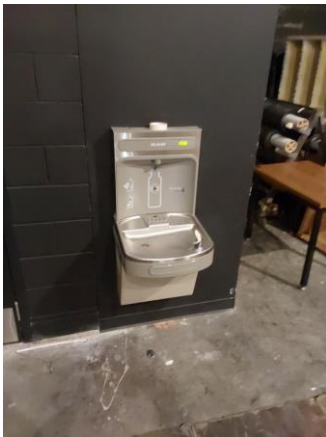
There are five single-level drinking fountains on the first and second floors of the building. The single-level drinking fountain configuration is a barrier to accessibility and all single-level drinking fountains should be replaced with dual-level, refrigerated units.

033006a 1/10/2023
Single water fountain
Room 209

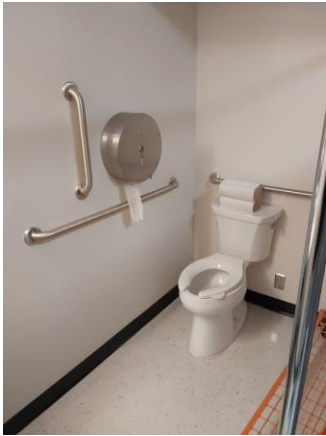
033007a 1/10/2023
Dressing room water closet
Room 210

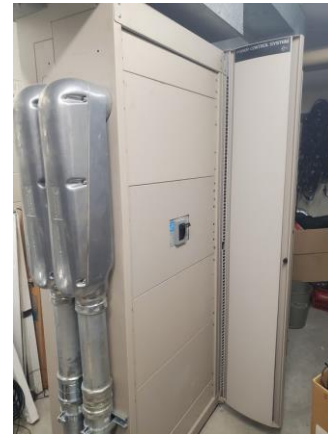
033007e 1/10/2023
800-amp dimmer panel
Dimmer room 214

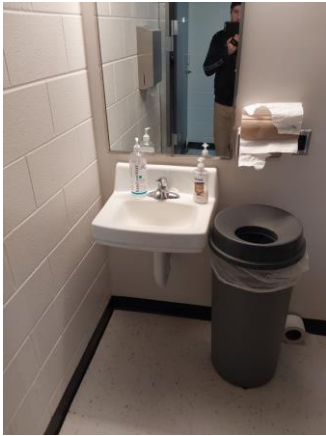
033008a 1/10/2023
Dressing room sink
Room 213

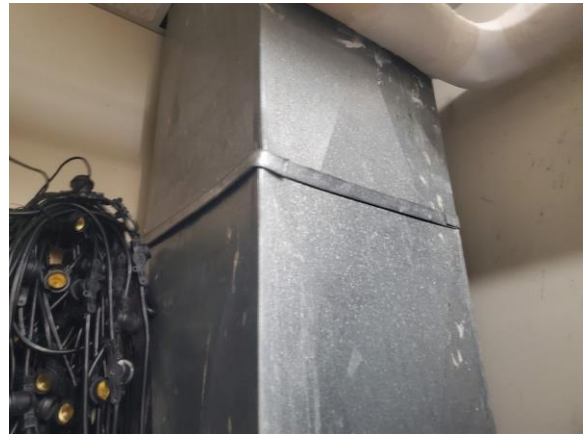
033008e 1/10/2023
Metal HVAC ductwork
Dimmer room 214

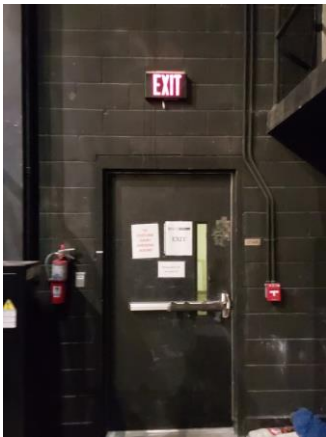
033009a 1/10/2023
Exit door with signage, panic hardware, and safety glass
Room 209

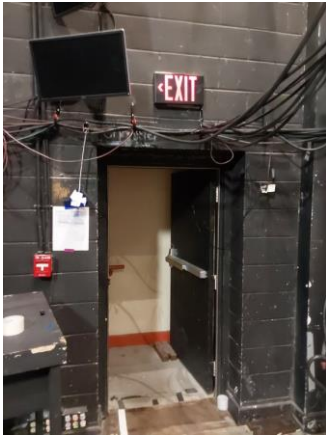
033010a 1/10/2023
Exit door with typical panic hardware and signage
Room 209

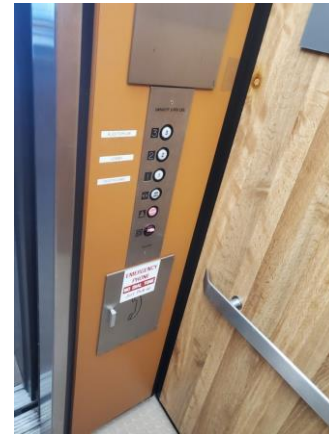
Inside the building, an elevator serves the first and second floors. However, the control systems are devoid of accessible features. It is recommended that the elevator controls be upgraded with a package consisting of a hands-free two-way telephone, Braille signage, and audible signals.

033011e 1/10/2023
Passenger elevator controls
Elevator

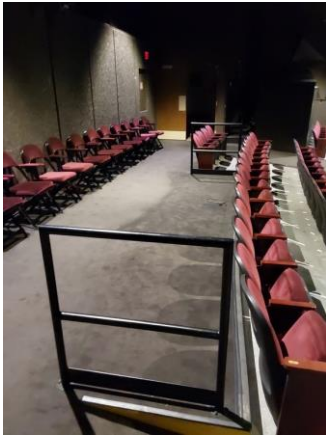
033013a 1/10/2023
Auditorium wheelchair zone
Room 209

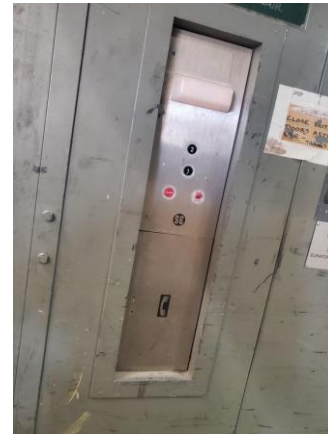
033014e 1/10/2023
Freight elevator control
Freight elevator

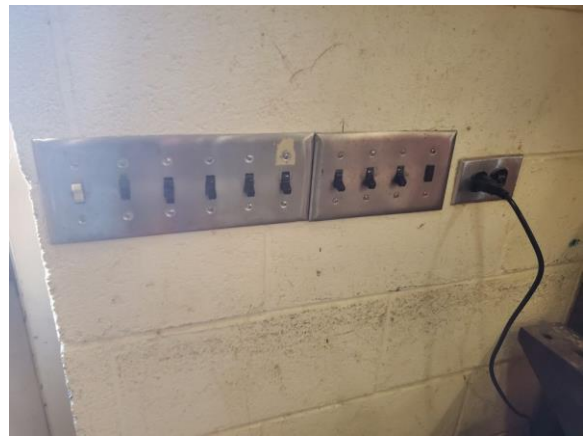
033015e 1/10/2023
Aged light switches
Scene shop 2-E-2

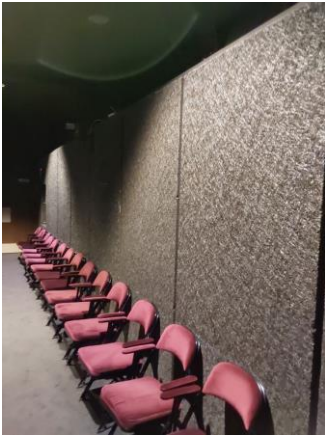
033016a 1/10/2023
Acoustic panel wall
Room 209

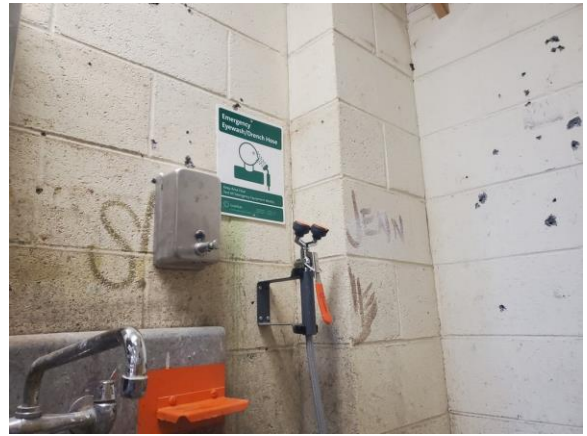
Multiple emergency eyewash/drench hose plumbing fixtures were observed to be in good condition. There are no recommendations.

033016e 1/10/2023
Emergency eyewash/drench hose
Room 204

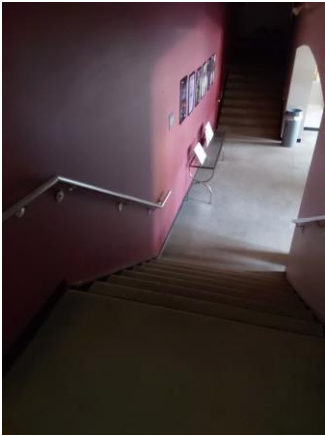
033017a 1/10/2023
Auditorium entry stair
Room 204

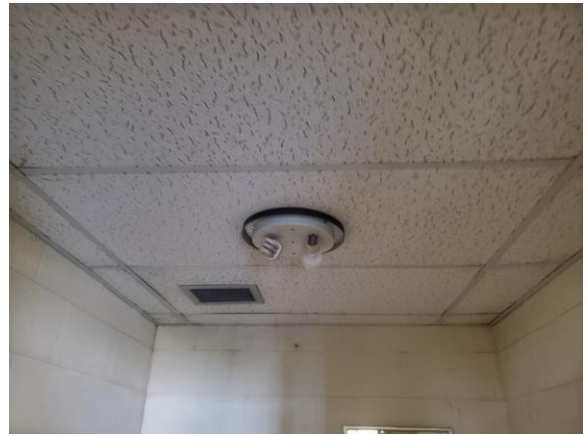
033017e 1/10/2023
Aged surface-mounted light fixture
Room 203

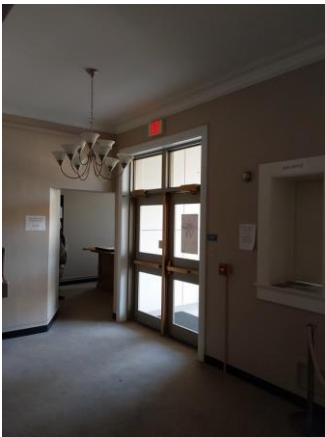
033018a 1/10/2023
Auditorium entrance doors with panic hardware
Room 201

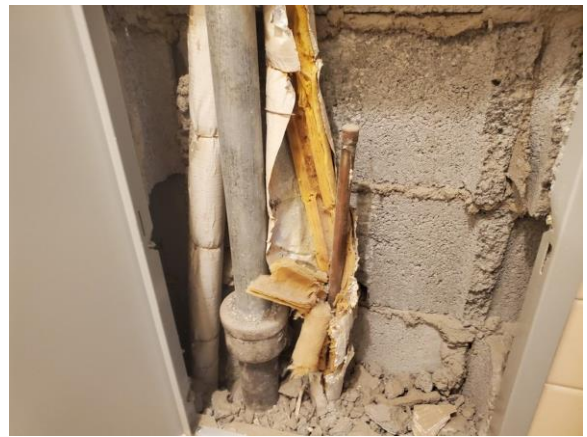
033018e 1/10/2023
Aged supply and waste piping
Room 203

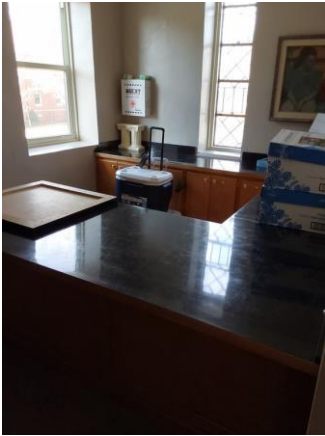
033019a 1/10/2023
Large laminate case work inside
Room 202

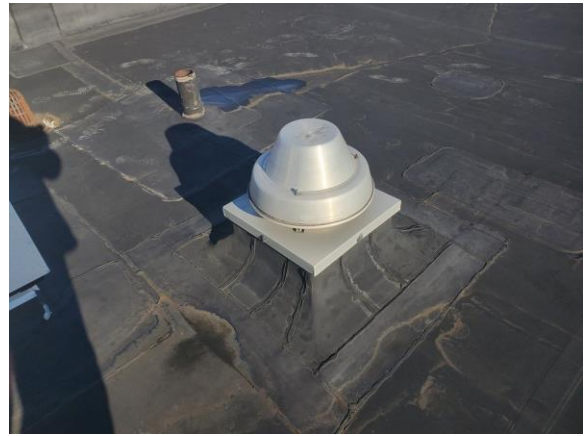
033019e 1/10/2023
Typical rooftop exhaust fan
Scene shop roof

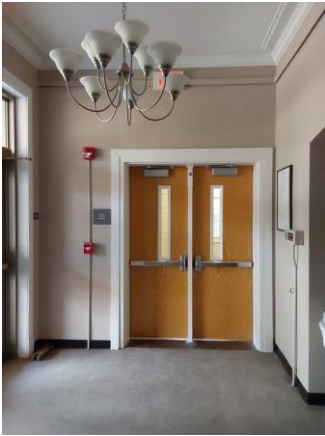
033020a 1/10/2023
Stairwell doors with panic hardware and safety glass
Room 201

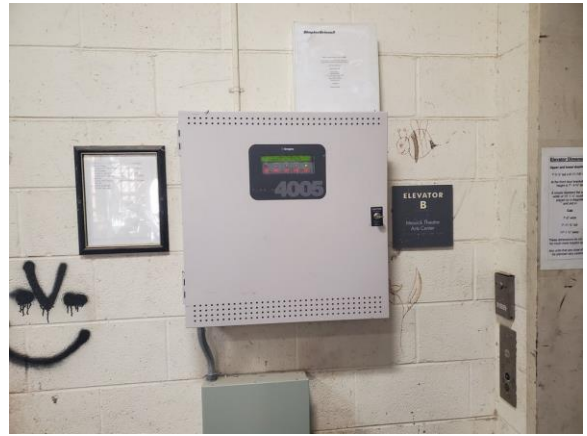
033020e 1/10/2023
Fire alarm control panel for Scene shop
Scene shop 2-E-2

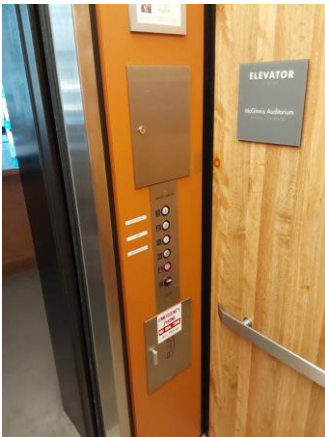
033021a 1/10/2023
Noncompliant elevator control board
Room 202

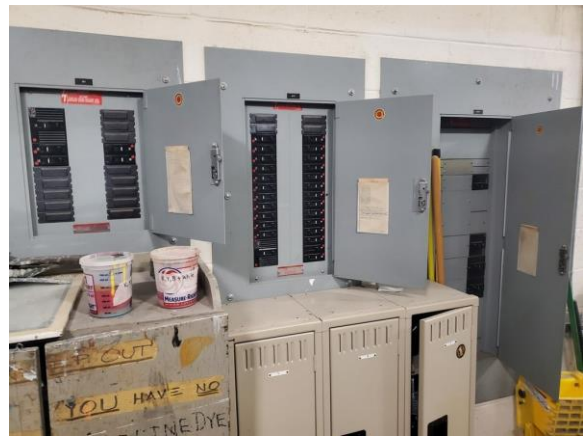
033021e 1/10/2023
1980s vintage secondary electrical equipment
Scene shop room 101

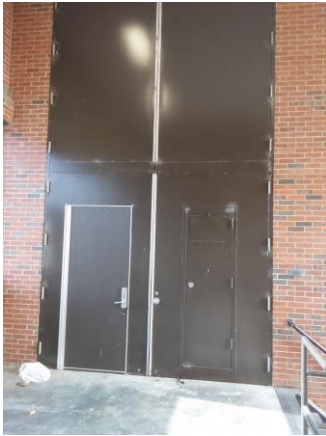
033022a 1/10/2023
Painted exterior stage door
2-E-1

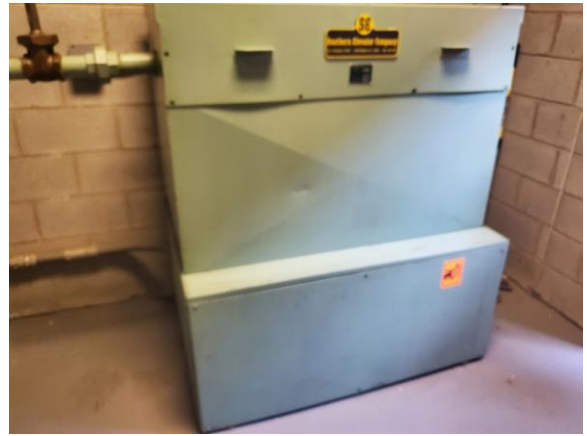
033022e 1/10/2023
Aged hydraulic elevator machine
Elevator machine room 128

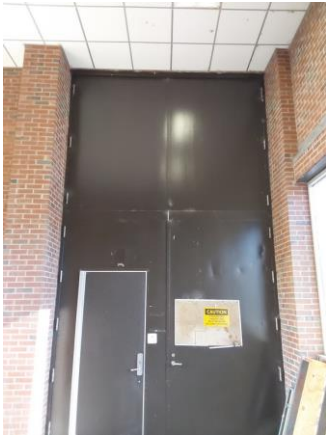
033023a 1/10/2023
Painted exterior shop door
2-E-1

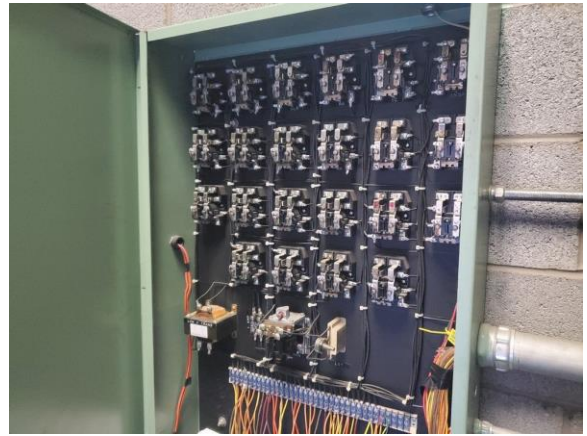
033023e 1/10/2023
Aged elevator machine controls
Elevator machine room 128

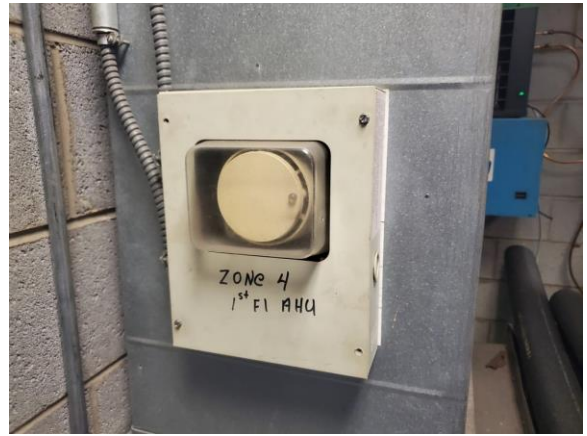
033026e 1/10/2023
Aged duct detector
Mechanical 127

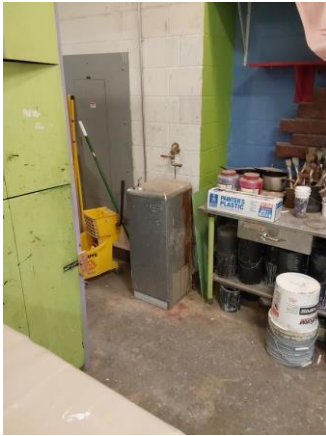
033038a 1/10/2023
Noncompliant water fountain
Room 101

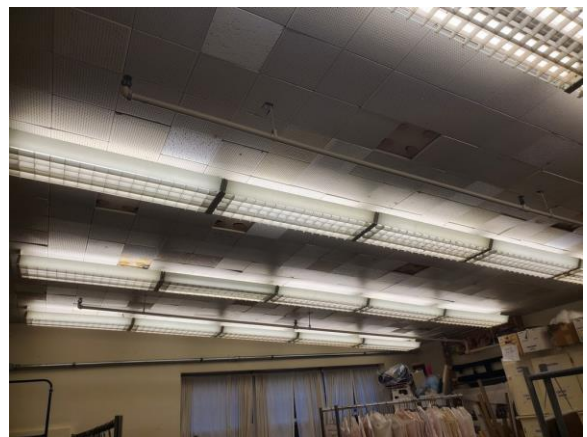
033042e 1/10/2023
Aged, open cell lighting
Room 112

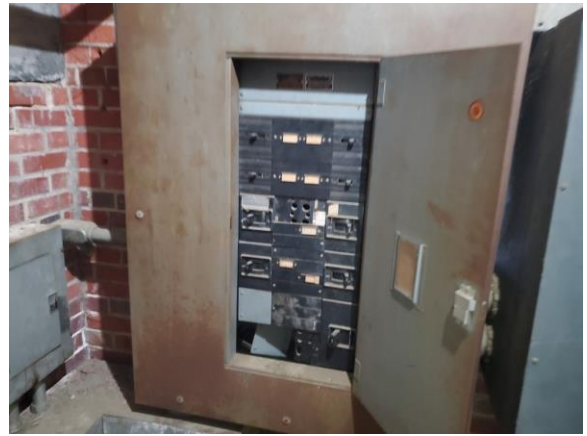
033043e 1/10/2023
Original electrical switchboard
Room 112A

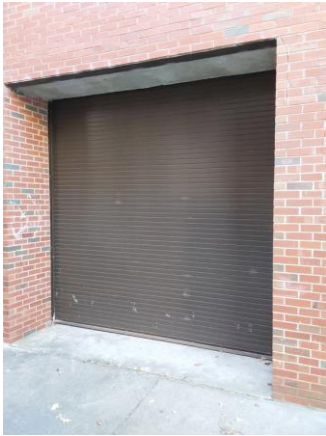
033044a 1/10/2023
Overhead coiling door
Room 131

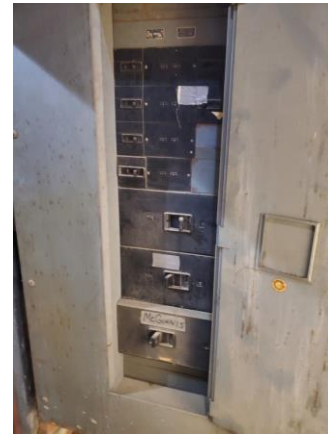
033044e 1/10/2023
Original electrical switchboard
Room 112A

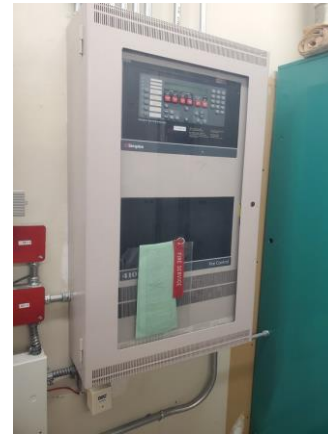
033046e 1/10/2023
Main fire alarm control panel
Mechanical 111

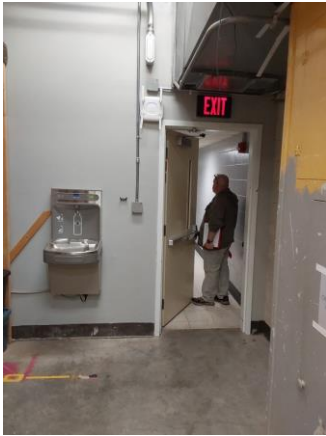
033047a 1/10/2023
Exit door with panic hardware, exit signage, and single
height water fountain
Room 131

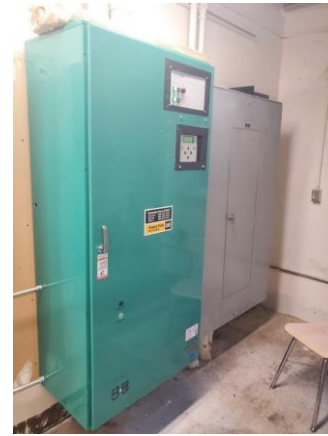
033047e 1/10/2023
208V, 800A automatic transfer switch
Mechanical 111

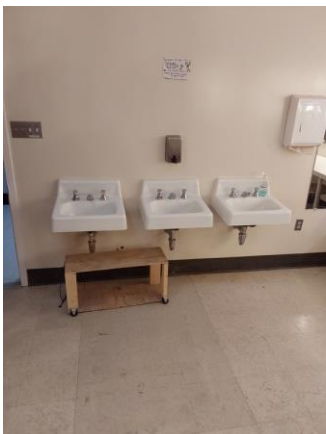
033048a 1/10/2023
Dressing room sinks
Room 125

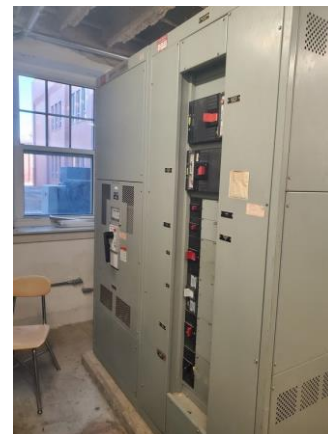
033048e 1/10/2023
2000A switchboard with main breaker
Mechanical 111

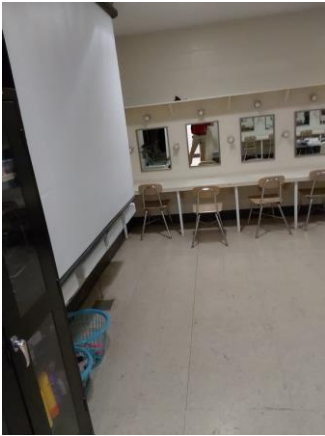
033049a 1/10/2023
Dressing room sinks and mirrors
Room 127

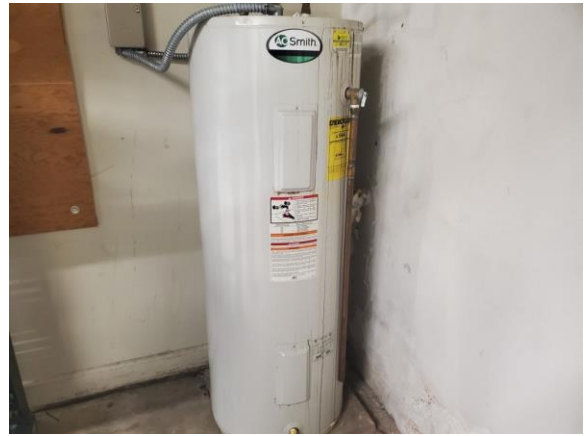
033049e 1/10/2023
Electric domestic water heater
Mechanical 111

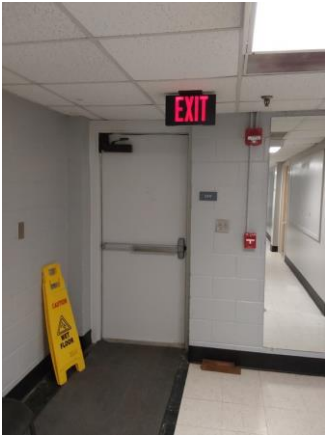
033050a 1/10/2023
Exit door with panic hardware and signage
Room 122

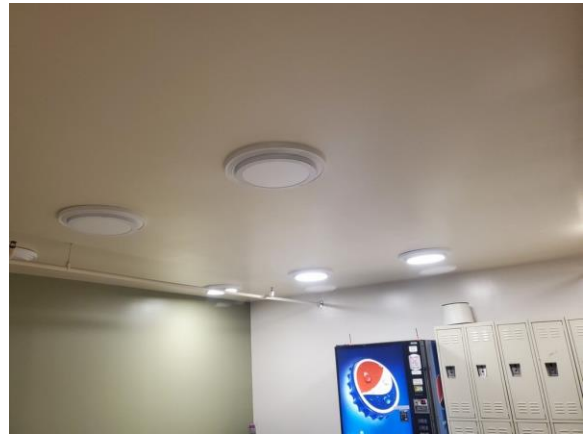
033050e 1/10/2023
Updated LED lighting
Room 115

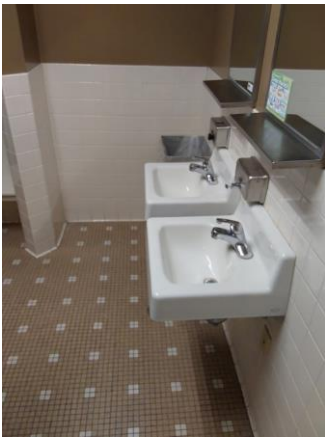
033051a 1/10/2023
Wall-hung lavatories
Room 128

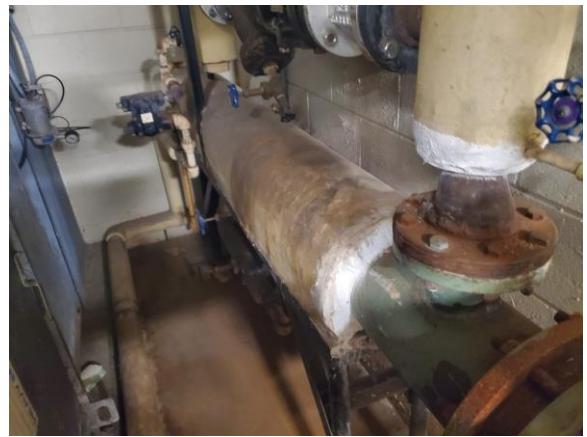
033051e 1/10/2023
Shell-and-tube heat exchanger
Mechanical 126

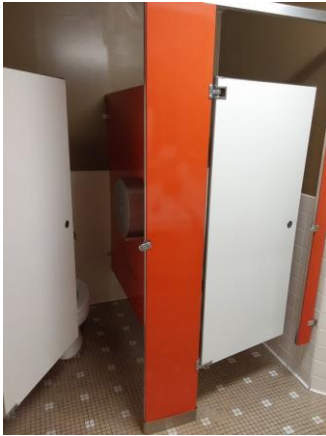
033052a 1/10/2023
Toilet partitions
Room 128

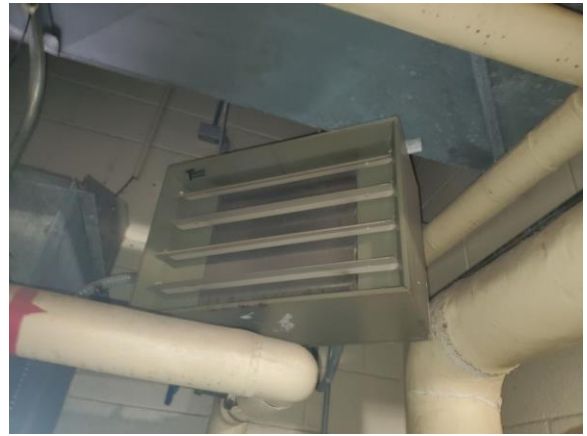
033052e 1/10/2023
Aged hydronic unit heater
Mechanical 126

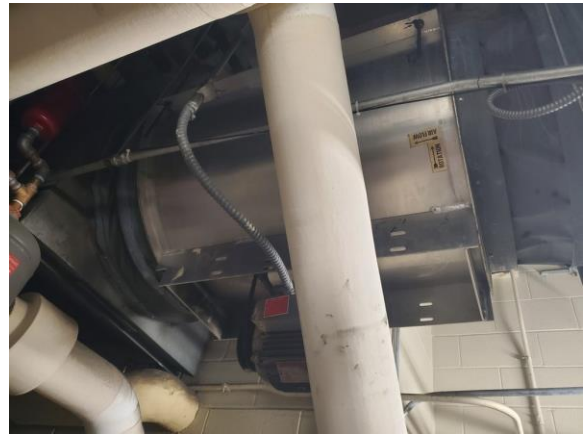
033053e 1/10/2023
Air handler return fan
Mechanical 126

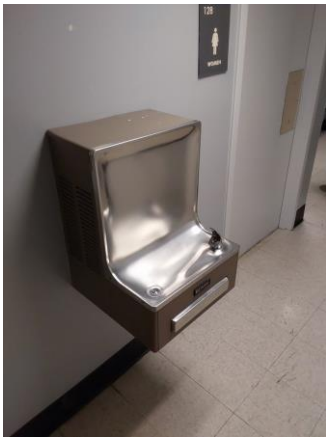
033054a 1/10/2023
Noncompliant water fountain
Room 122

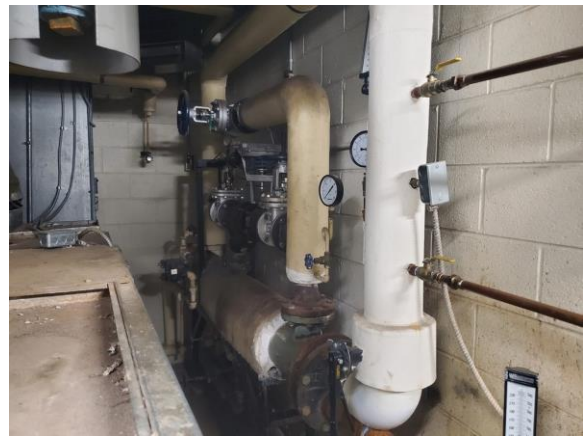
033054e 1/10/2023
Updated isolation valves on heat exchanger
Mechanical 126

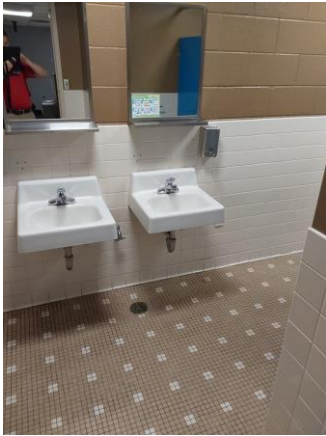
033055a 1/10/2023
Wall-hung lavatories
Room 129

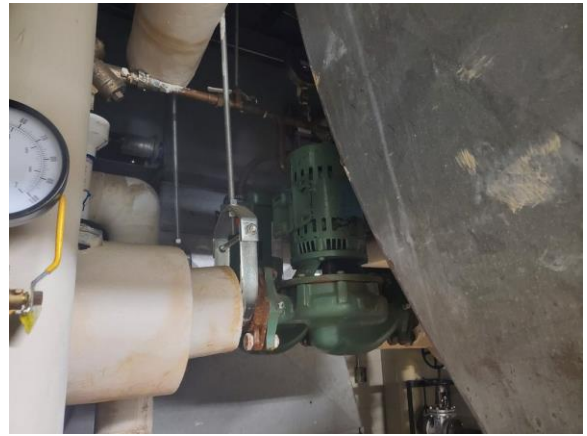
033055e 1/10/2023
Heating water pump
Mechanical 126

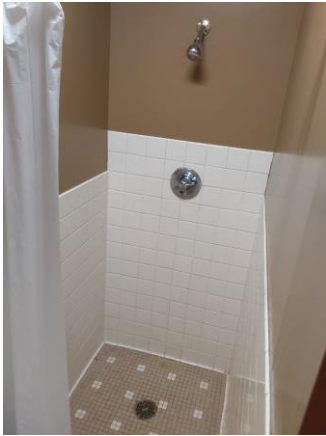
033056a 1/10/2023
Shower
Room 129

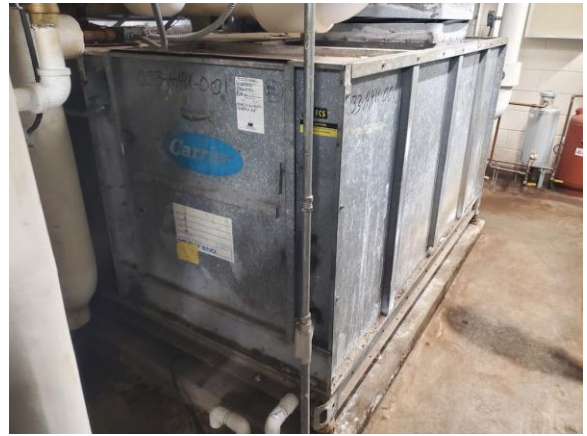
033056e 1/10/2023
Air handler
Mechanical 126

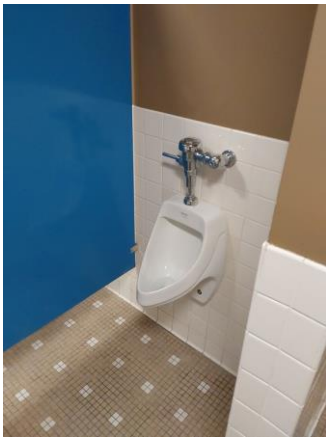
033057a 1/10/2023
Urinal and ceramic finishes
Room 129

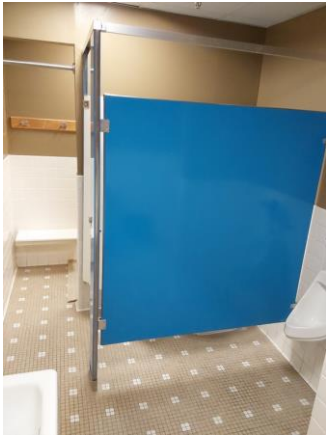
033058a 1/10/2023
Toilet partition
Room 129

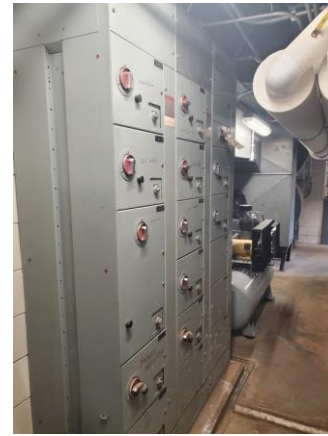
033058e 1/10/2023
Aged motor control center
Mechanical 126

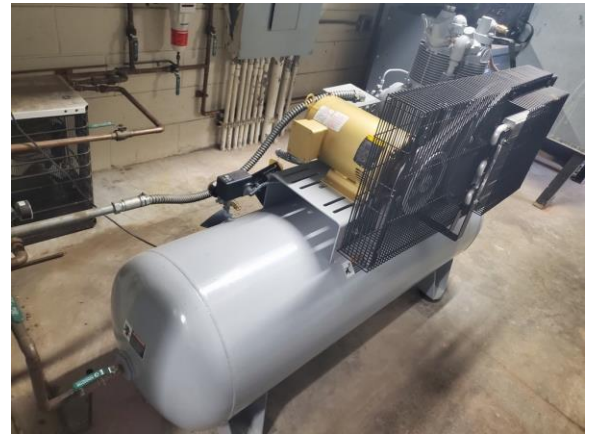
033059e 1/10/2023
Reciprocating air compressor
Mechanical 126

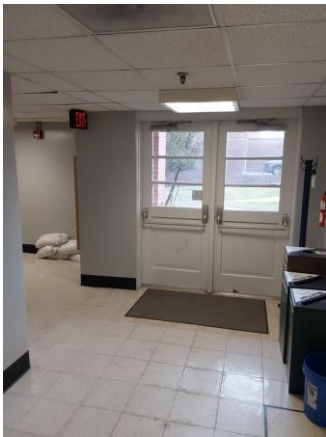
033060a 1/10/2023
Exterior door with old panic hardware and exit signage
Room 110

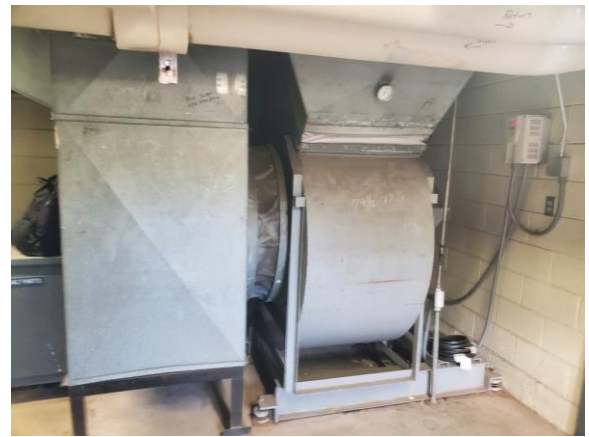
033060e 1/10/2023
Utility set return fan #5
Mechanical 126

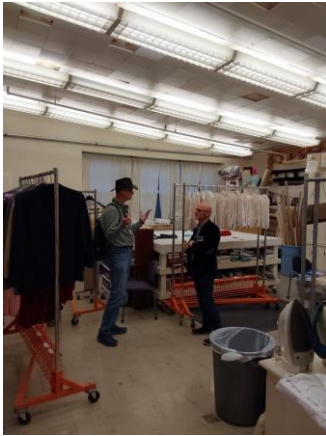
033061a 1/10/2023
Asbestos acoustic ceiling tile and 9x9 tile
Room 112

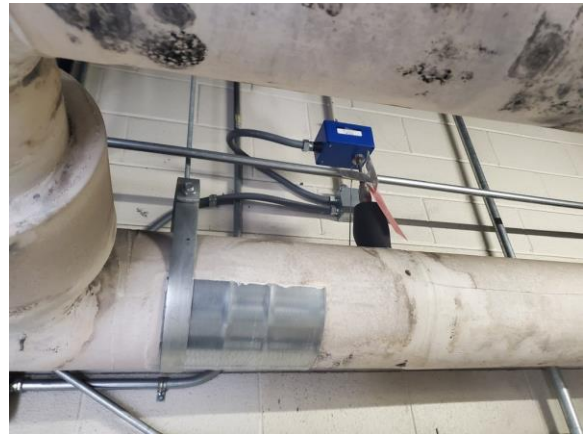
033061e 1/10/2023
Updated controls on distribution piping
Mechanical 126

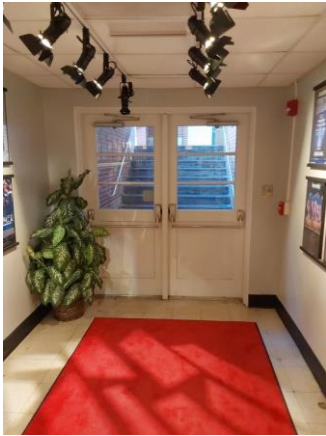
033062a 1/10/2023
Exterior door with old panic hardware
Room 106

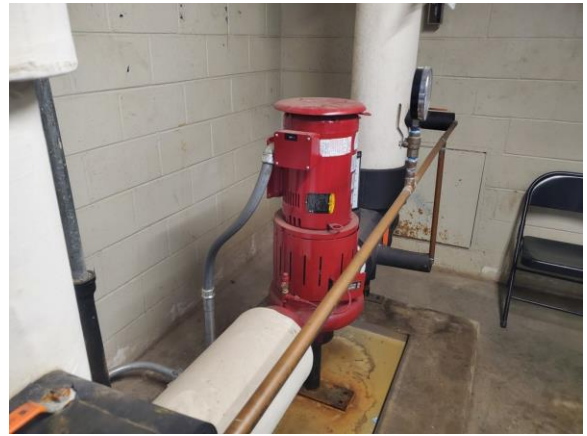
033062e 1/10/2023
Chilled water pump
Mechanical 126

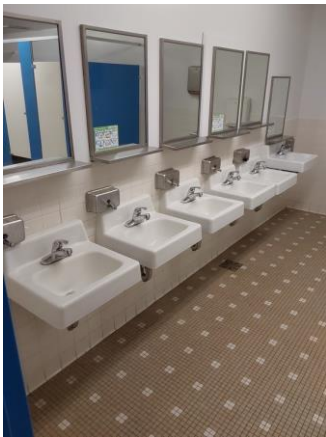
033063a 1/10/2023
Wall-hung lavatories
Room 105

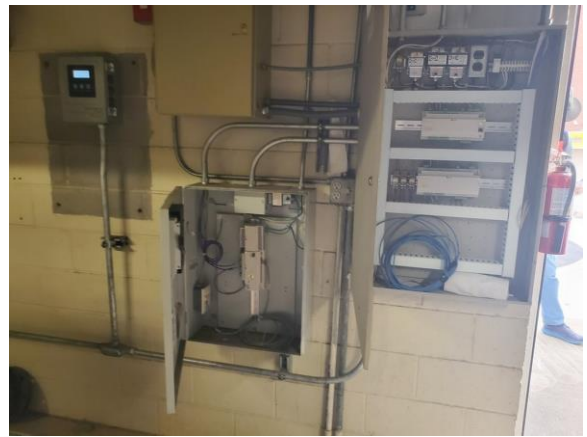
033063e 1/10/2023
Updated HVAC control system components
Mechanical 126

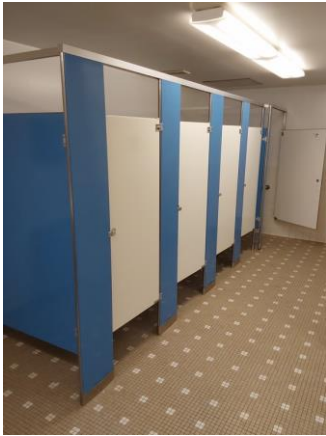
033064a
Toilet partitions
Room 105
1/10/2023

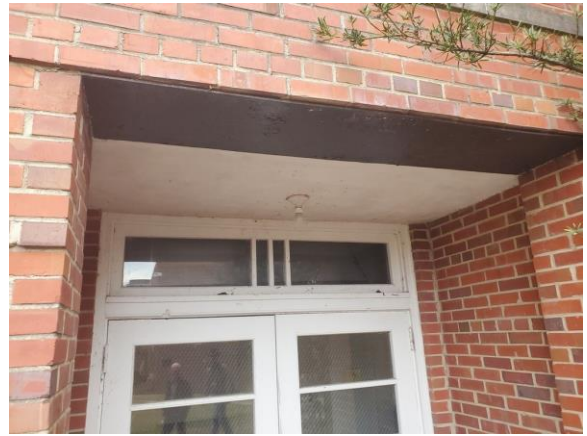
033065e
Aged surface mounted light fixture
Exterior
1/10/2023

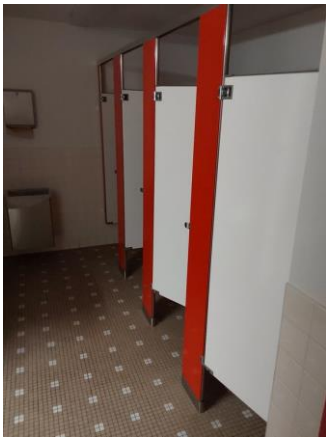
033066a
Toilet partitions
Room 108
1/10/2023

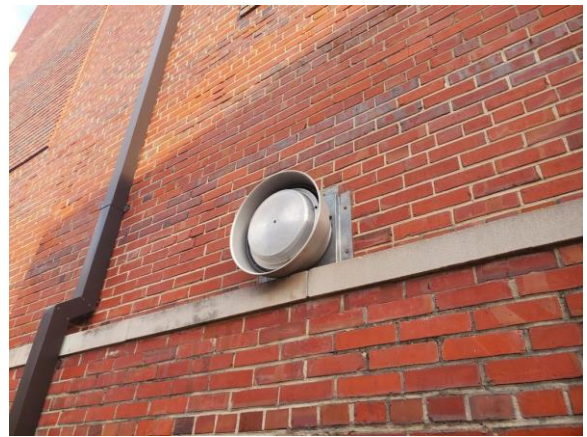
033066e
Steam kettle hood exhaust fan
Exterior
1/10/2023

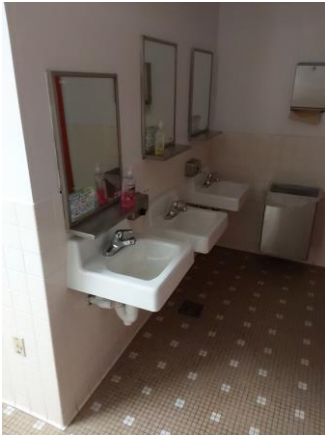
033067a 1/10/2023
Wall-hung lavatories with mirrors
Room 108

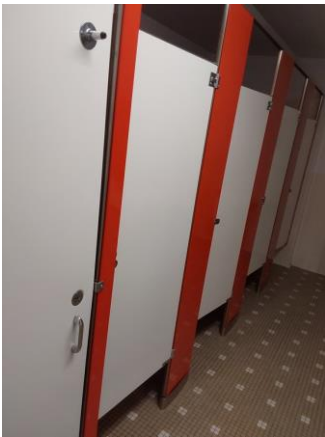
033069a 1/10/2023
Toilet partitions
Room 108

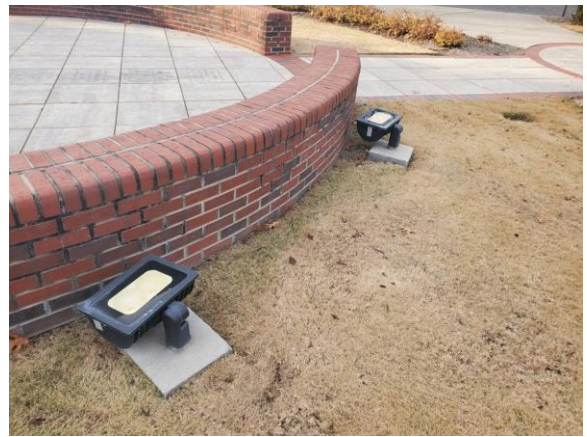
033069e 1/10/2023
Upward illuminating site lighting
Exterior

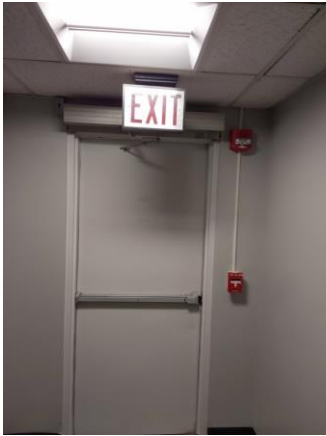
033070a 1/10/2023
Exit door with panic hardware signage
Room 101

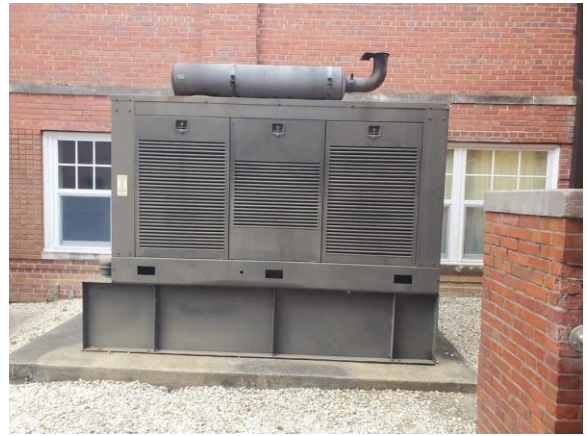
033070e 1/10/2023
Diesel-fired emergency generator
Exterior

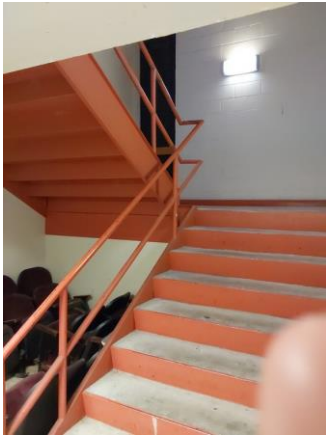
033075a 1/10/2023
Noncompliant stair handrail
Room 121

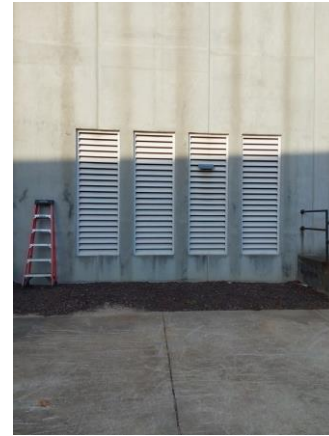
033076a 1/10/2023
Exterior mechanical louvers
South elevation

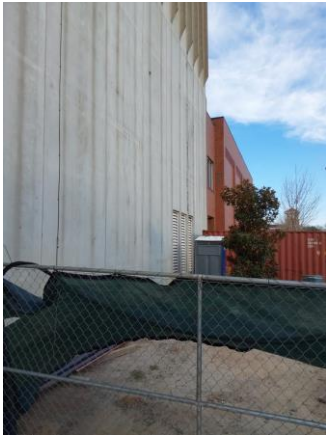
033077a 1/10/2023
Exterior concrete wall
South elevation

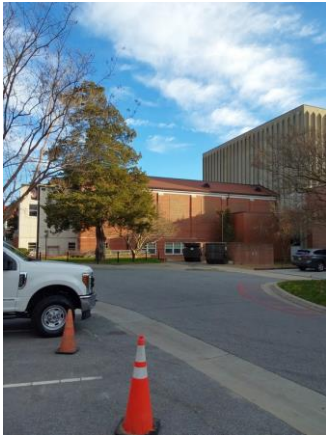
033081a 1/10/2023
Exterior brick, stone, and glazing
West elevation

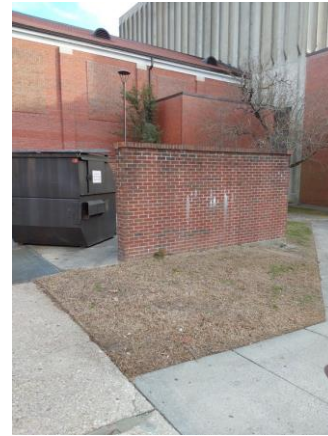
033082a 1/10/2023
Efflorescence on dumpster walls
West elevation

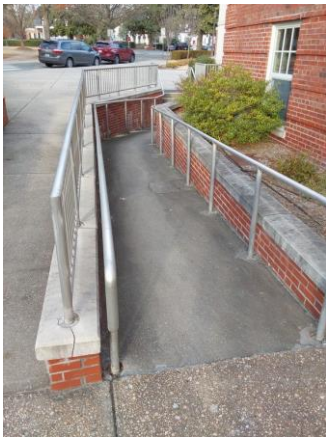
033083a 1/10/2023
ADA ramp
West elevation

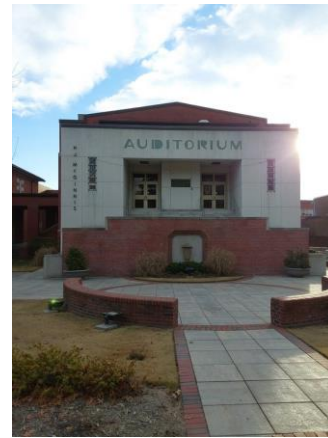
033084a 1/10/2023
Exterior brick, stone, and glazing
North elevation

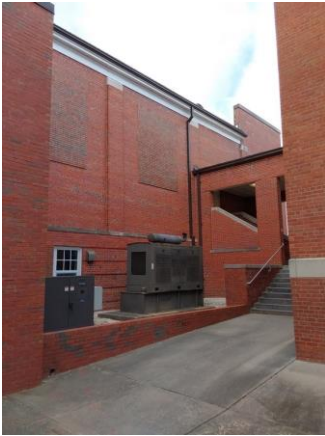
033087a 1/10/2023
Exterior brick and glazing
East elevation

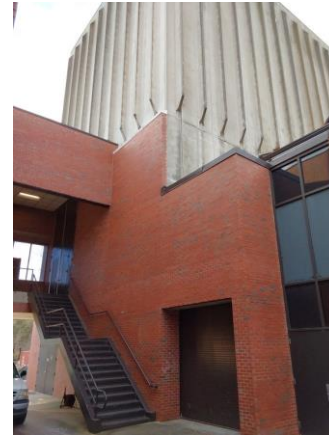
033090a 1/10/2023
Exterior brick, glazing, and doors
East elevation

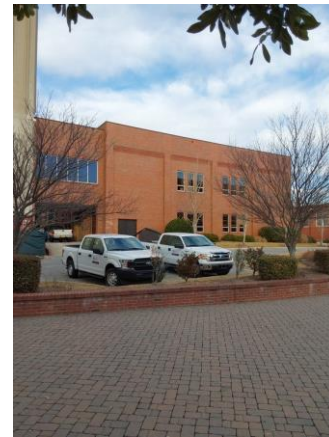
033092a 1/10/2023
Exterior brick and glazing with drive
Shop south elevation

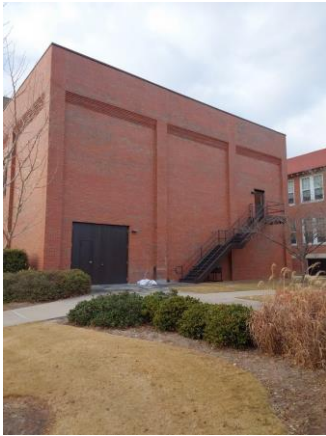
033093a 1/10/2023
Exterior brick and hollow-metal doors
Shop east elevation

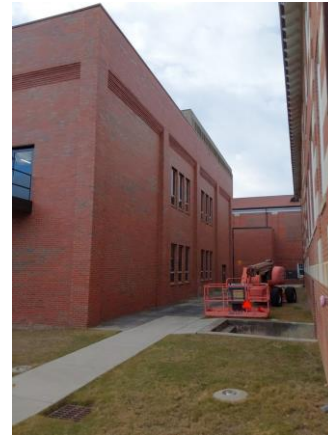
033094a 1/10/2023
Exterior brick and glazing
Shop north elevation
